# VEHICLE INSPECTION REPORT

**LG17YYC**

## Kia Ceed 1.6 CRDi ISG 2 5dr DCT

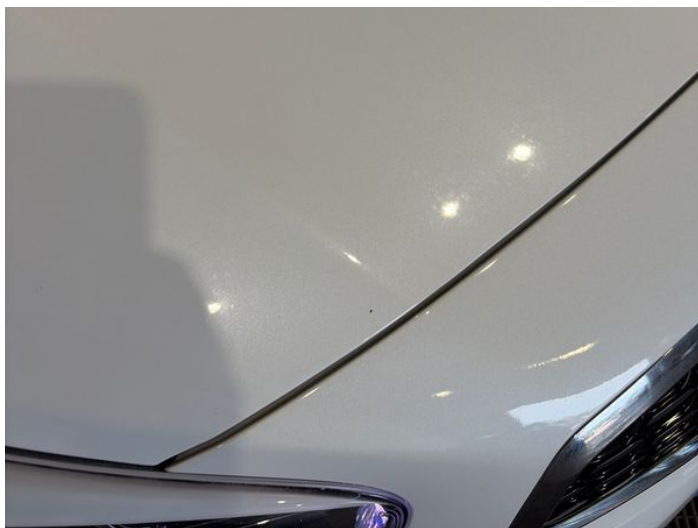
1: Bonnet  
Chipped  
1 To 5

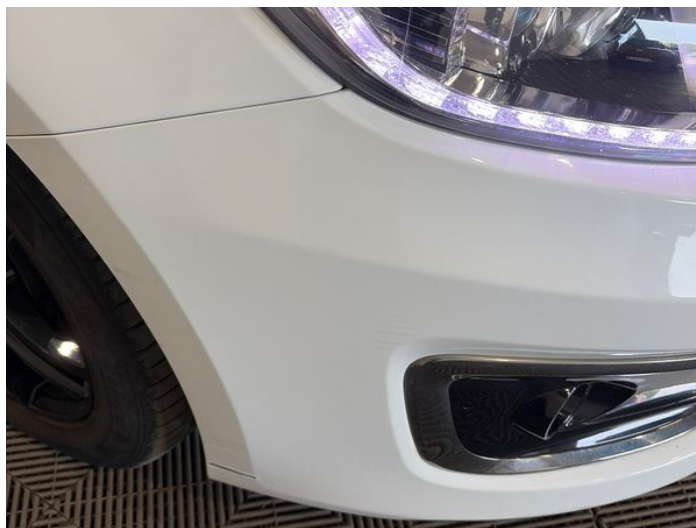
2: Bumper Front  
Scratched  
25 to 100mm Thru Paint

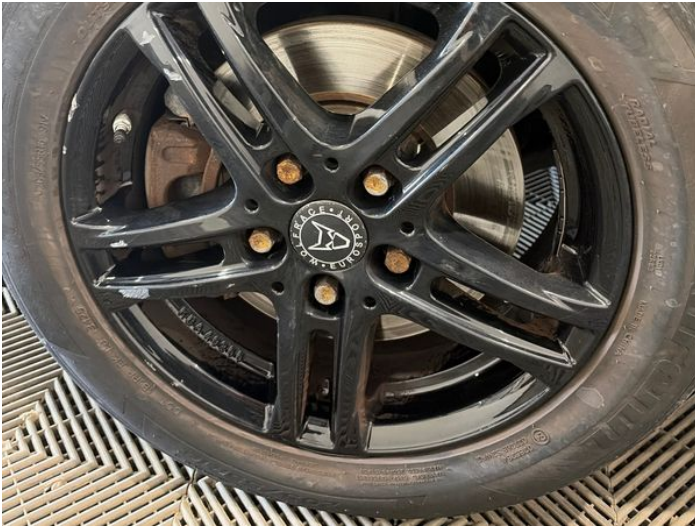
3: Wheel nsf  
Scratched  
Over 50mm

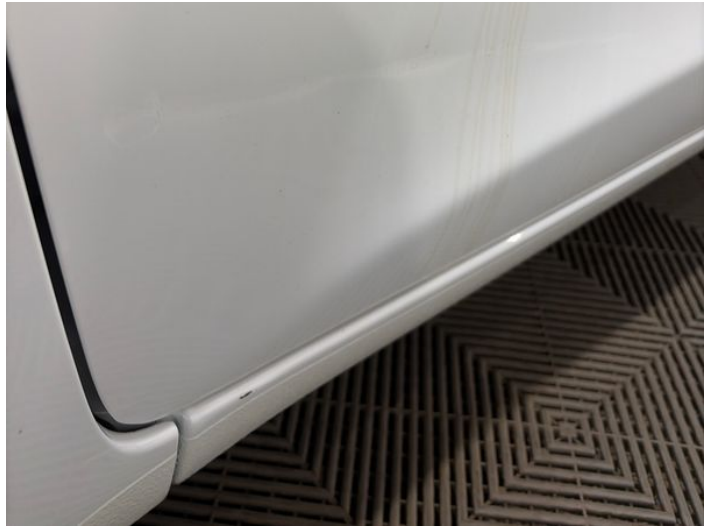
4: Door nsf  
Dented  
Over 30mm

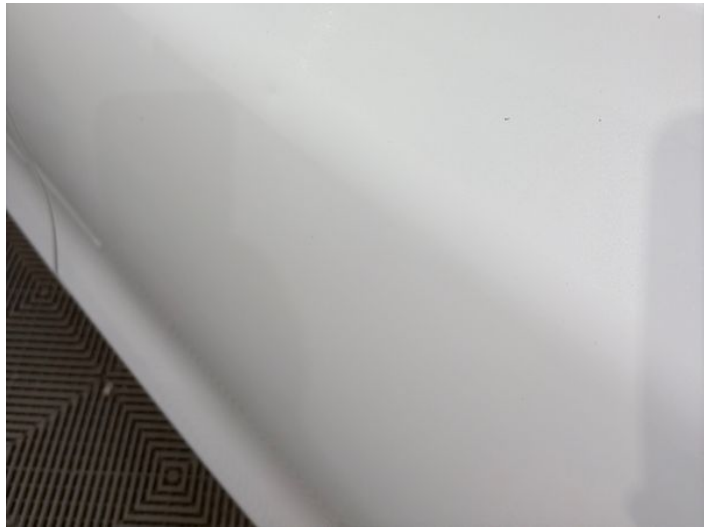
6: Door nsr  
Dented  
Between 10mm + 30mm

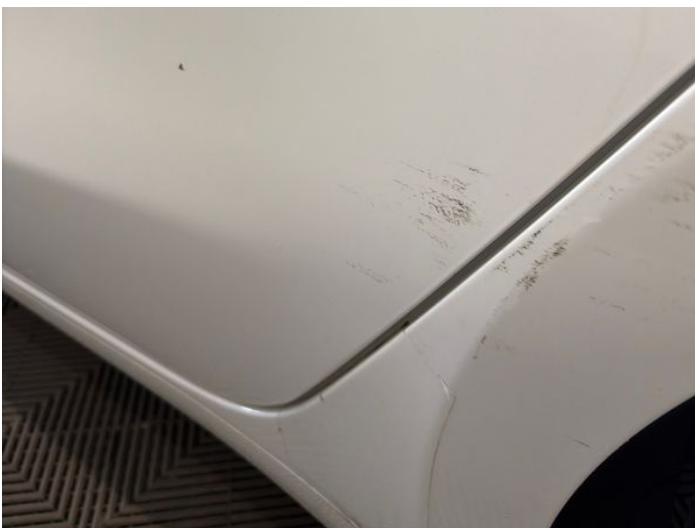
7: Door nsr  
Scratched  
Over 25mm Thru Paint

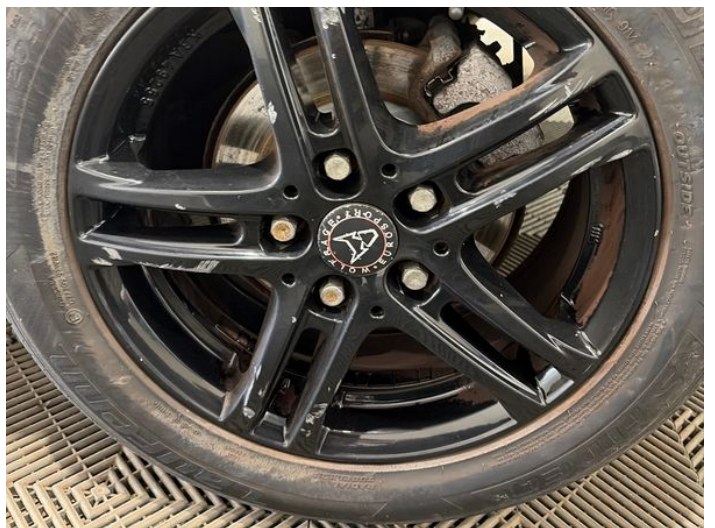
8: Wheel nsr  
Scratched  
Over 50mm

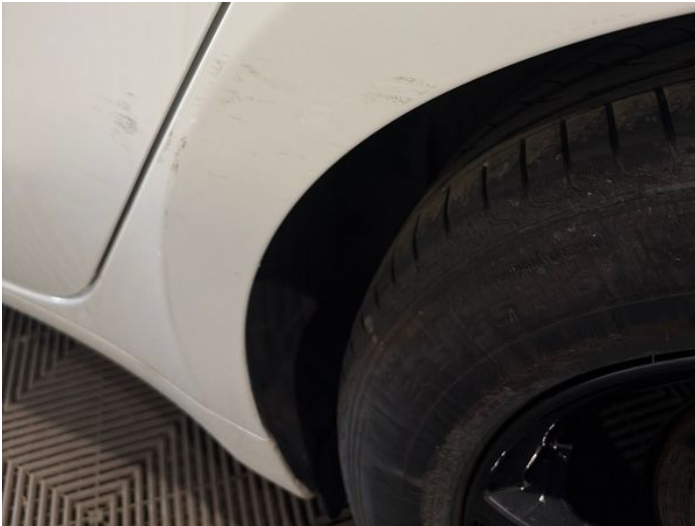
9: Qtr Panel nsr  
Scratched  
Over 25mm Thru Paint

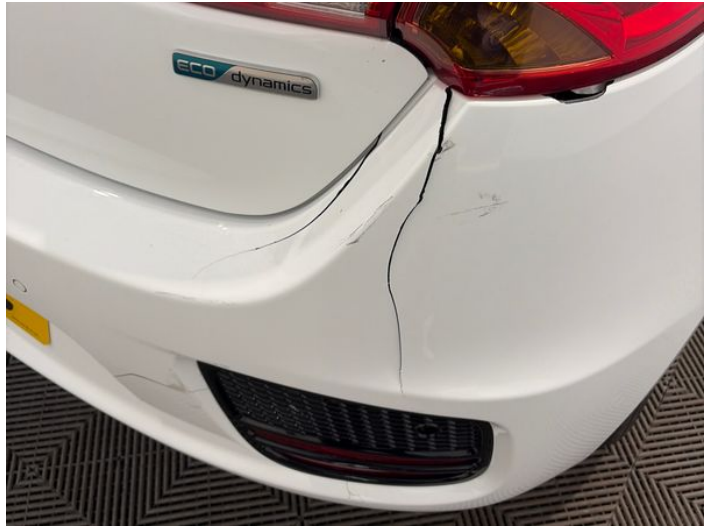
10: Bumper Rear  
Cracked  
Over 25mm

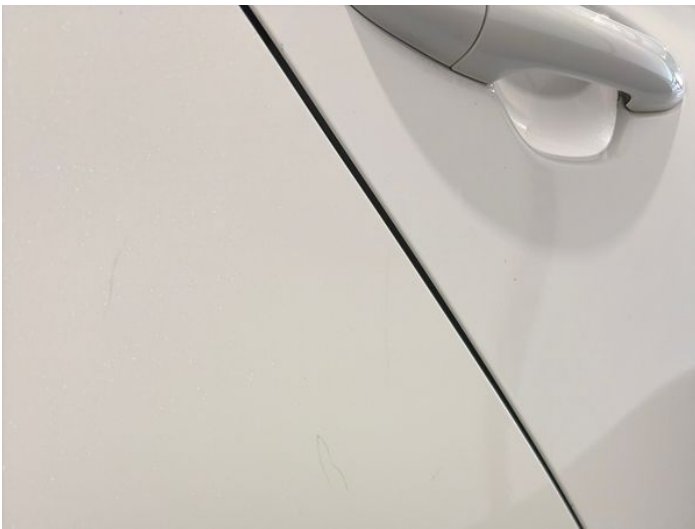
11: Qtr Panel osr  
Scratched  
UpTo 25mm Thru Paint

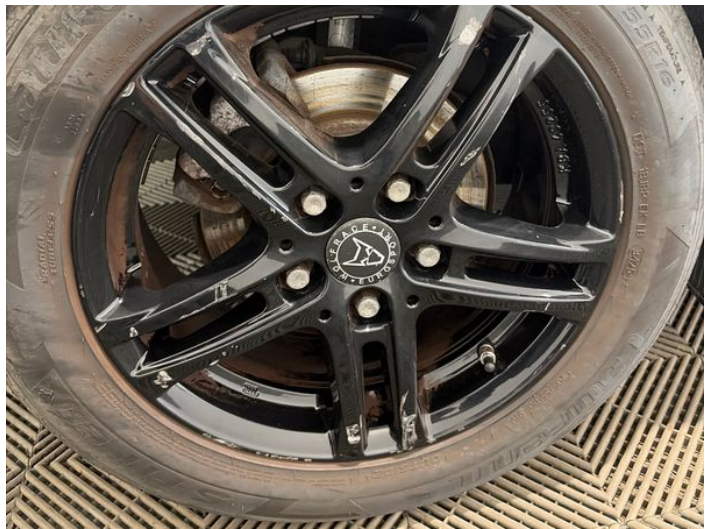
12: Wheel osr  
Scratched  
Over 50mm

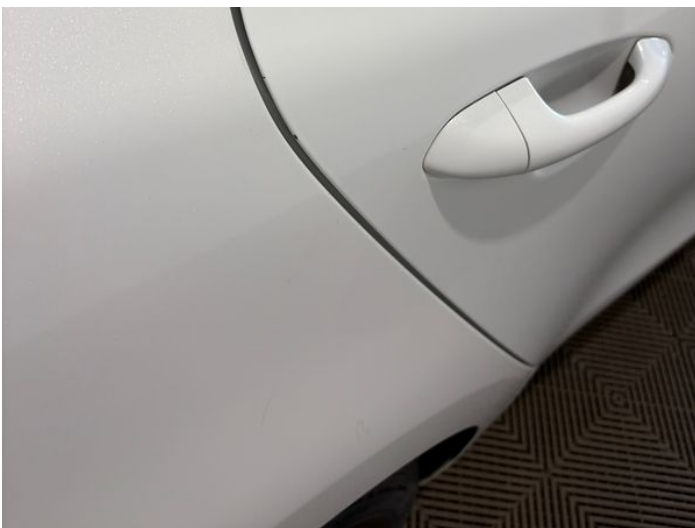
13: Door osr  
Chipped  
Edge Chip

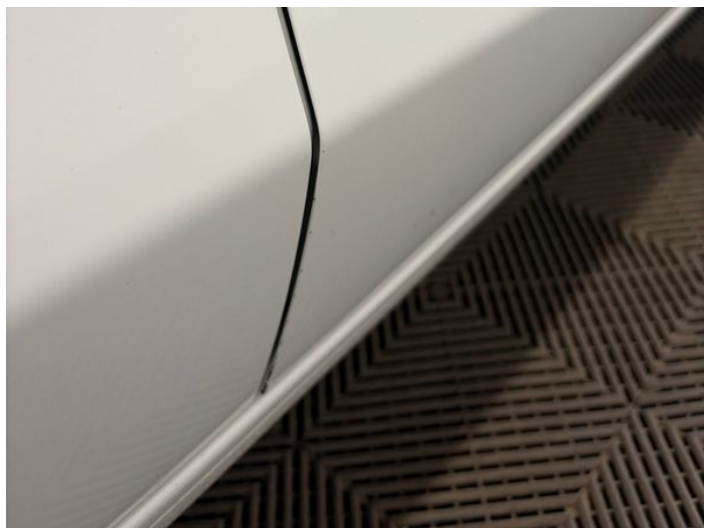
14: Door osf  
Chipped  
Edge Chip

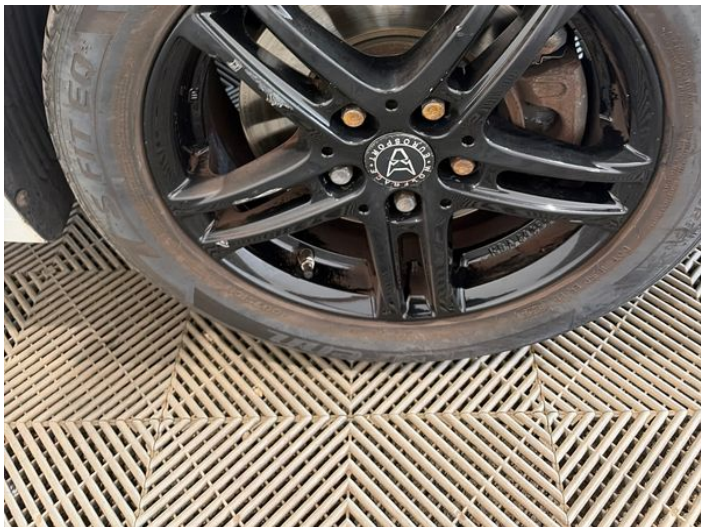
15: Wheel osf  
Scratched  
Over 50mm

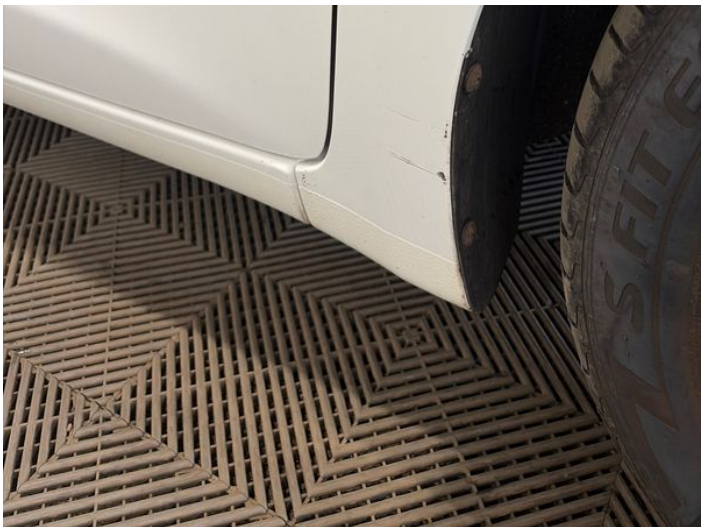
16: Wing osf  
Scratched  
Over 25mm Thru Paint

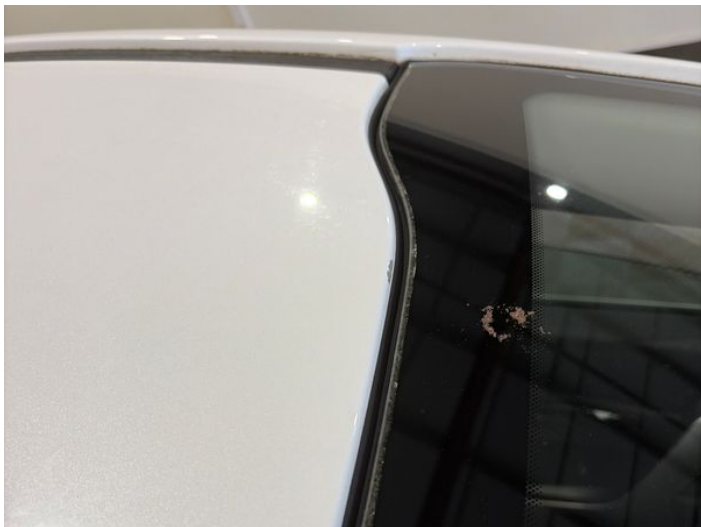
17: Roof  
Chipped  
Edge Chip
