# VEHICLE INSPECTION REPORT

**GU58BVA**

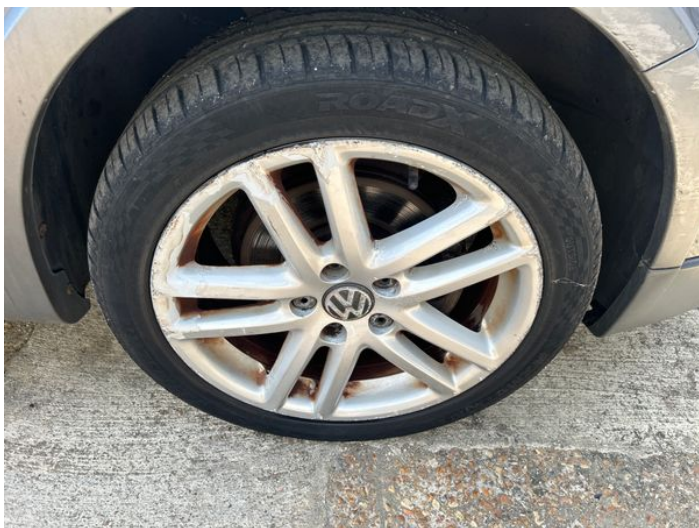
1: Wheel osf  
Scratched  
Over 50mm

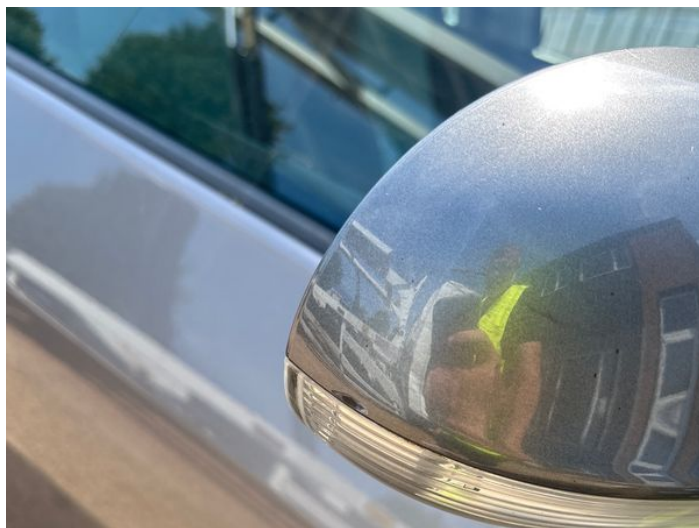
2: Door Mirror Assy osf  
Scratched (Painted)  
UpTo 25mm Thru Paint

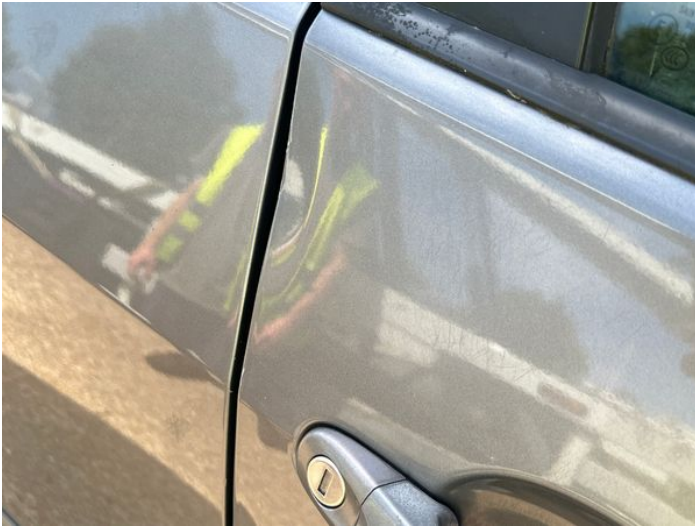
3: Door osf  
Dented  
Over 30mm

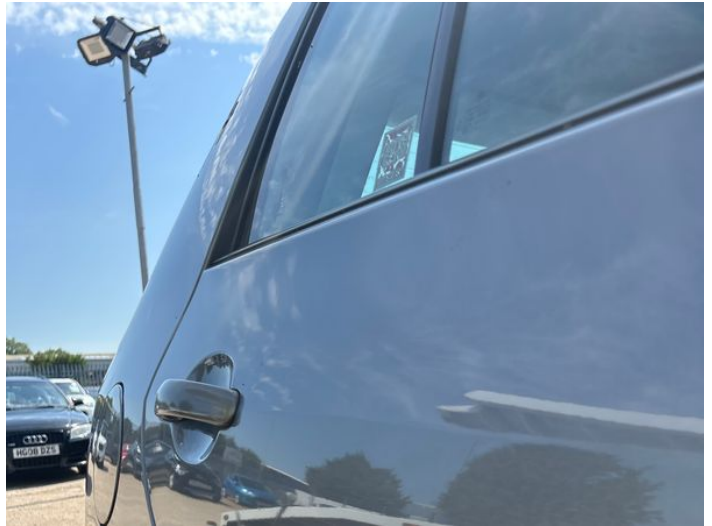
4: Door osr  
Dented  
Between 10mm + 30mm

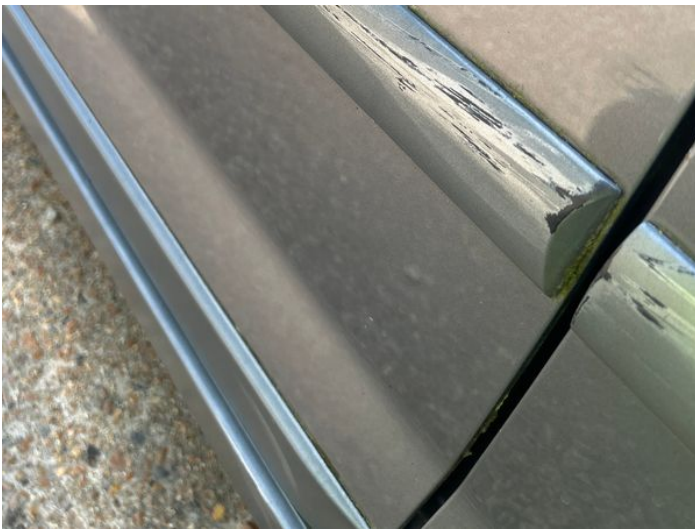
5: Door Moulding osr  
Scratched (Painted)  
Over 25mm Thru Paint

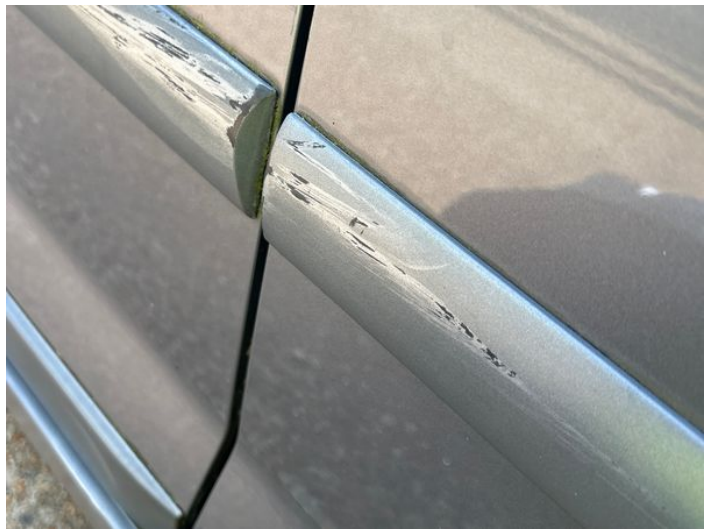
6: Door Moulding osf  
Scratched (Painted)  
Over 25mm Thru Paint

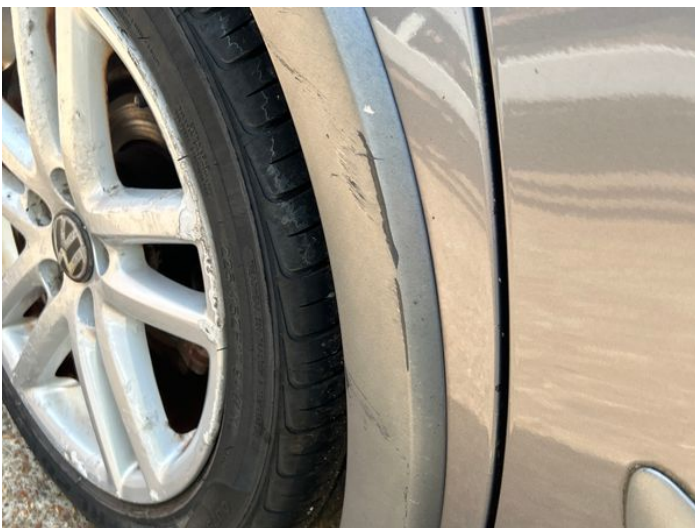
7: Qtr Panel Arch Extension os  
Scratched (Painted)  
Over 25mm Thru Paint

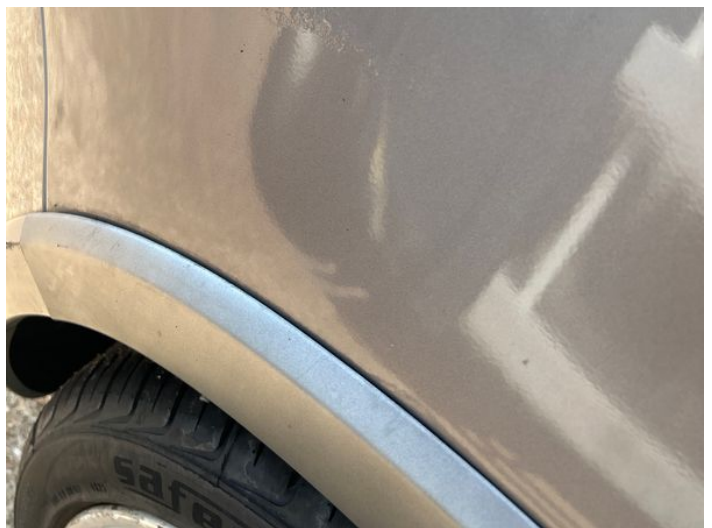
8: Qtr Panel osr  
Rusted  
Over 5mm

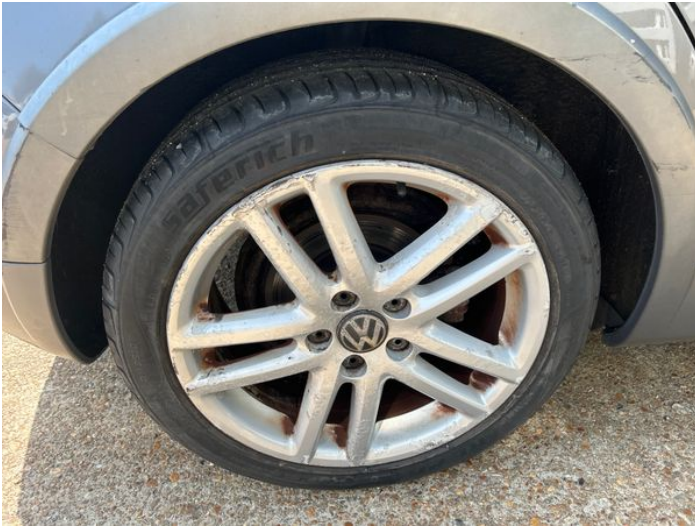
9: Wheel osr  
Corroded  
Light

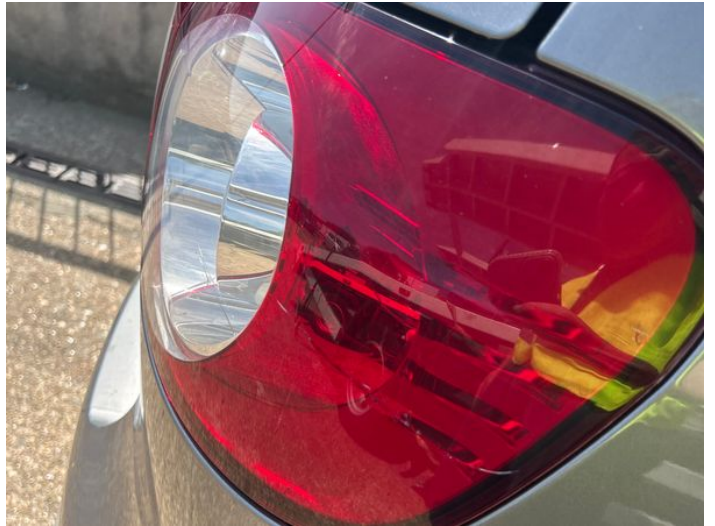
10: Lamp osr  
Broken  
Replace

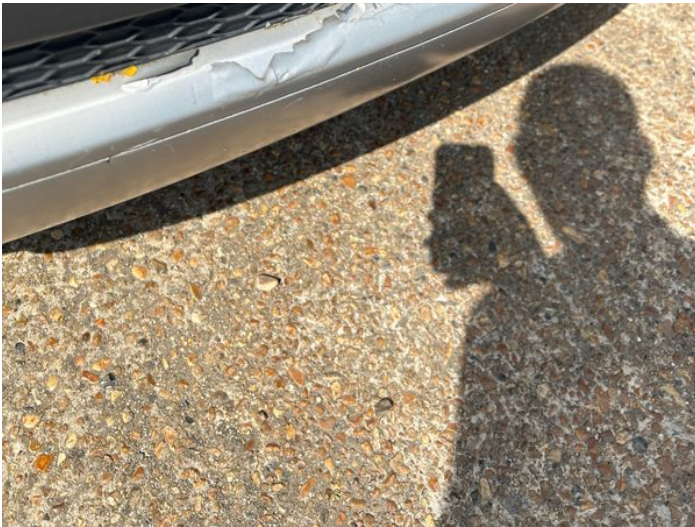
11: Bumper Rear Moulding  
Scratched (Painted)  
Over 25mm Thru Paint

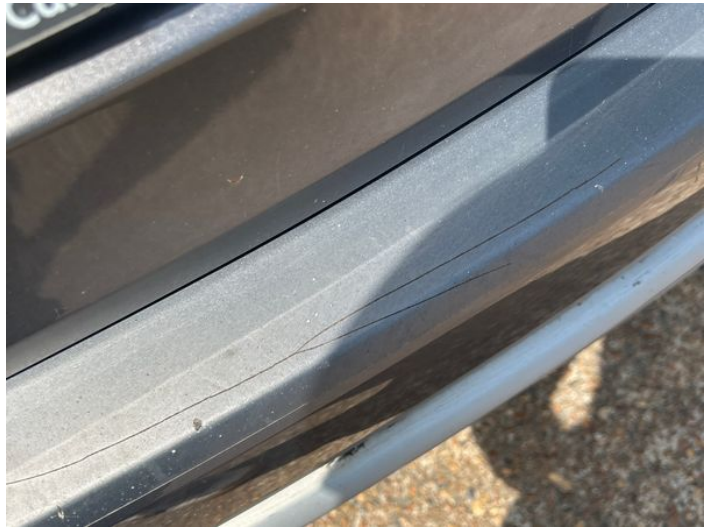
12: Bumper Rear  
Scratched  
Over 100mm Thru Paint

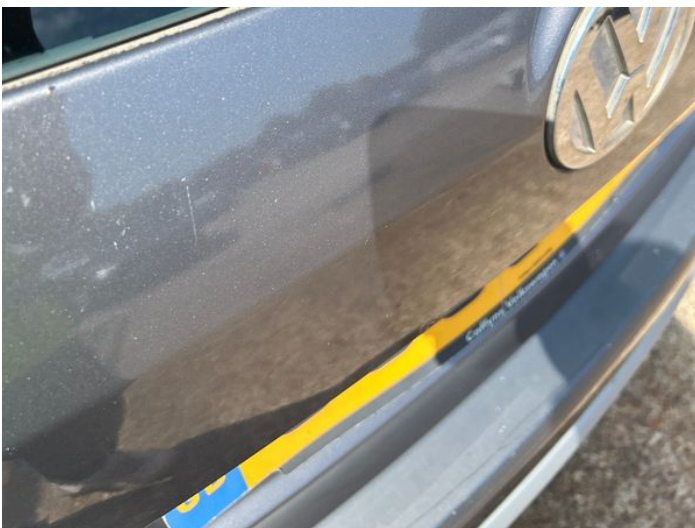
13: Tailgate  
Chipped  
1 To 5

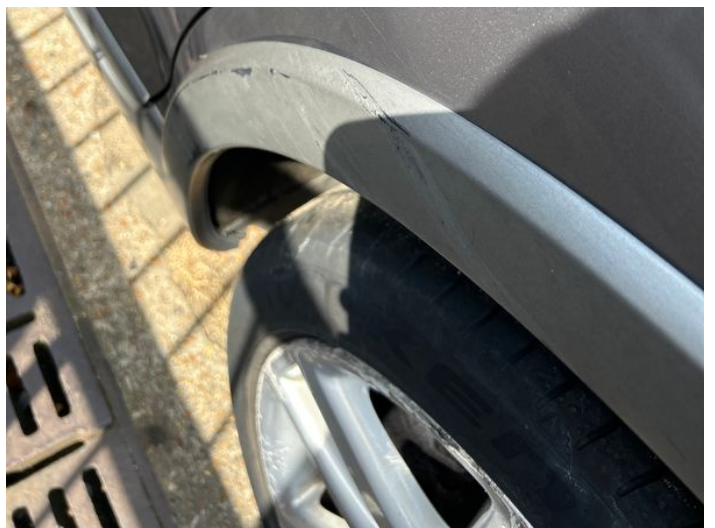
14: Qtr Panel nsr  
Dented  
Over 30mm

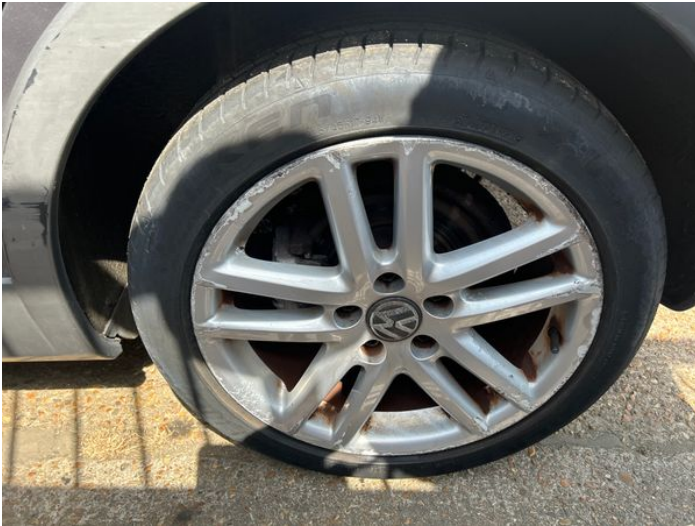
15: Wheel nsr  
Scratched  
Over 50mm

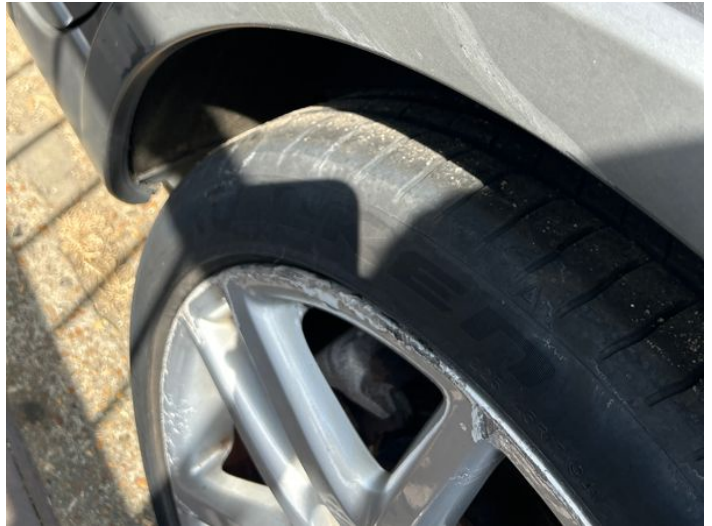
16: Qtr Panel Arch Extension ns  
Scratched (Painted)  
Over 25mm Thru Paint

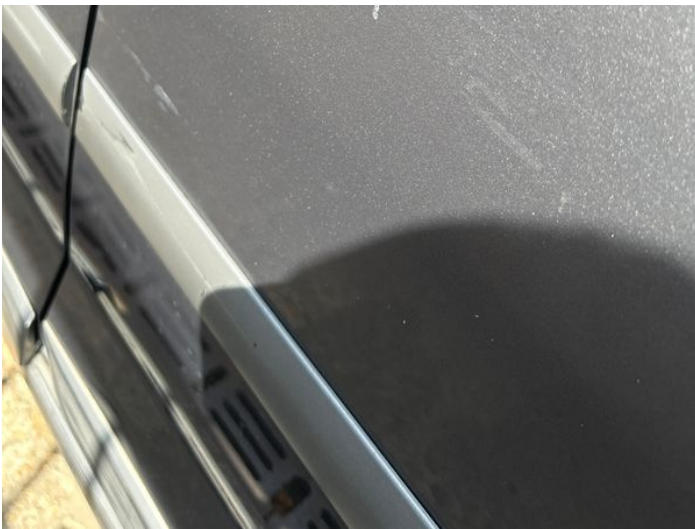
17: Door nsr  
Chipped  
1 To 5

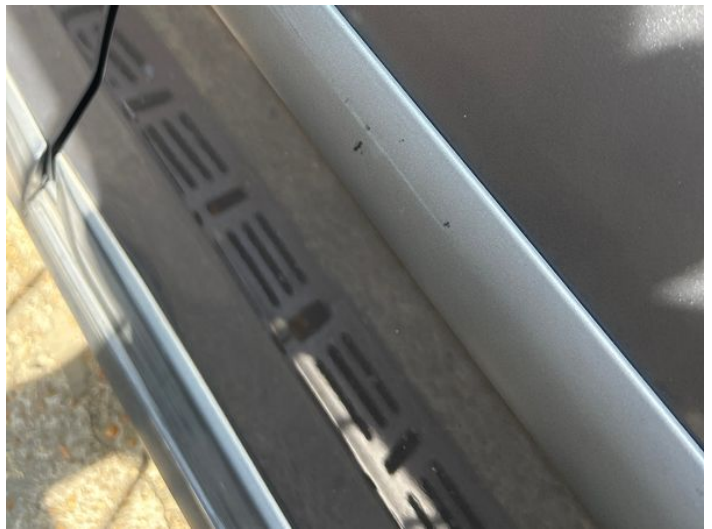
18: Door Moulding nsr  
Scratched (Painted)  
Over 25mm Thru Paint

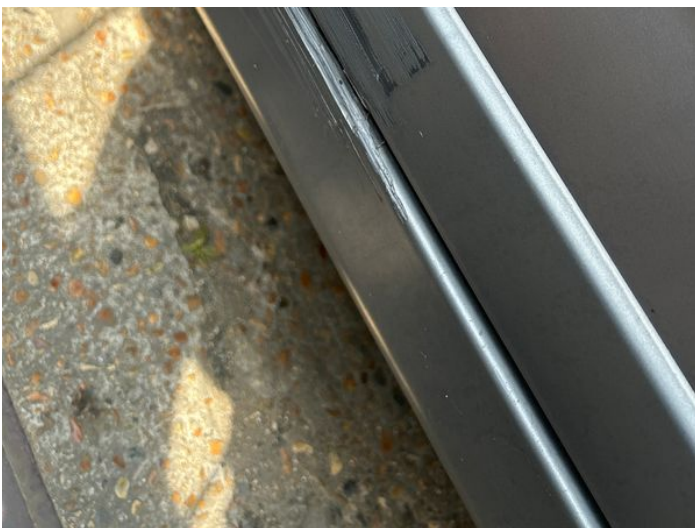
19: Sill Panel Trim ns  
Scratched (Painted)  
Over 25mm Thru Paint

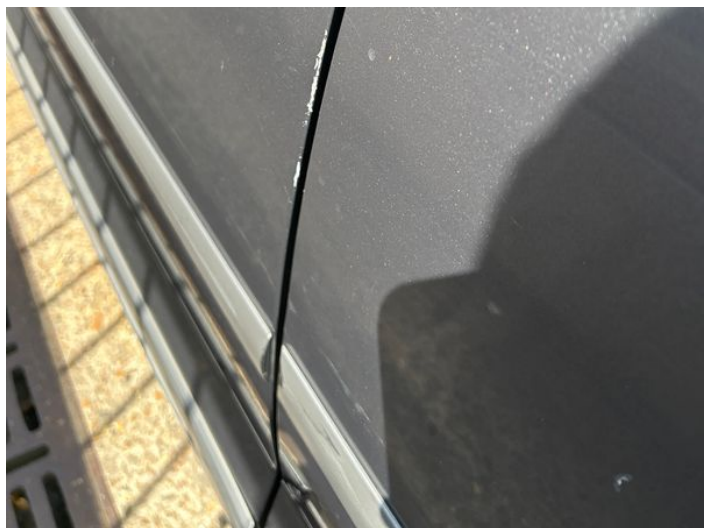
20: Door nsf  
Chipped  
Edge Chip

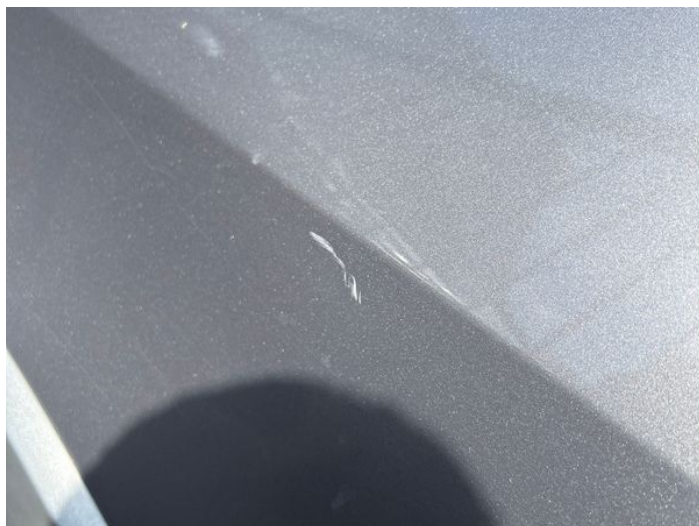
22: Wing nsf  
Scratched  
UpTo 25mm Thru Paint

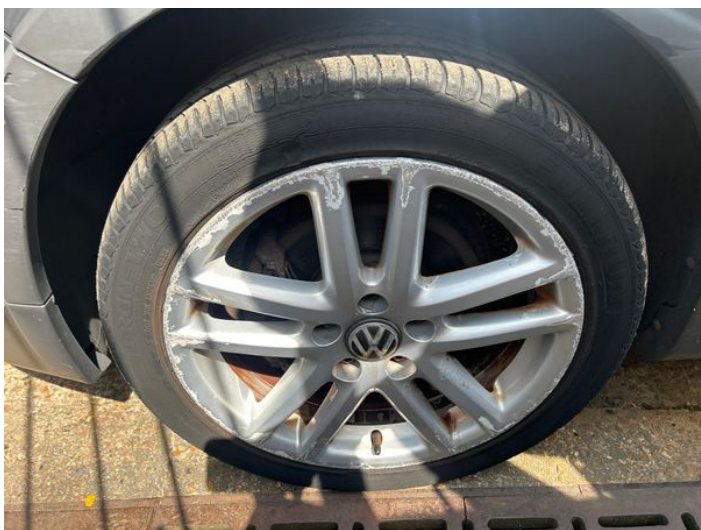
23: Wheel nsf  
Scratched  
Over 50mm

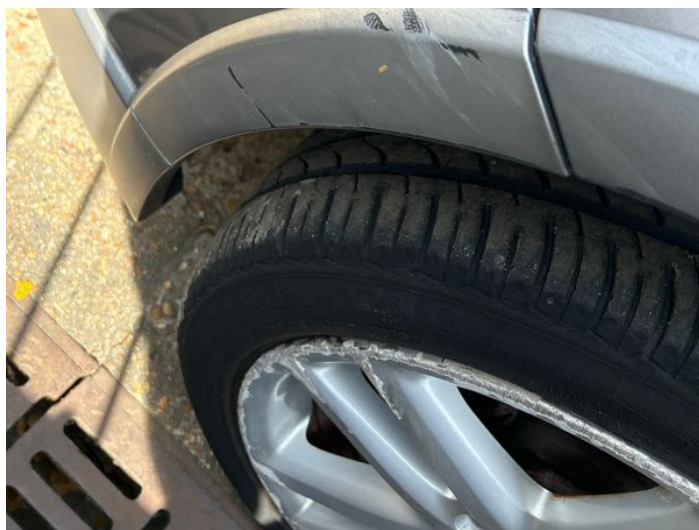
24: Bumper Front Moulding  
Scratched (Painted)  
Over 25mm Thru Paint

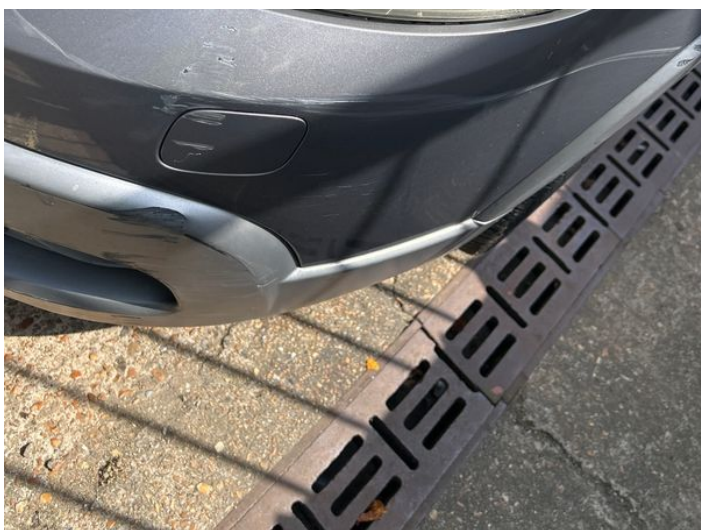
25: Bumper Front  
Scratched  
Over 100mm Thru Paint

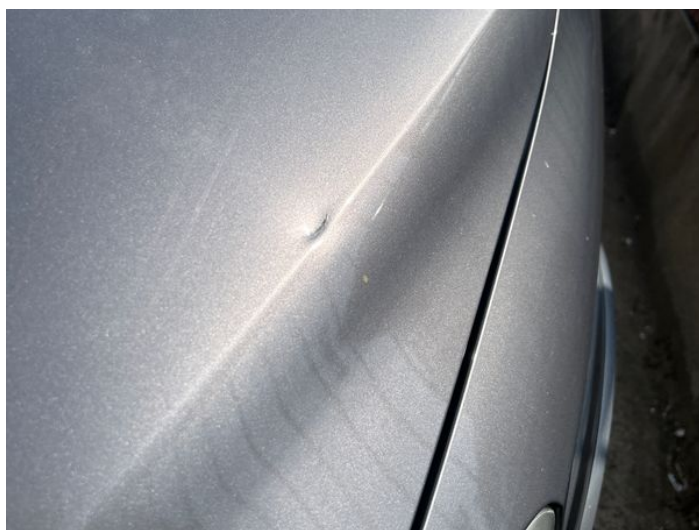
26: Bonnet  
Dented  
With Paint Damage
