VEHICLE INSPECTION REPORT

GC16CDY

Dacia Duster 1.5 dCi 110 Laureate 5dr 4X4

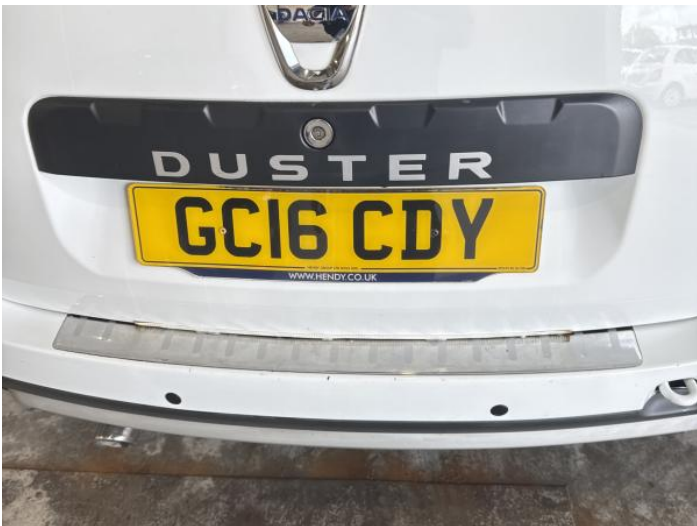
1: Bumper Rear
Scratched
25 to 100mm Thru Paint

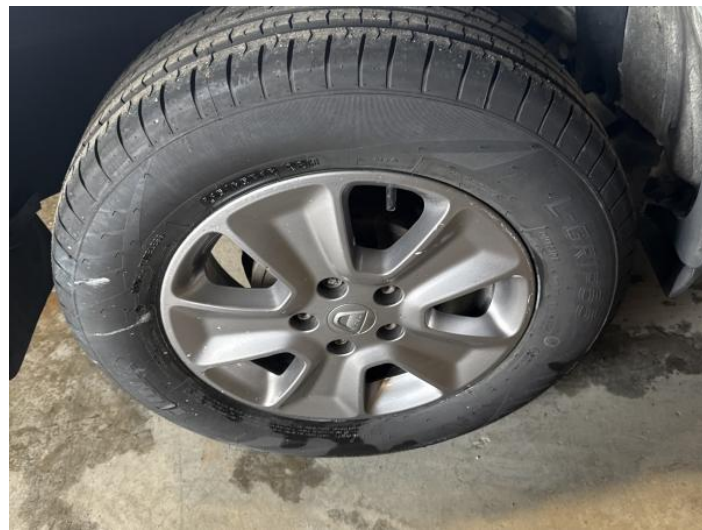
5: Wheel osr
Scratched
Over 50mm

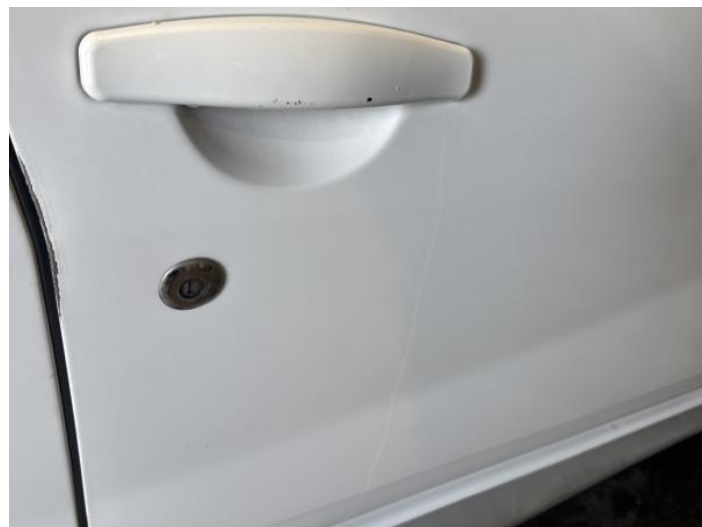
7: Door osf
Chipped
1 To 5

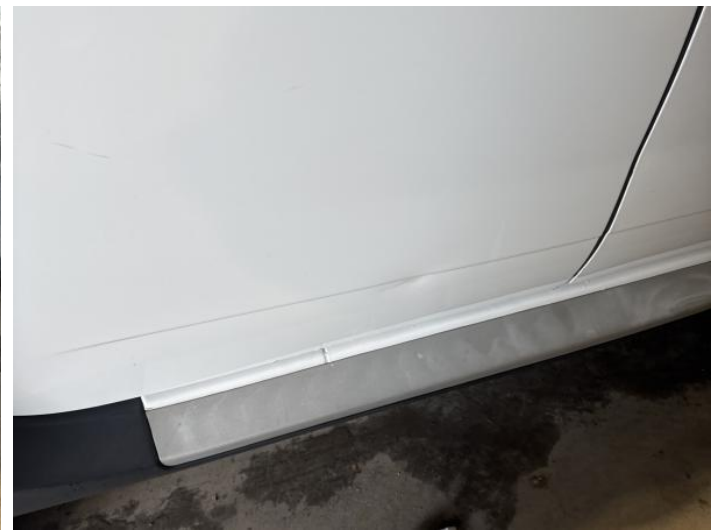
6: Door osr
Dented
Over 30mm

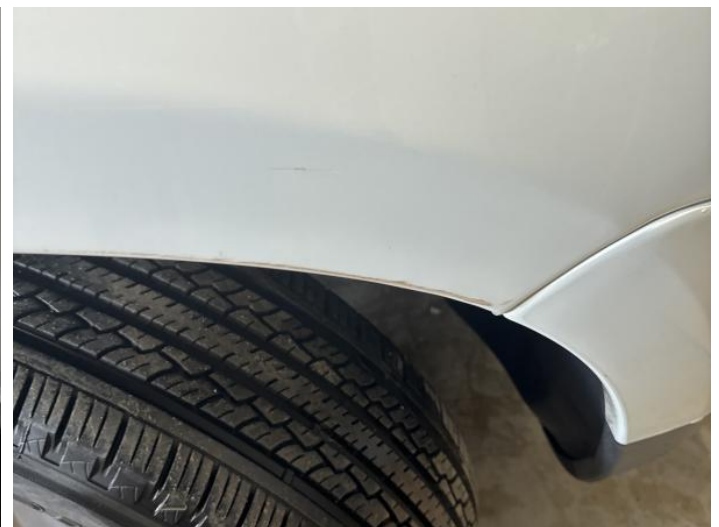
8: Wing osf
Scratched
UpTo 25mm Thru Paint

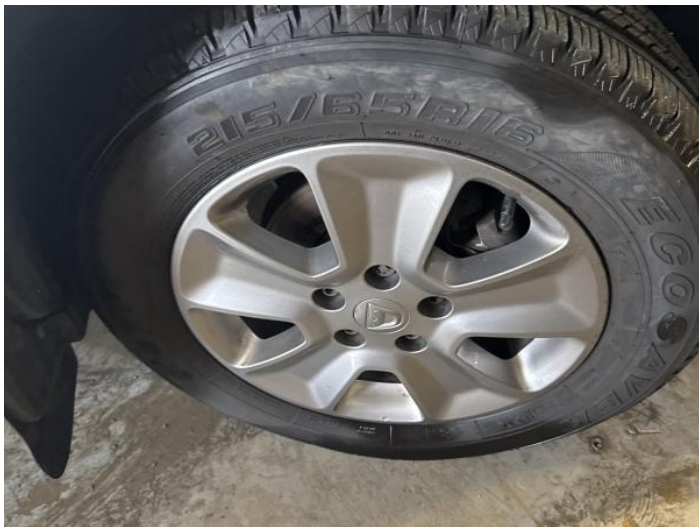
9: Wheel osf
Scratched
Up To 50mm

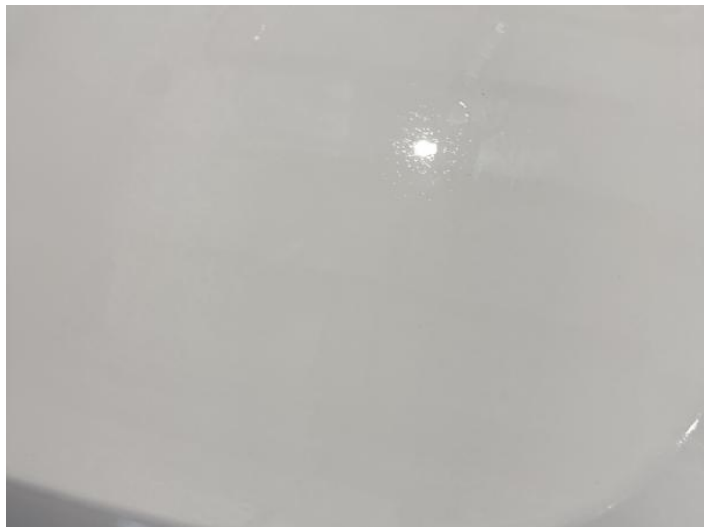
10: Bonnet
Dented
With Paint Damage

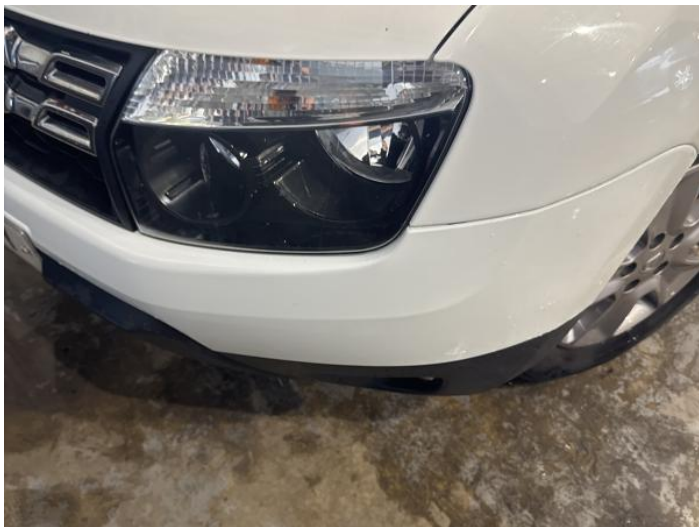
11: Bumper Front
Chipped
Multiple Chips

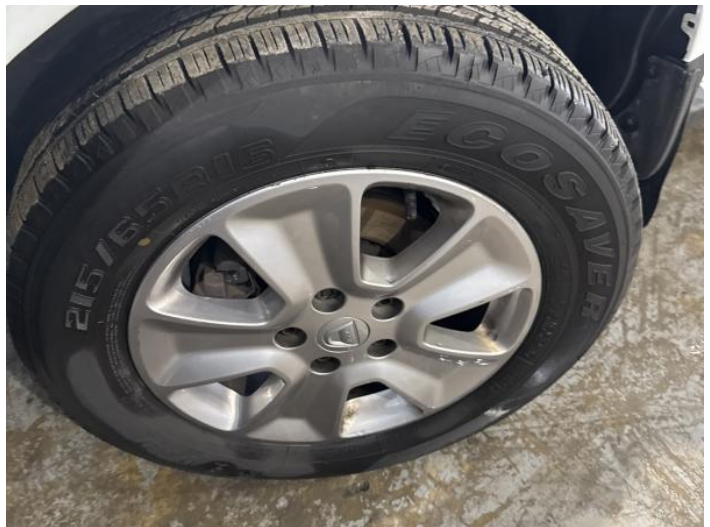
12: Wheel nsf
Scratched
Up To 50mm

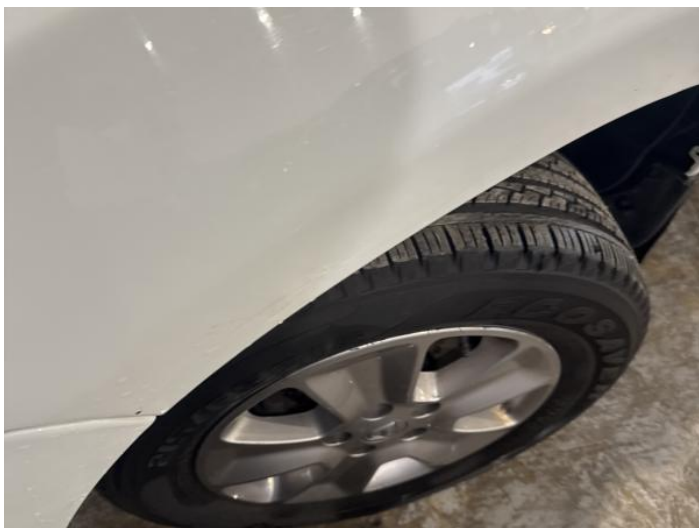
13: Wing nsf
Scratched
Over 25mm Thru Paint

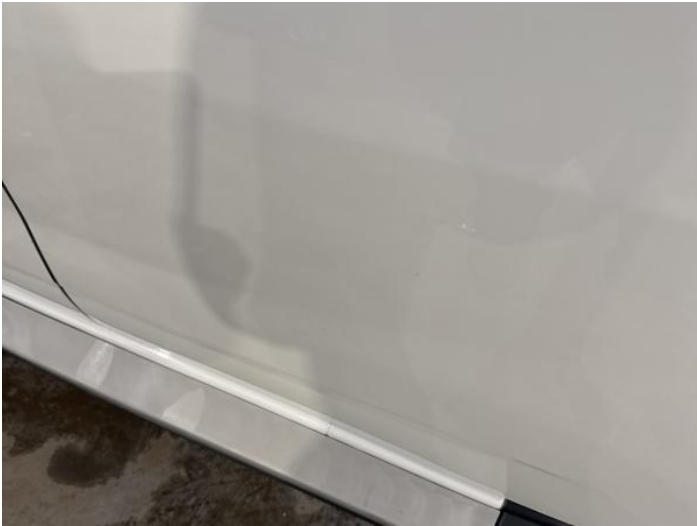
15: Door nsr
Dented
Between 10mm + 30mm

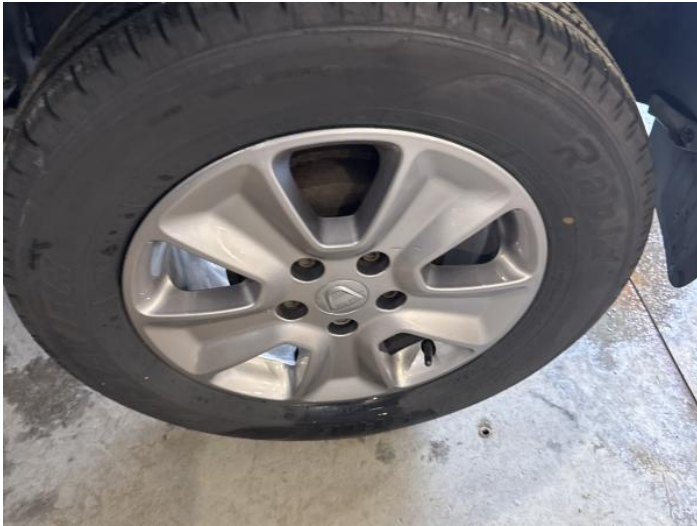
16: Wheel nsr
Scratched
Up To 50mm

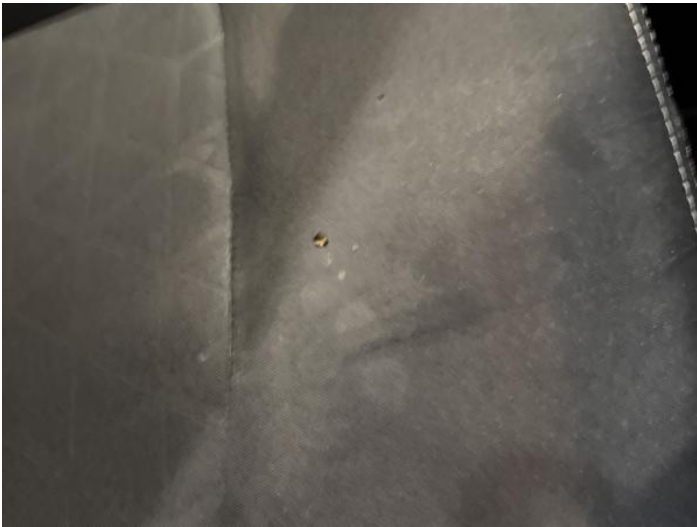
17: Seat Base Cover osf
Holed
UpTo 3mm
