VEHICLE INSPECTION REPORT

YG59BDV

Vauxhall Zafira 1.9 CDTi Elite [120] 5dr Auto

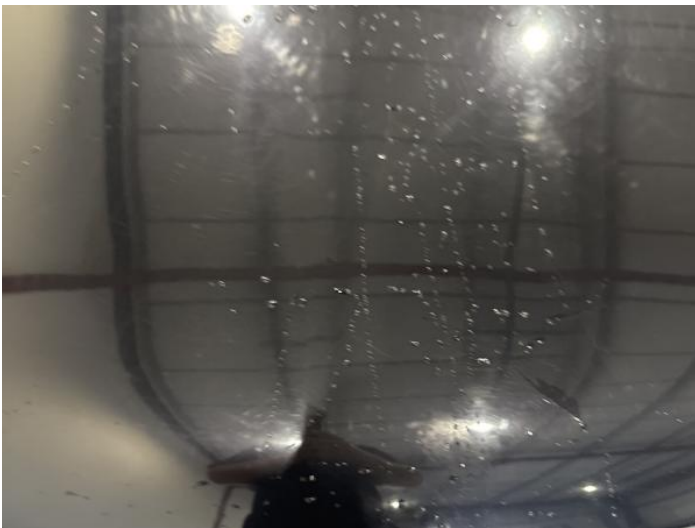
1: Bonnet
Scratched
Over 25mm Not Thru Paint

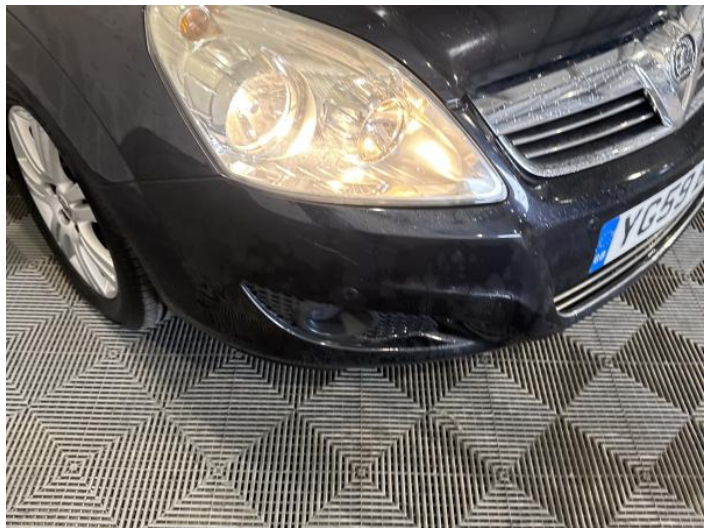
2: Bumper Front
Scratched
Over 100mm Thru Paint

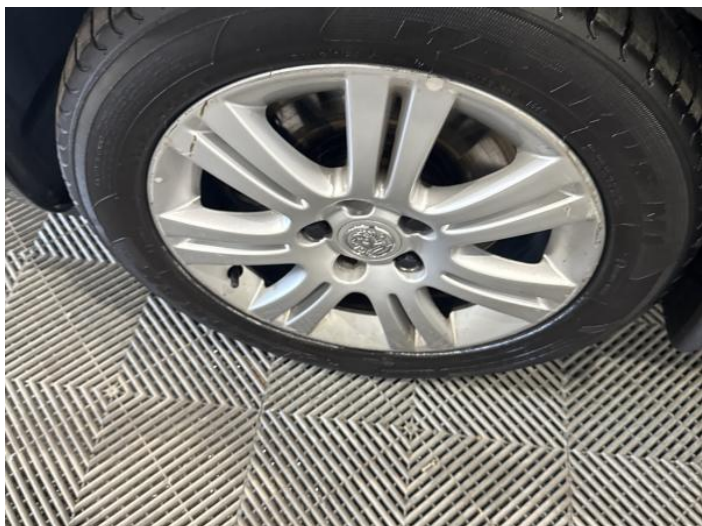
3: Wheel nsf
Scratched
Over 50mm

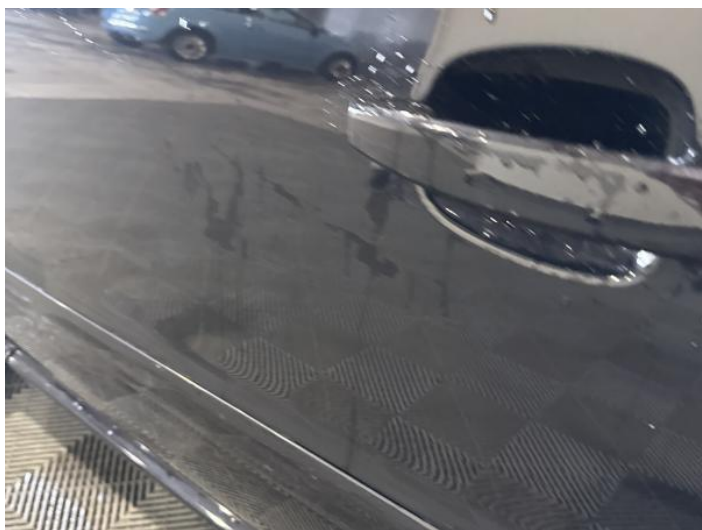
5: Door nsf
Chipped
1 To 5

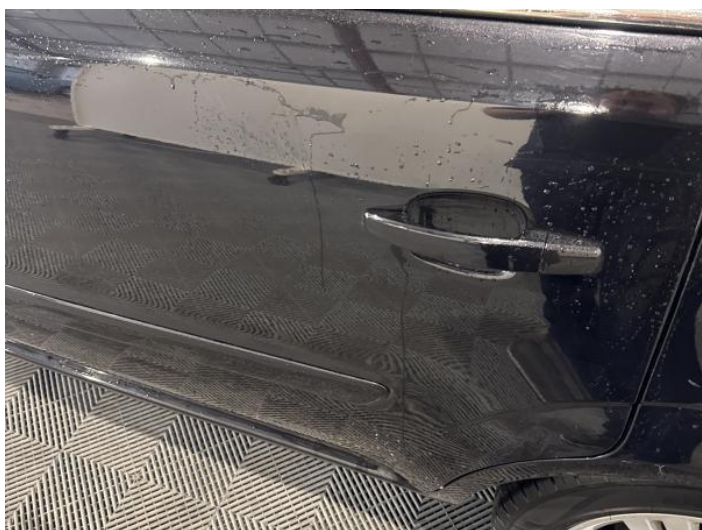
7: Door nsr
Chipped
1 To 5

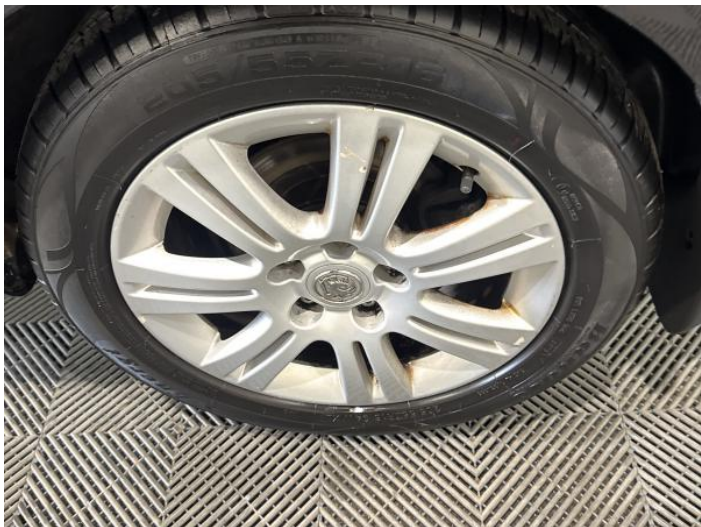
9: Wheel nsr
Scratched
Over 50mm

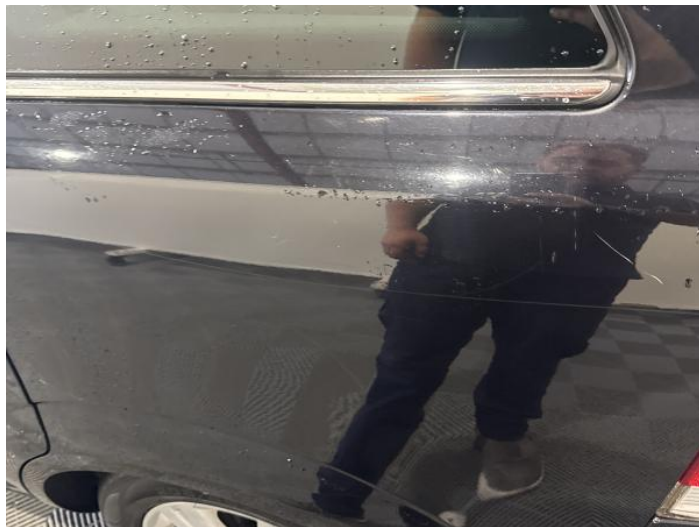
10: Qtr Panel nsr
Scratched
Over 25mm Thru Paint

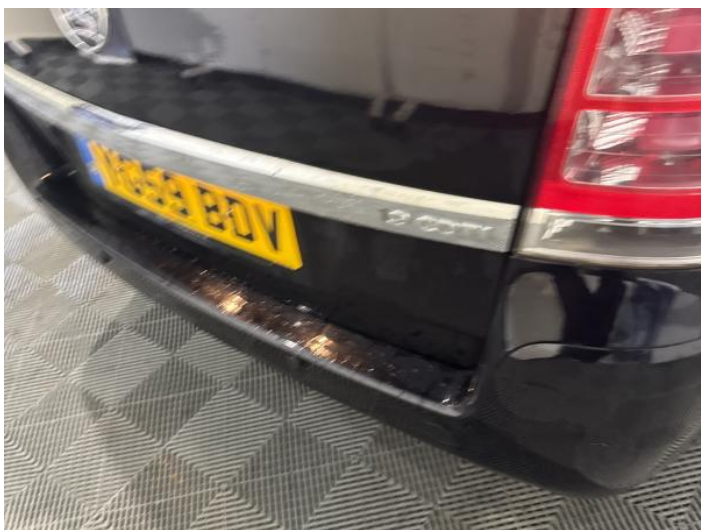
11: Bumper Rear
Scratched
25 to 100mm Thru Paint

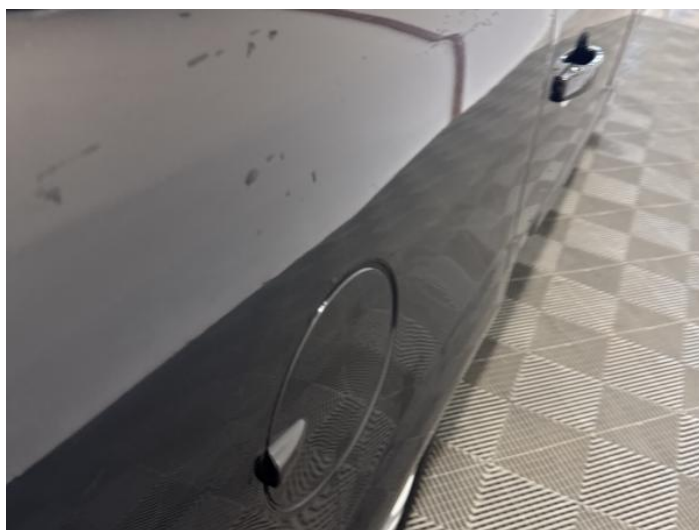
14: Qtr Panel osr
Chipped
1 To 5

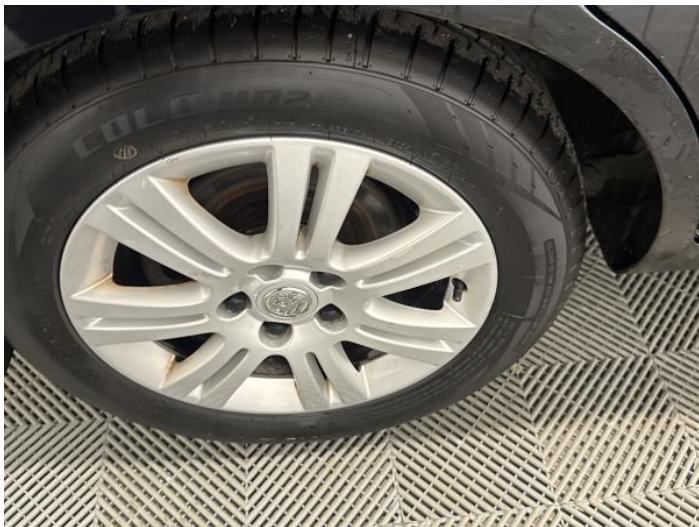
15: Wheel osr
Scratched
Over 50mm

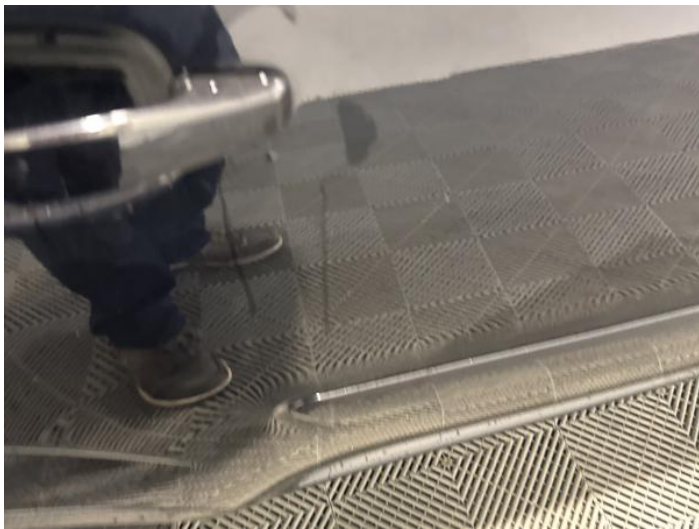
17: Door osr
Chipped
1 To 5

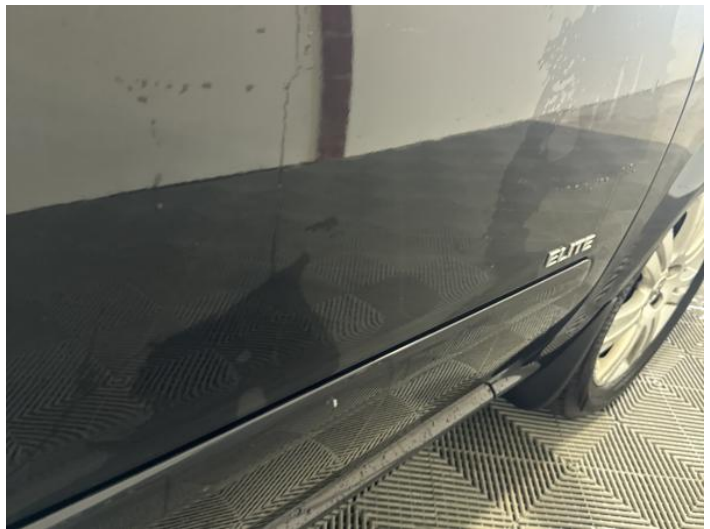
18: Door osf
Scratched
Over 25mm Thru Paint

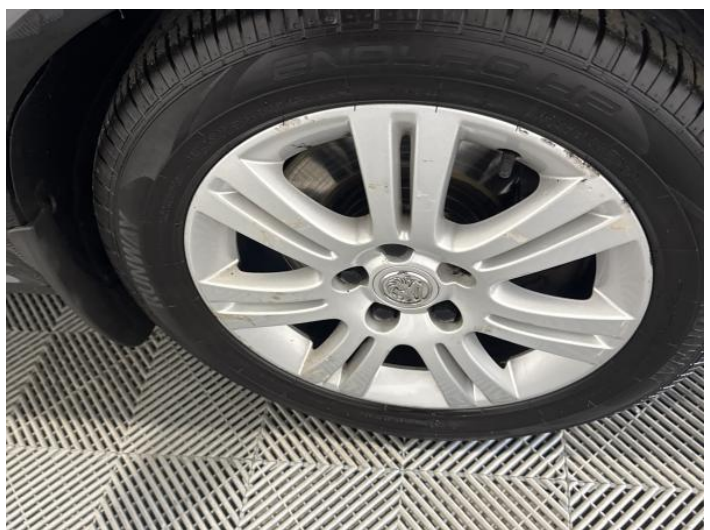
20: Wheel osf
Scratched
Over 50mm
