## VEHICLE INSPECTION REPORT

**HG63LSC**

### Honda Civic 1.8 i-VTEC ES 5dr

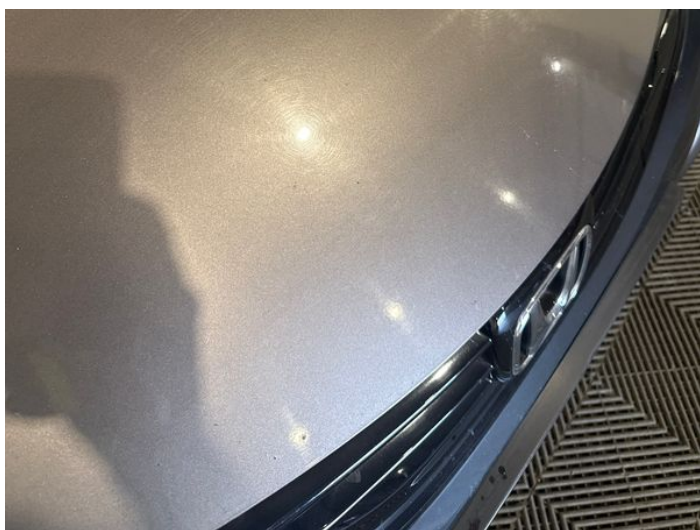
1: Bonnet  
Chipped  
Multiple Chips

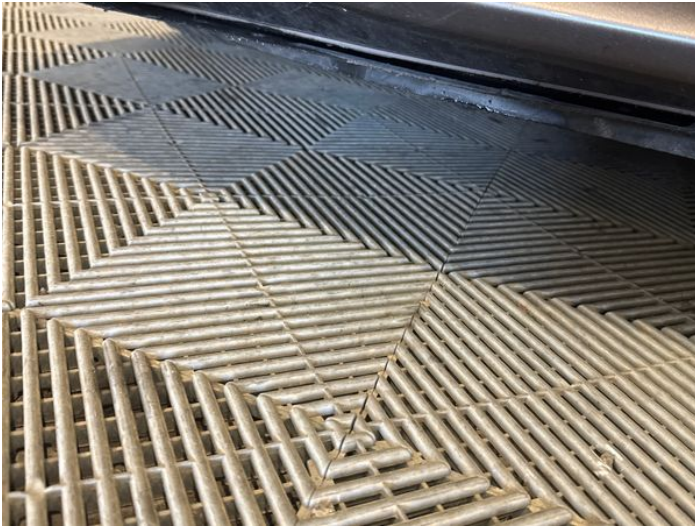
3: Bumper Front Moulding  
Broken  
Replace

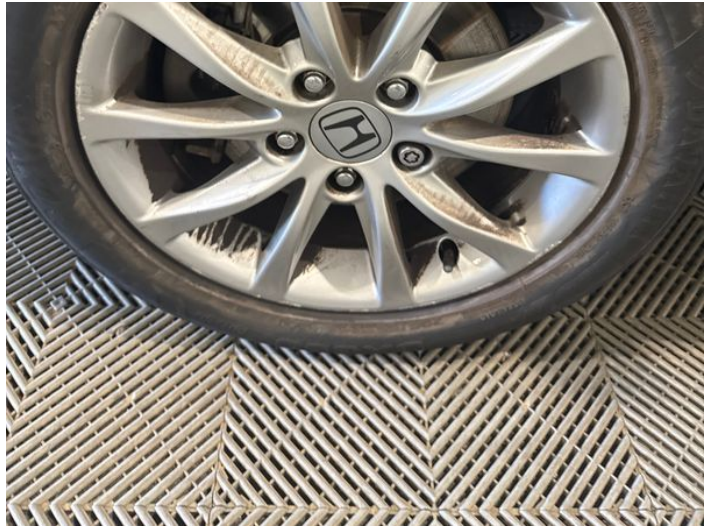
4: Wheel nsf  
Scratched  
Over 50mm

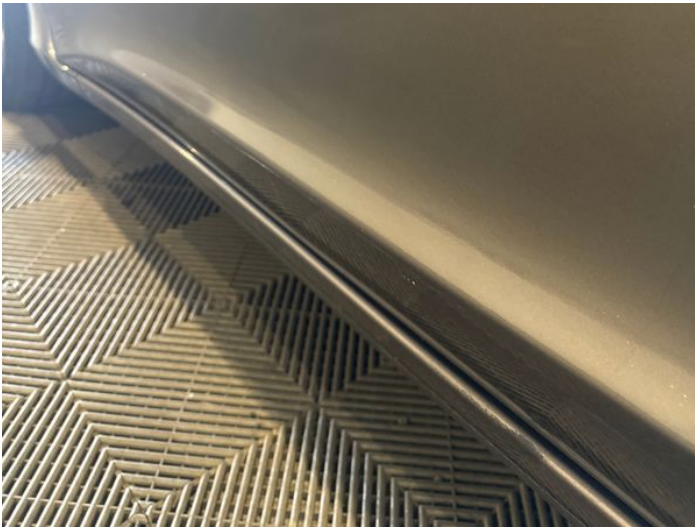
5: Door nsf  
Dented  
With Paint Damage

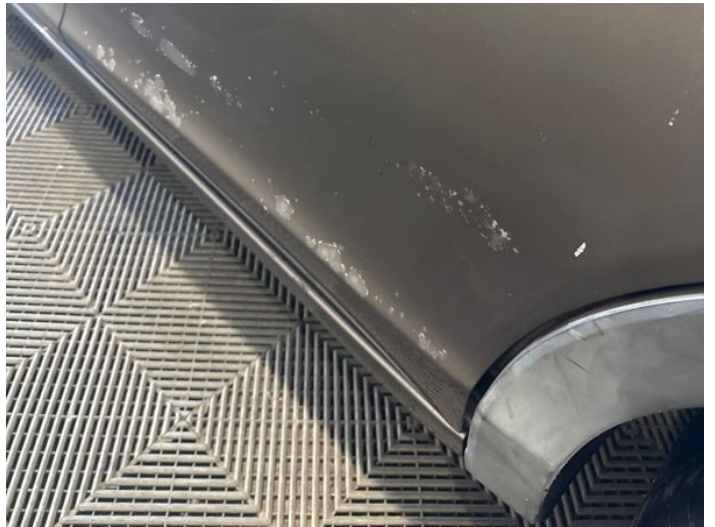
6: Door nsr  
Poor Previous Repair  
Paint Flake

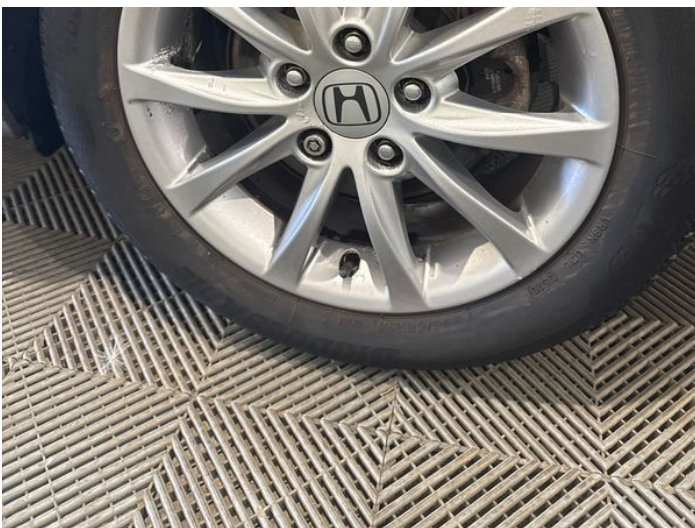
7: Wheel nsr  
Scratched  
Up To 50mm

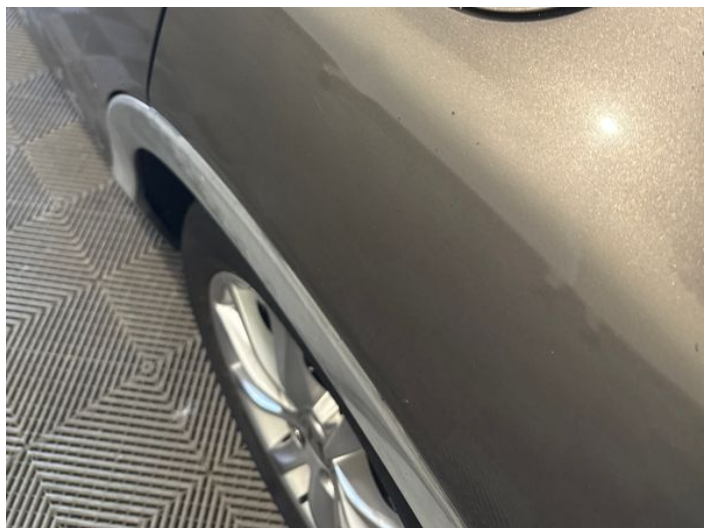
8: Qtr Panel nsr  
Dented  
Between 10mm + 30mm

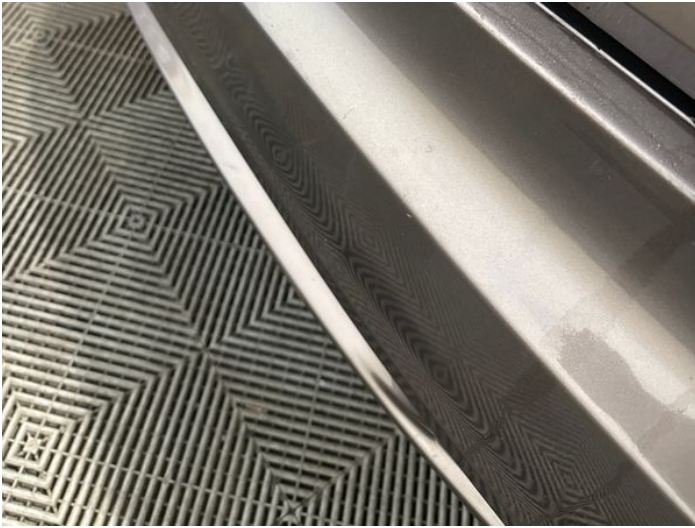
9: Bumper Rear  
Scratched  
25 to 100mm Thru Paint

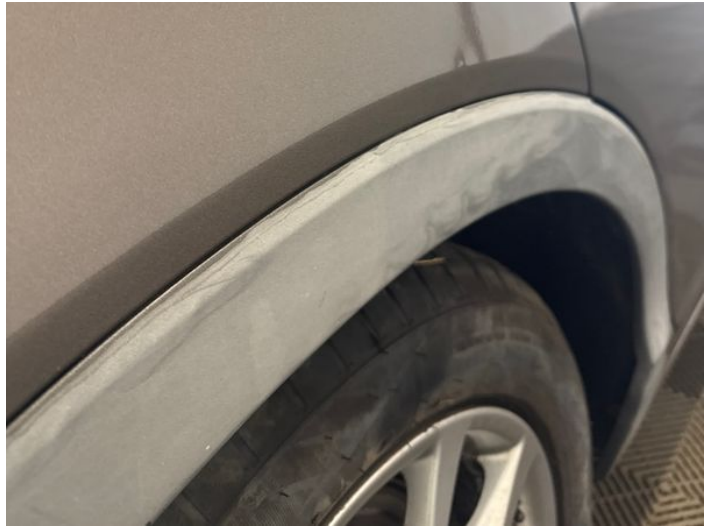
10: Qtr Panel osr  
Dented  
Between 10mm + 30mm

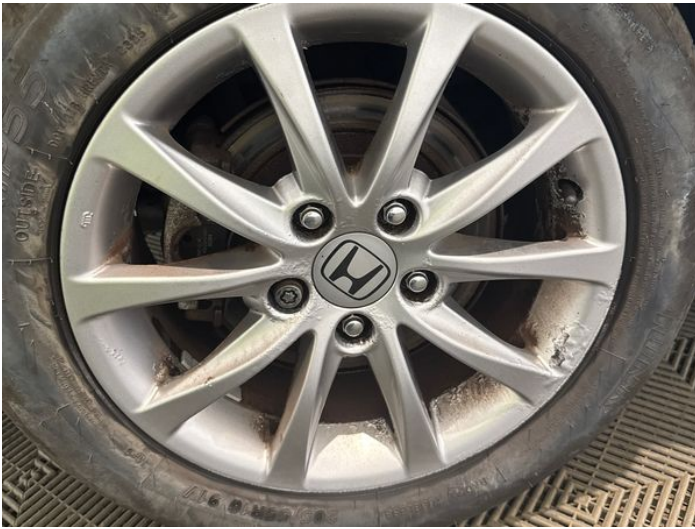
11: Wheel osr  
Scratched  
Over 50mm

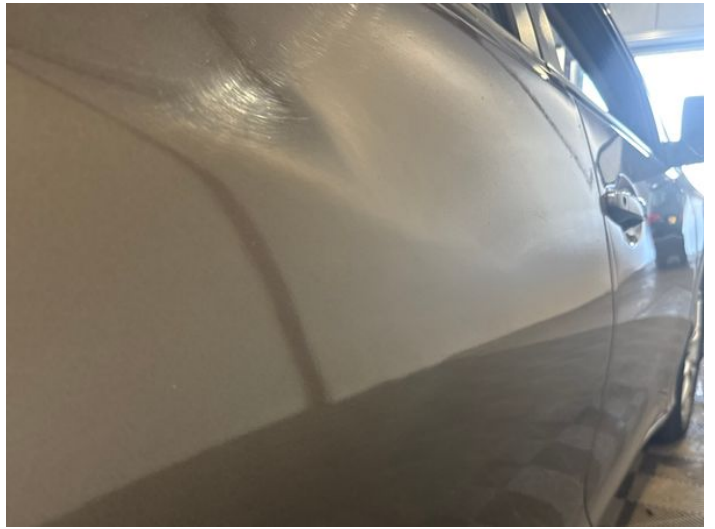
12: Door osr  
Poor Previous Repair  
Rippled UpTo 30%

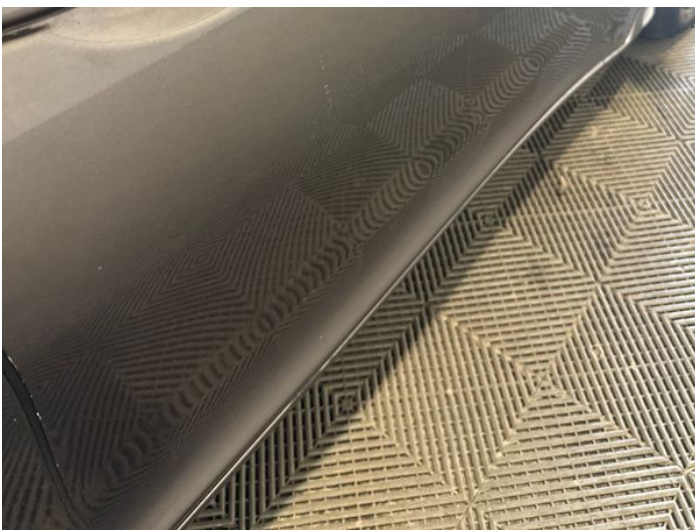
13: Door osf  
Dented  
With Paint Damage

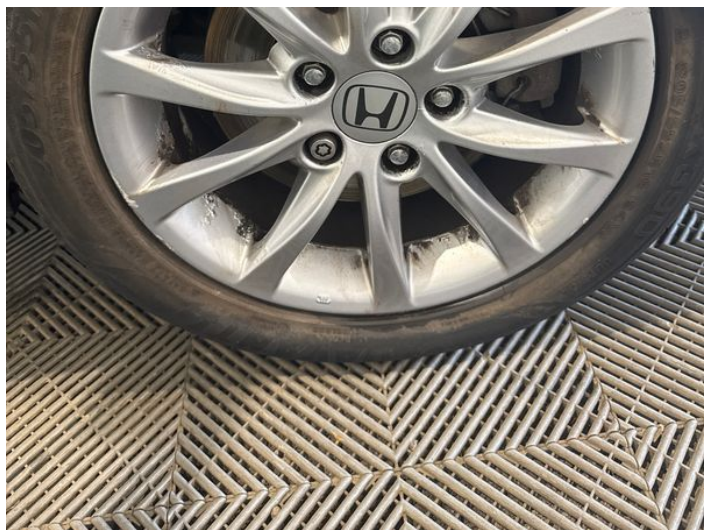
14: Wheel osf  
Scratched  
Over 50mm

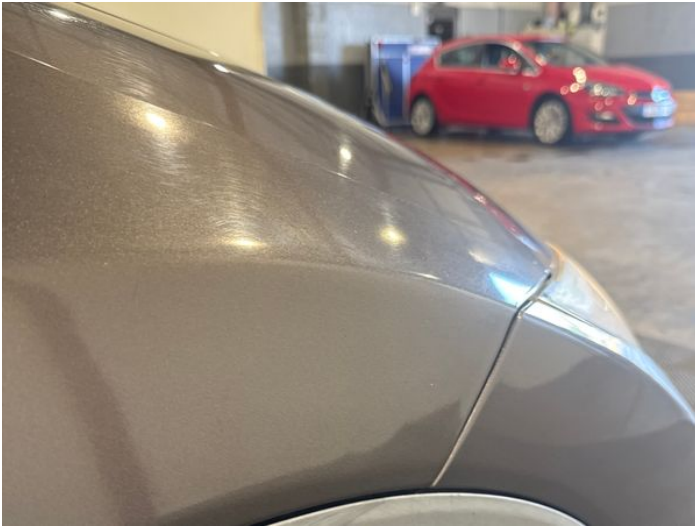
15: Wing osf  
Chipped  
1 To 5

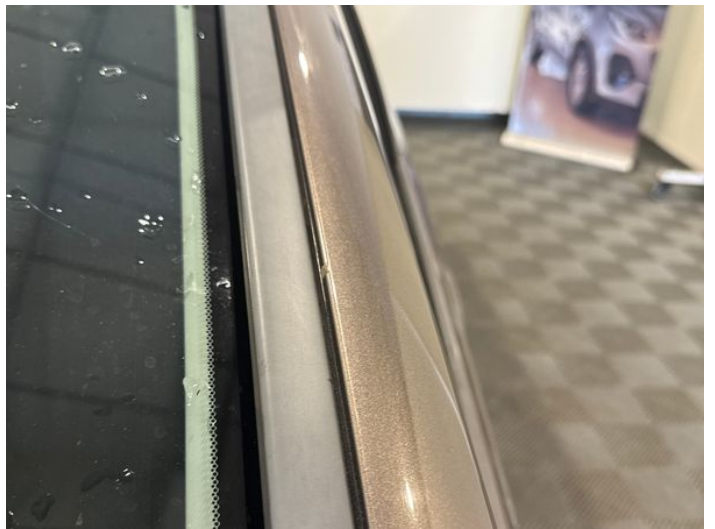
18: A Post ns  
Chipped  
Edge Chip

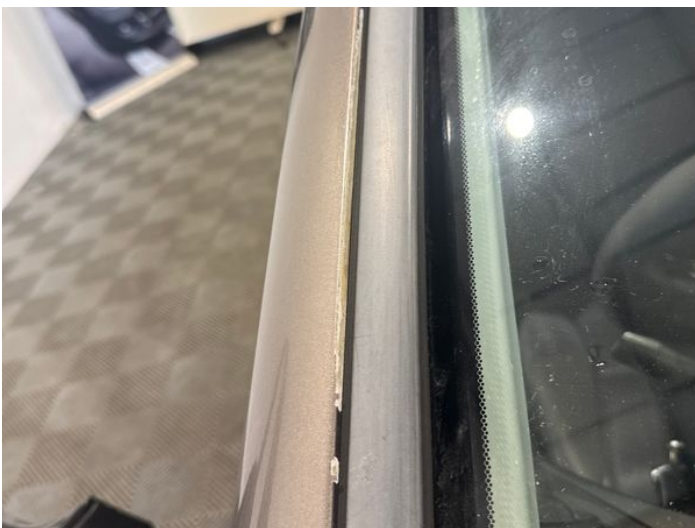
19: A Post os  
Scratched  
Over 25mm Thru Paint
