# VEHICLE INSPECTION REPORT

**AF65TYV**

## Volvo V40 D2 [120] Cross Country Lux 5dr Geartronic

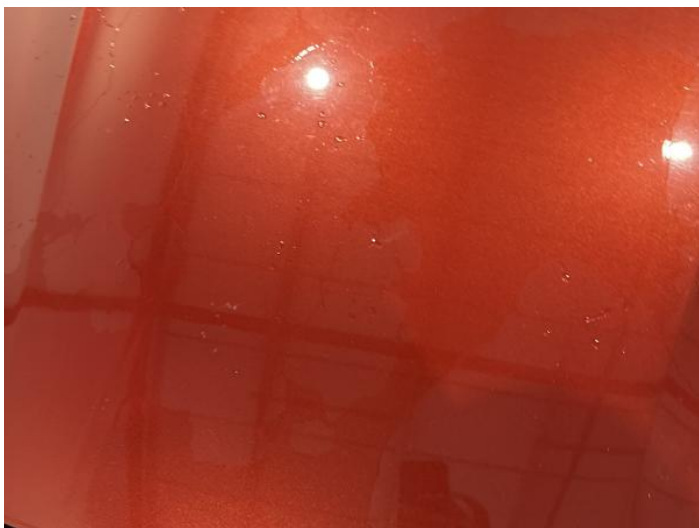
1: Bonnet  
Chipped  
1 To 5

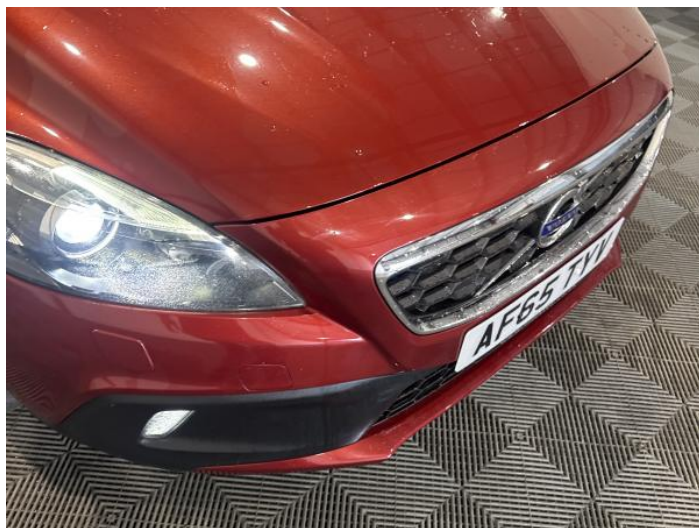
2: Bumper Front  
Chipped  
Multiple Chips

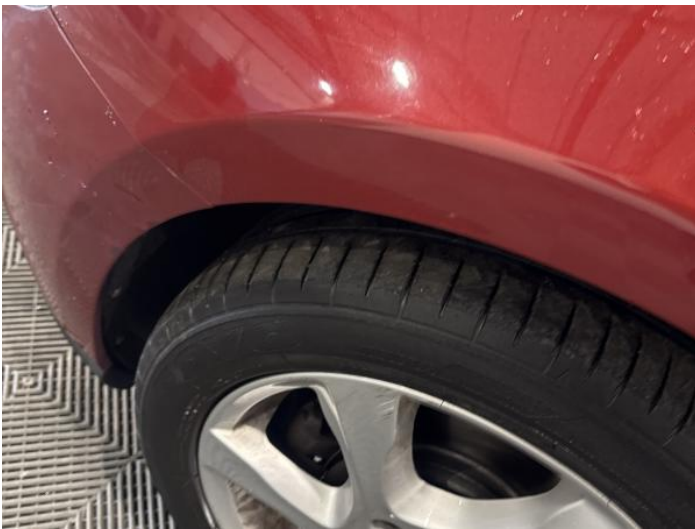
5: Wing nsf  
Chipped  
1 To 5

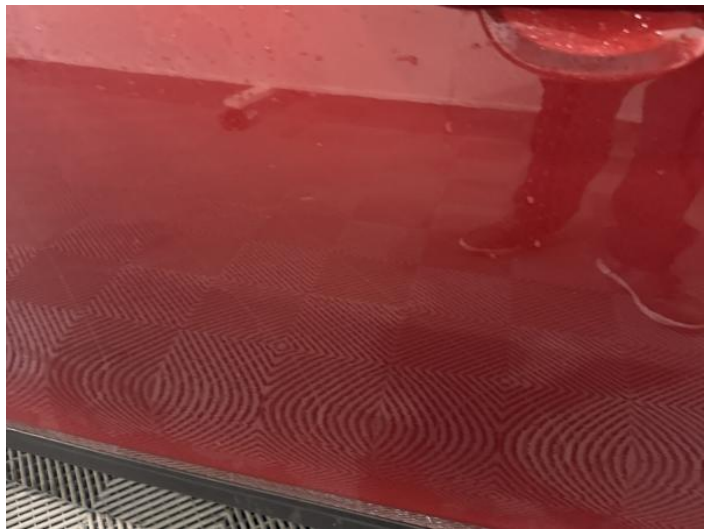
6: Door nsf  
Chipped  
1 To 5

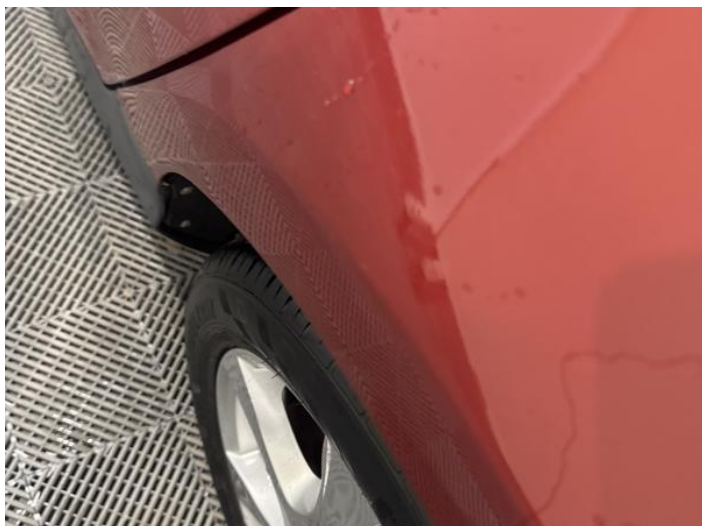
9: Qtr Panel nsr  
Dented  
Over 2 UpTo 10mm

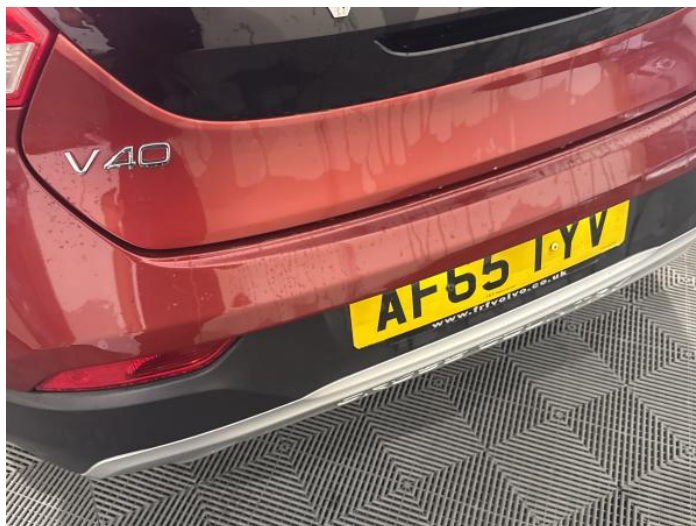
10: Bumper Rear  
Chipped  
Multiple Chips

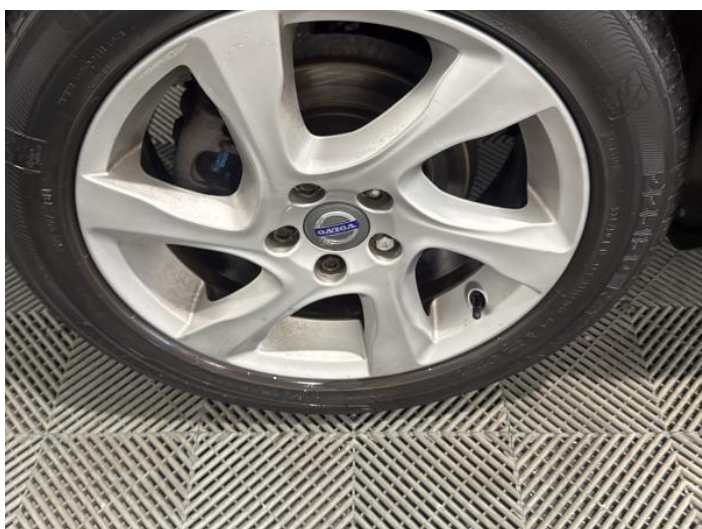
11: Wheel osr  
Scratched  
Up To 50mm

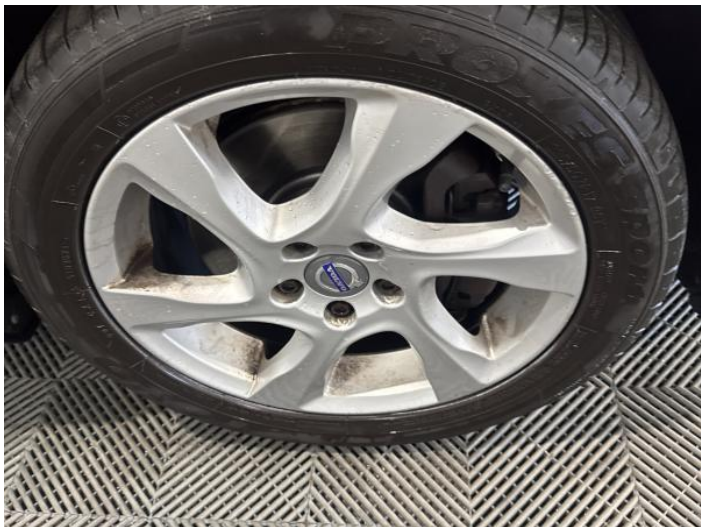
15: Wheel of  
Scratched  
Over 50mm
