VEHICLE INSPECTION REPORT

YE66KMG

Hyundai Ioniq 1.6 GDi Hybrid Premium SE 5dr DCT

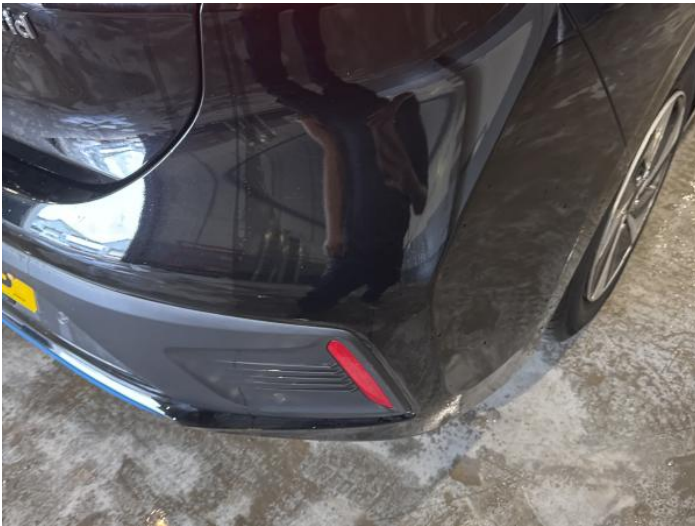
1: Bumper Rear
Scratched
Over 100mm Thru Paint

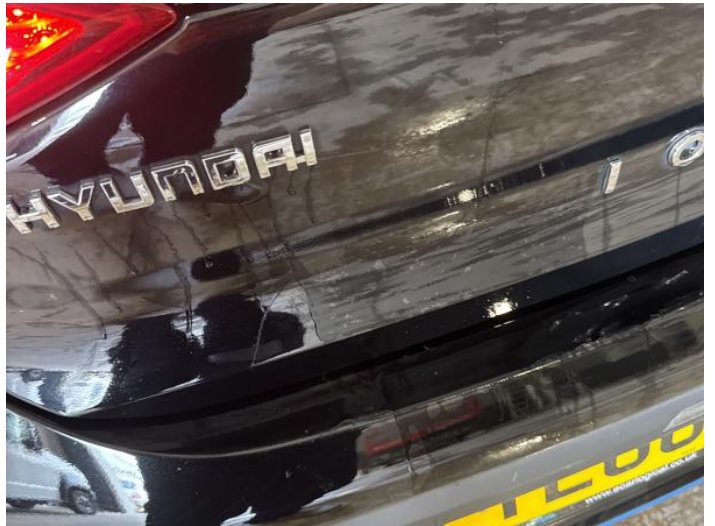
2: Boot Lid
Scratched
Over 25mm Thru Paint

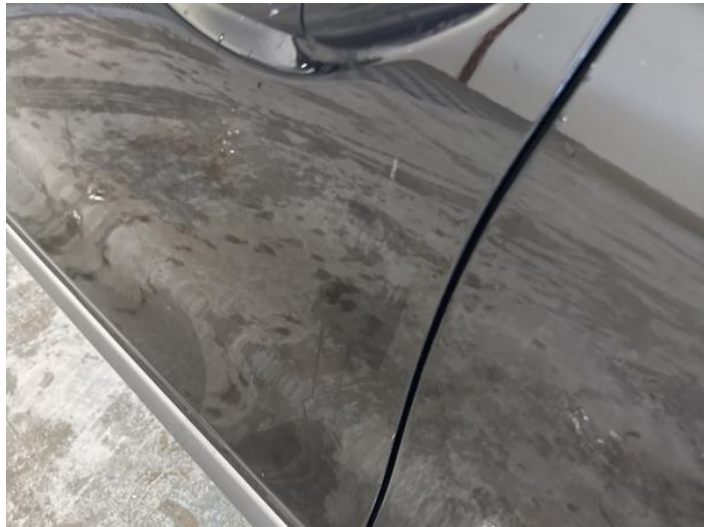
6: Door nsf
Chipped
1 To 5

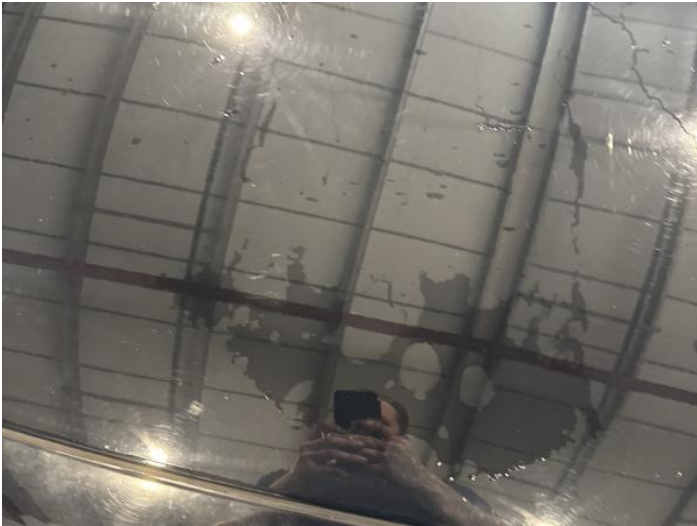
9: Bonnet
Chipped
1 To 5

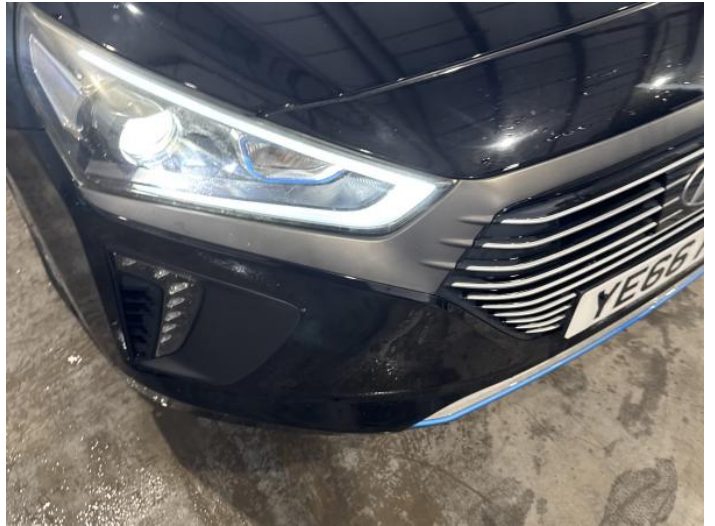
10: Bumper Front
Chipped
Multiple Chips

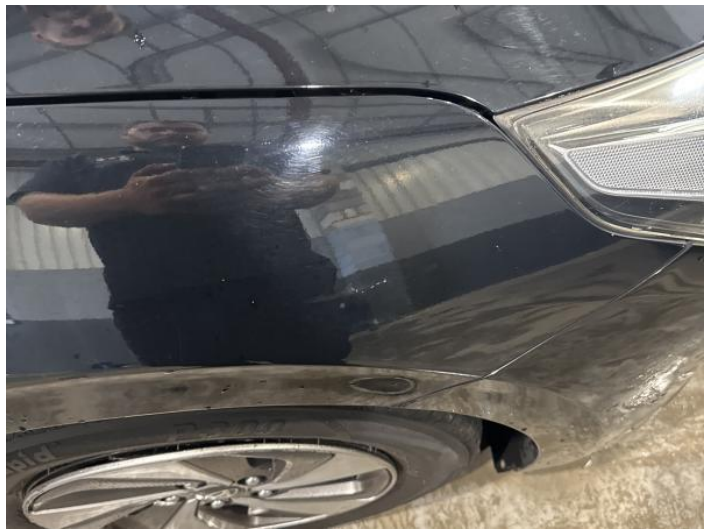
12: Wing osf
Chipped
1 To 5

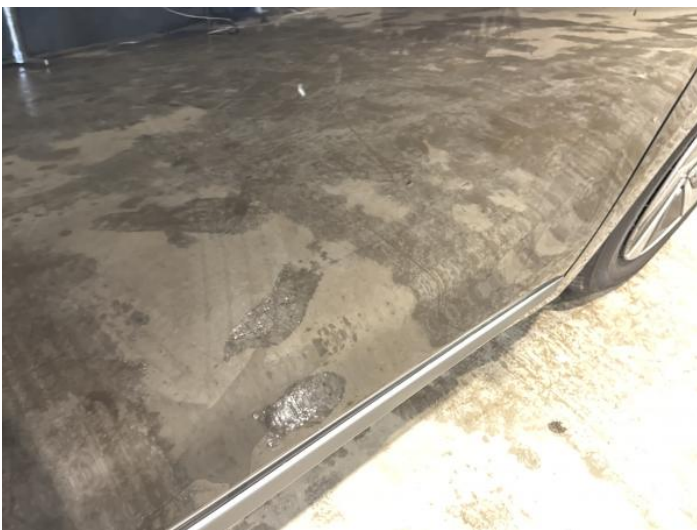
13: Door osf
Chipped
1 To 5

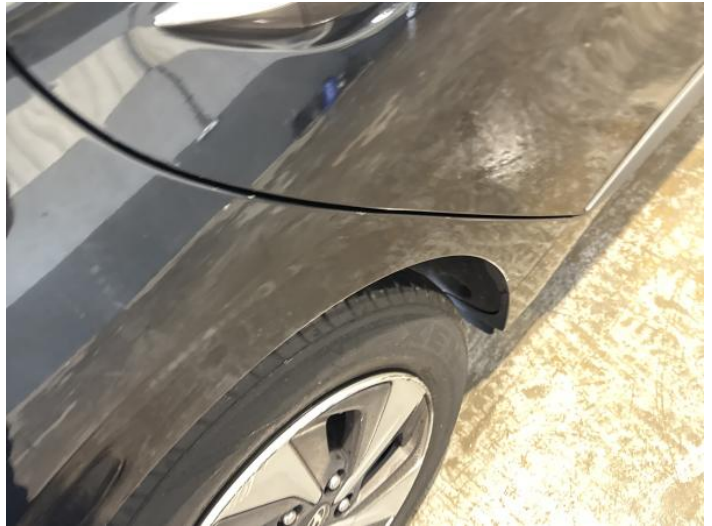
15: Door osr
Scratched
Over 25mm Not Thru Paint
