VEHICLE INSPECTION REPORT

WX63TVU

Kia Rio 1.4 CRDi 2 EcoDynamics 5dr

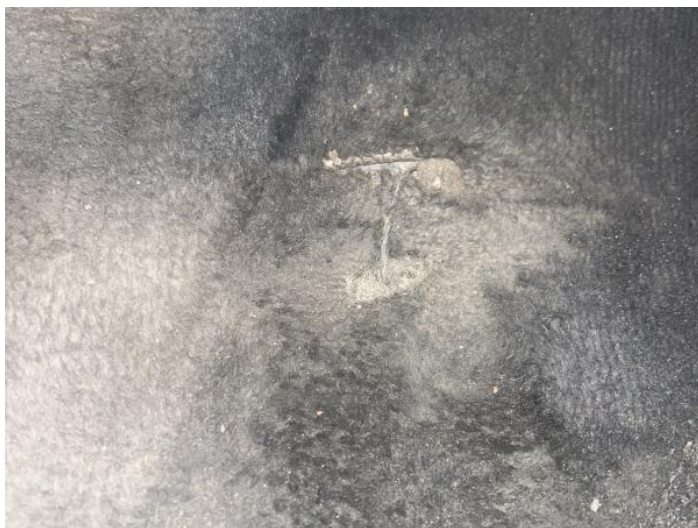
1: Carpets Front
Holed
Over 3mm

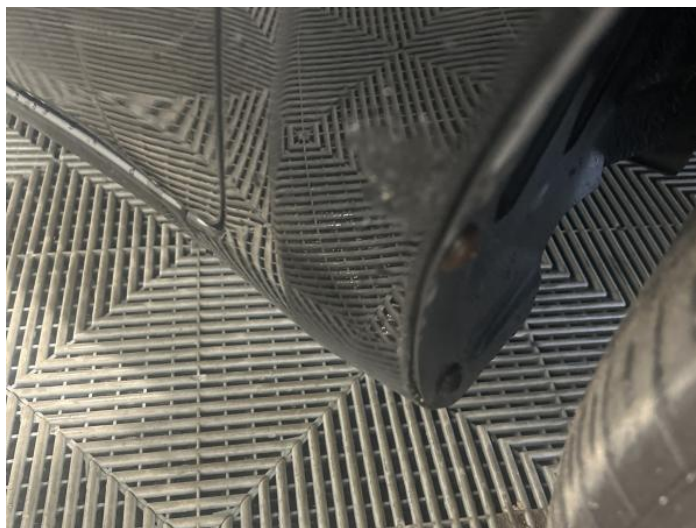
2: Wing osf
Chipped
Over 5mm

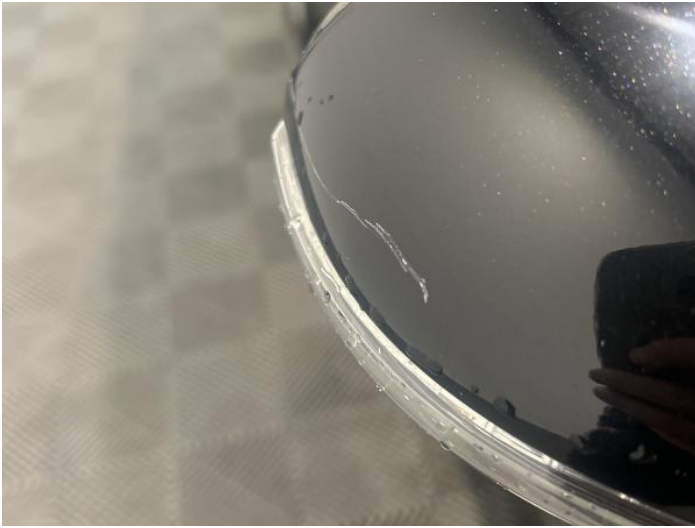
3: Door Mirror Assy osf
Scratched (Painted)
Over 25mm Thru Paint

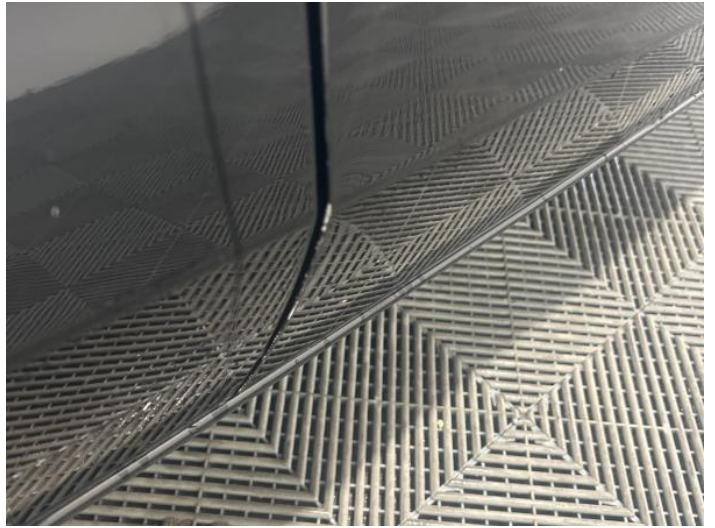
4: Door osf
Chipped
Edge Chip

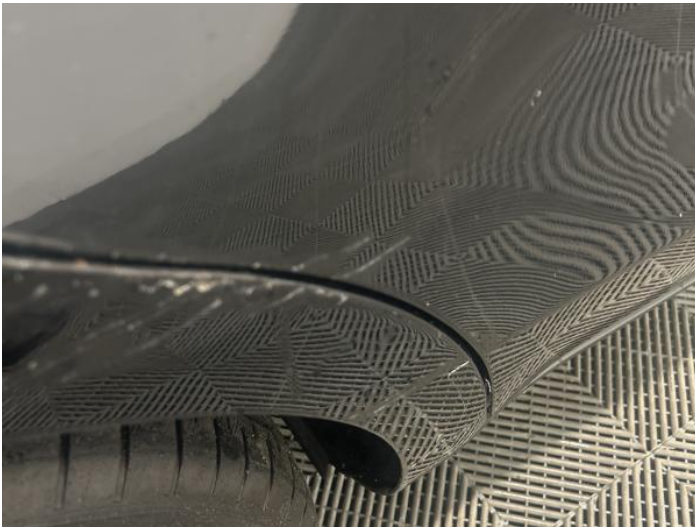
5: Door osr
Scratched
Over 25mm Thru Paint

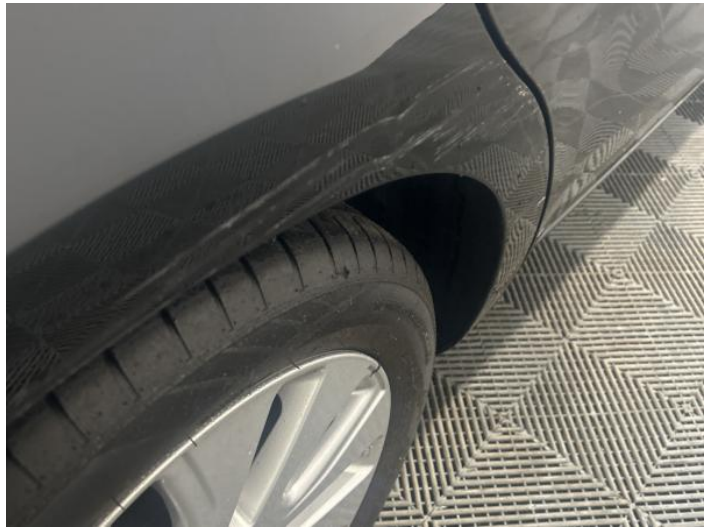
6: Qtr Panel osr
Dented
With Paint Damage

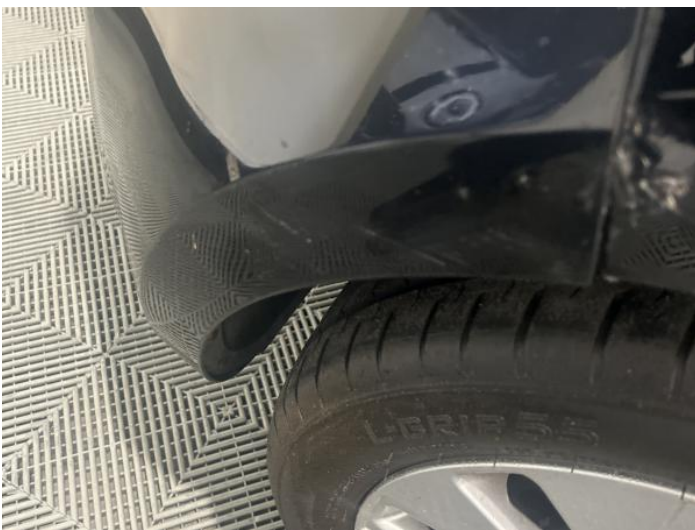
7: Bumper Rear
Scratched
Over 100mm Thru Paint

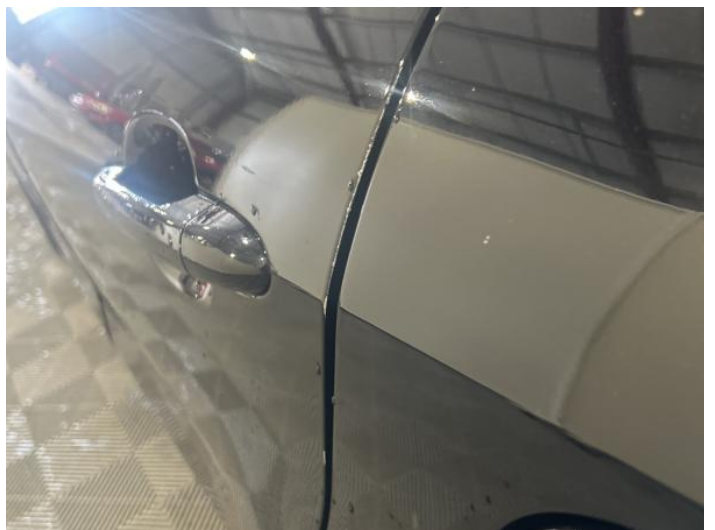
8: Door nsr
Chipped
Edge Chip

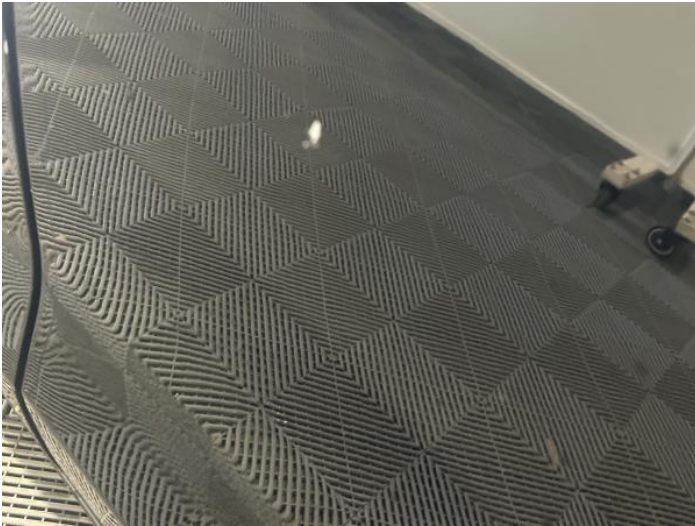
9: Door nsr
Chipped
1 To 5

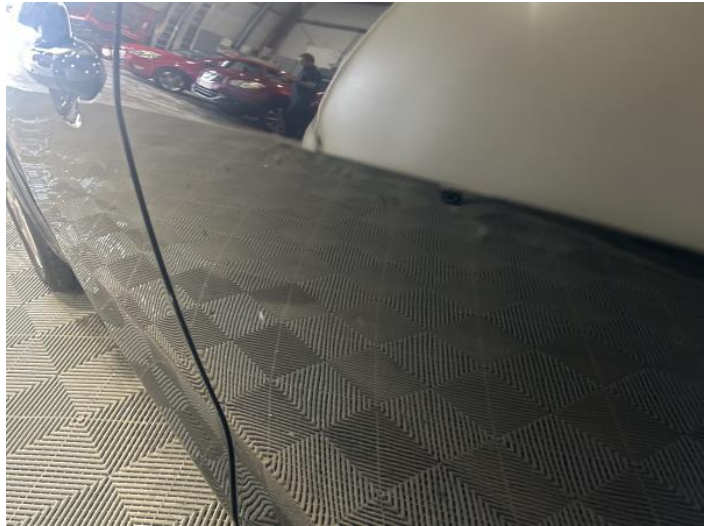
10: Door nsr
Dented
Between 10mm + 30mm

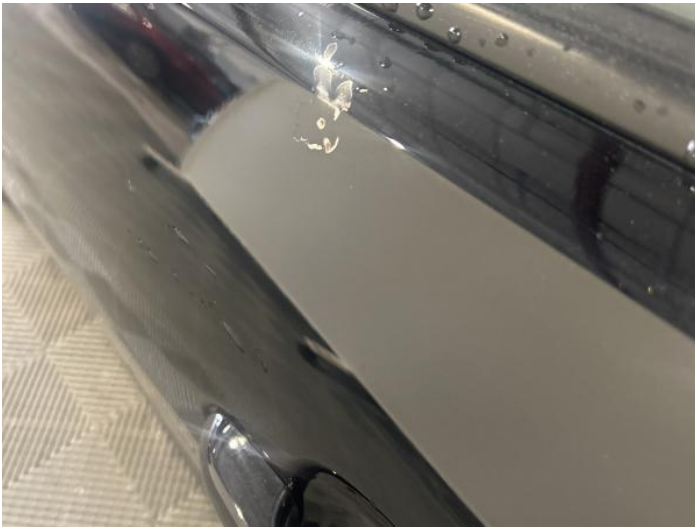
11: Door nsf
Poor Previous Repair
Paint Flake

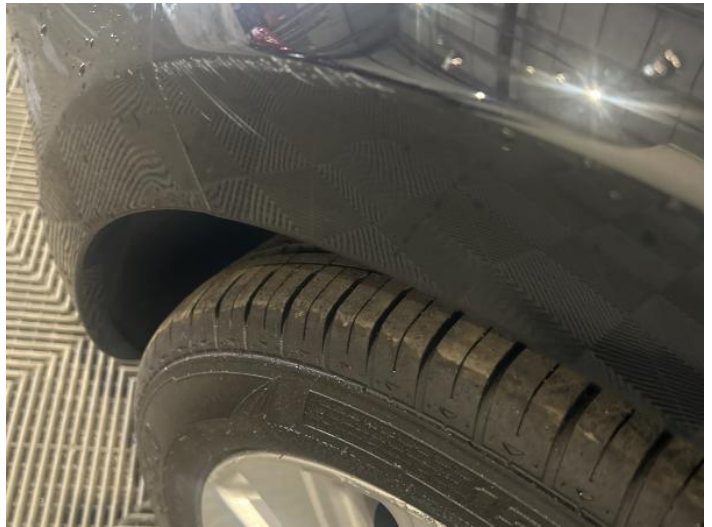
12: Wing nsf
Scratched
Over 25mm Thru Paint

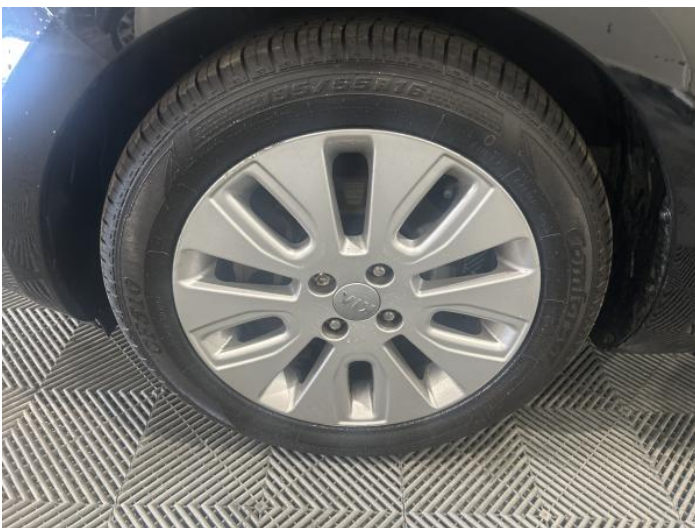
13: Wheel nsf
Scratched
Over 50mm

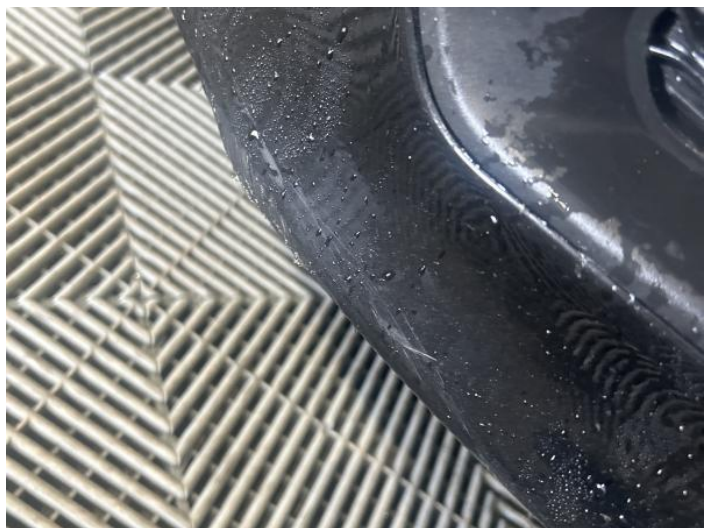
14: Bumper Front
Scratched
25 to 100mm Thru Paint

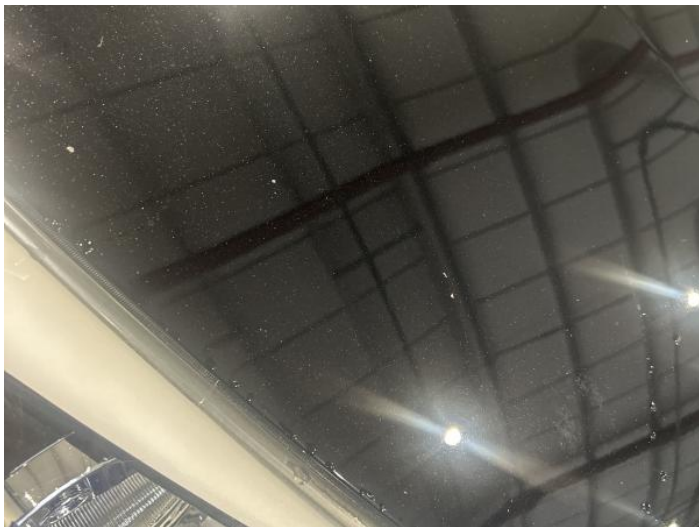
15: Bonnet
Chipped
1 To 5
