# VEHICLE INSPECTION REPORT

**GL62XGB**

## Peugeot 3008 1.6 VTi Active II 5dr

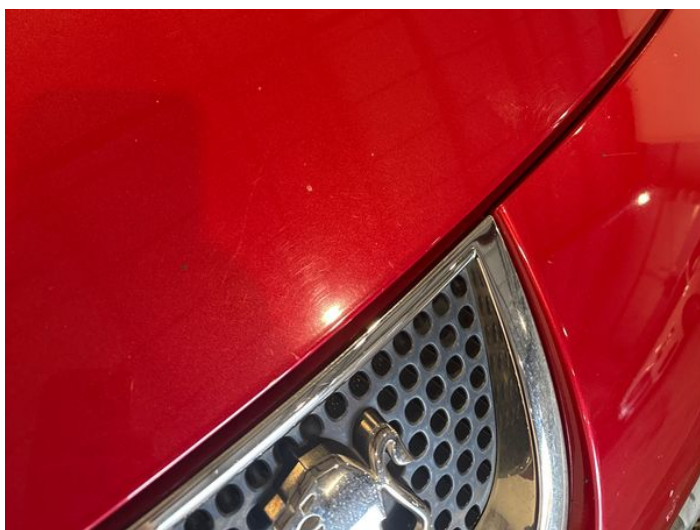
1: Bonnet  
Chipped  
1 To 5

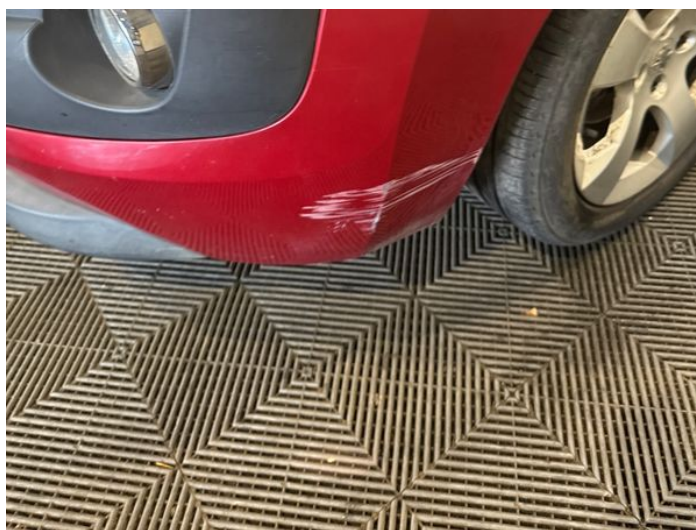
2: Bumper Front  
Scratched  
Over 100mm Thru Paint

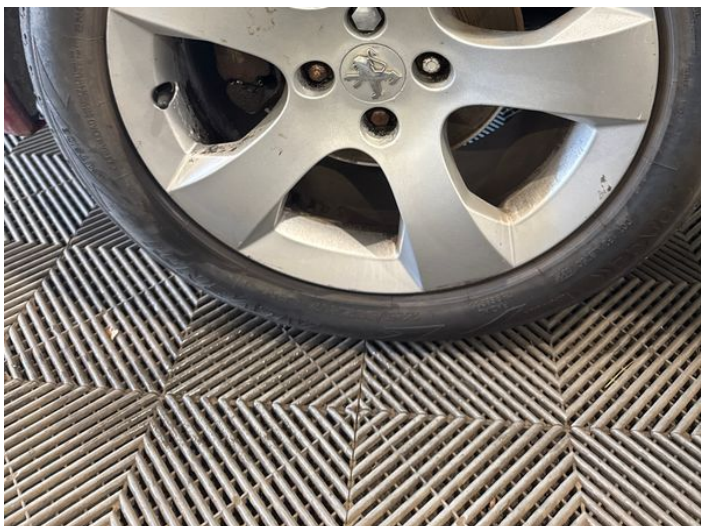
3: Wheel nsf  
Corroded  
Light

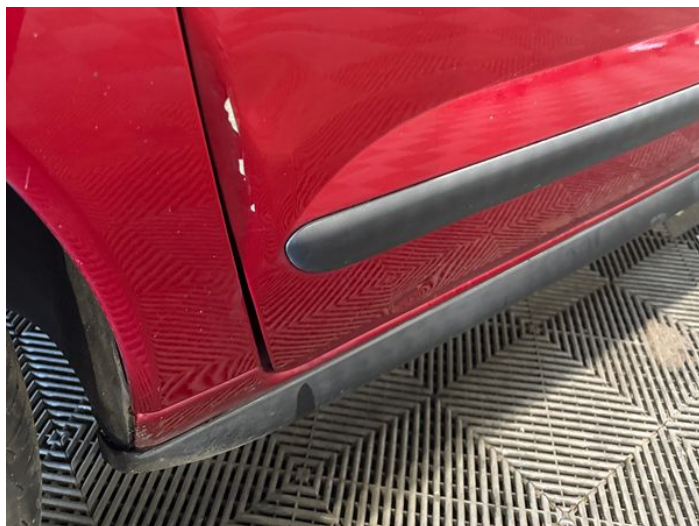
4: Door nsf  
Dented  
With Paint Damage

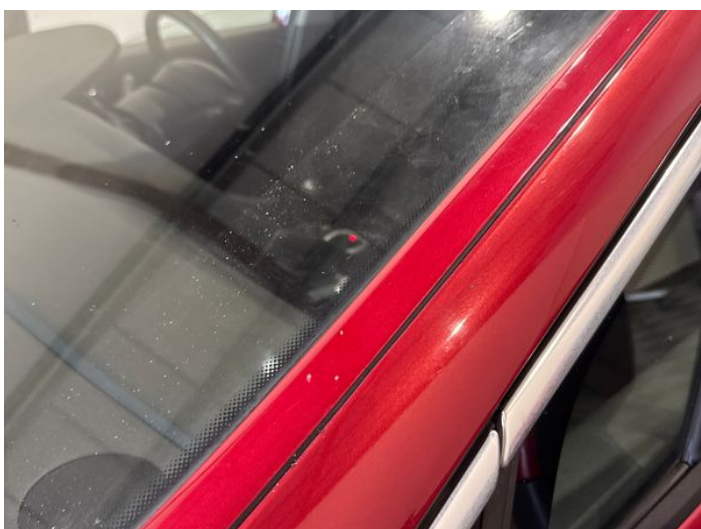
5: A Post ns  
Chipped  
1 To 5

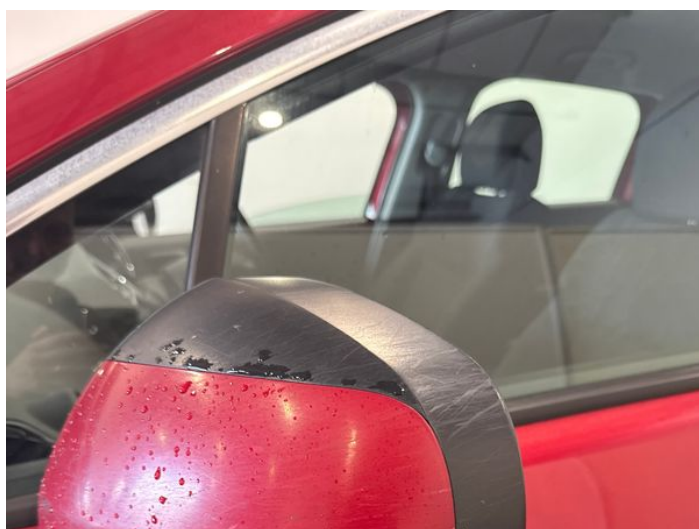
6: Door Mirror Assy nsf  
Scratched (Painted)  
UpTo 25mm Thru Paint

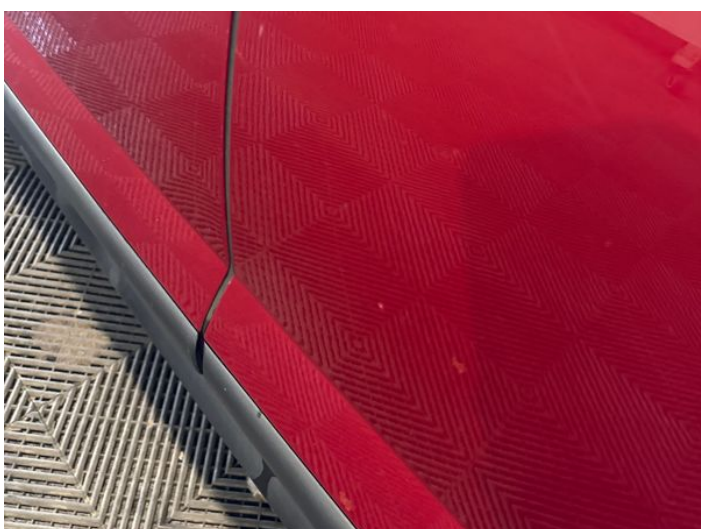
7: Door nsr  
Scratched  
UpTo 25mm Thru Paint

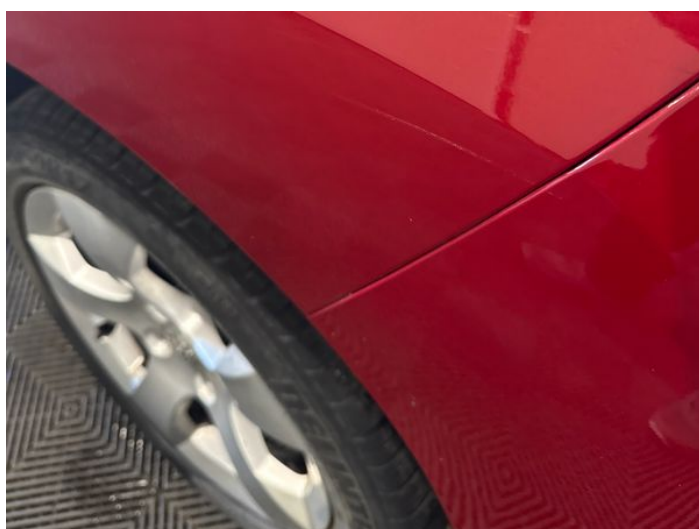
8: Qtr Panel nsr  
Scratched  
UpTo 25mm Thru Paint

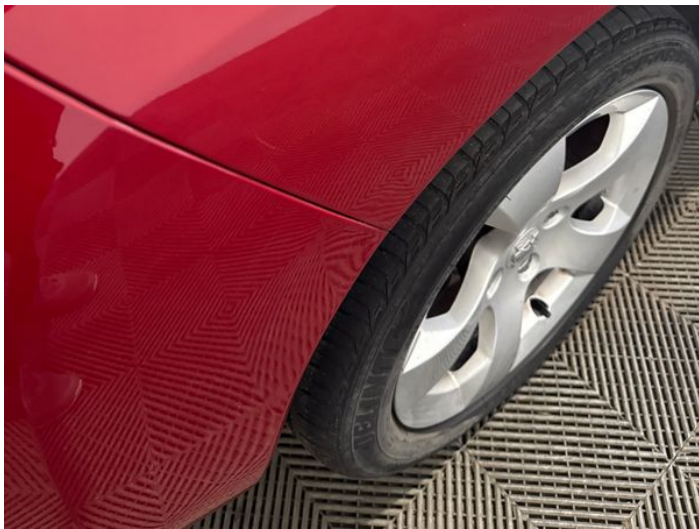
9: Qtr Panel osr  
Scratched  
UpTo 25mm Thru Paint

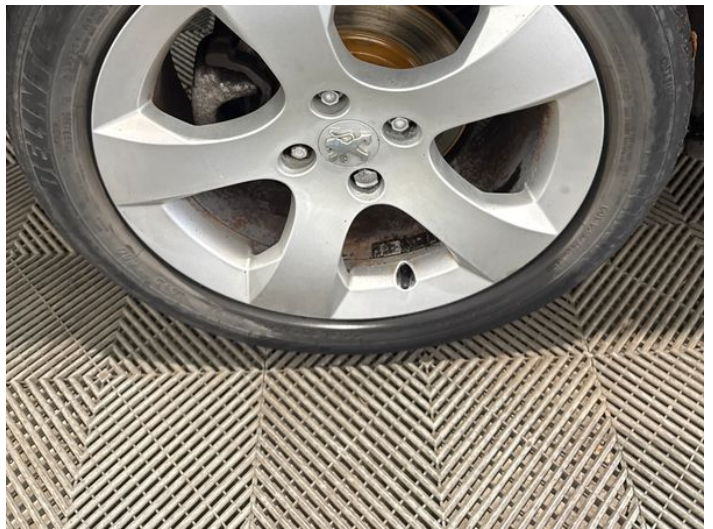
10: Wheel osr  
Scratched  
Up To 50mm

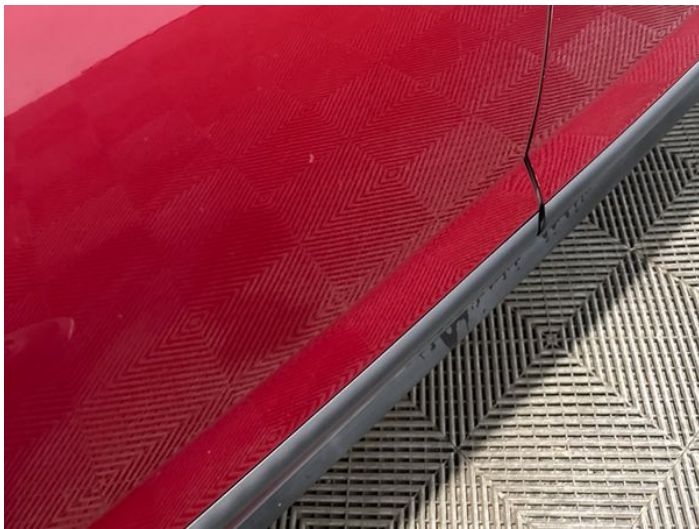
11: Door osr  
Chipped  
1 To 5

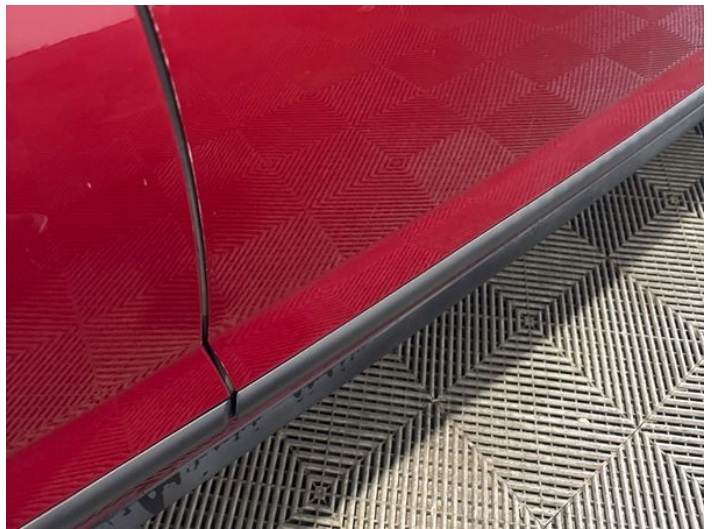
12: Door osf  
Scratched  
Over 25mm Thru Paint

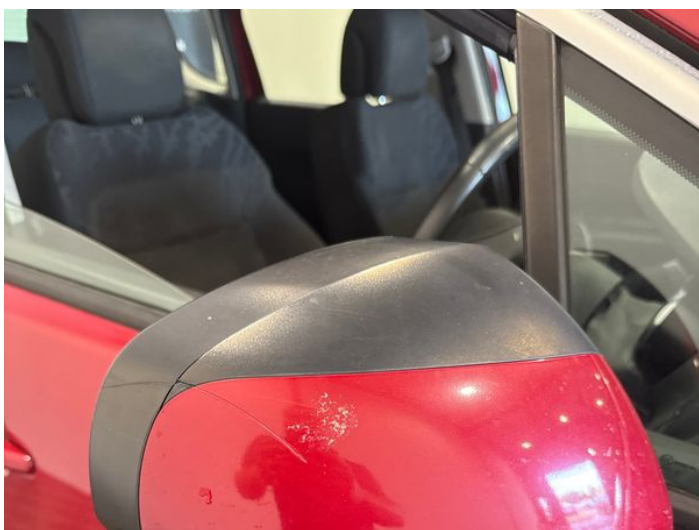
13: Door Mirror Assy osf  
Scratched (Painted)  
Over 25mm Thru Paint

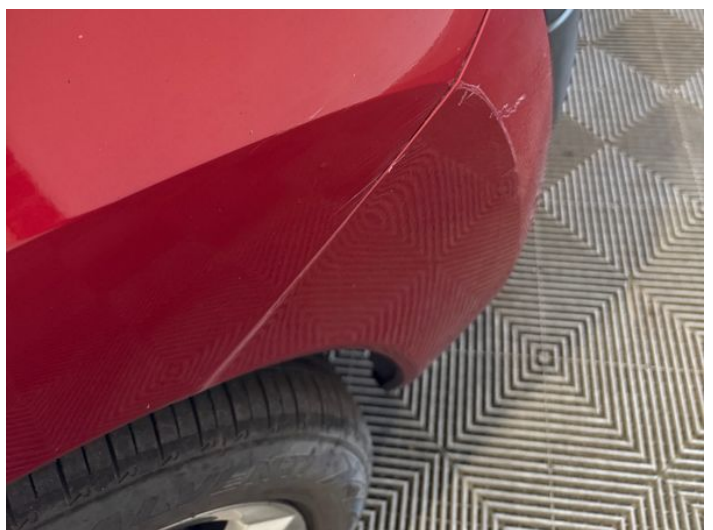
14: Wing osf  
Scratched  
Over 25mm Thru Paint

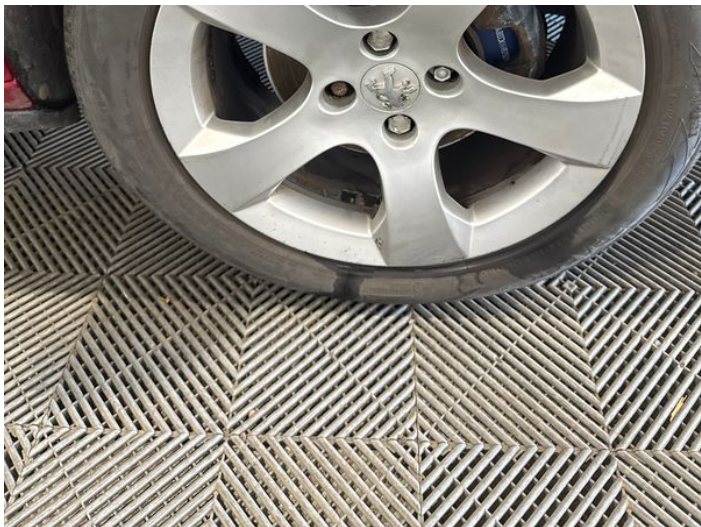
15: Wheel osf  
Scratched  
Up To 50mm

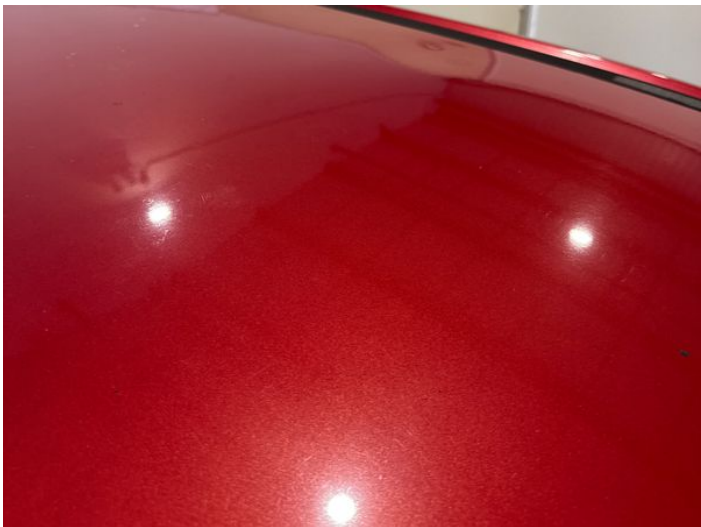
16: Roof  
Dented  
Over 30mm

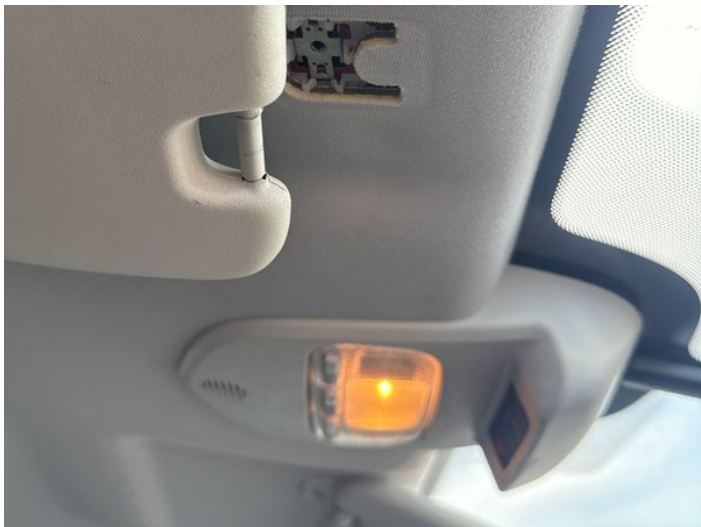
17: Fascia Trim  
Missing  
Replace
