# VEHICLE INSPECTION REPORT

**GU09DZZ**

## Honda Jazz 1.4 i-VTEC ES 5dr

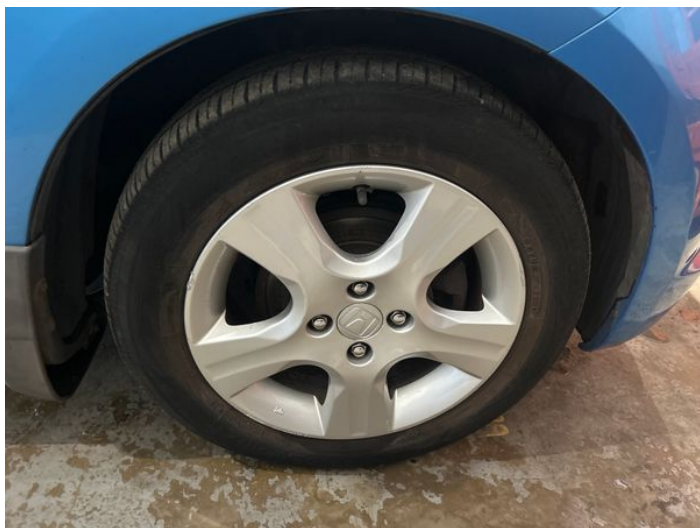
1: Wheel osf  
Scratched  
Over 50mm

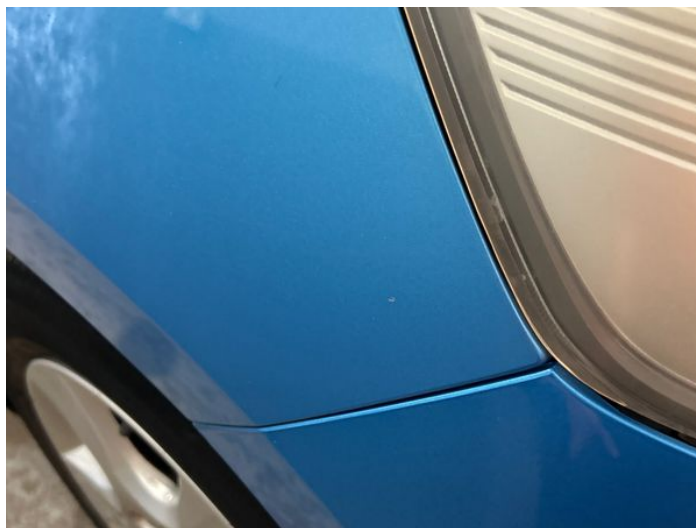
2: Wing osf  
Chipped  
1 To 5

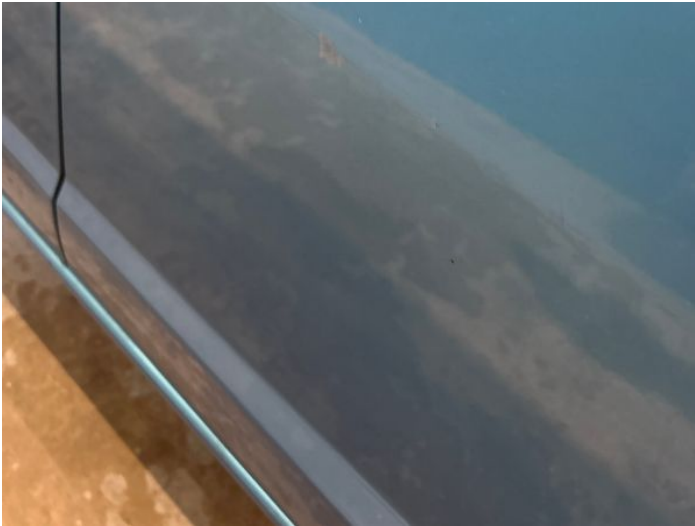
3: Door osf  
Chipped  
1 To 5

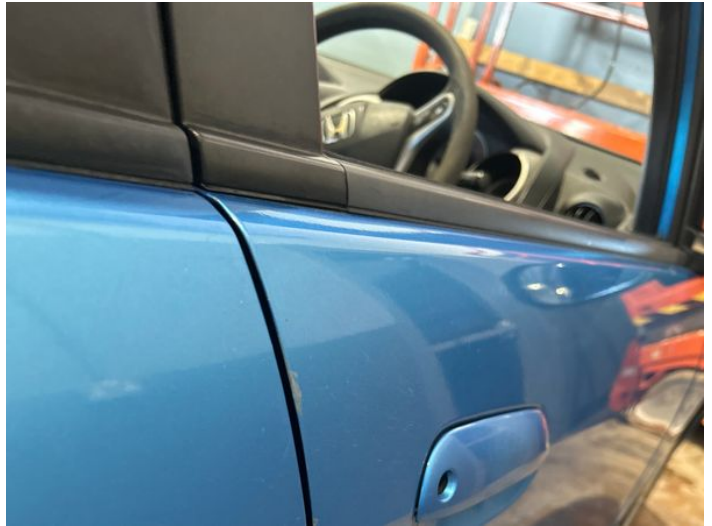
4: Door osf  
Chipped  
Edge Chip

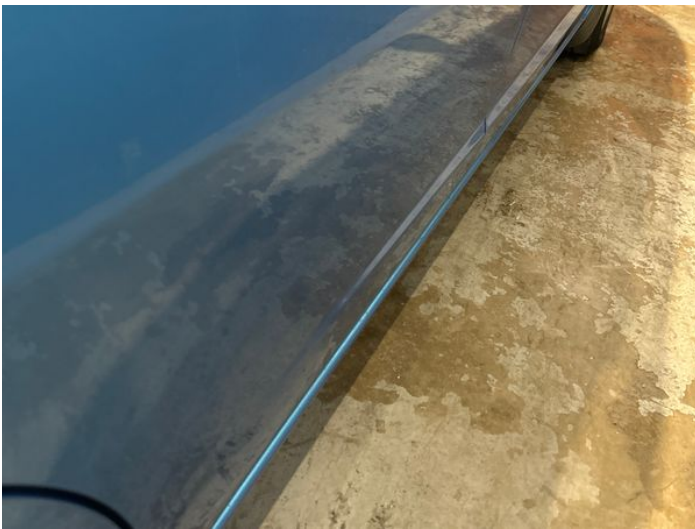
5: Door osr  
Dented  
Between 10mm + 30mm

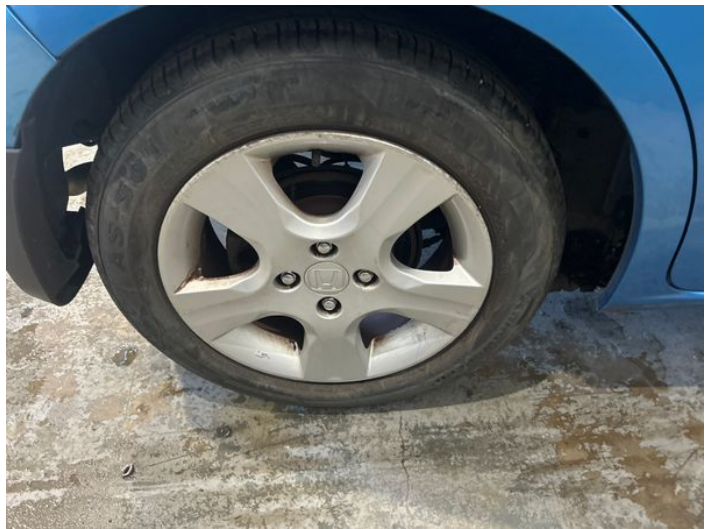
6: Wheel osr  
Scratched  
Over 50mm

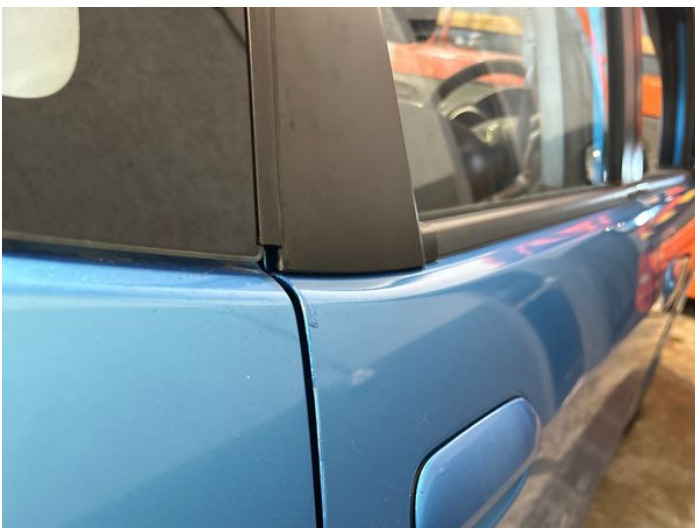
7: Door osr  
Chipped  
Edge Chip

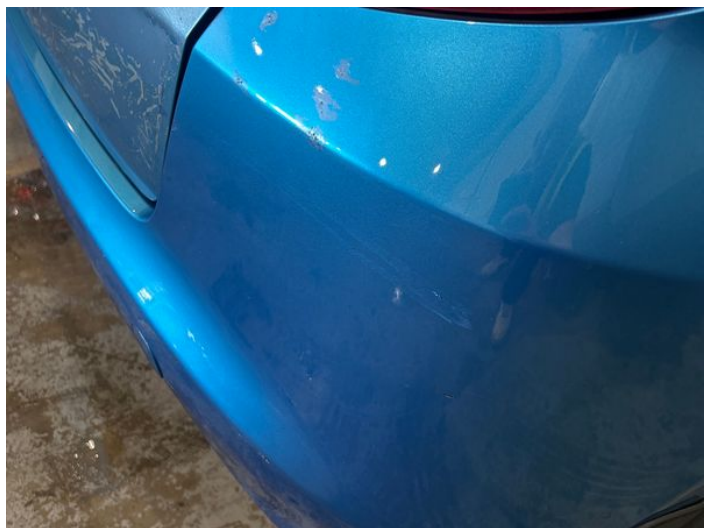
8: Bumper Rear  
Scratched  
25 to 100mm Thru Paint

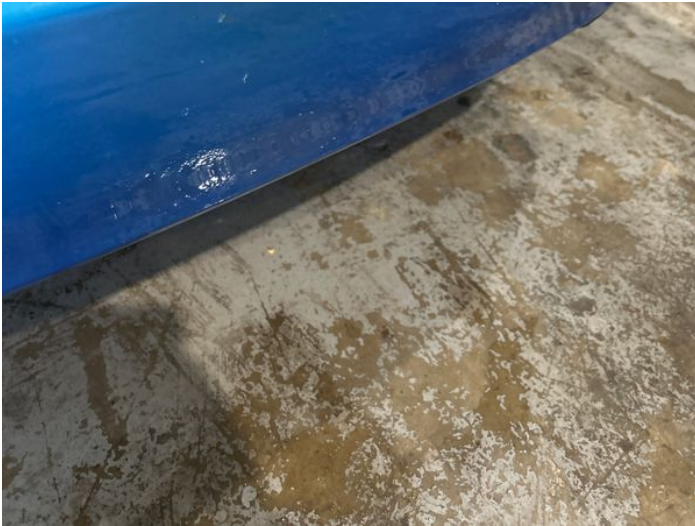
9: Bumper Rear  
Chipped  
Multiple Chips

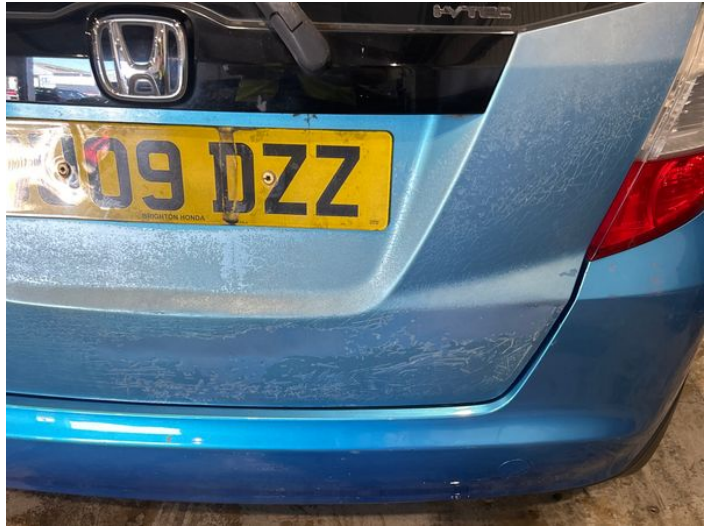
10: Tailgate  
Poor Previous Repair  
Poor Paint

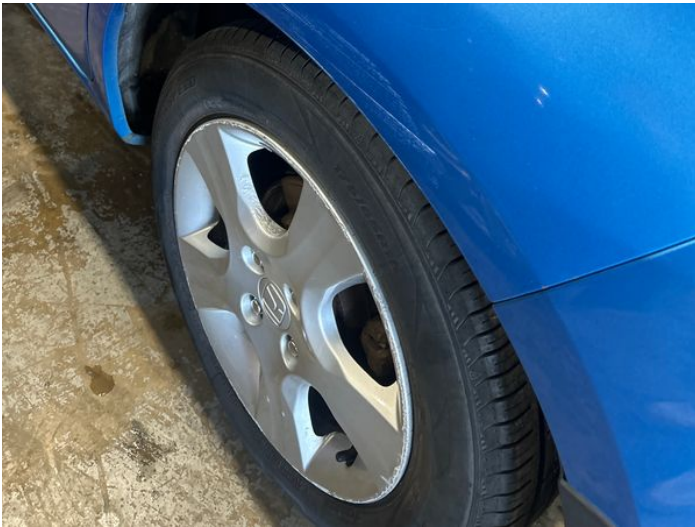
11: Qtr Panel nsr  
Scratched  
Over 25mm Thru Paint

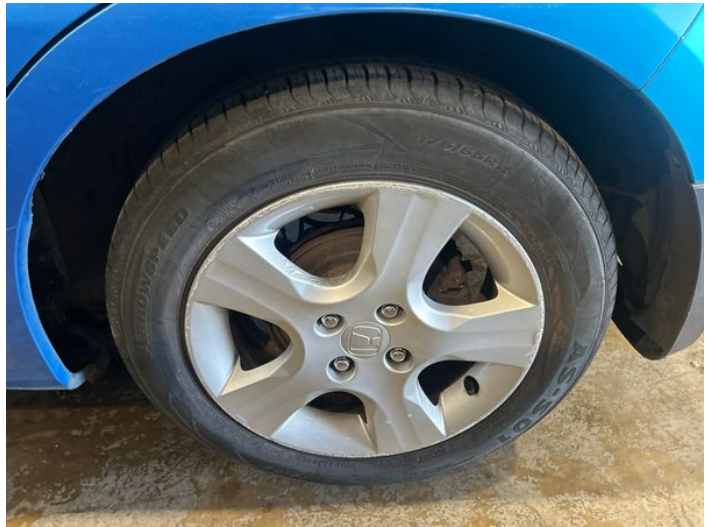
12: Wheel nsr  
Scratched  
Over 50mm

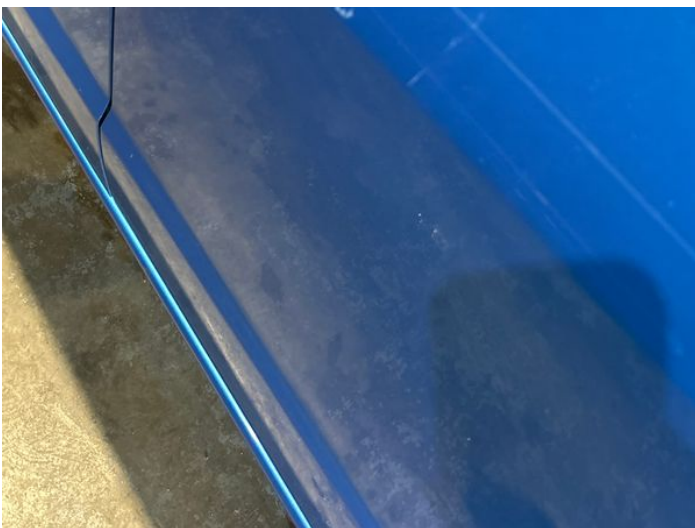
13: Door nsr  
Chipped  
1 To 5

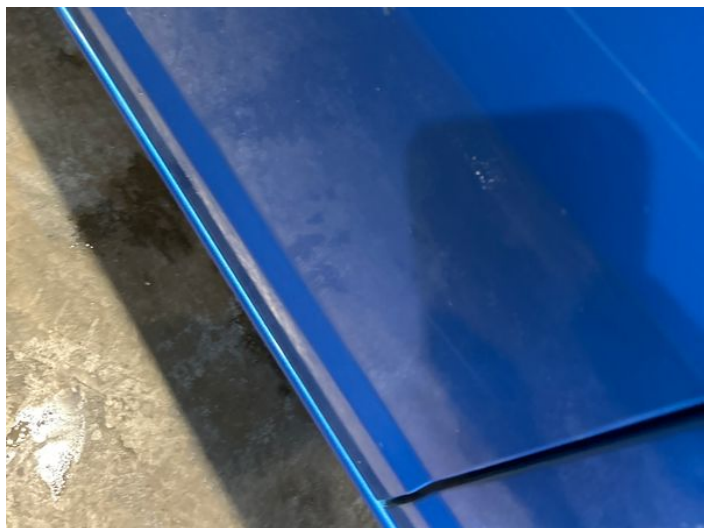
14: Door nsf  
Chipped  
1 To 5

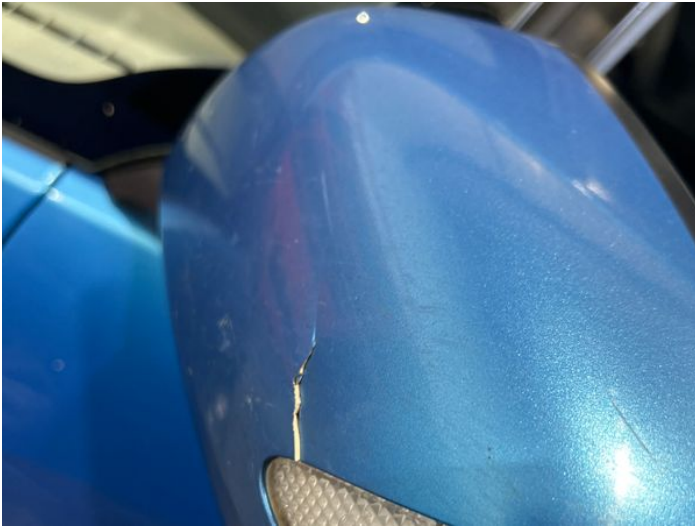
15: Door Mirror Assy nsf  
Broken  
Replace

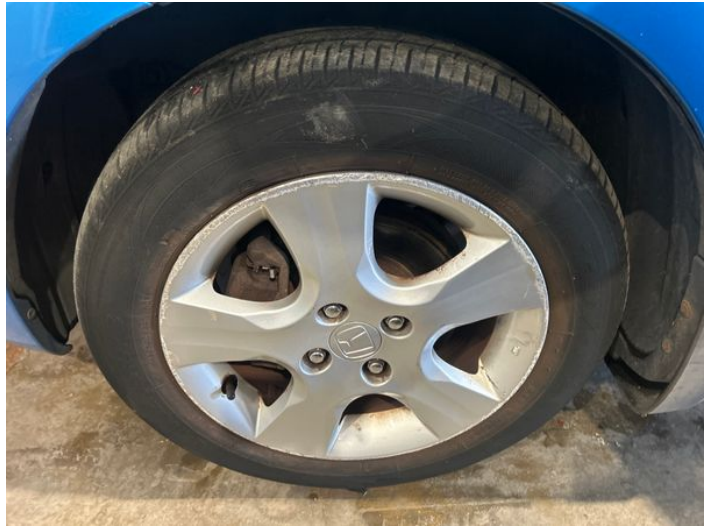
16: Wheel nsf  
Scratched  
Over 50mm

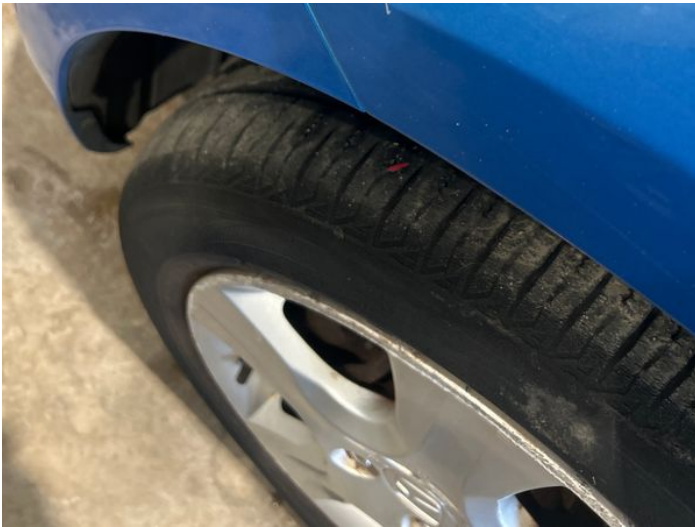
17: Wing nsf  
Scratched  
UpTo 25mm Thru Paint

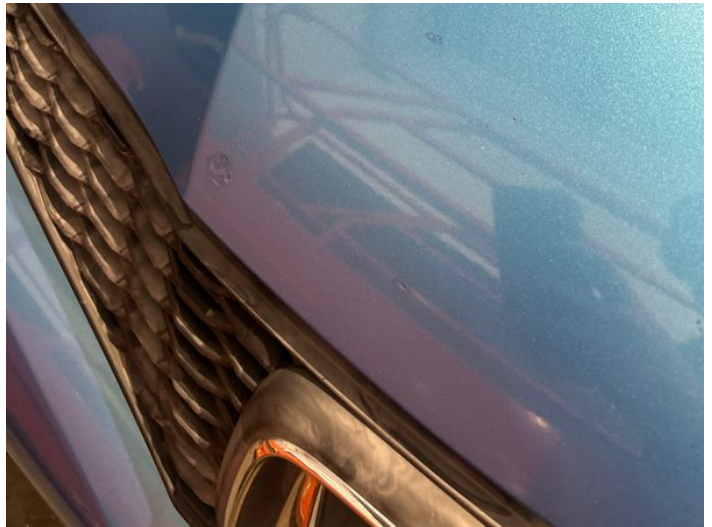
18: Bonnet  
Chipped  
Multiple Chips

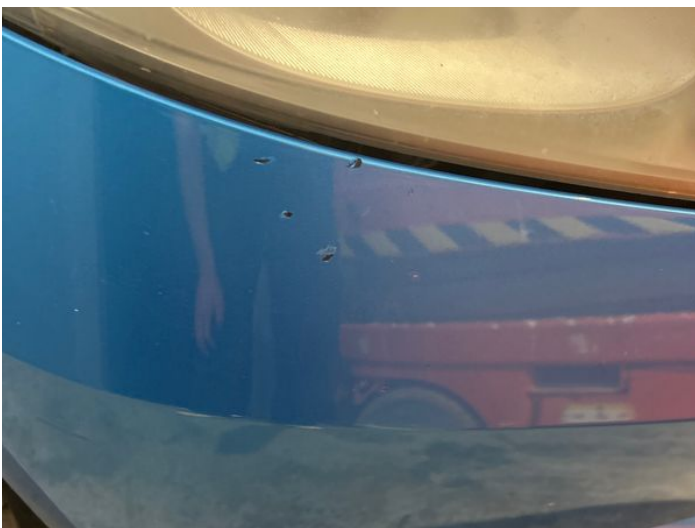
19: Bumper Front  
Chipped  
Multiple Chips

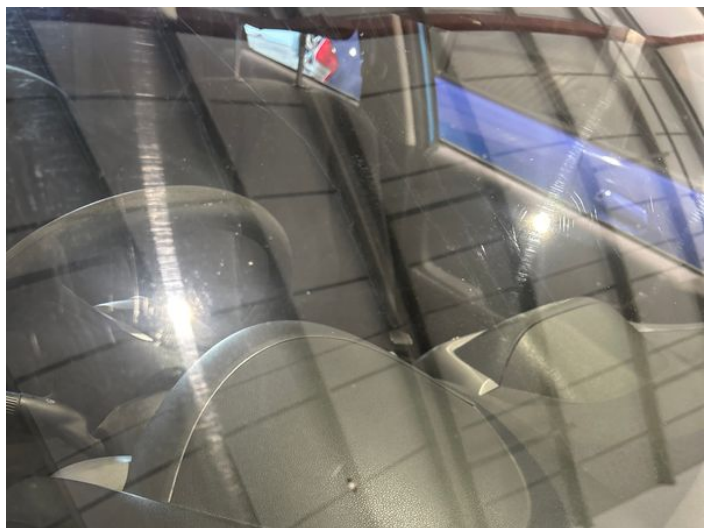
20: Screen Front  
Chipped  
UpTo 10mm
