# VEHICLE INSPECTION REPORT

**KS65XJV**

## Nissan Qashqai 1.5 dCi N-Tec+ 5dr

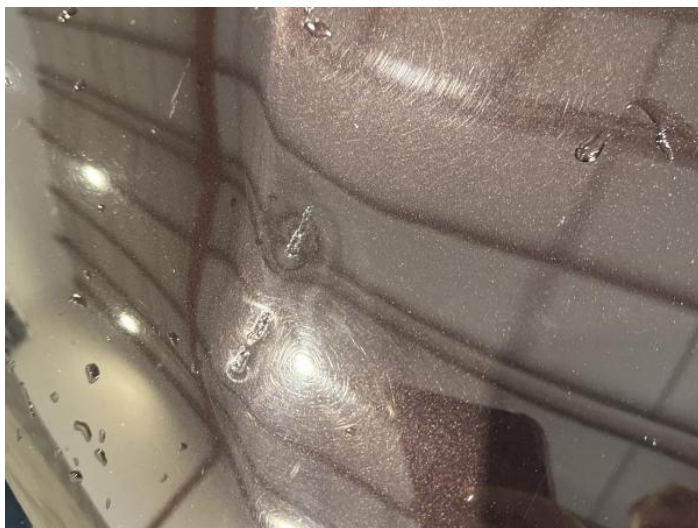
1: Bonnet  
Dented  
With Paint Damage

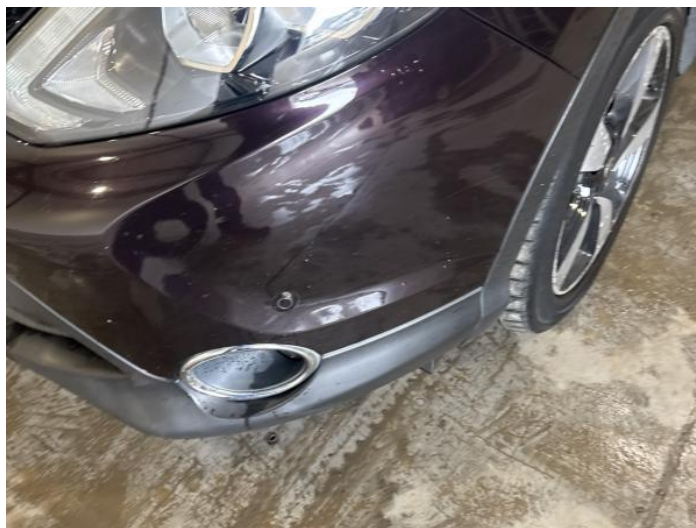
2: Bumper Front  
Scratched  
25 to 100mm Thru Paint

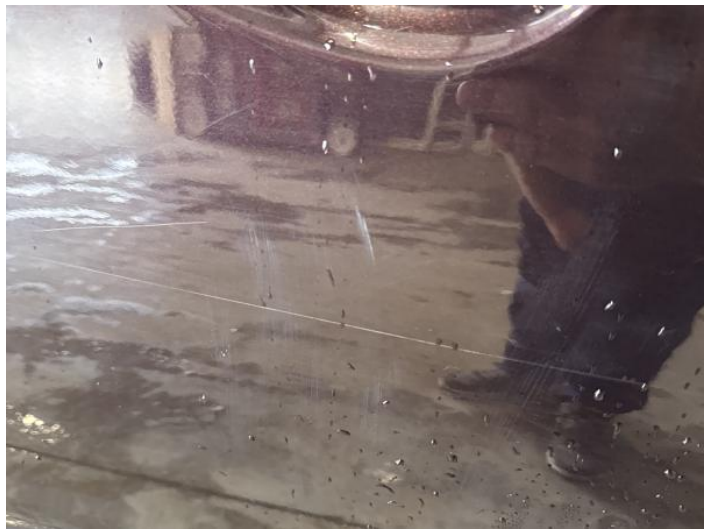
5: Wing nsf  
Scratched  
Over 25mm Not Thru Paint

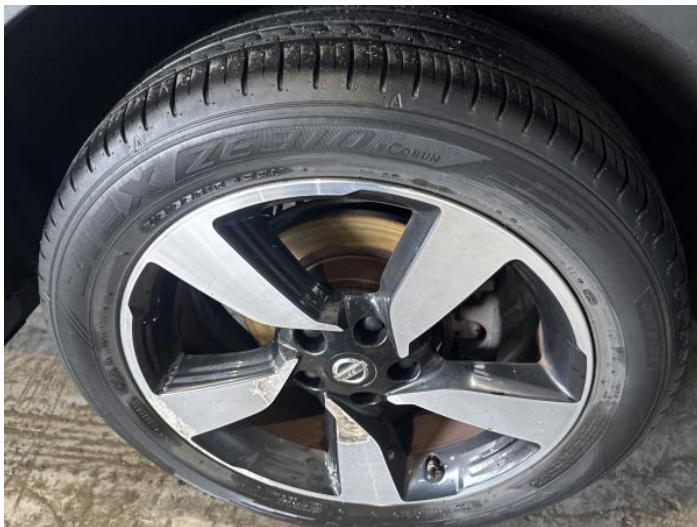
9: Wheel nsr  
Corroded  
Light

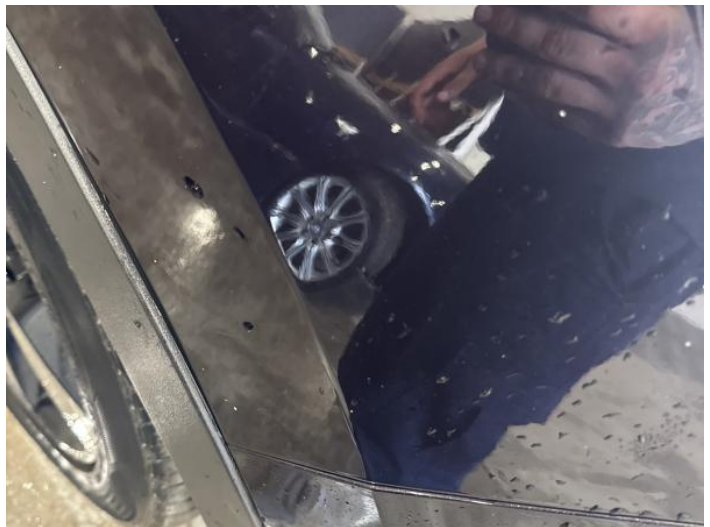
10: Wing osf  
Chipped  
1 To 5

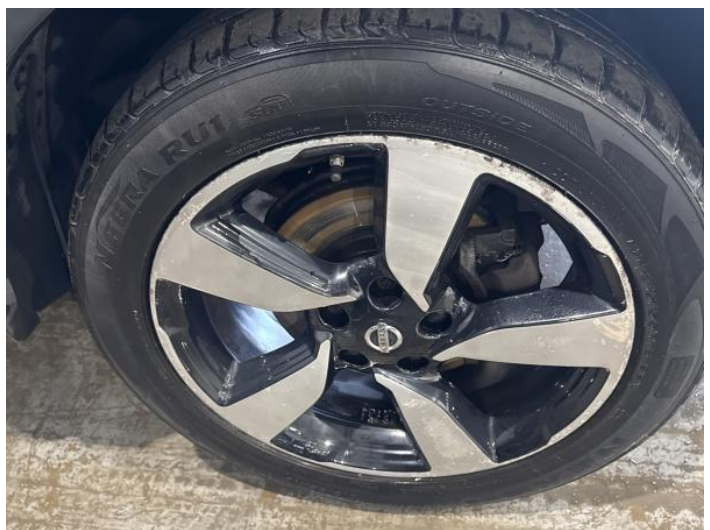
12: Wheel osf  
Scratched  
Over 50mm

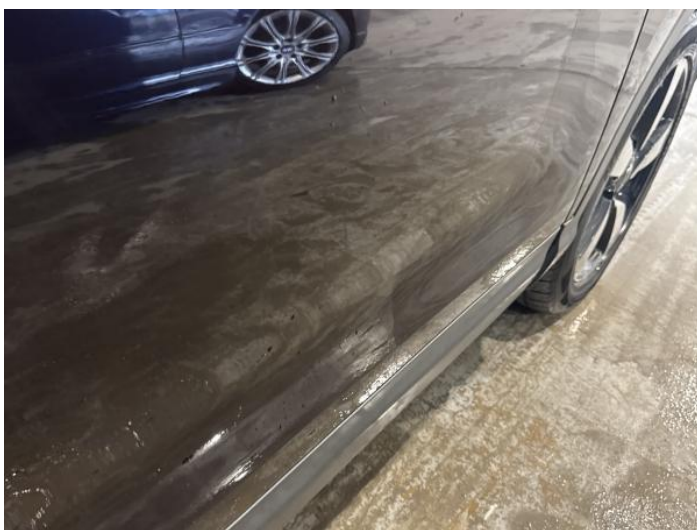
13: Door osf  
Dented  
Over 2 UpTo 10mm

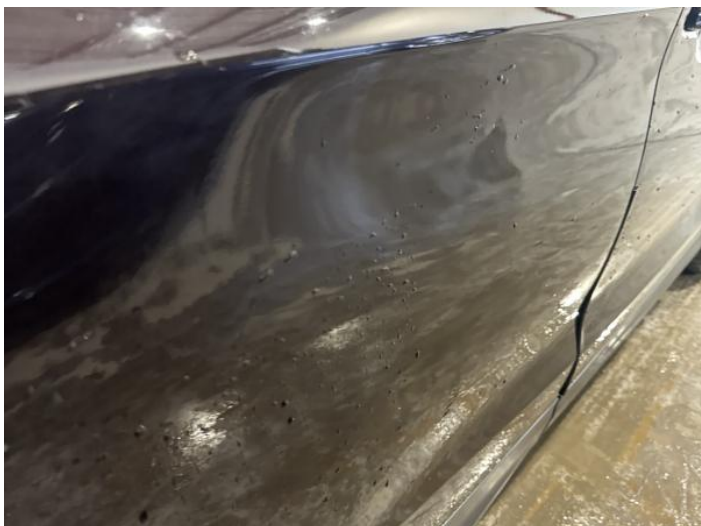
15: Door osr  
Dented  
Over 2 UpTo 10mm

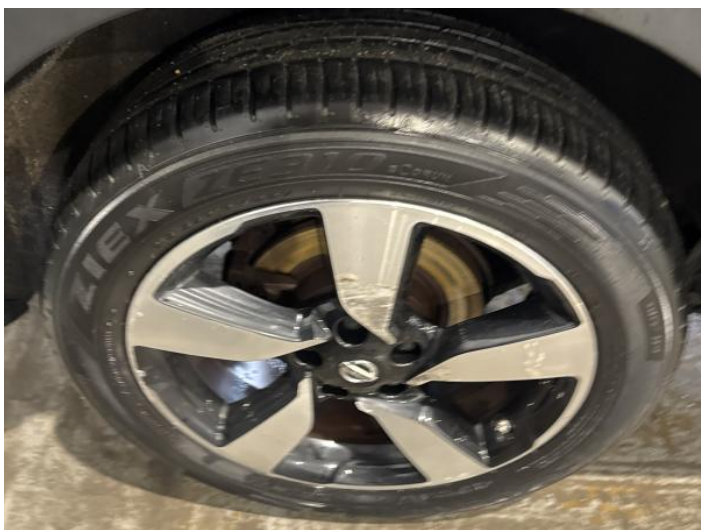
17: Wheel osr  
Scratched  
Over 50mm

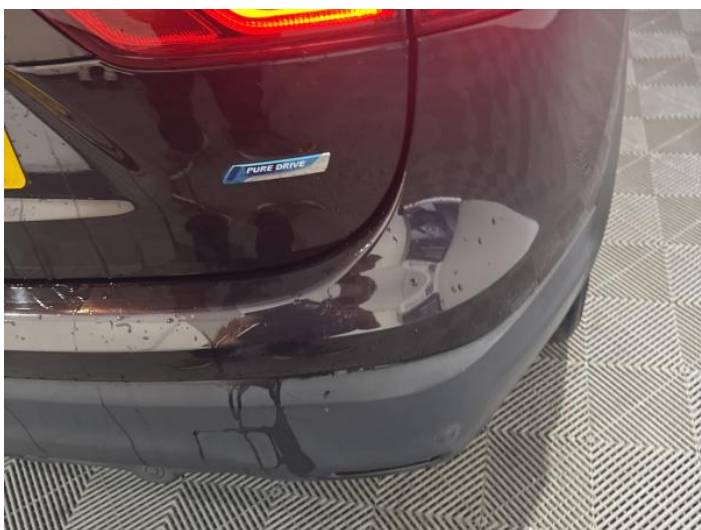
19: Bumper Rear  
Chipped  
Multiple Chips

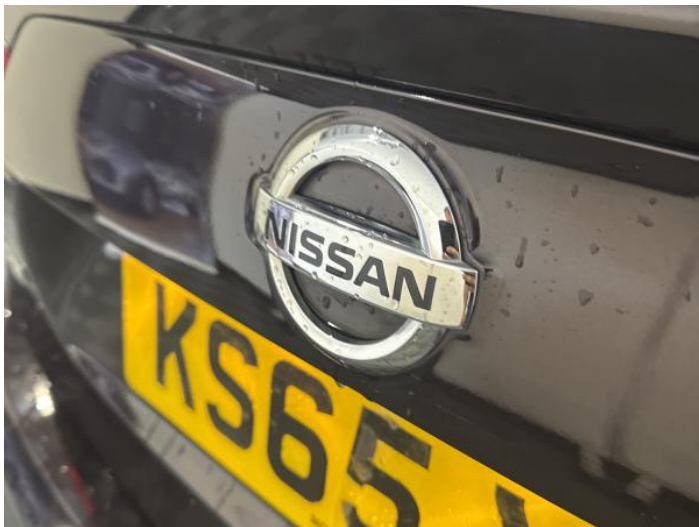
21: Boot Lid  
Dented  
Over 2 UpTo 10mm
