VEHICLE INSPECTION REPORT

PN64ZKJ

Nissan Qashqai 1.5 dCi Tekna 5dr

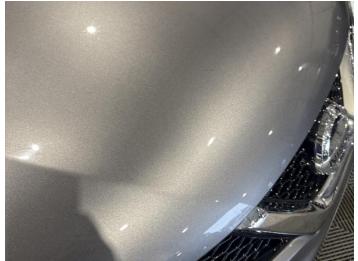
1: Bonnet Chipped 1 To 5

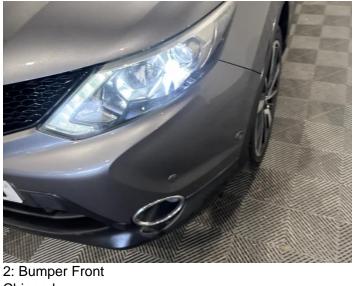
2: Bumper From Chipped Multiple Chips

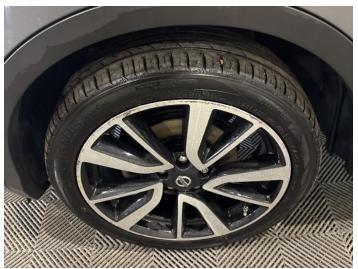
3: Wheel nsf Scratched Over 50mm

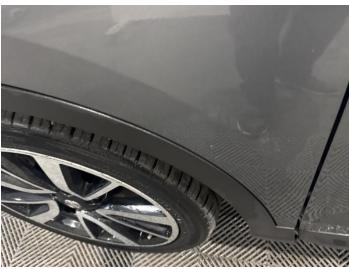
4: Wing nsf Chipped 1 To 5

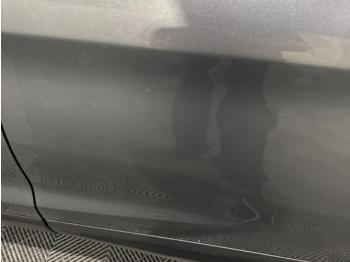
6: Door nsr Chipped 1 To 5

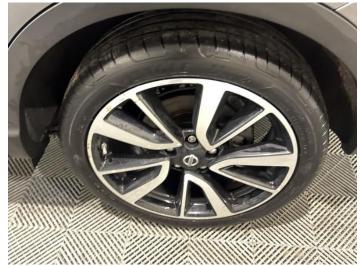
7: Wheel nsr Scratched Over 50mm

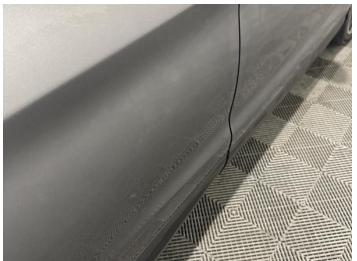
11: Door osr Dented Over 2 UpTo 10mm

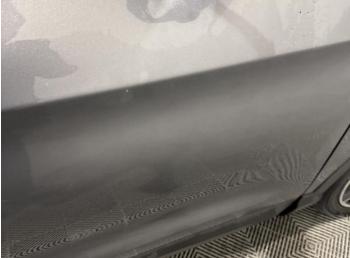
12: Door osf Chipped 1 To 5

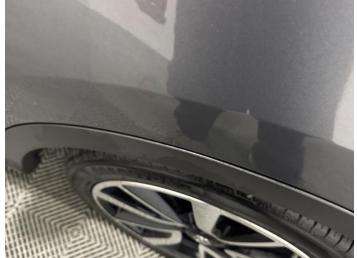
13: Wing osf Chipped 1 To 5

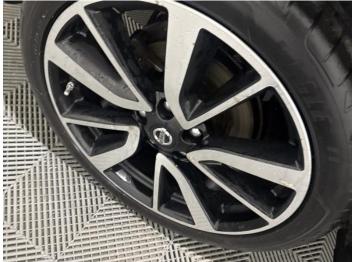
14: Wheel osr Scratched Over 50mm

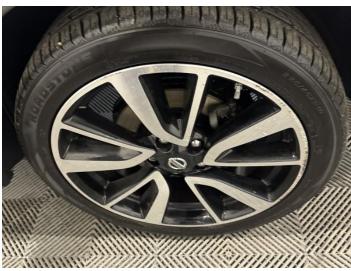
15: Wheel osf Scratched Over 50mm
