# VEHICLE INSPECTION REPORT

**GJ23MJE**

## Dacia Jogger 1.0 TCe Expression 5dr

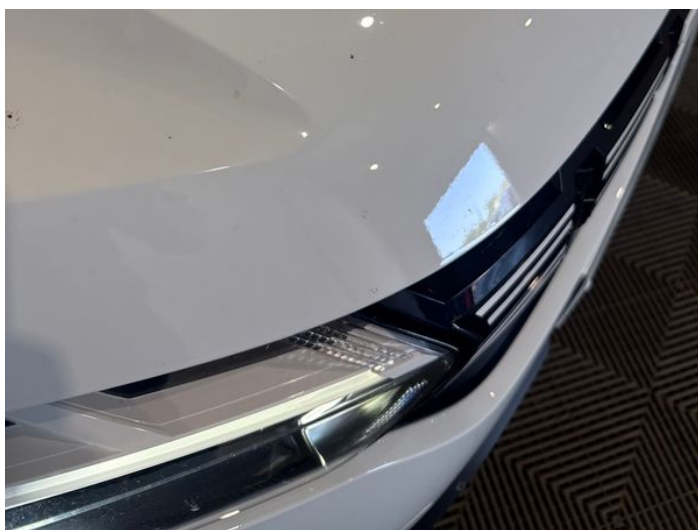
1: Bonnet  
Chipped  
1 To 5

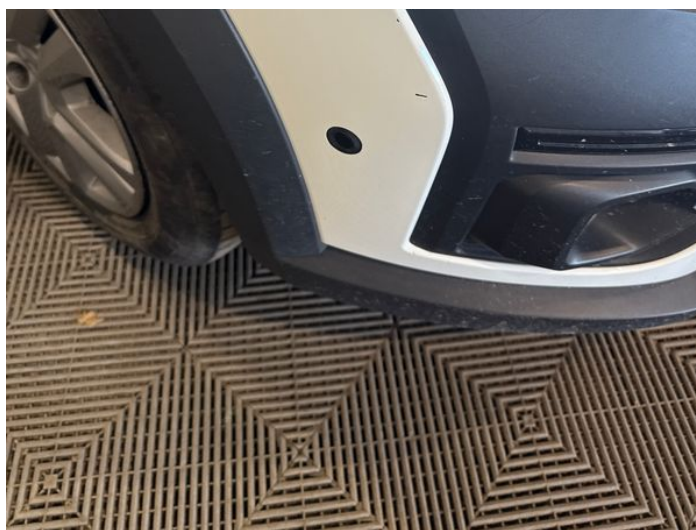
2: Bumper Front  
Scratched  
25 to 100mm Thru Paint

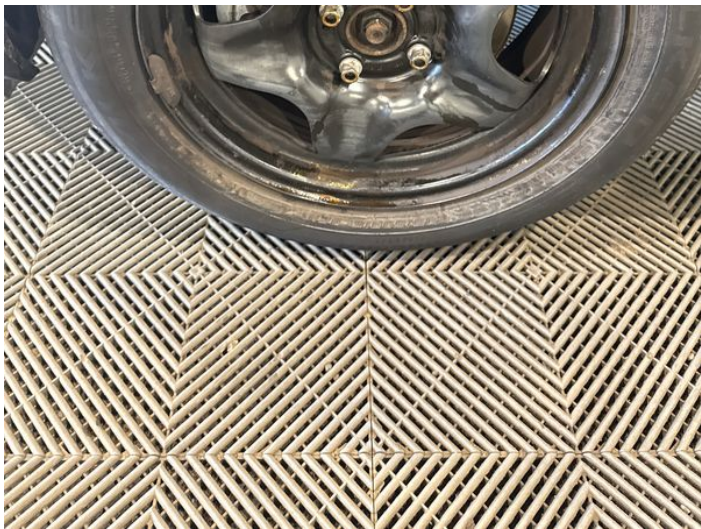
3: Wheel Trim nsf  
Missing  
Replace

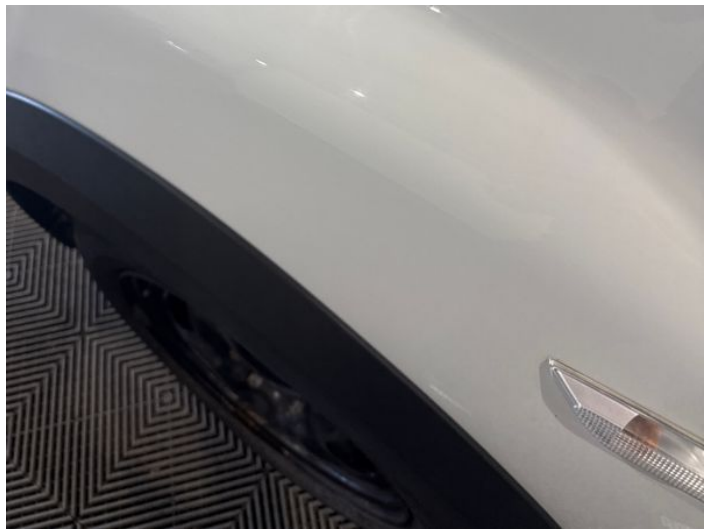
4: Wing nsf  
Chipped  
1 To 5

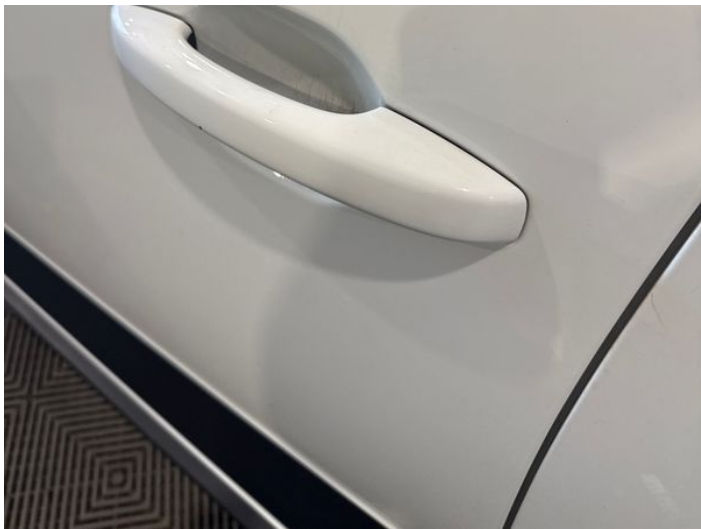
5: Door nsf  
Chipped  
1 To 5

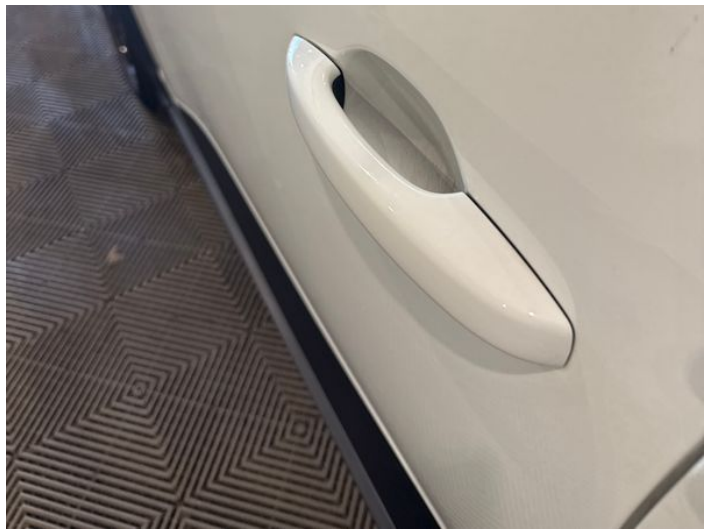
6: Door nsf  
Dented  
Over 30mm

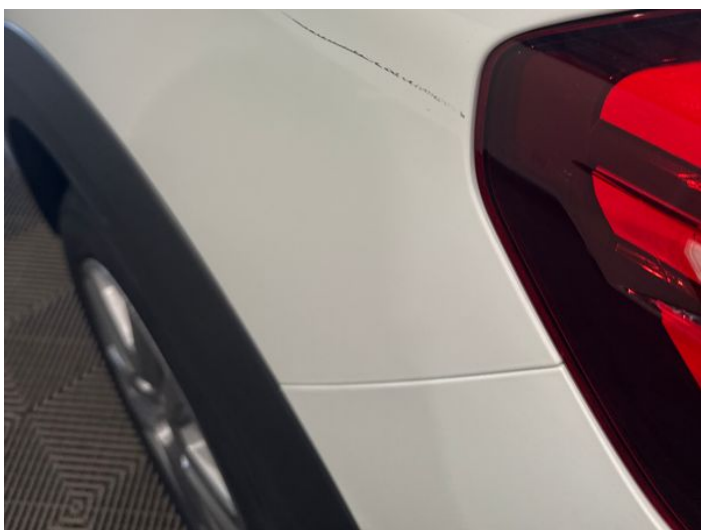
7: Qtr Panel nsr  
Scratched  
Over 25mm Thru Paint

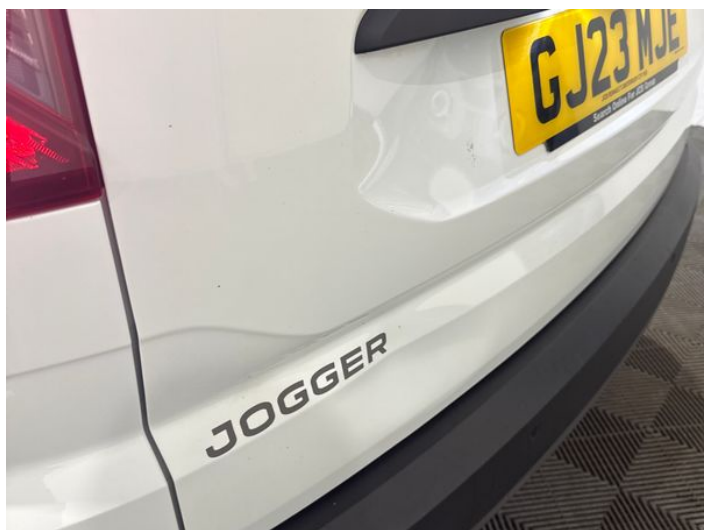
8: Tailgate  
Dented  
Over 30mm

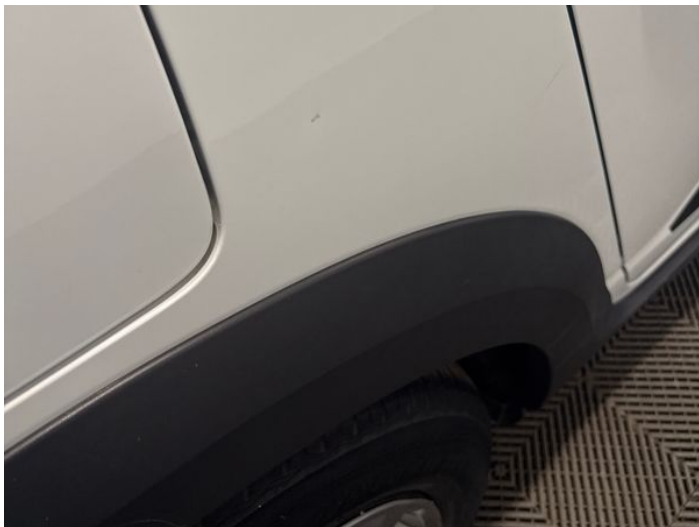
9: Qtr Panel osr  
Scratched  
UpTo 25mm Thru Paint

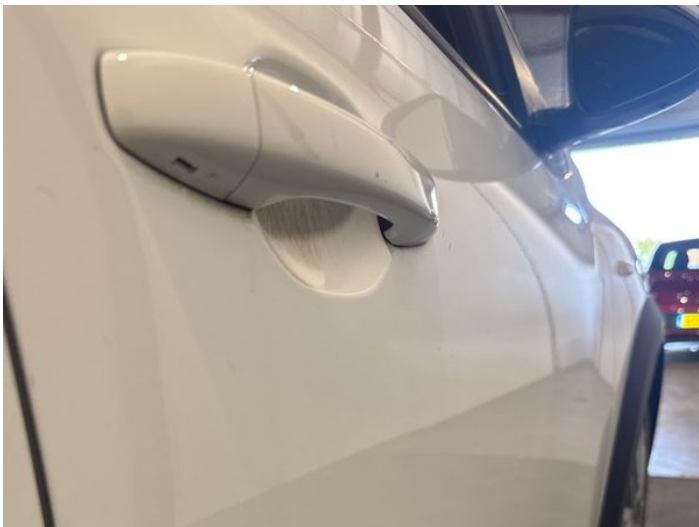
10: Door osf  
Dented  
Over 30mm

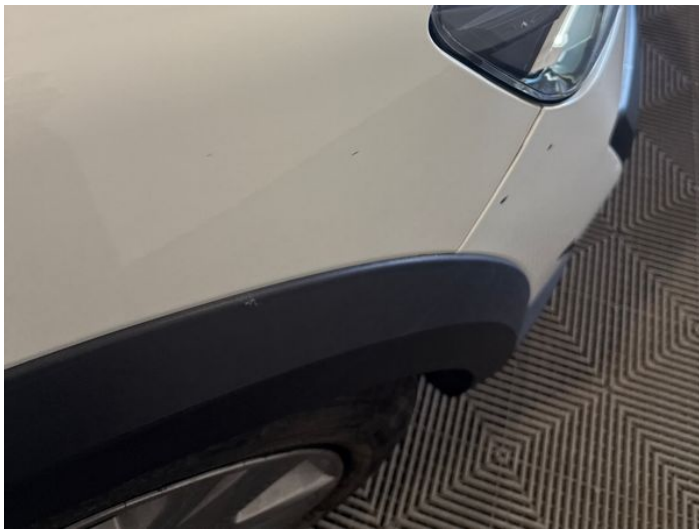
11: Wing osf  
Chipped  
1 To 5
