# VEHICLE INSPECTION REPORT

**KR70BCZ**

## Land Rover Range Rover Velar 2.0 D240 R-Dynamic HSE 5dr Auto

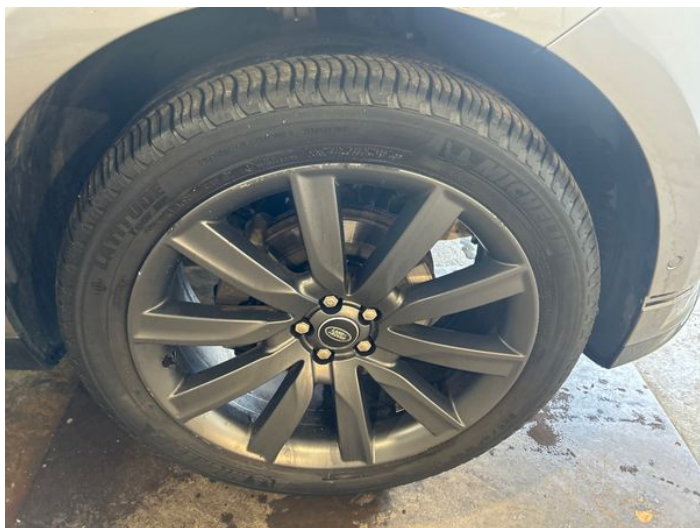
1: Wheel osf  
Scratched  
Over 50mm

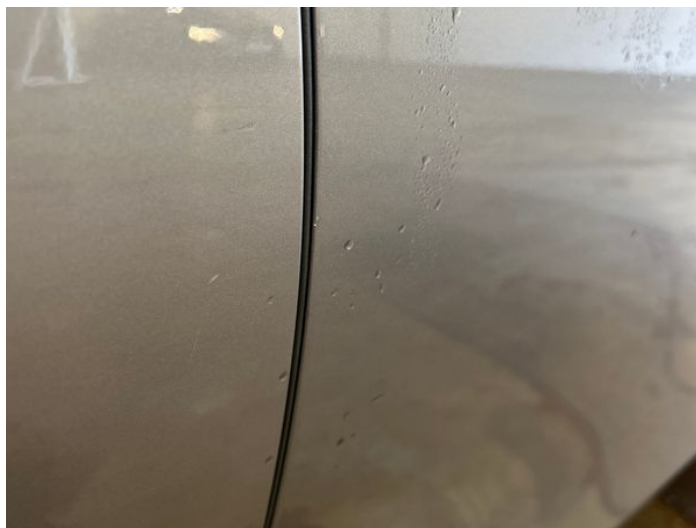
2: Door osf  
Chipped  
Edge Chip

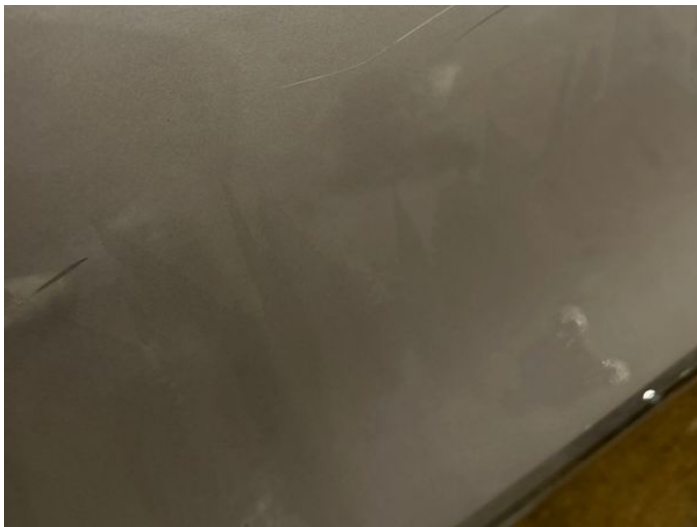
3: Door osr  
Scratched  
Over 25mm Thru Paint

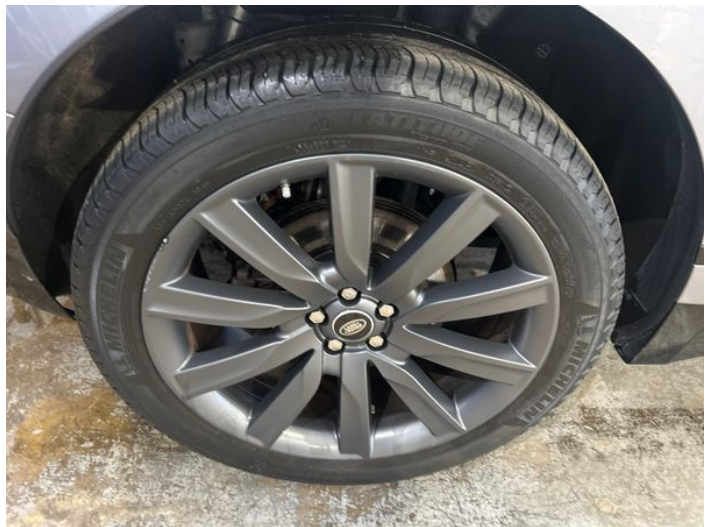
4: Wheel osr  
Scratched  
Over 50mm

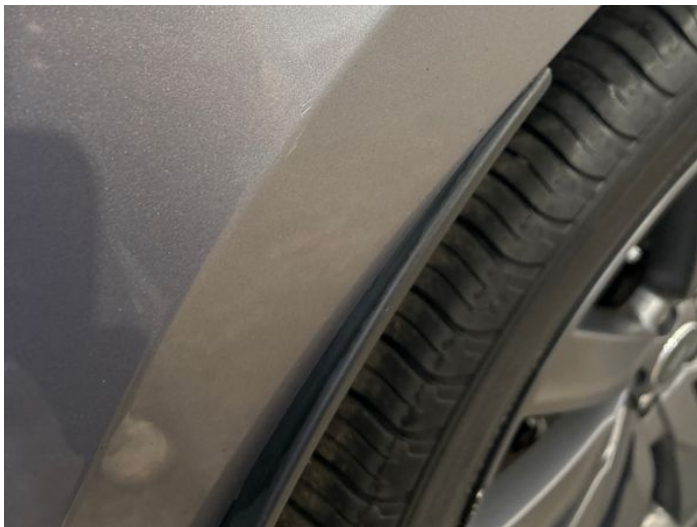
5: Qtr Panel osr  
Chipped  
1 To 5

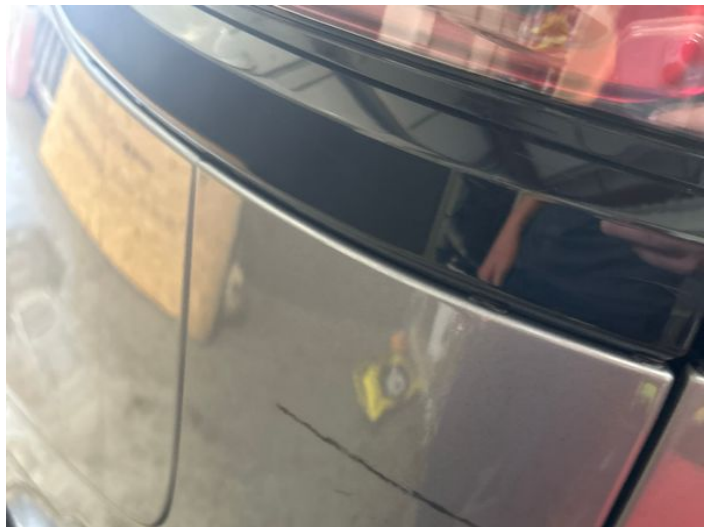
6: Bumper Rear  
Scratched  
25 to 100mm Thru Paint

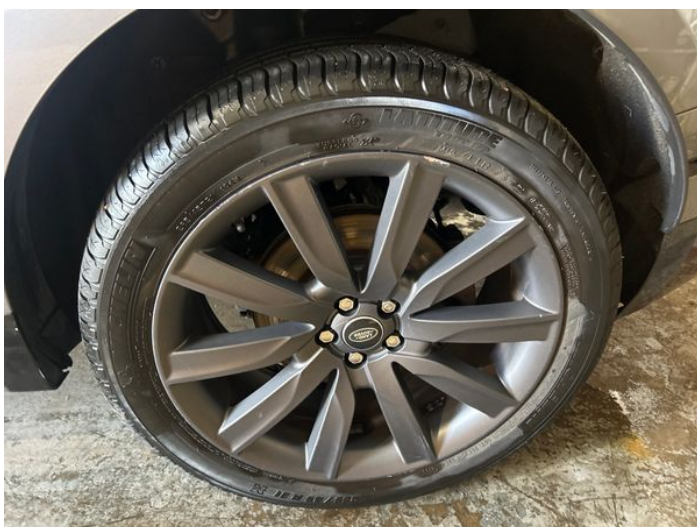
7: Wheel nsr  
Scratched  
Over 50mm

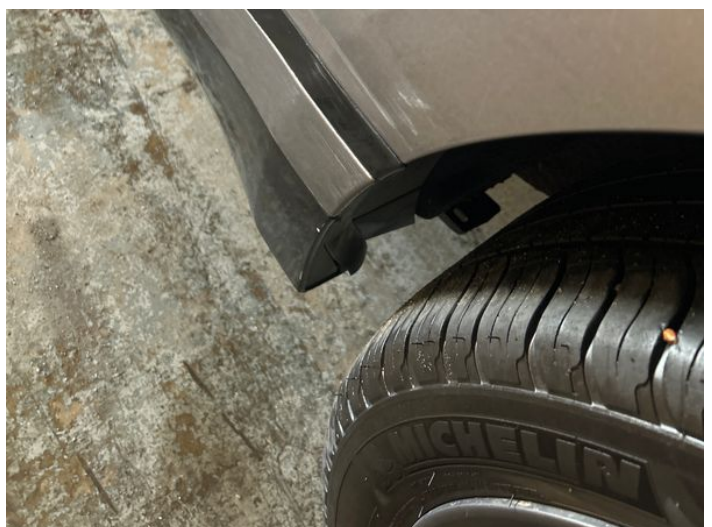
8: Door nsr  
Dented  
With Paint Damage

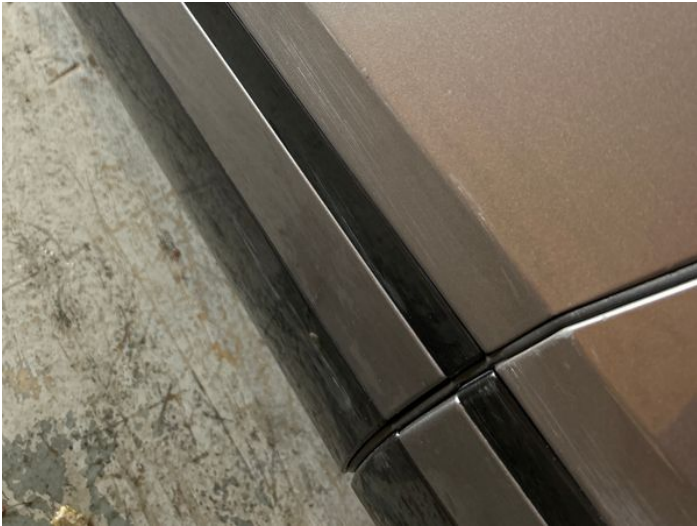
9: Door nsf  
Scratched  
Over 25mm Thru Paint

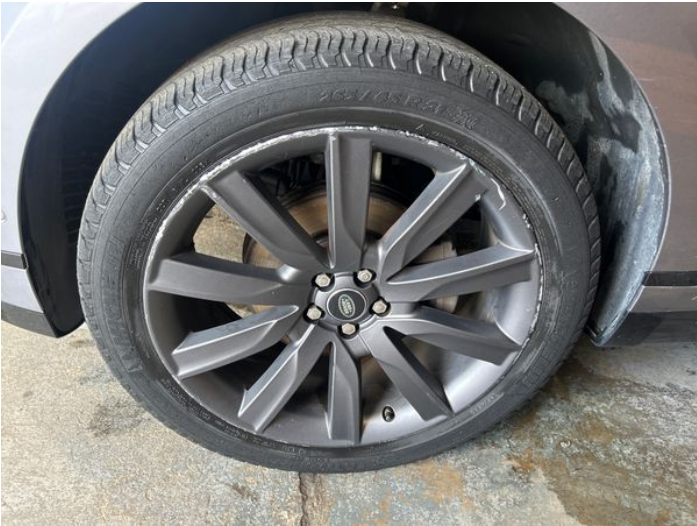
10: Wheel nsf  
Scratched  
Over 50mm

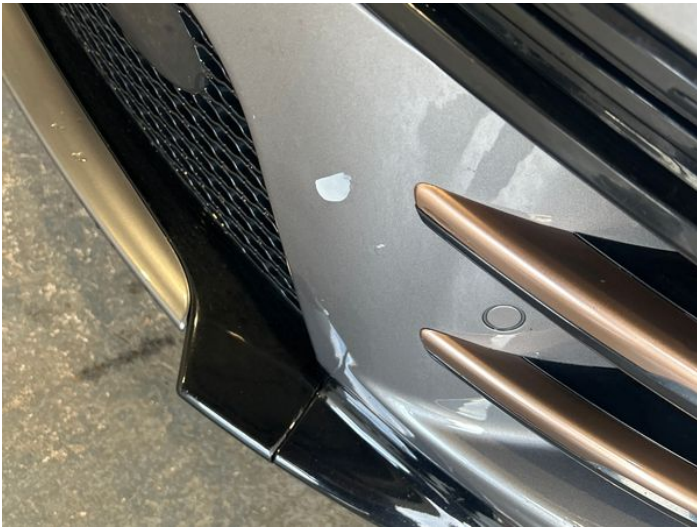
11: Bumper Front  
Poor Previous Repair  
Paint Flake

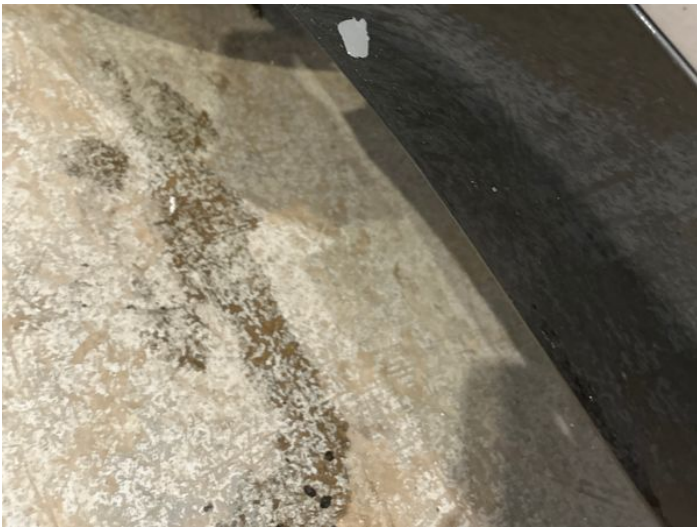
13: Door Moulding osr  
Scratched (Painted)  
Over 25mm Thru Paint
