## VEHICLE INSPECTION REPORT

**GX20HGC**

### Ford Puma 1.0 EcoBoost Hybrid mHEV 155 ST-Line X 1st Ed 5dr

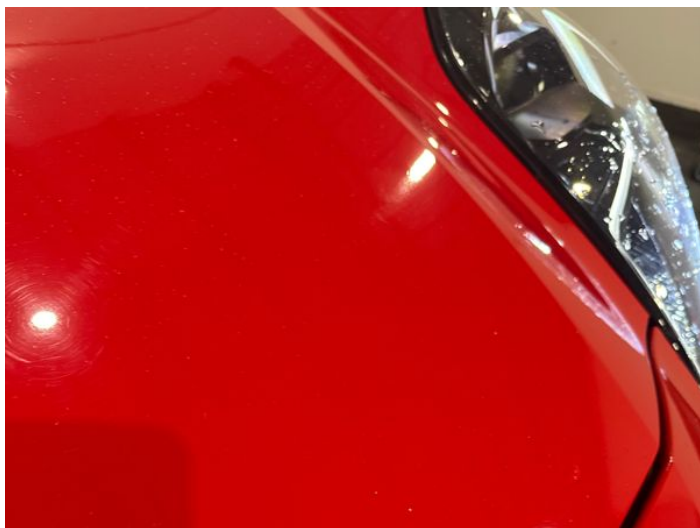
1: Bonnet  
Chipped  
1 To 5

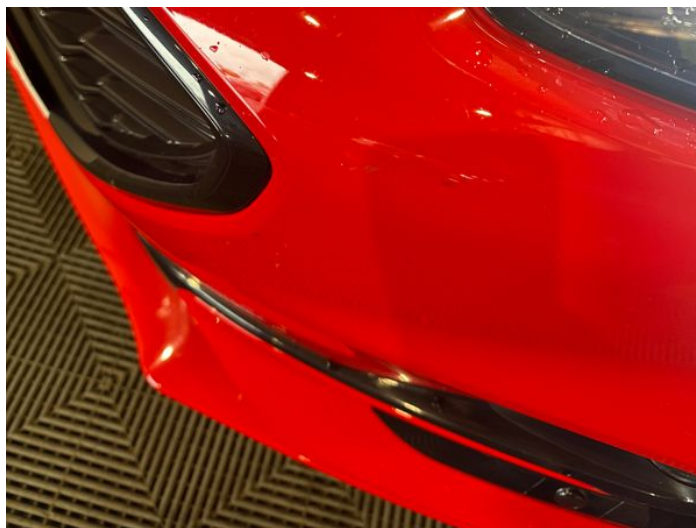
2: Bumper Front  
Chipped  
1 To 5

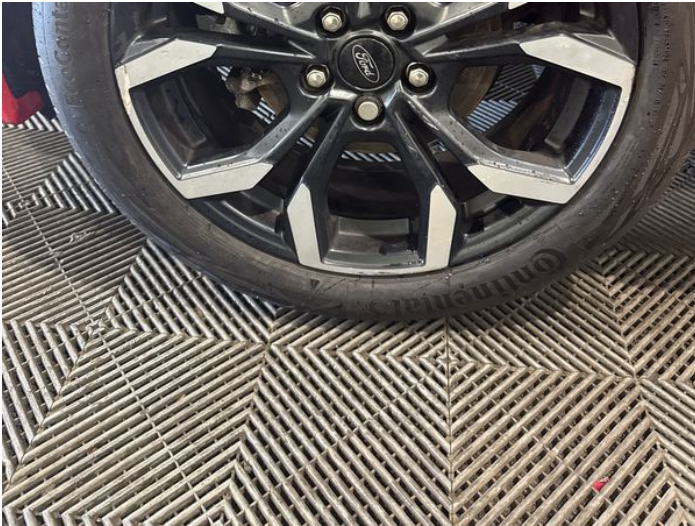
3: Wheel nsf  
Scratched  
Over 50mm

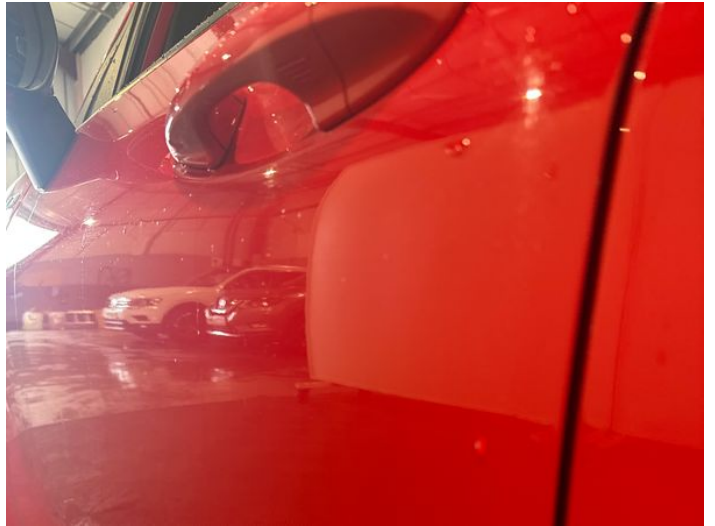
4: Door nsf  
Dented  
Between 10mm + 30mm

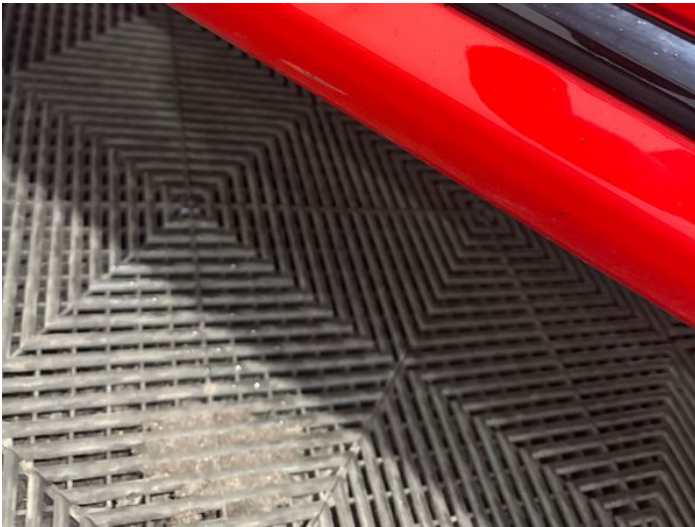
5: Sill ns  
Scratched  
Up To 25mm Thru Paint

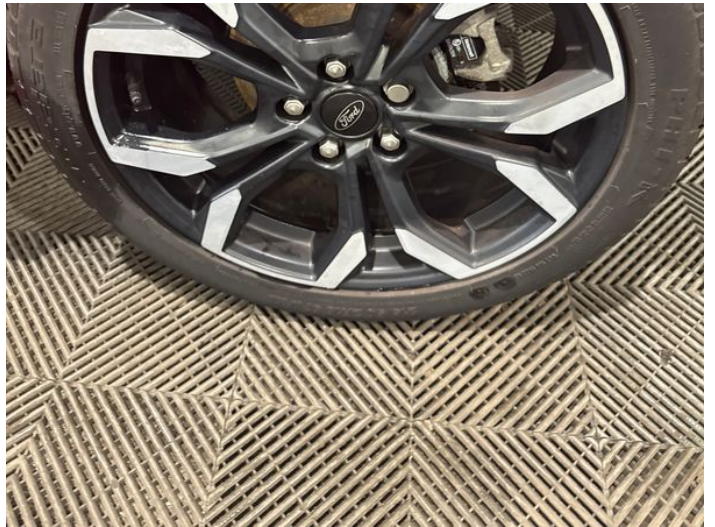
6: Wheel nsr  
Scratched  
Up To 50mm

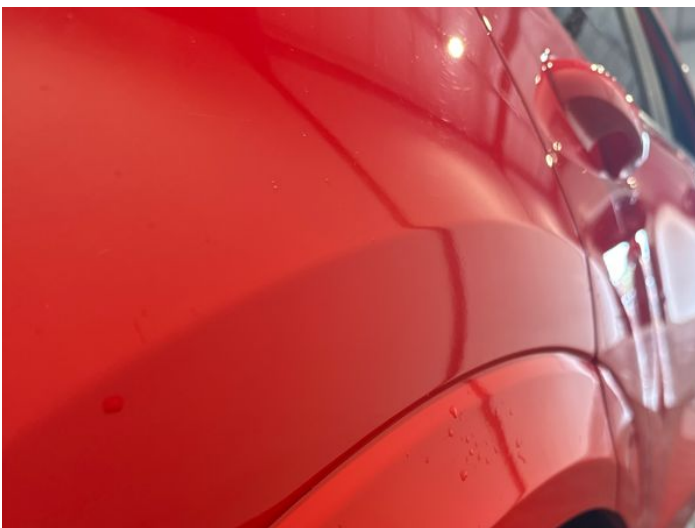
7: Qtr Panel osr  
Dented  
Between 10mm + 30mm

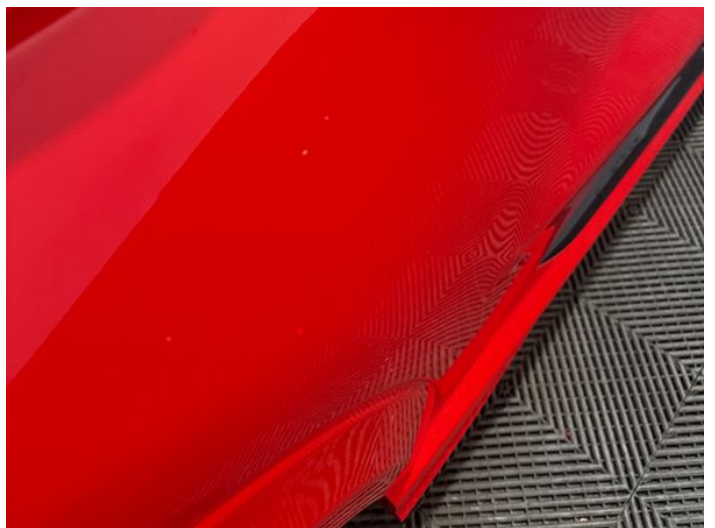
8: Door osr  
Chipped  
1 To 5

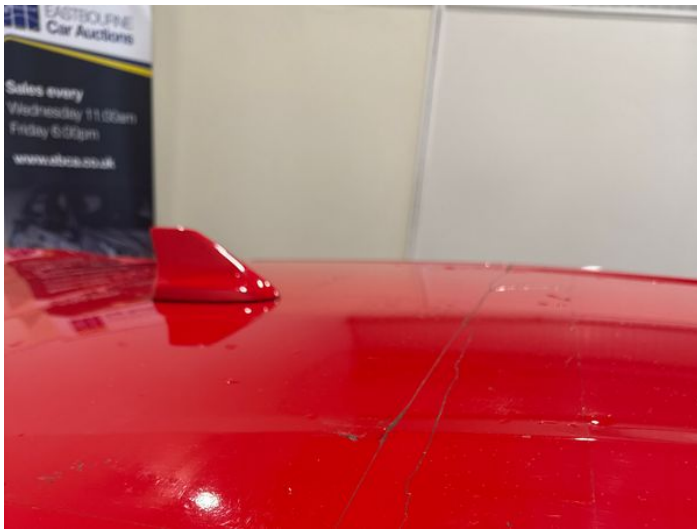
9: Roof  
Scratched  
Over 25mm Not Thru Paint

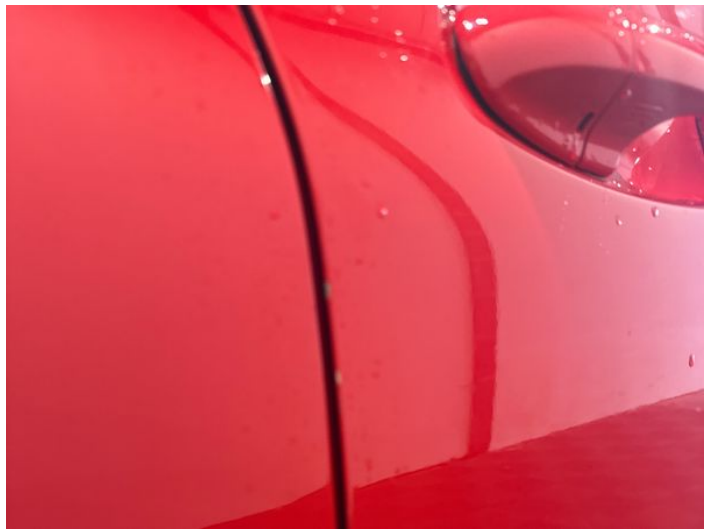
10: Door osf  
Chipped  
Edge Chip

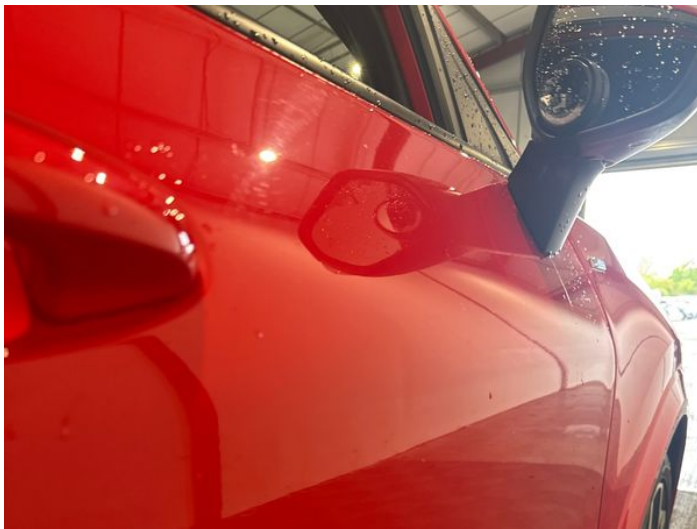
11: Door osf  
Dented  
Over 30mm

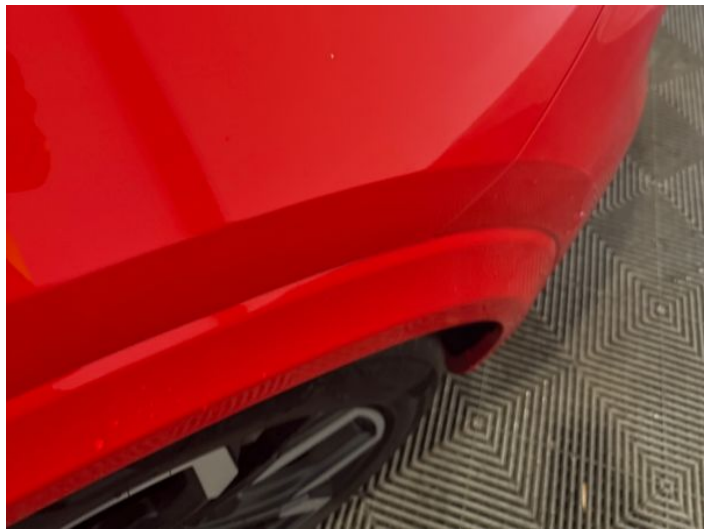
12: Wing osf  
Chipped  
1 To 5
