# VEHICLE INSPECTION REPORT

**GJ60OFH**

## Kia Soul 1.6 CRDi Echo 5dr

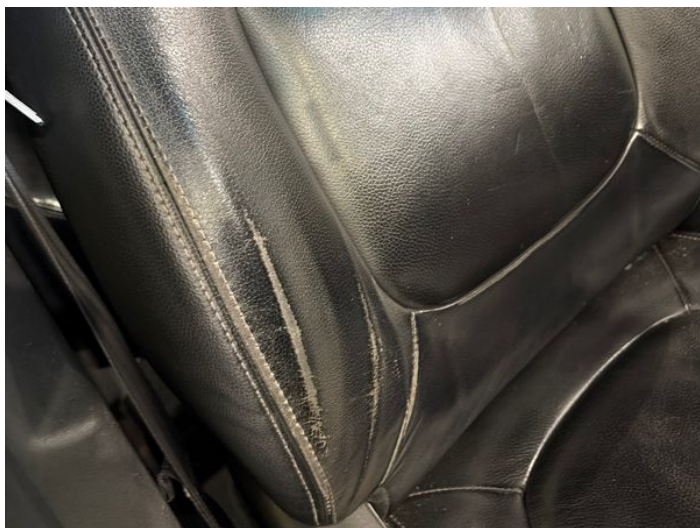
1: Seat Back Cover osf  
Scuffed  
Over 25mm

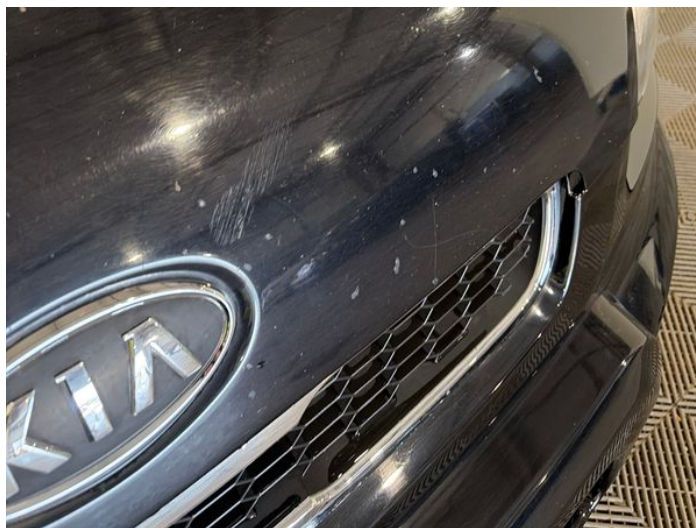
2: Bonnet  
Scratched  
Over 25mm Thru Paint

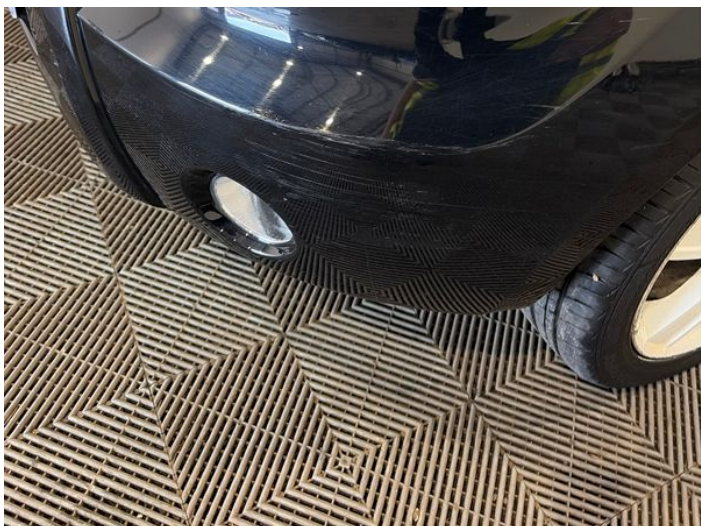
3: Bumper Front  
Scratched  
Over 100mm Thru Paint

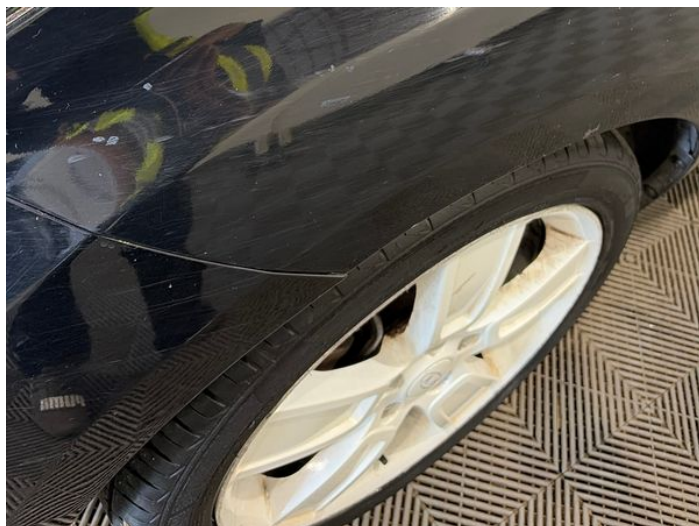
4: Wing nsf  
Scratched  
Over 25mm Thru Paint

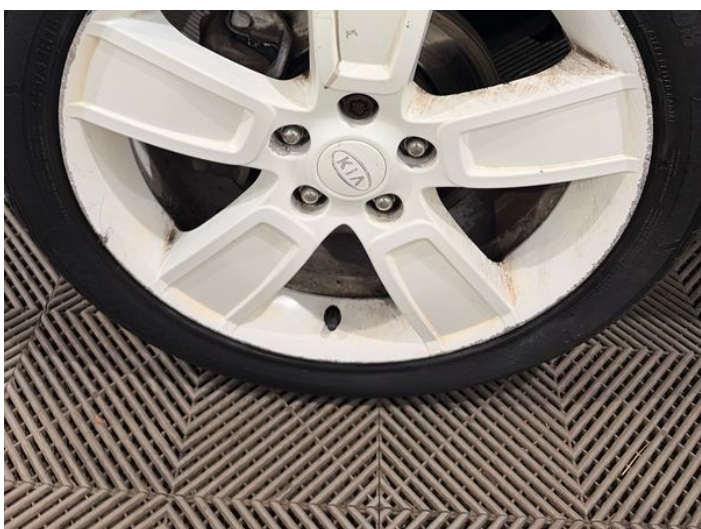
5: Wheel nsf  
Scratched  
Over 50mm

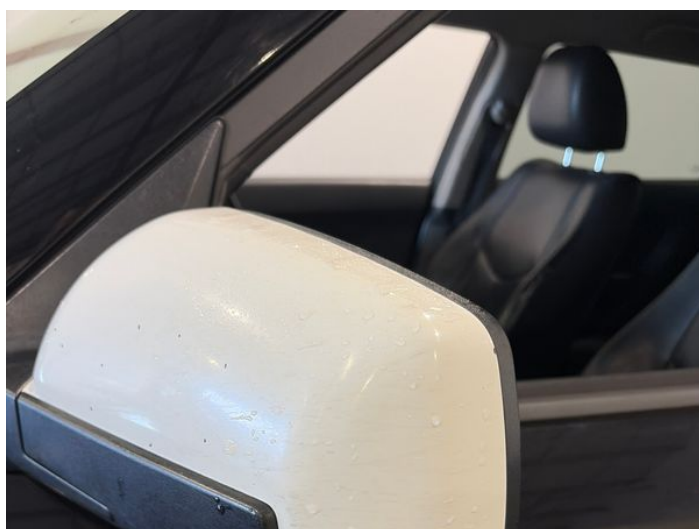
6: Door Mirror Assy nsf  
Scratched (Painted)  
UpTo 25mm Thru Paint

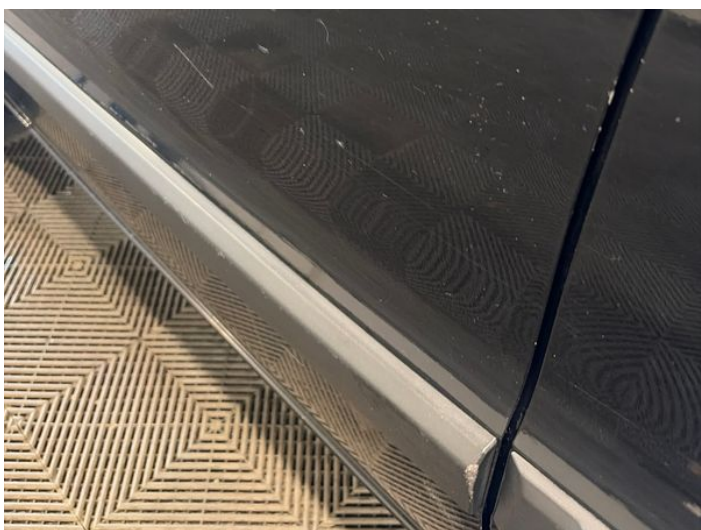
7: Door nsf  
Scratched  
Over 25mm Thru Paint

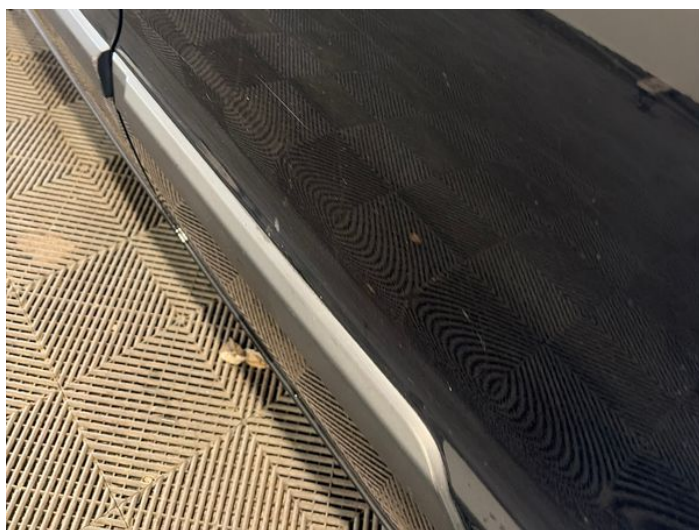
8: Door nsr  
Scratched  
Over 25mm Thru Paint

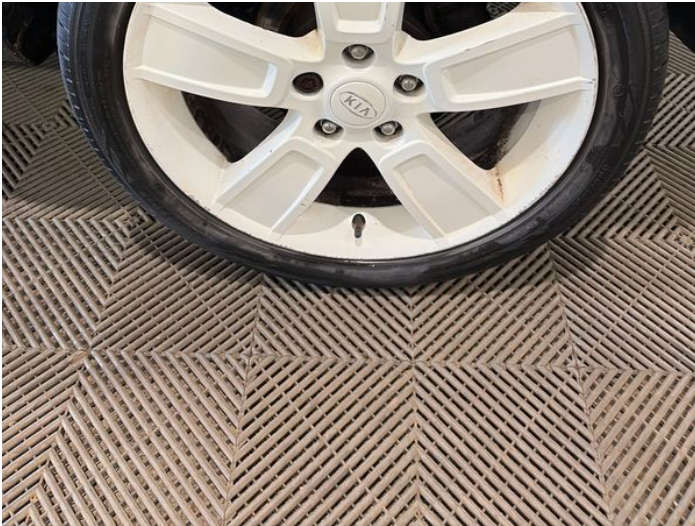
9: Wheel nsr  
Scratched  
Over 50mm

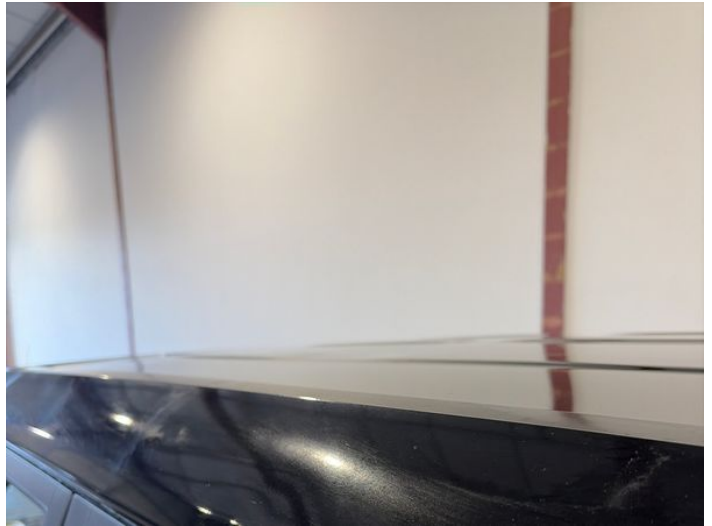
10: B Post ns  
Dented  
Over 30mm

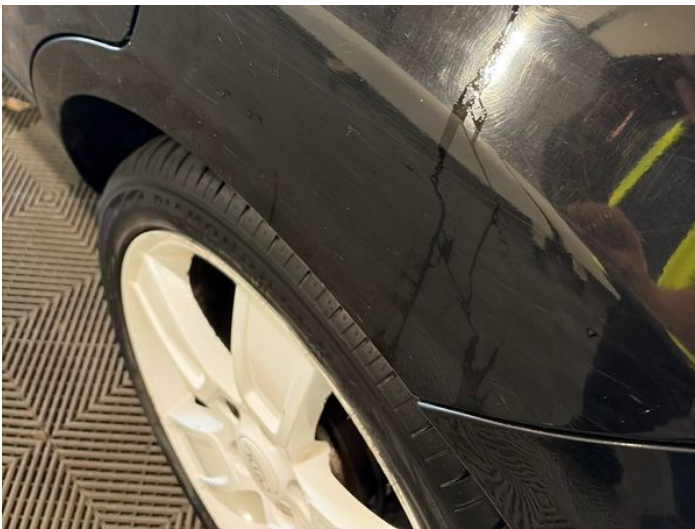
11: Qtr Panel nsr  
Scratched  
Over 25mm Thru Paint

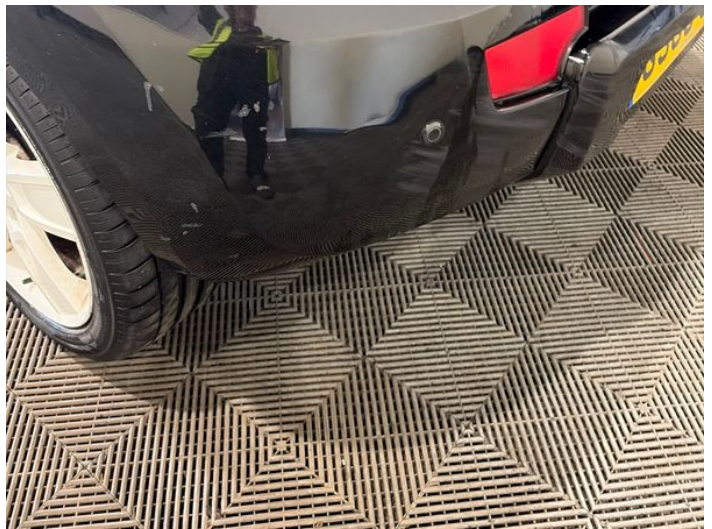
12: Bumper Rear  
Scratched  
Over 100mm Thru Paint

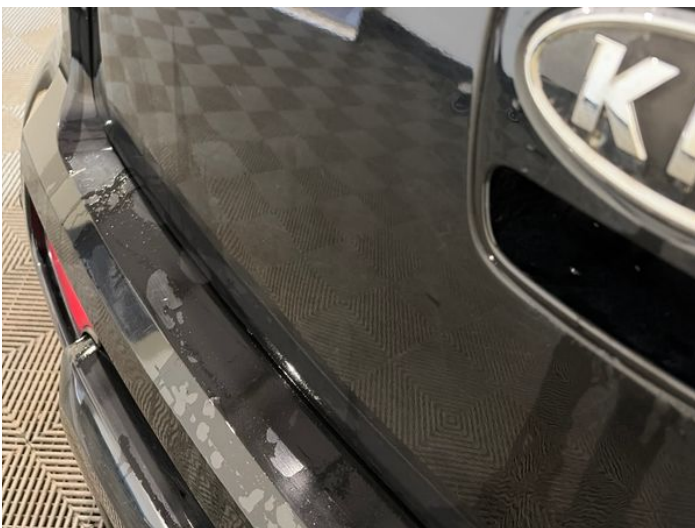
13: Tailgate  
Scratched  
Over 25mm Thru Paint

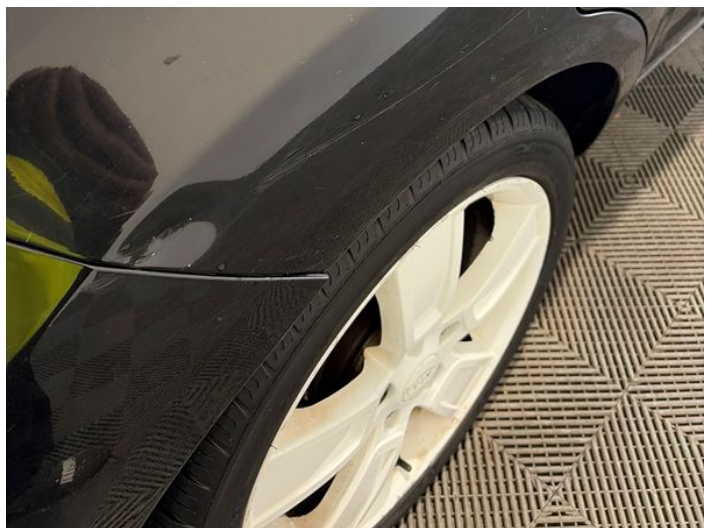
14: Qtr Panel osr  
Dented  
With Paint Damage

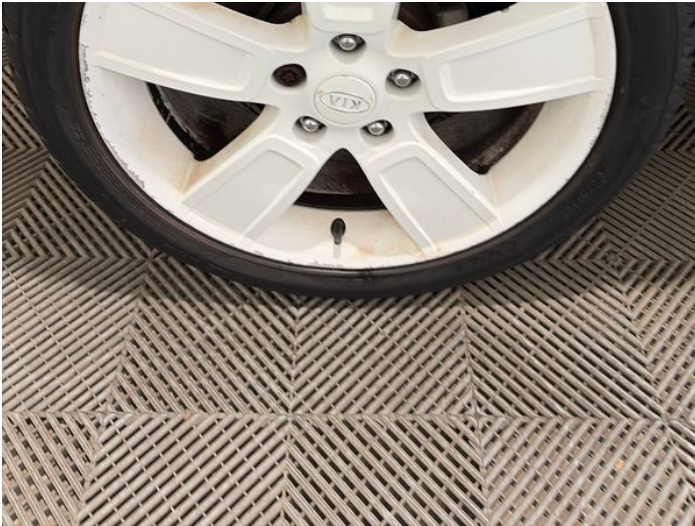
15: Wheel osf  
Scratched  
Over 50mm

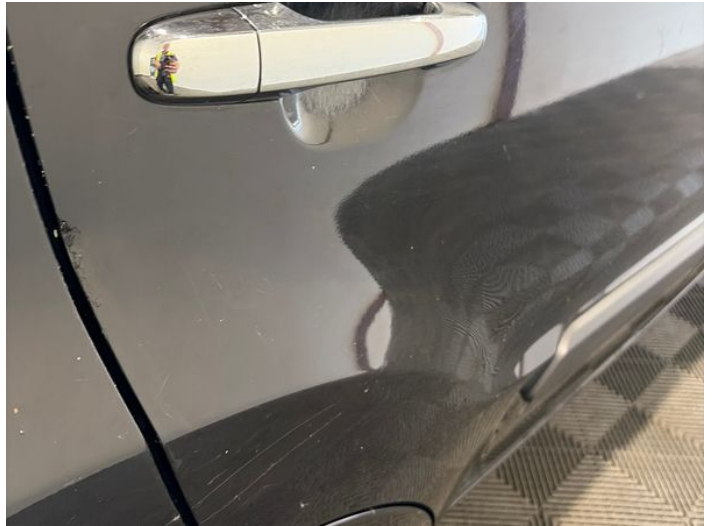
16: Door osr  
Dented  
With Paint Damage

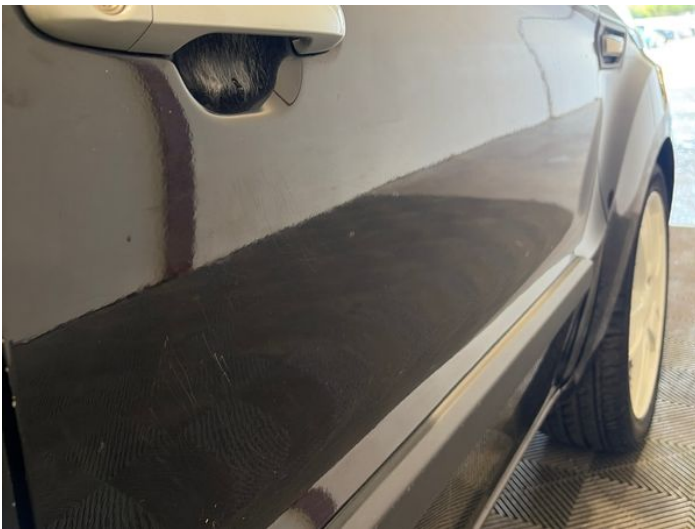
17: Door osf  
Dented  
Over 30mm

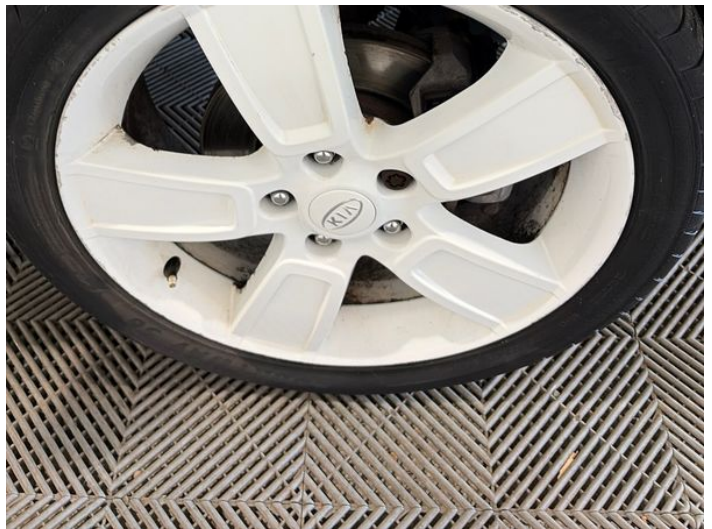
18: Wheel osf  
Scratched  
Over 50mm

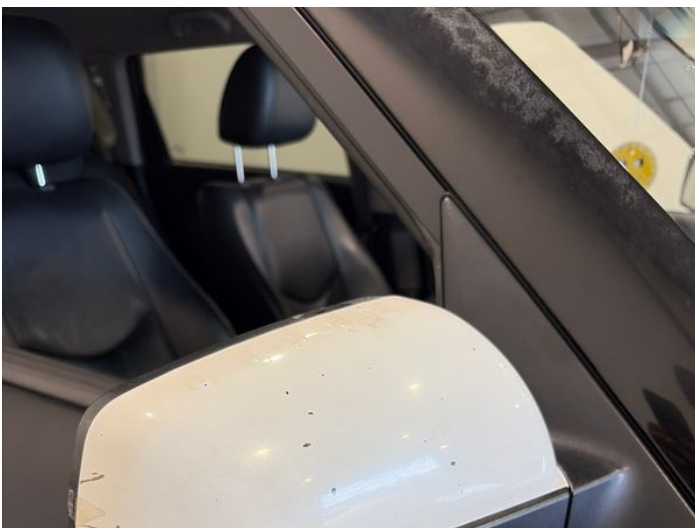
19: Door Mirror Assy osf  
Scratched (Painted)  
Over 25mm Thru Paint

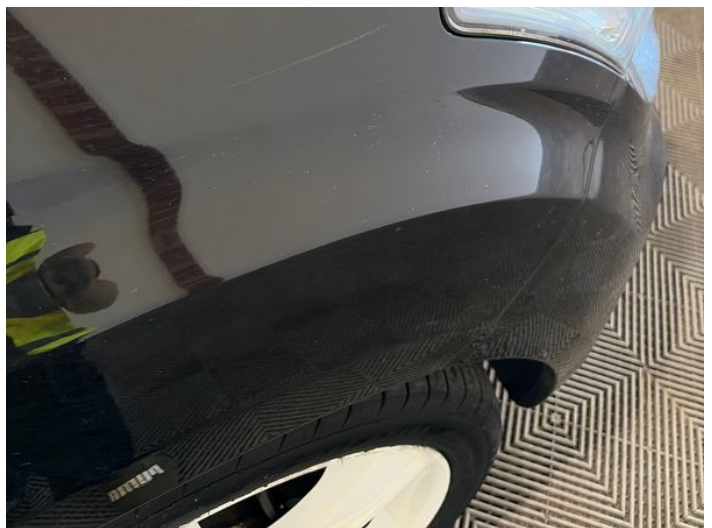
20: Wing osf  
Scratched  
Over 25mm Thru Paint

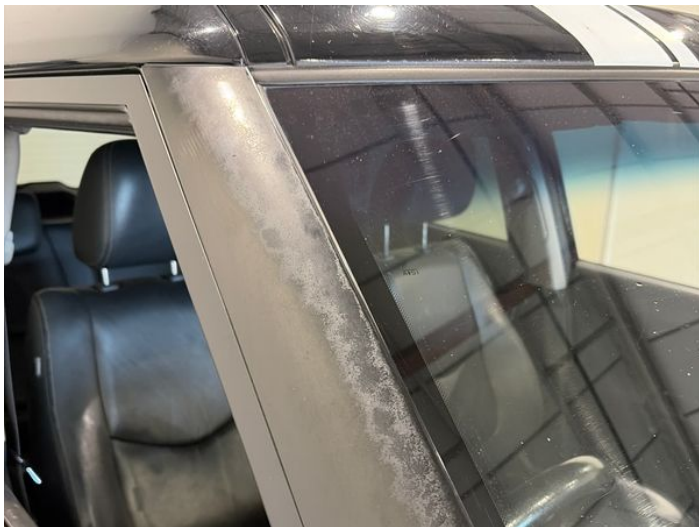
21: A Post os  
Scratched  
Over 25mm Thru Paint

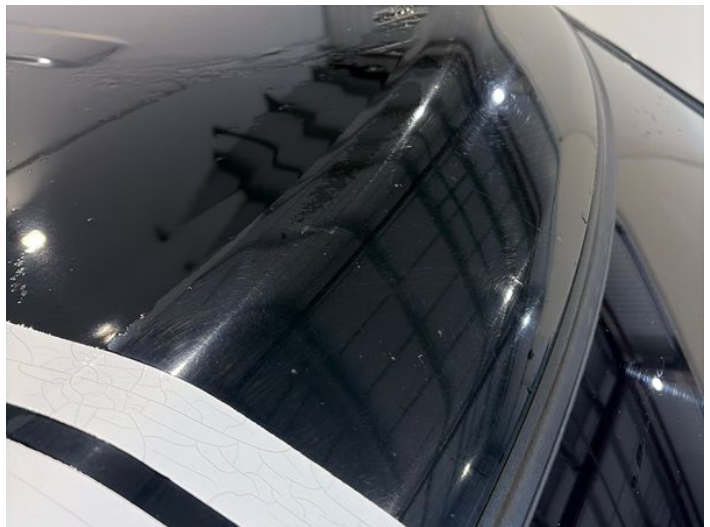
22: Roof  
Chipped  
1 To 5

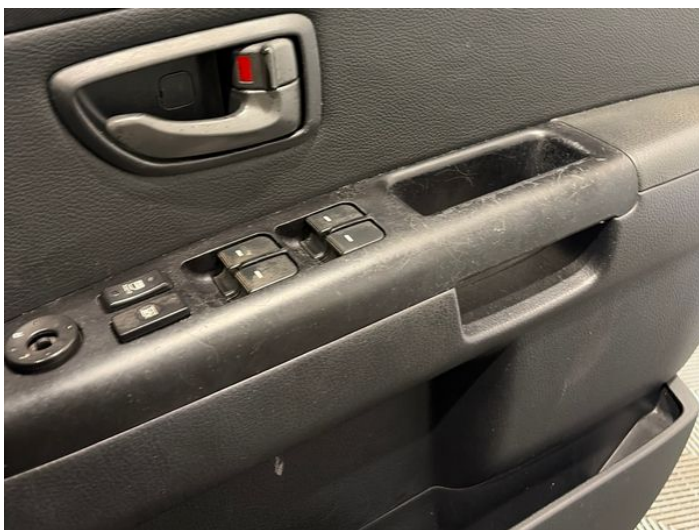
23: Door Pad osf  
Scuffed  
Over 25mm

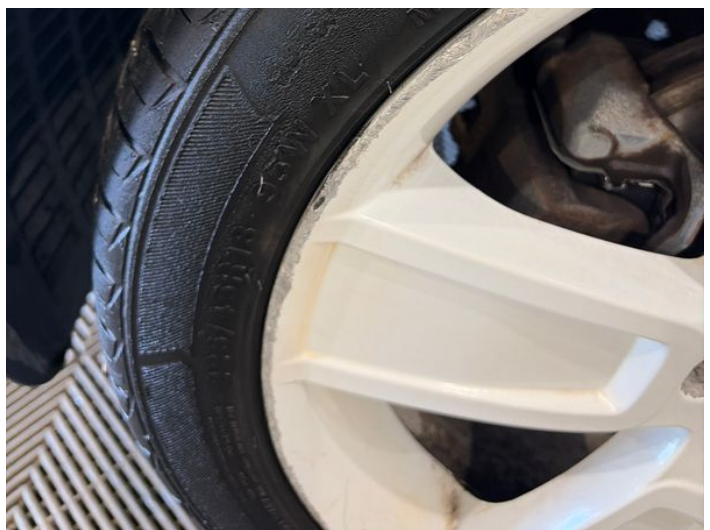
| Tyres | | |
|---|---|---|
| NSF | BUDGET | Damaged |

24: Tyre nsf  
Damaged  
Replace
