# VEHICLE INSPECTION REPORT

**RO59NLM**

## Audi A4 2.0 TDI 143 SE 5dr

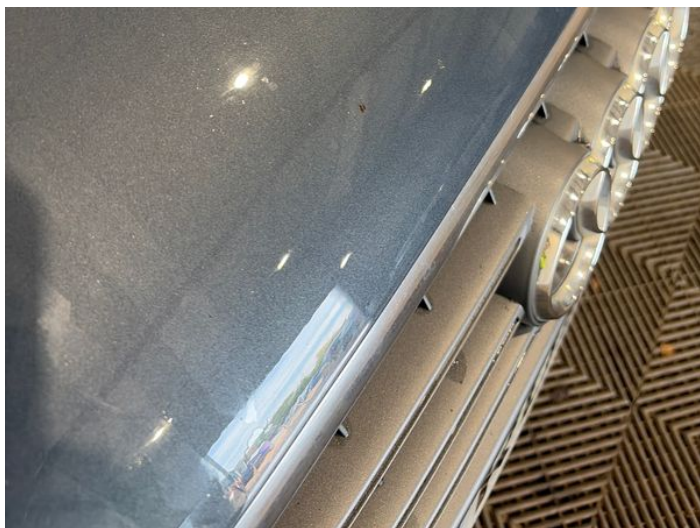
1: Bonnet  
Chipped  
1 To 5

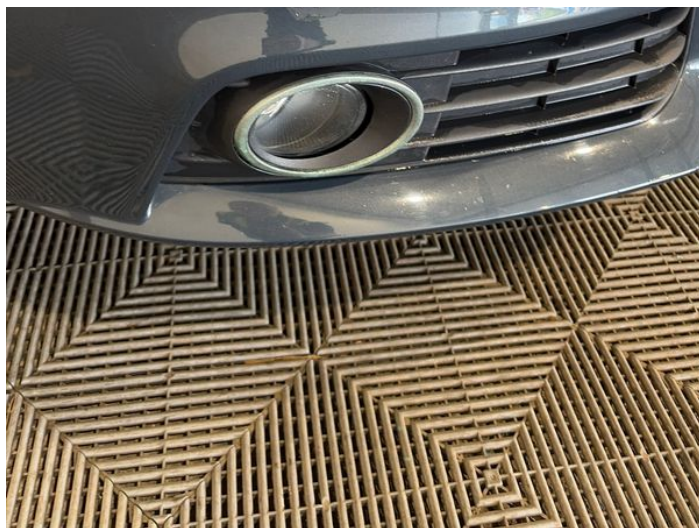
2: Bumper Front  
Poor Previous Repair  
Paint Flake

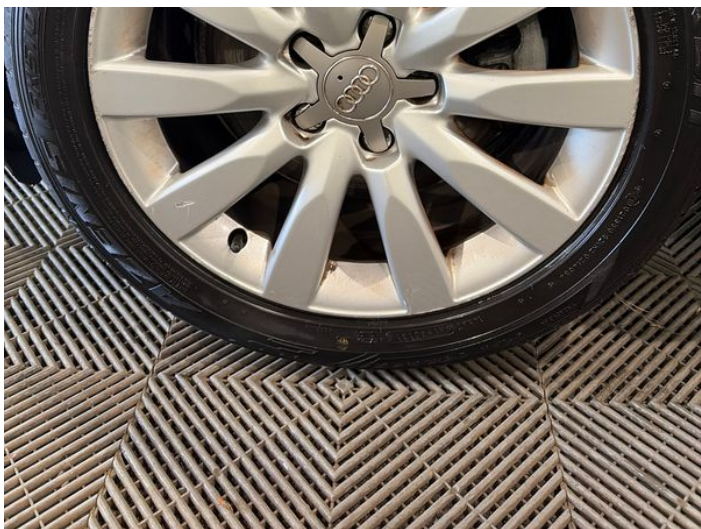
3: Wheel nsf  
 Scratched  
 Over 50mm

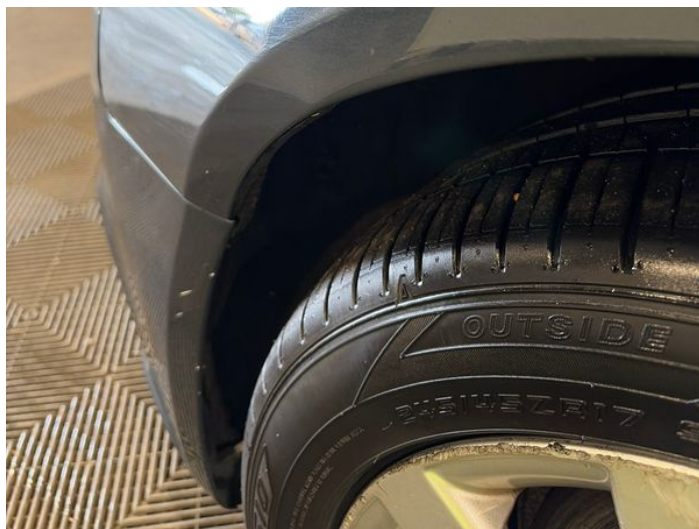
4: Wing nsf  
 Dented  
 Between 10mm + 30mm

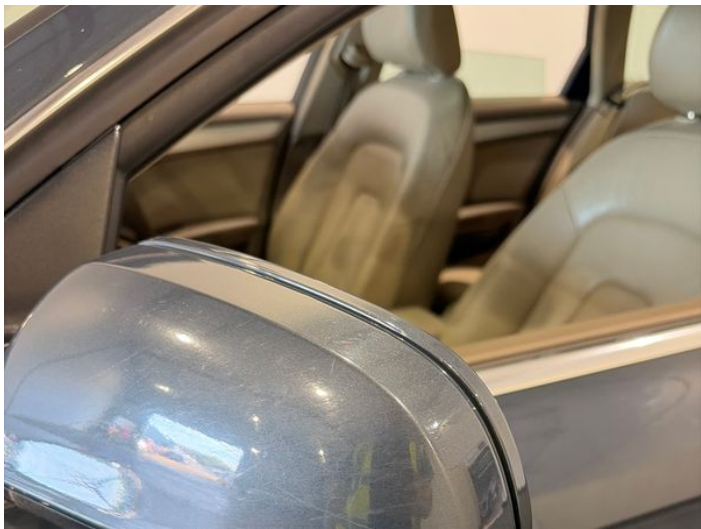
5: Door Mirror Assy nsf  
 Scratched (Painted)  
 UpTo 25mm Thru Paint

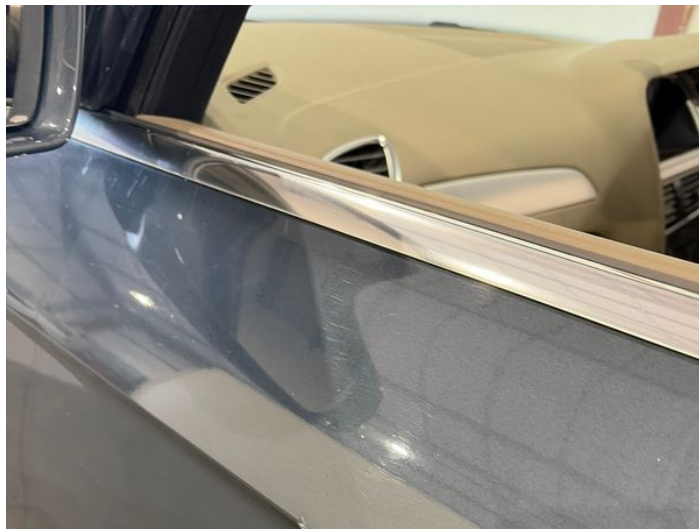
6: Door nsf  
 Dented  
 Between 10mm + 30mm

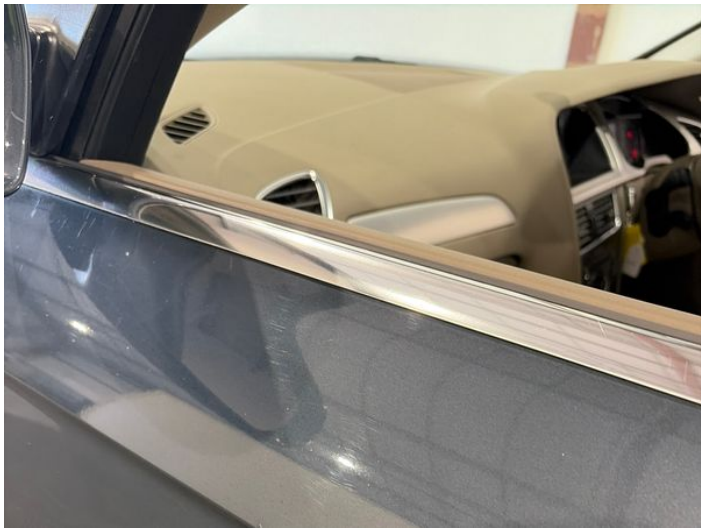
7: Door nsf  
 Scratched  
 UpTo 25mm Thru Paint

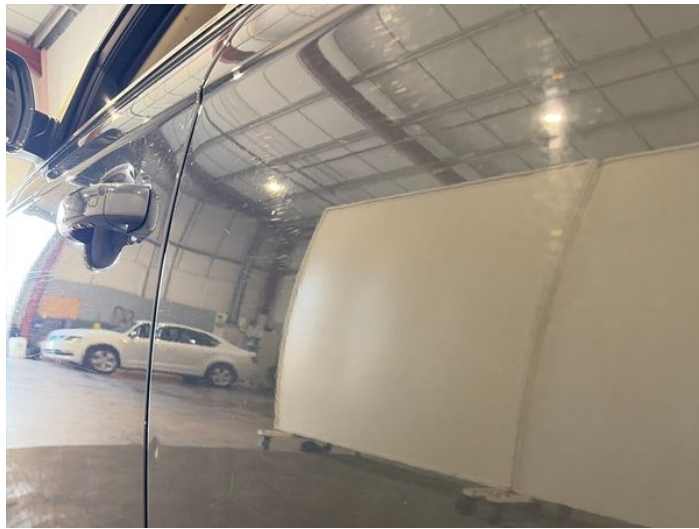
8: Door nsr  
 Dented  
 Over 30mm

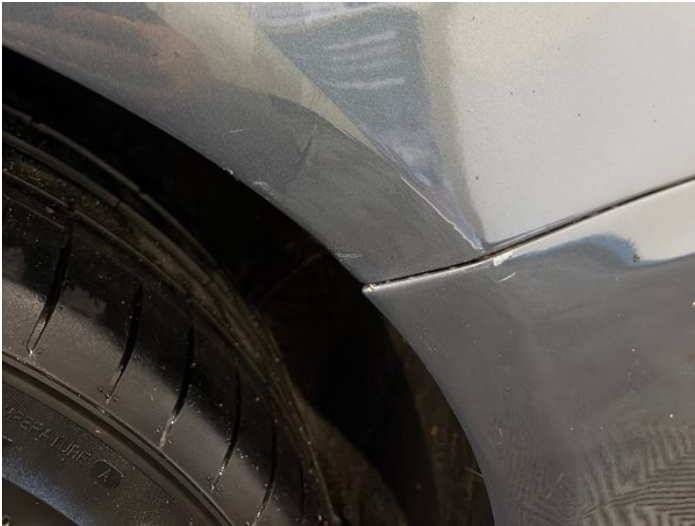
9: Qtr Panel nsr  
Rusted  
Over 5mm

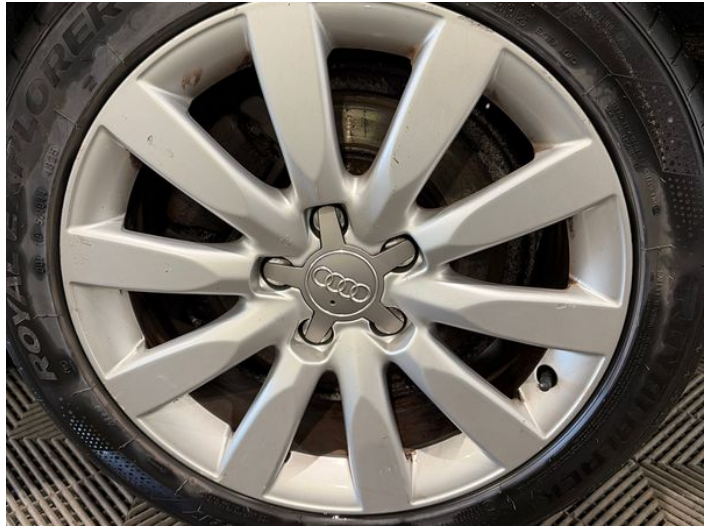
10: Wheel nsr  
Scratched  
Over 50mm

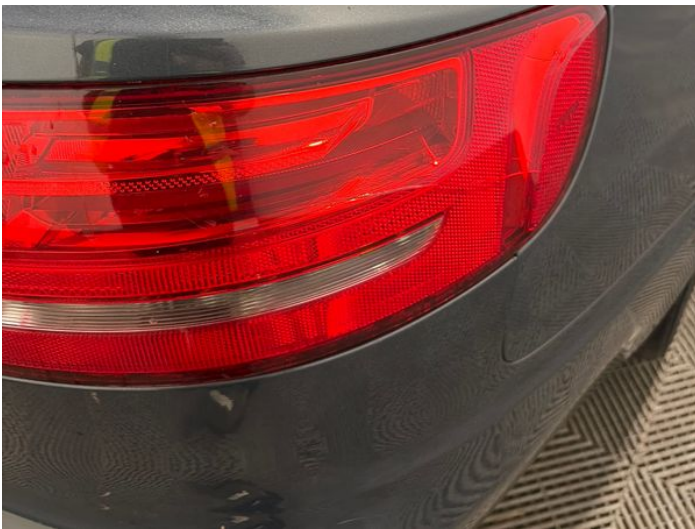
11: Lamp osr  
Broken  
Replace

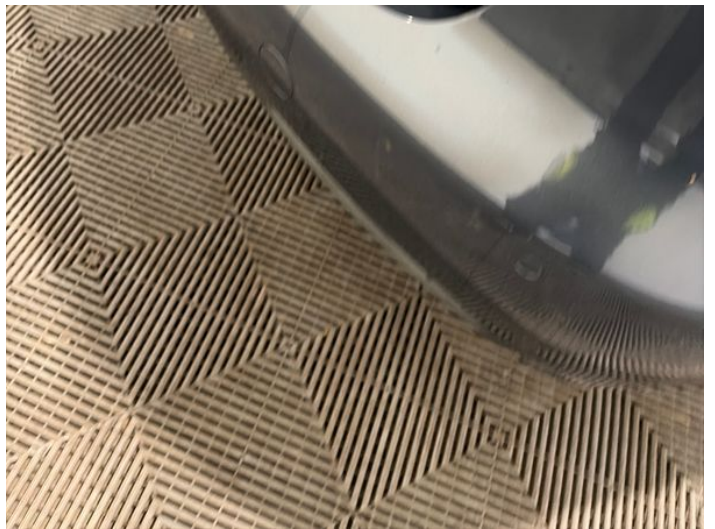
12: Bumper Rear  
Scratched  
25 to 100mm Thru Paint

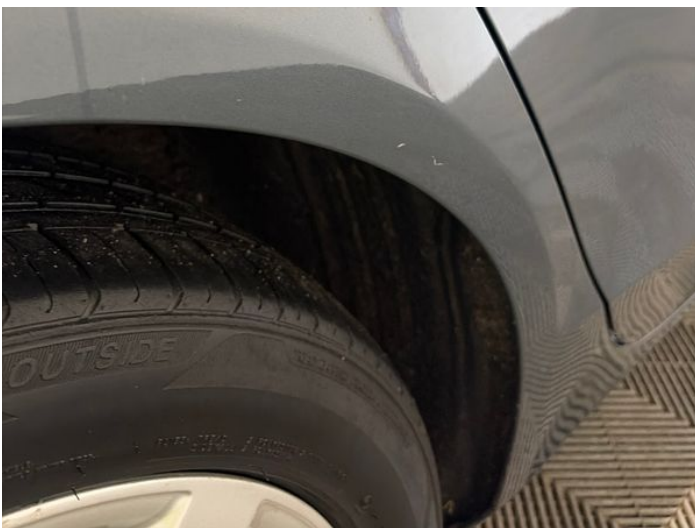
13: Qtr Panel osr  
Chipped  
1 To 5

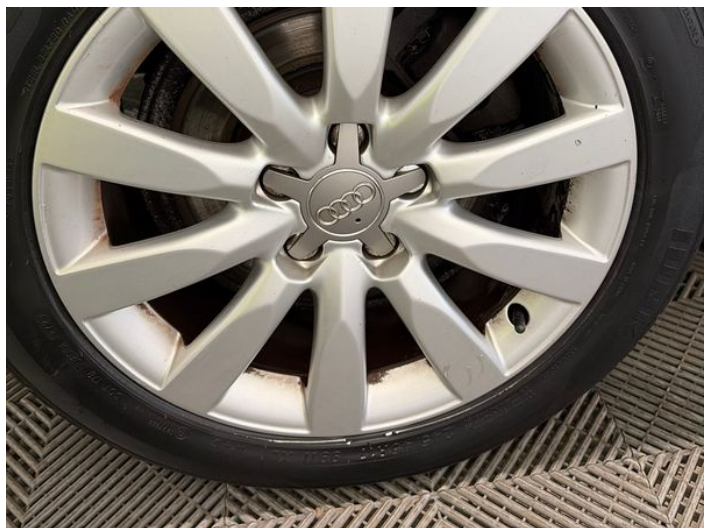
14: Wheel osr  
Scratched  
Up To 50mm

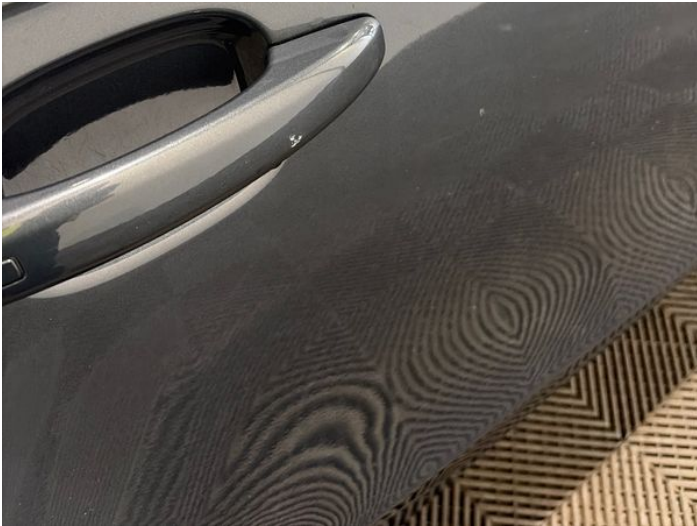
15: Door osr  
Chipped  
1 To 5

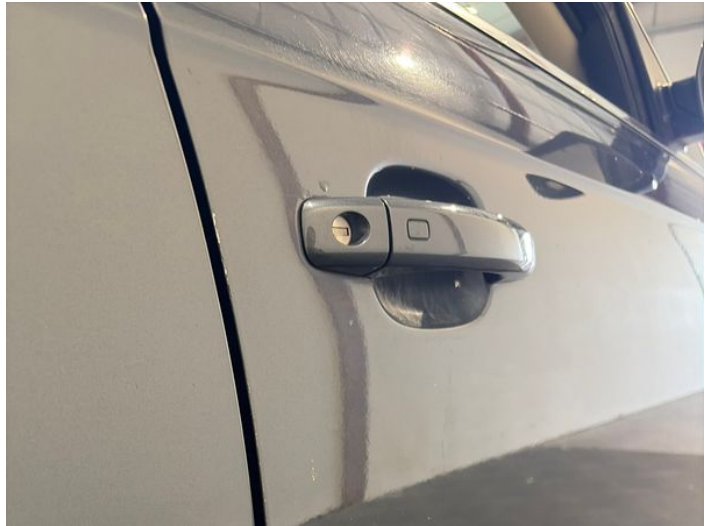
16: Door osf  
Scratched  
Over 25mm Thru Paint

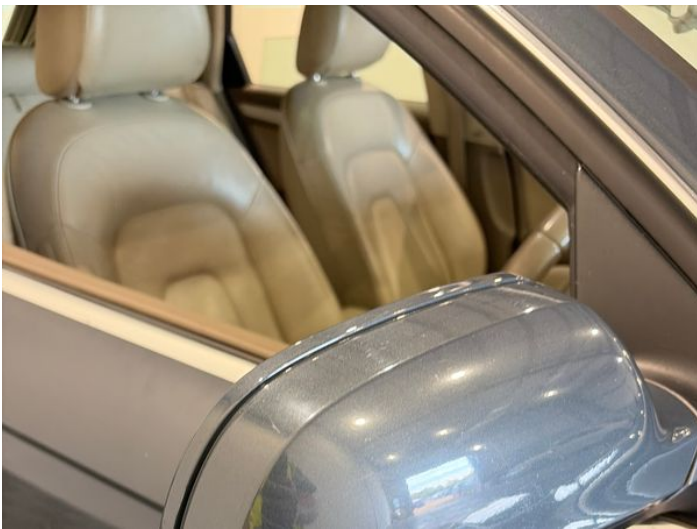
17: Door Mirror Assy osf  
Scratched (Painted)  
UpTo 25mm Thru Paint

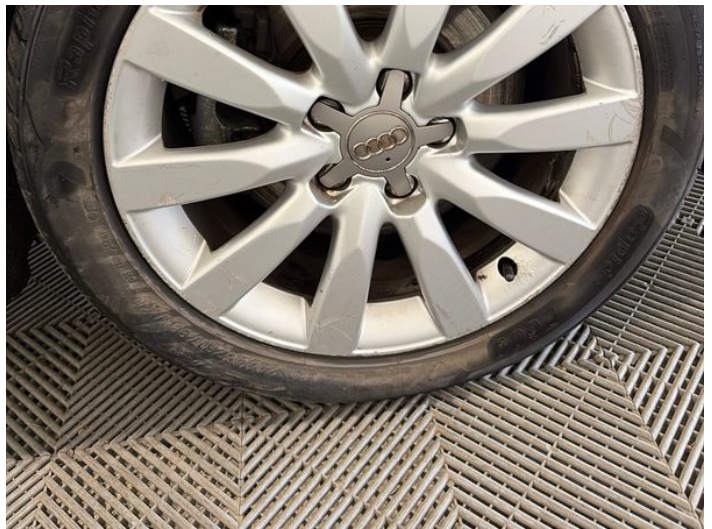
18: Wheel osf  
Scratched  
Over 50mm

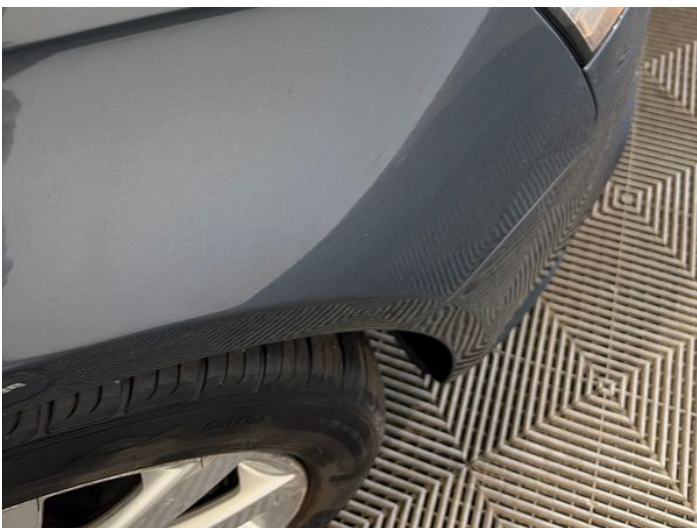
19: Wing osf  
Chipped  
1 To 5

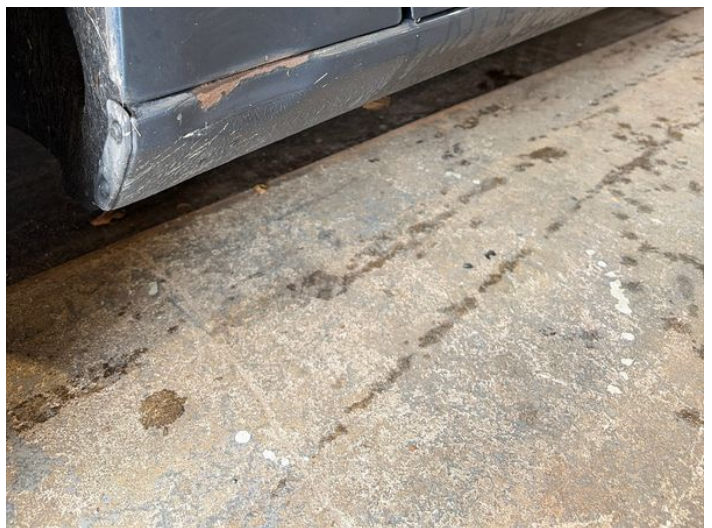
20: Sill ns  
Dented  
With Paint Damage
