## VEHICLE INSPECTION REPORT

**EJ61UUM**

### Audi A5 2.0 TDI 143 S Line 5dr Multitronic

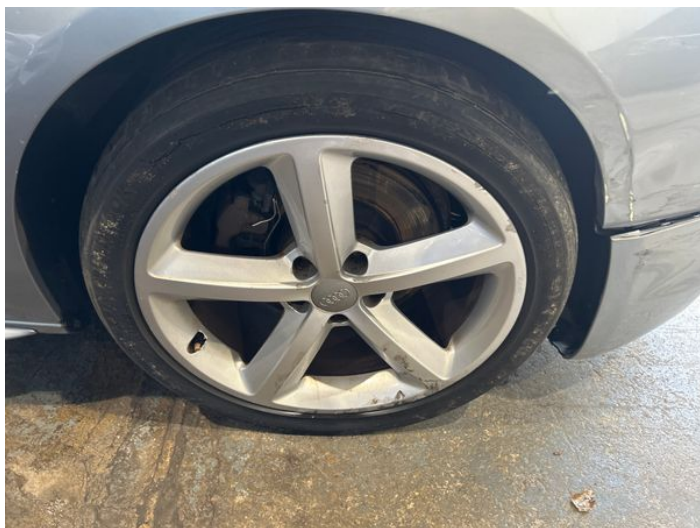
1: Wheel osf  
Scratched  
Over 50mm

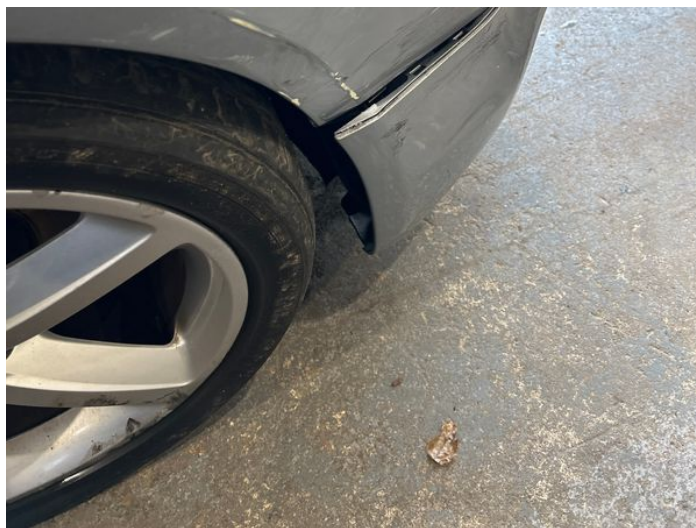
2: Wing osf  
Dented  
With Paint Damage

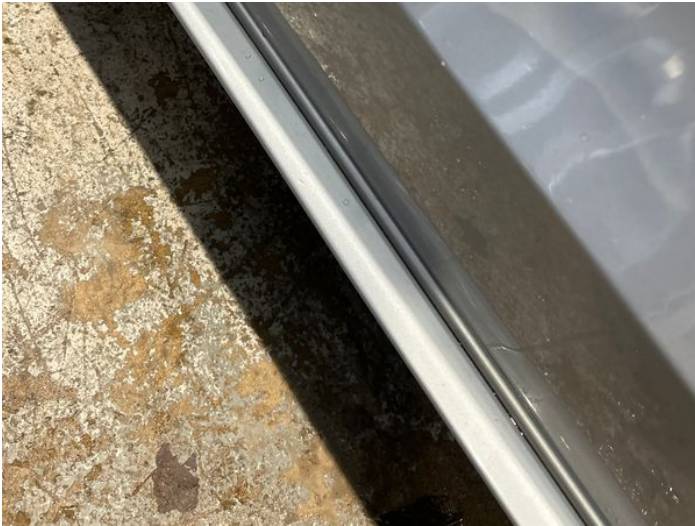
3: Door osf  
Chipped  
1 To 5

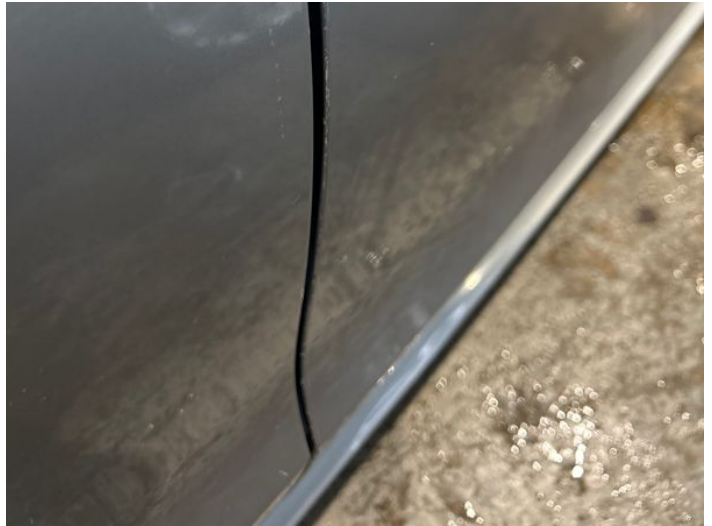
4: Door osf  
Chipped  
Edge Chip

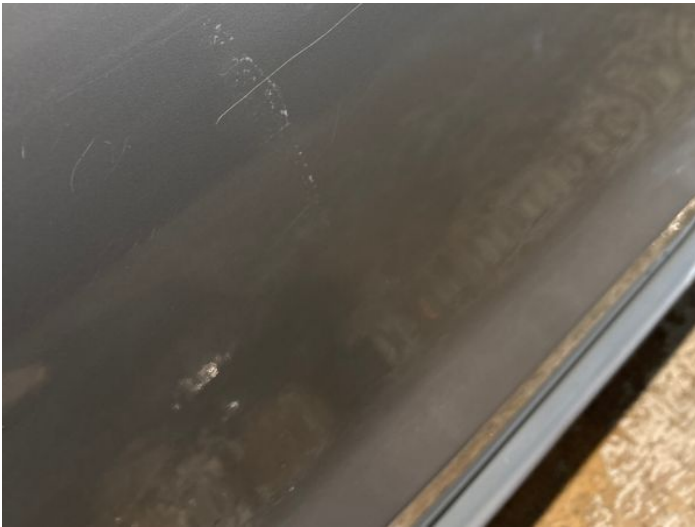
5: Door osr  
Scratched  
Over 25mm Thru Paint

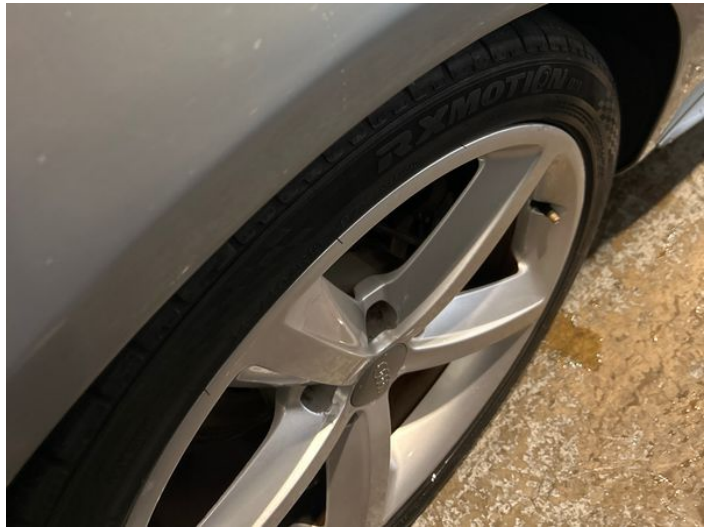
6: Qtr Panel osr  
Poor Previous Repair  
Poor Paint

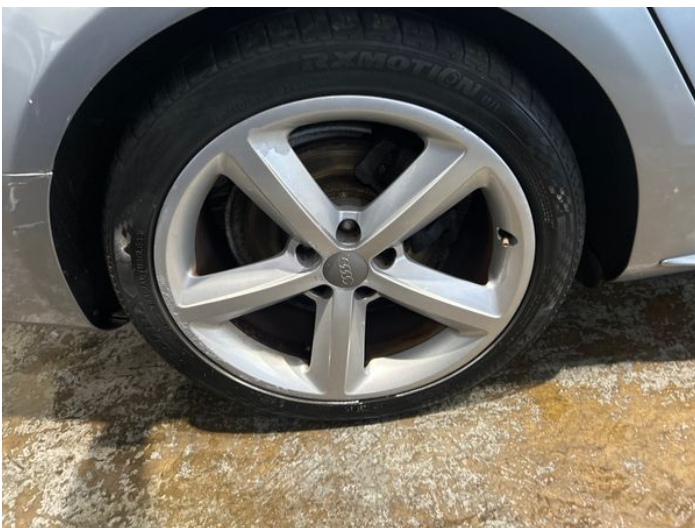
7: Wheel osr  
Scratched  
Over 50mm

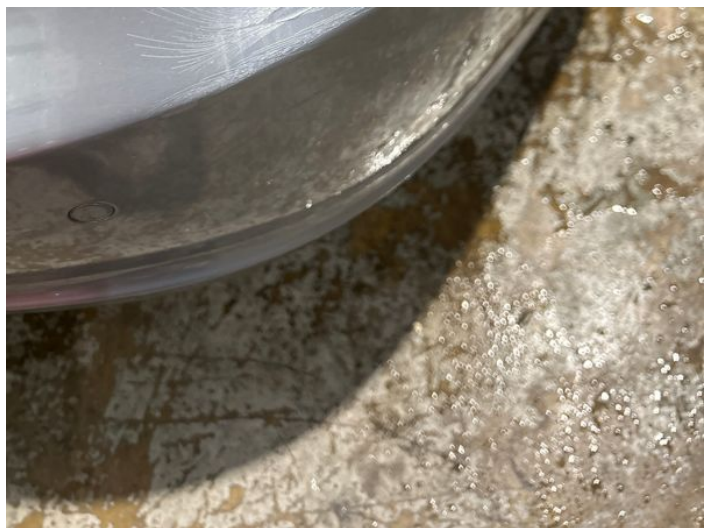
8: Bumper Rear  
Poor Previous Repair  
Paint Flake

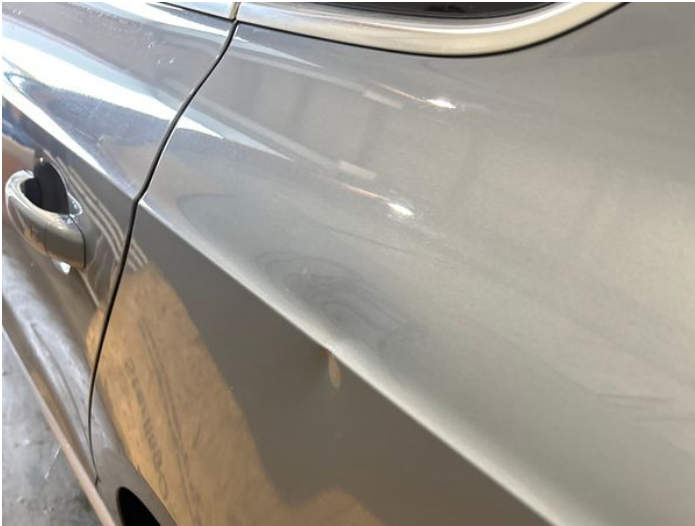
9: Qtr Panel nsr  
Dented  
With Paint Damage

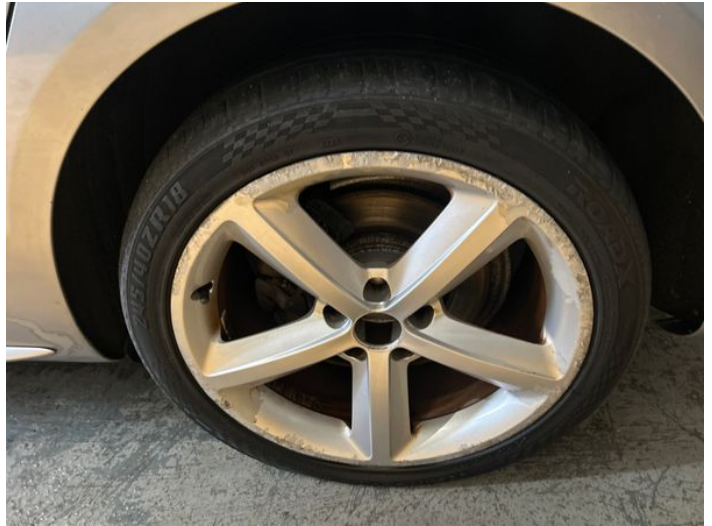
10: Wheel nsr  
Scratched  
Over 50mm

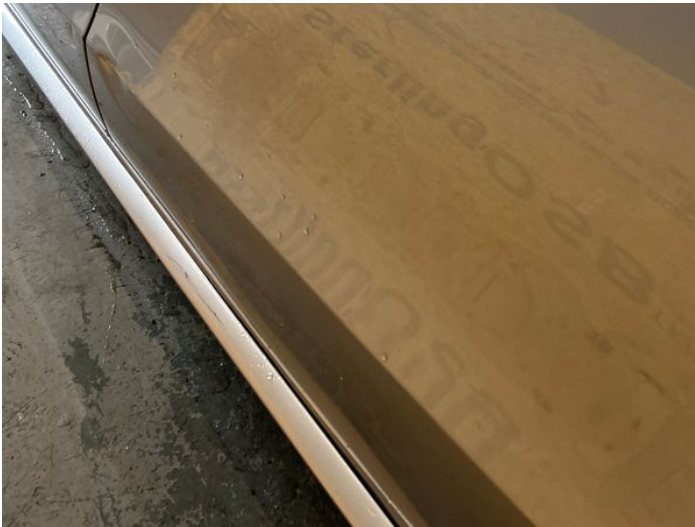
11: Door nsr  
Dented  
Over 30mm

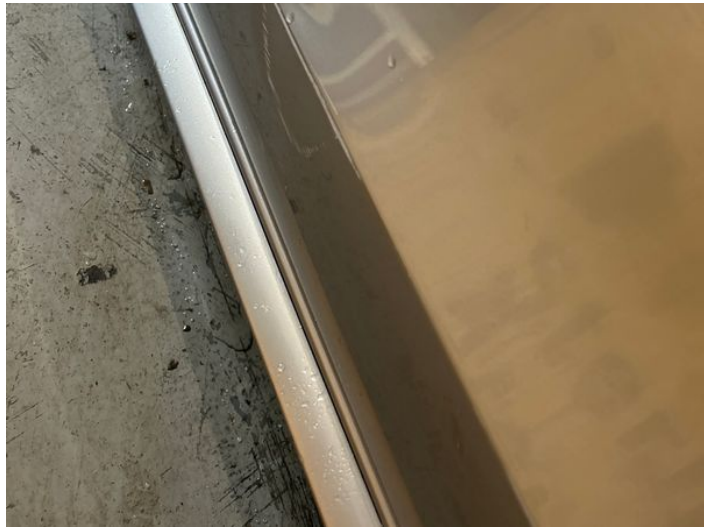
12: Door nsf  
Dented  
With Paint Damage

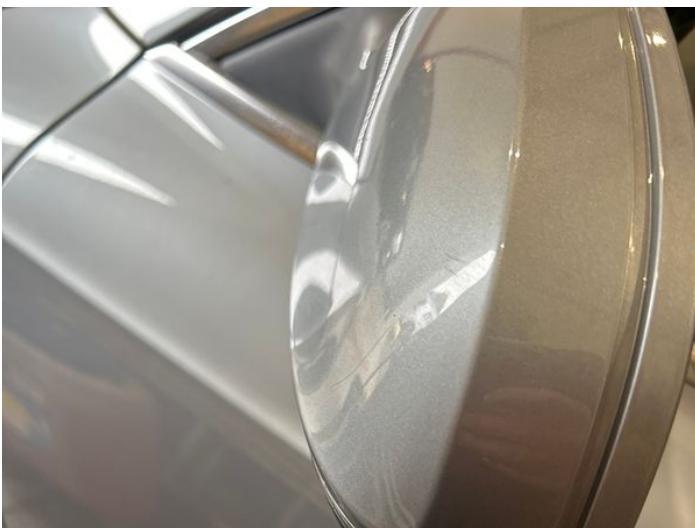
13: Door Mirror Assy nsf  
Scratched (Painted)  
UpTo 25mm Thru Paint

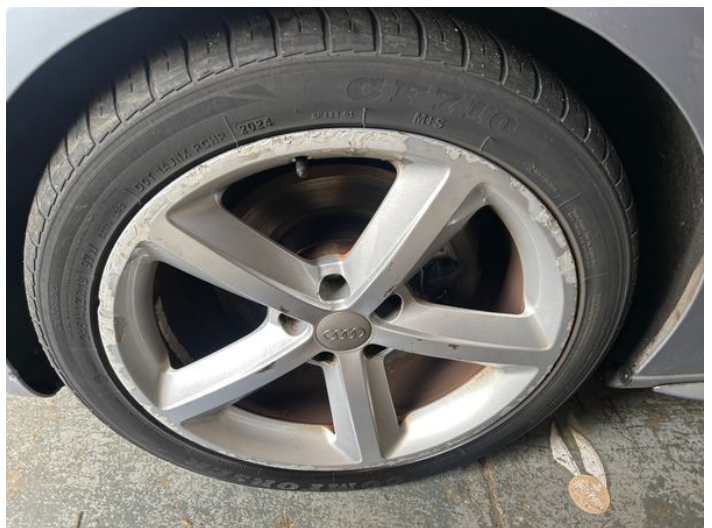
14: Wheel nsf  
Scratched  
Over 50mm

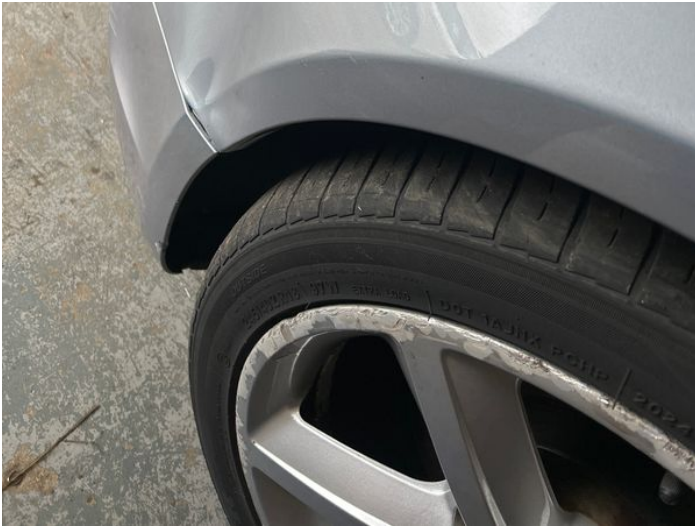
15: Wing nsf  
Dented  
With Paint Damage

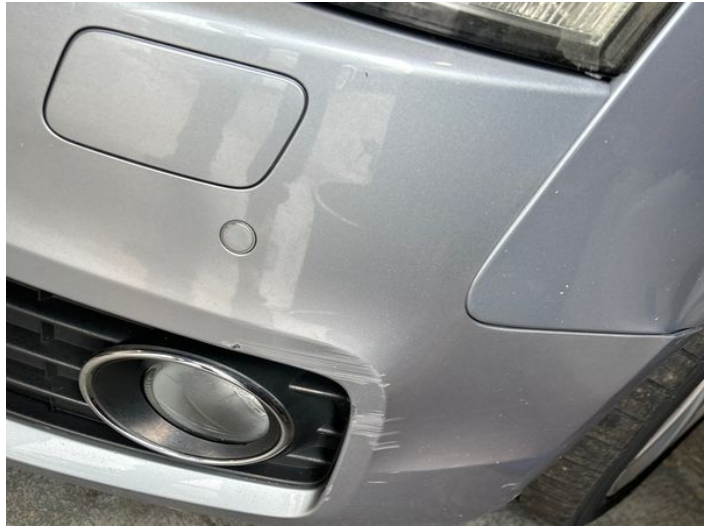
16: Bumper Front  
Scratched  
Over 100mm Thru Paint

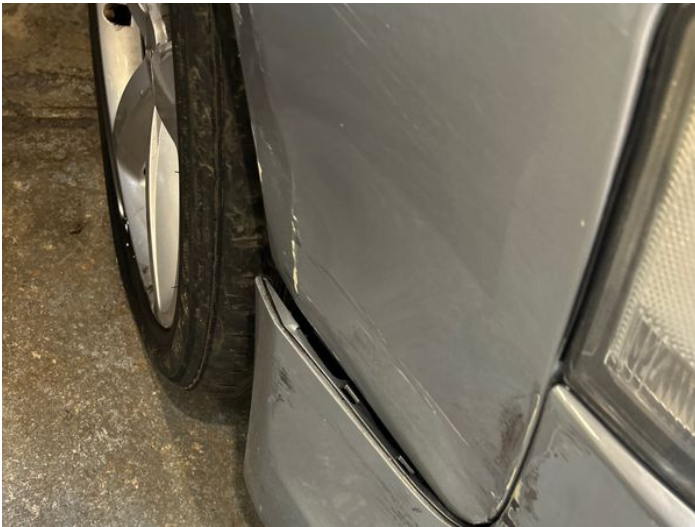
17: Bumper Front  
Insecure  
Action Required

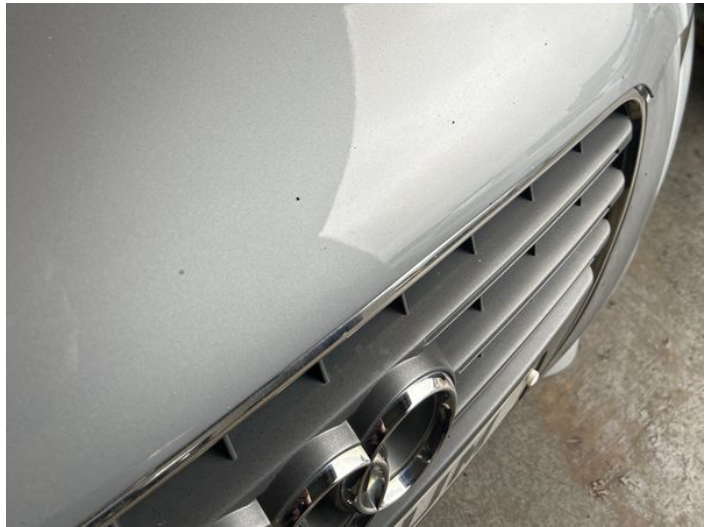
18: Bonnet  
Chipped  
Multiple Chips

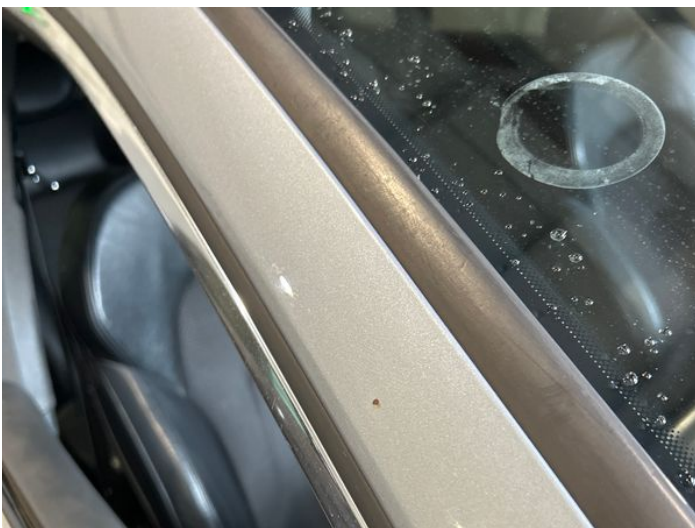
19: A Post os  
Chipped  
1 To 5

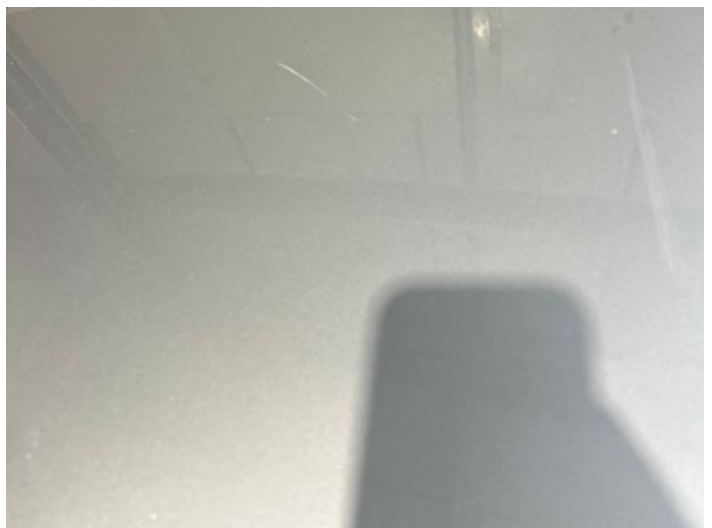
20: Roof  
Scratched  
Over 25mm Thru Paint

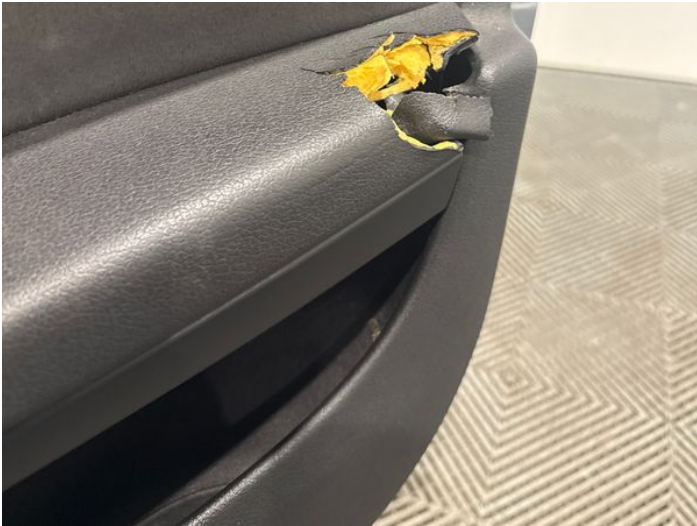
21: Door Pad osf  
Broken  
Replace

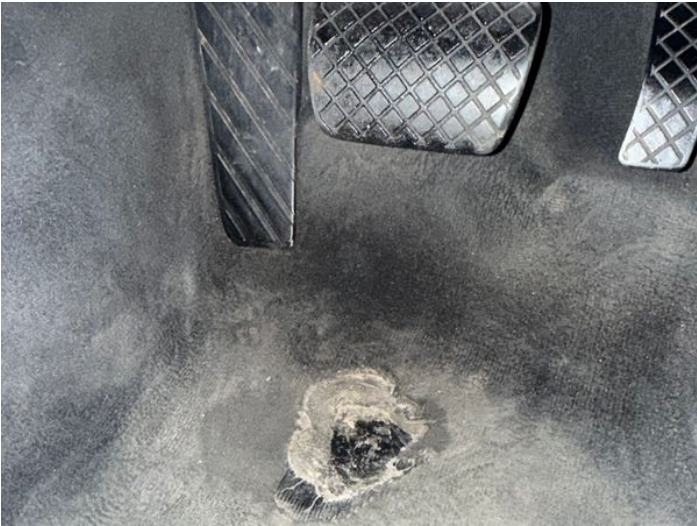
22: Carpets Front  
Holed  
Over 3mm

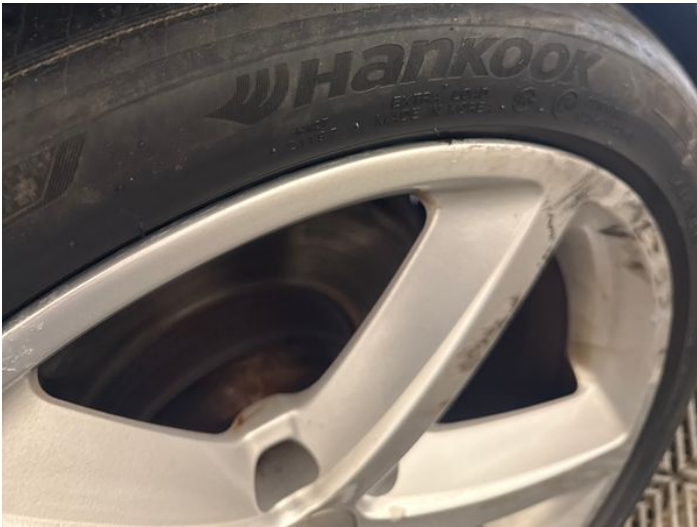
| OSF | HANKOOK | Damaged |

23: Tyre osf  
Damaged  
Replace
