# VEHICLE INSPECTION REPORT

**BT14XMR**

## Ford Fiesta 1.0 EcoBoost 125 Zetec S 3dr

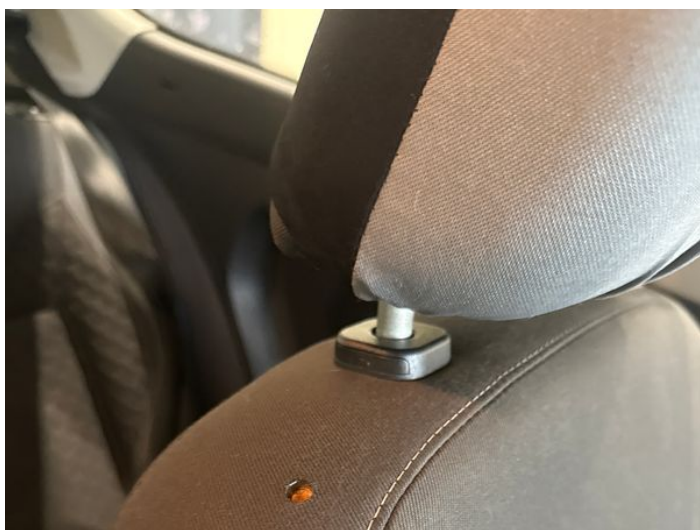
1: Seat Back Cover nsf  
Burn  
Over 3mm

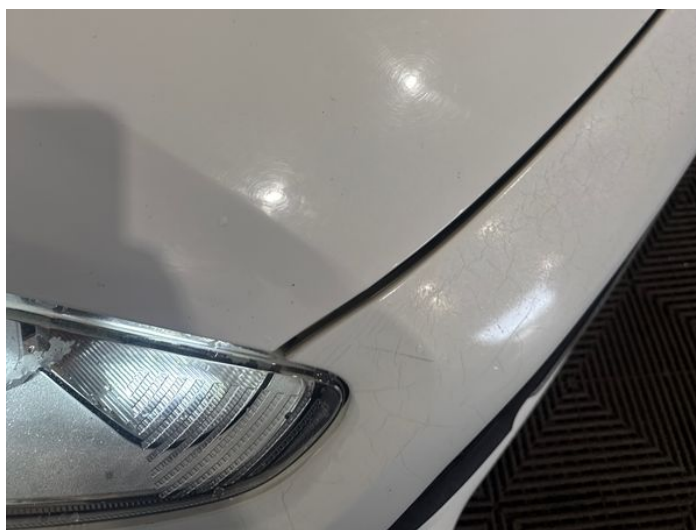
2: Bonnet  
Chipped  
1 To 5

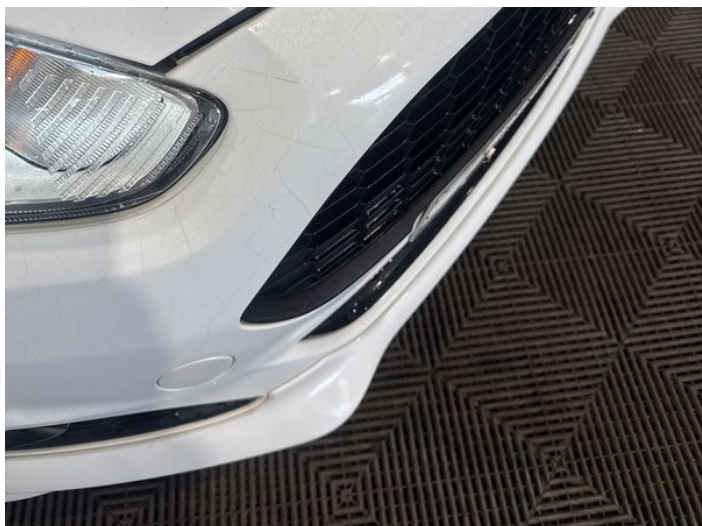
3: Bumper Front  
Poor Previous Repair  
Poor Paint

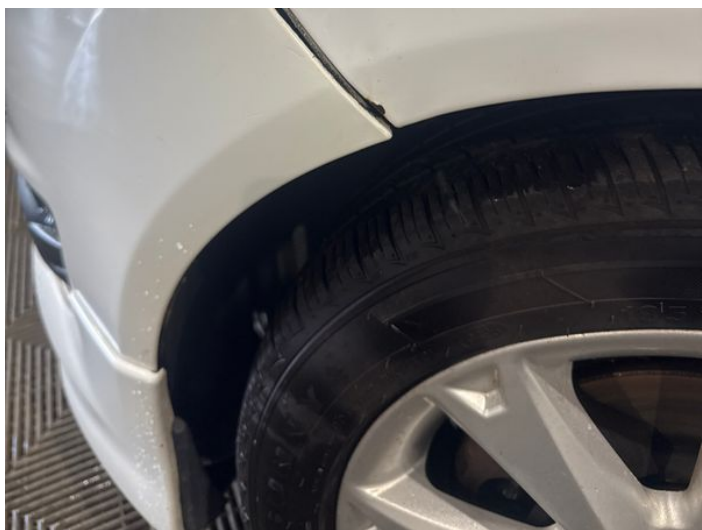
5: Wing nsf  
Dented  
Between 10mm + 30mm

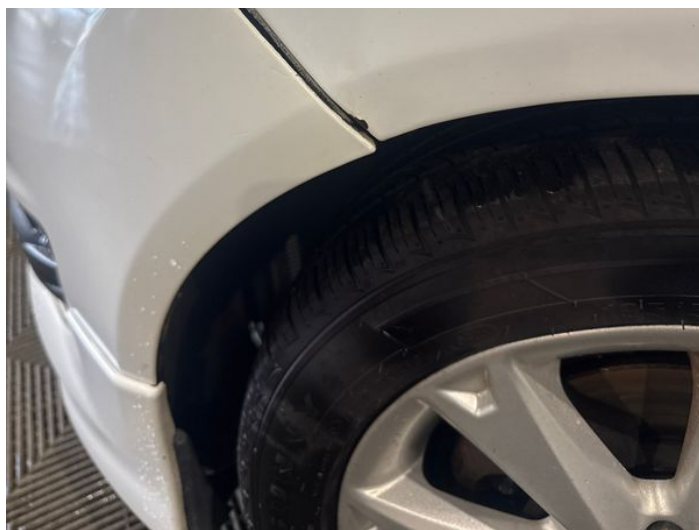
6: Wing nsf  
Chipped  
1 To 5

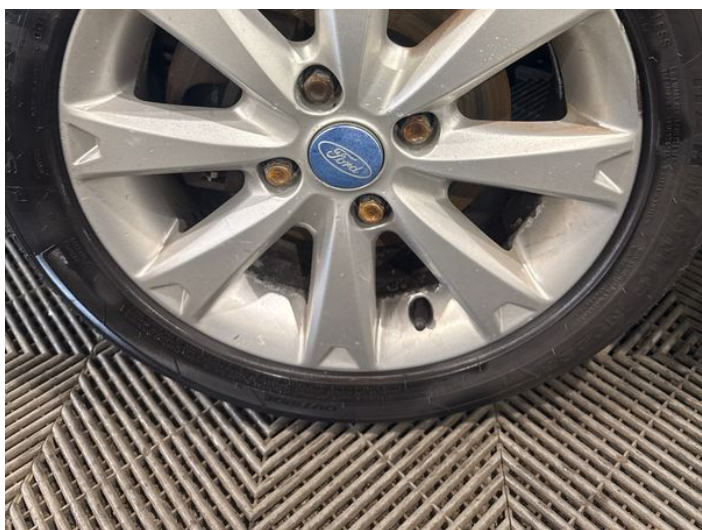
7: Wheel nsf  
Scratched  
Over 50mm

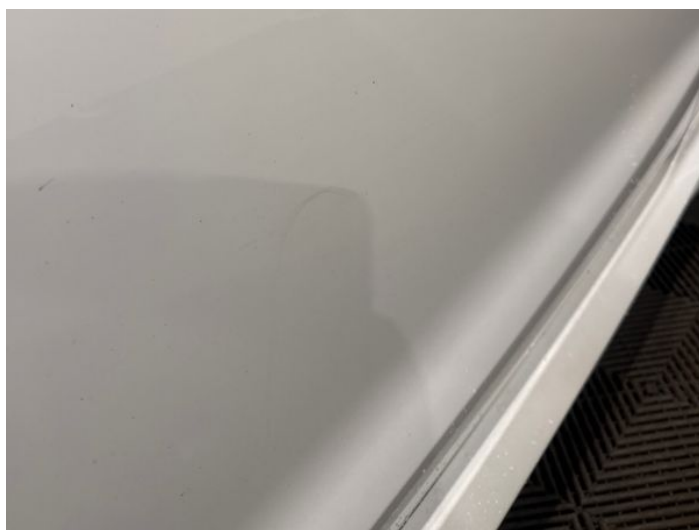
8: Door nsf  
Scratched  
Over 25mm Thru Paint

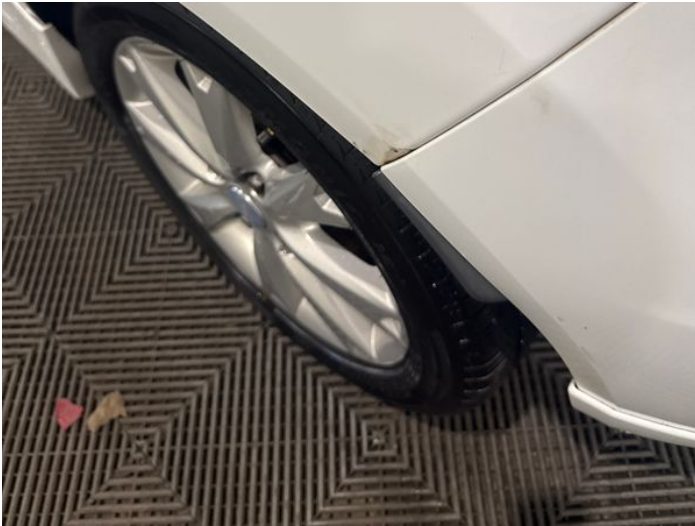
9: Qtr Panel nsr  
Dented  
With Paint Damage

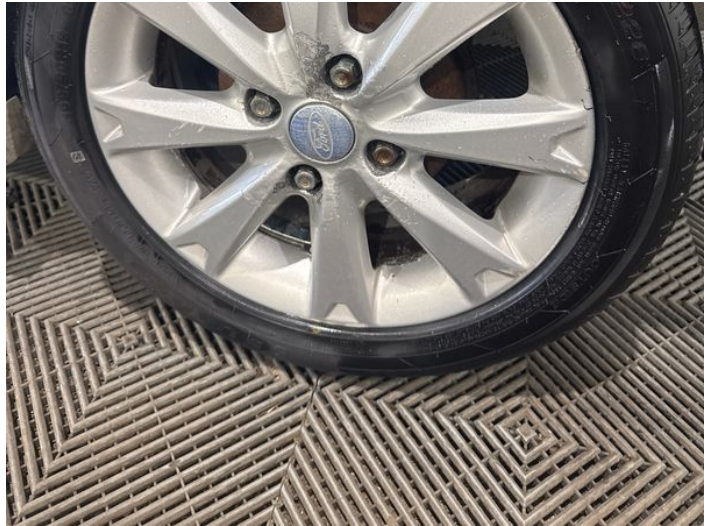
10: Wheel nsr  
Scratched  
Over 50mm

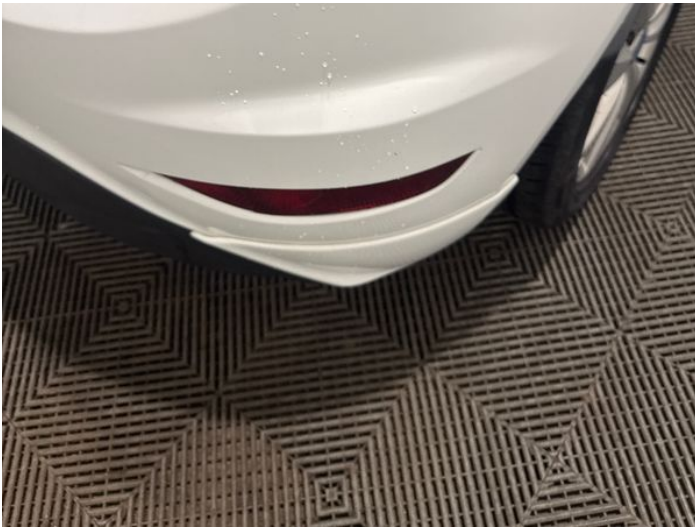
11: Bumper Rear  
Chipped  
1 To 5

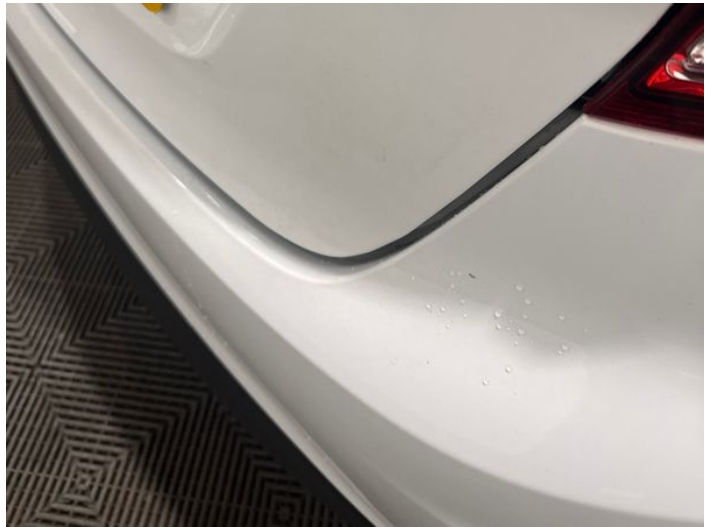
12: Tailgate  
Scratched  
Over 25mm Thru Paint

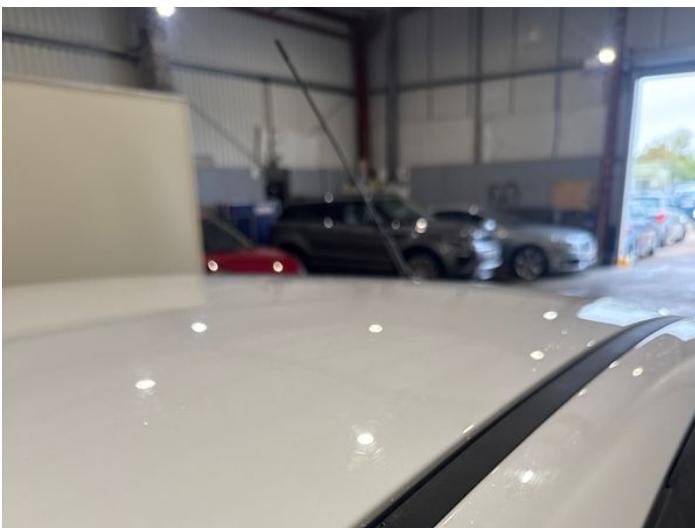
13: Roof  
Dented  
Over 30mm

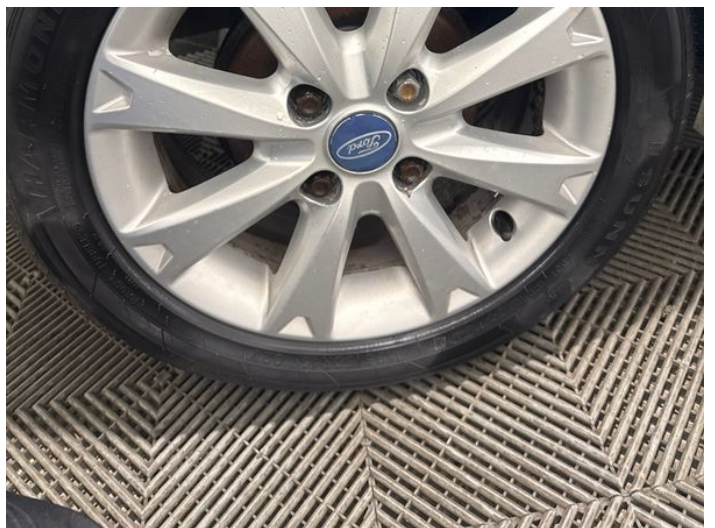
14: Wheel osr  
Scratched  
Over 50mm

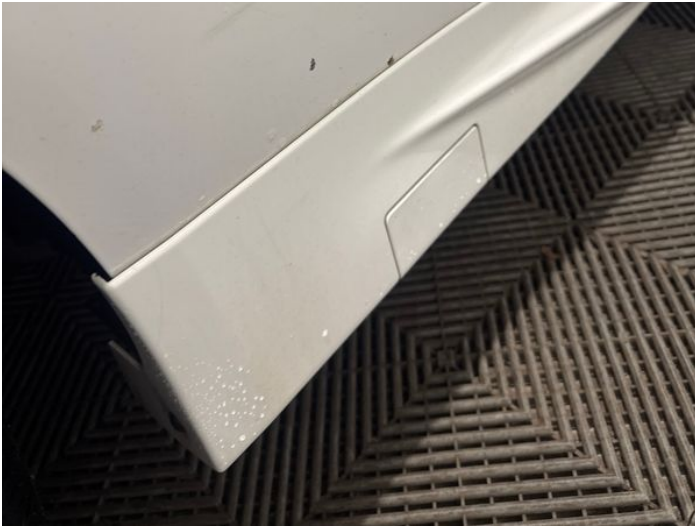
15: Qtr Panel osf  
Chipped  
Over 5mm

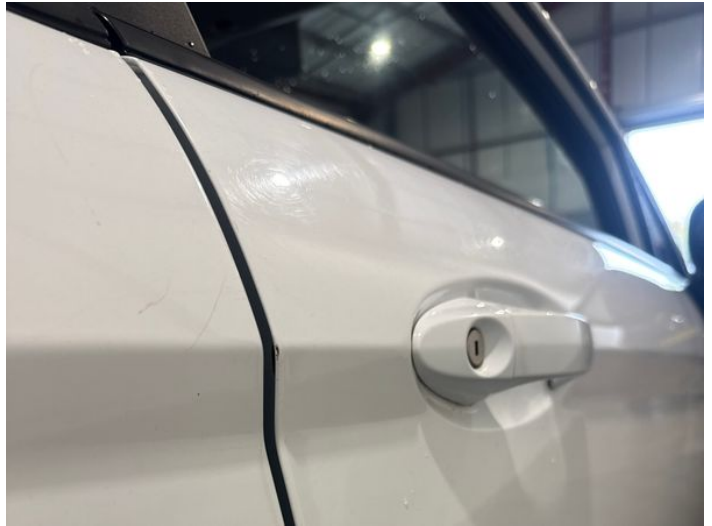
16: Door osf  
Chipped  
Edge Chip

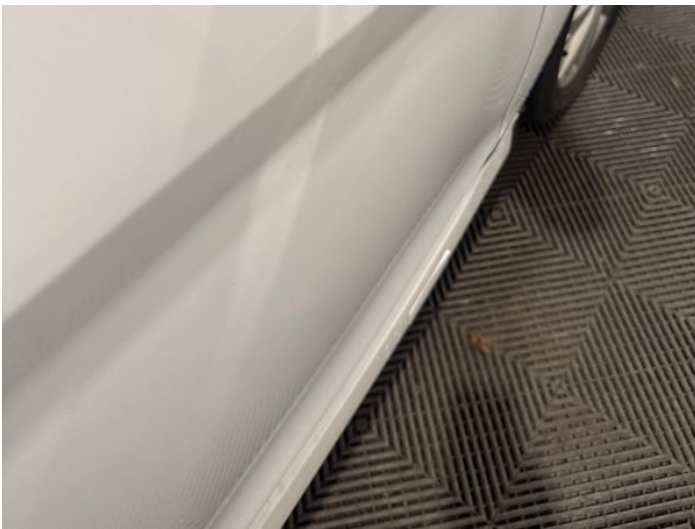
17: Door osf  
Dented  
Between 10mm + 30mm

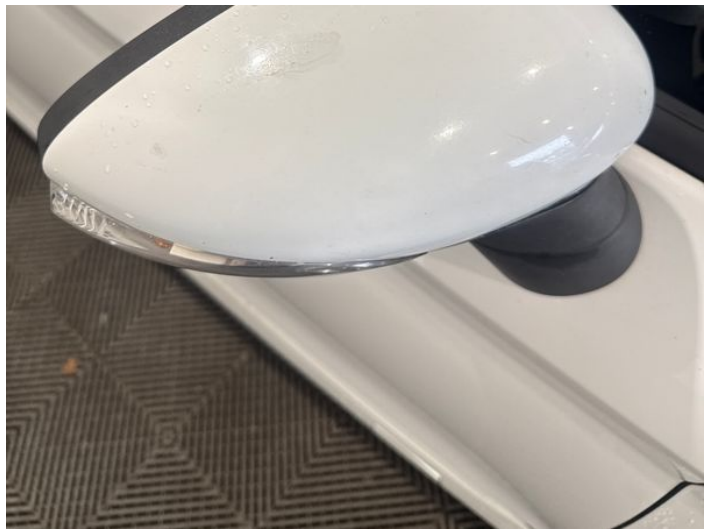
18: Door Mirror Assy osf  
Scratched (Painted)  
Over 25mm Thru Paint

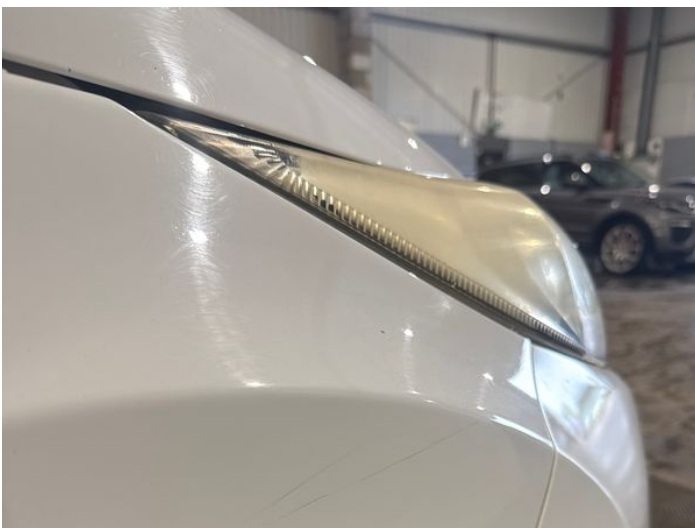
19: Wing osf  
Scratched  
Over 25mm Thru Paint

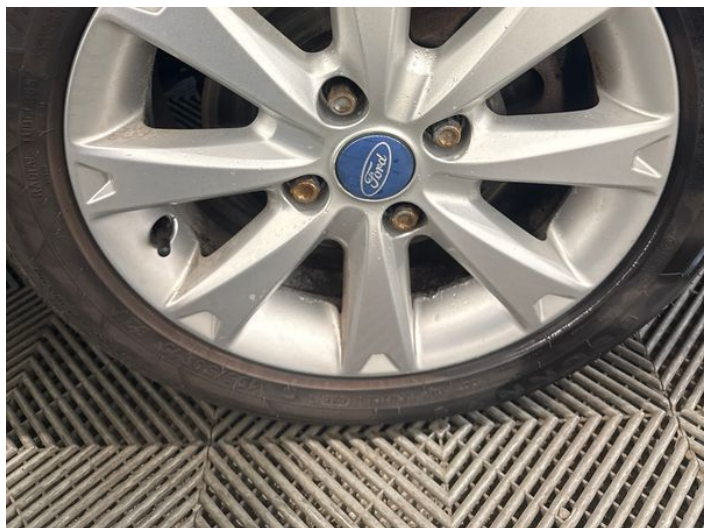
20: Wheel osf  
Scratched  
Over 50mm

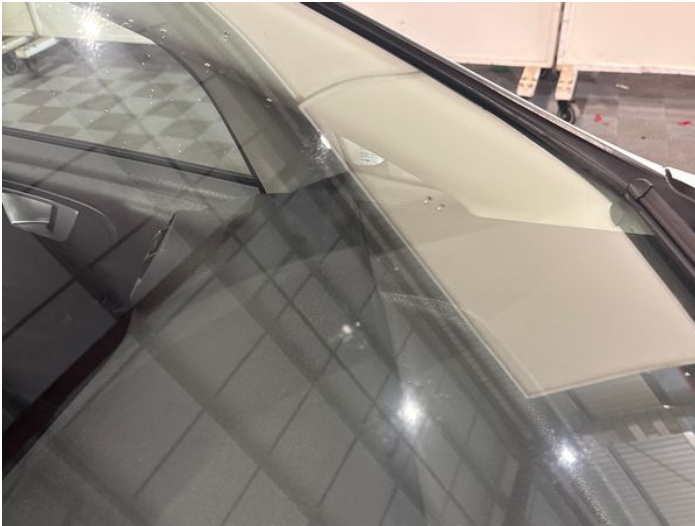
21: Screen Front  
Cracked  
Replace

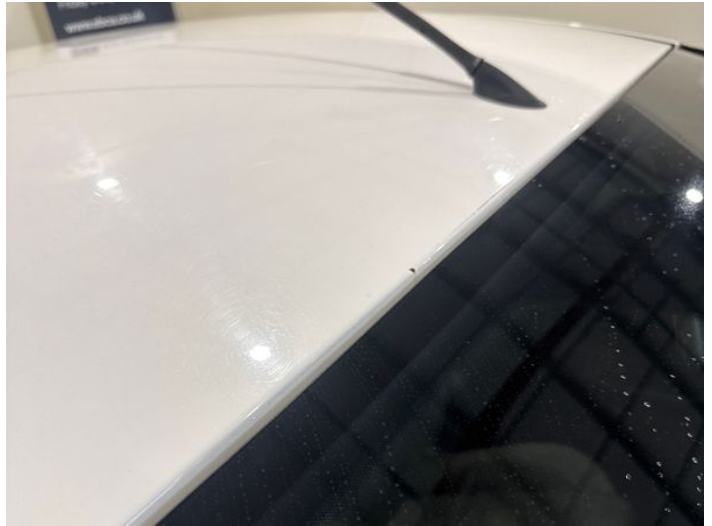
22: Roof  
Chipped  
Edge Chip

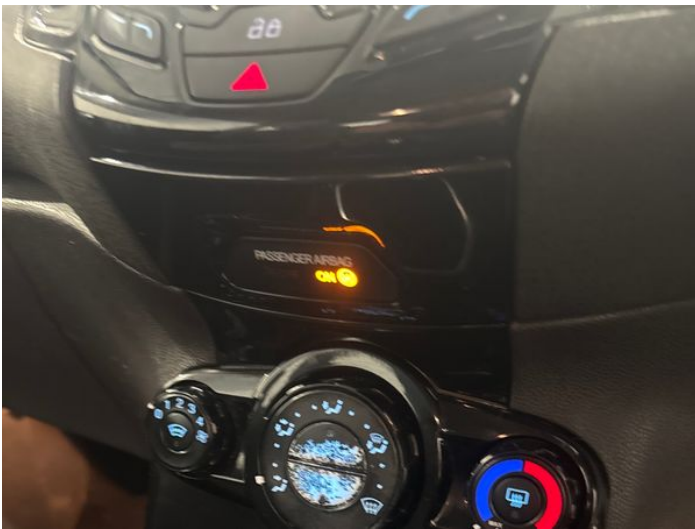
23: Centre Console Front  
Scuffed  
Over 25mm

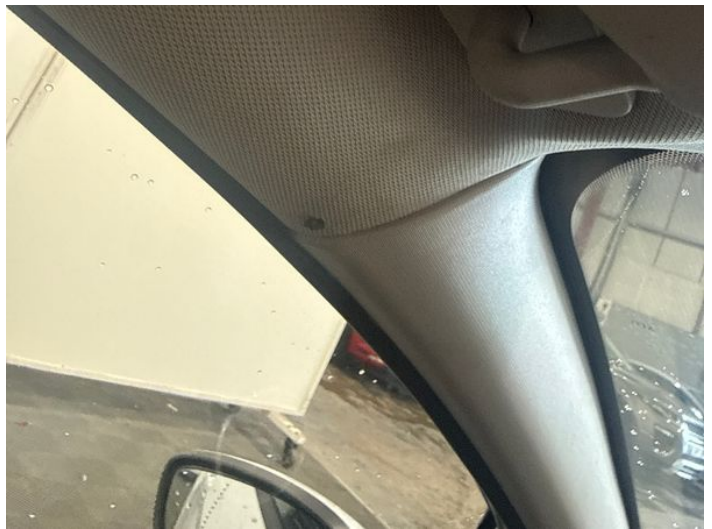
24: Roof Lining  
Burn  
Over 3mm
