# VEHICLE INSPECTION REPORT

**LG13XHP**

## Kia Ceed 1.6 CRDi 3 EcoDynamics 5dr

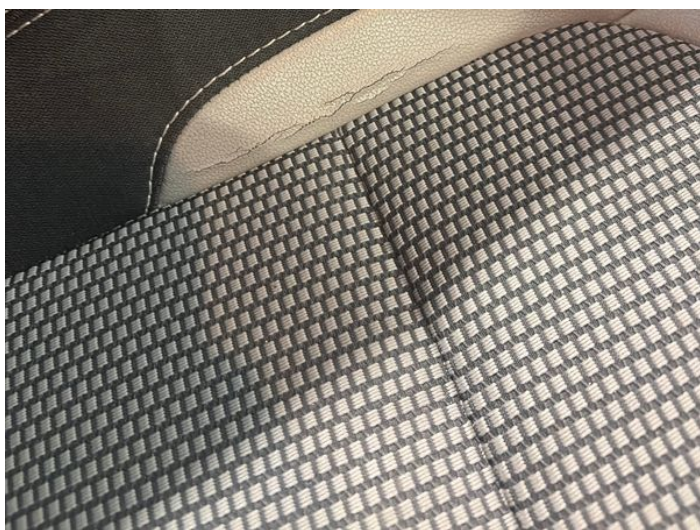
1: Seat Base Cover nsf  
Torn  
Over 3mm

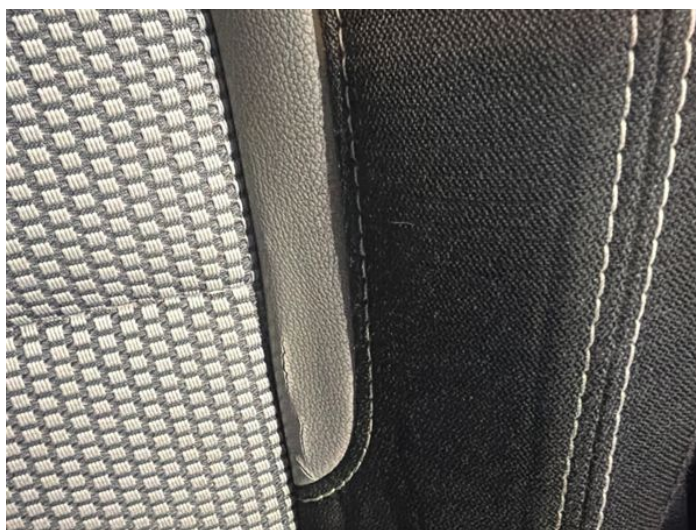
2: Seat Base Cover osf  
Torn  
UpTo 3mm

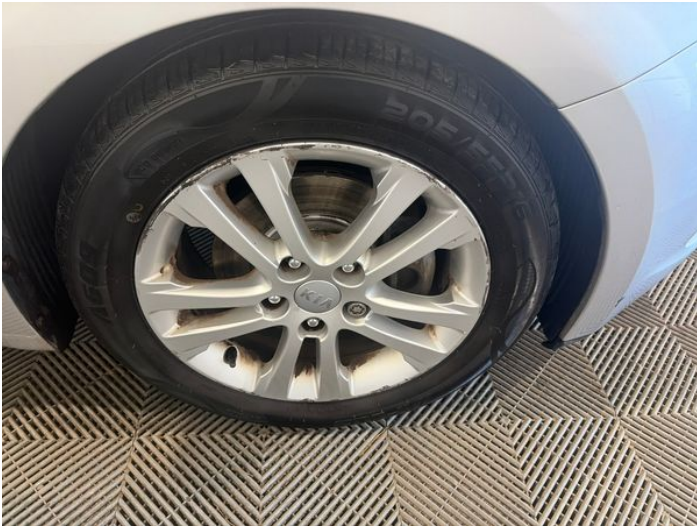
3: Wheel osf  
Scratched  
Over 50mm

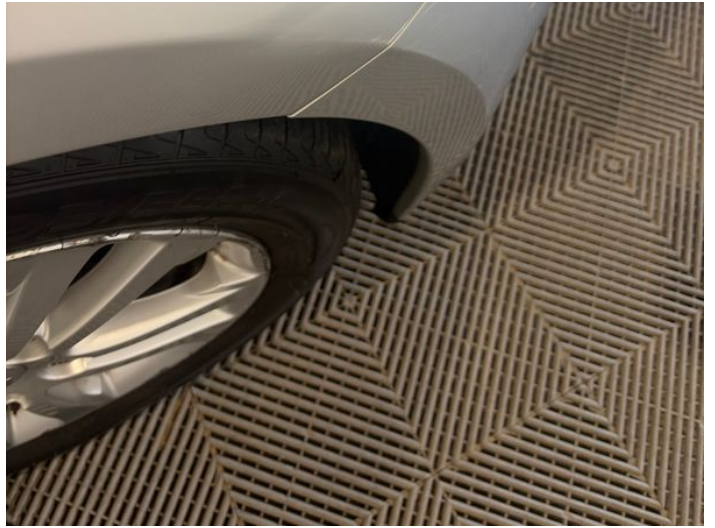
4: Door osf  
Dented  
Over 30mm

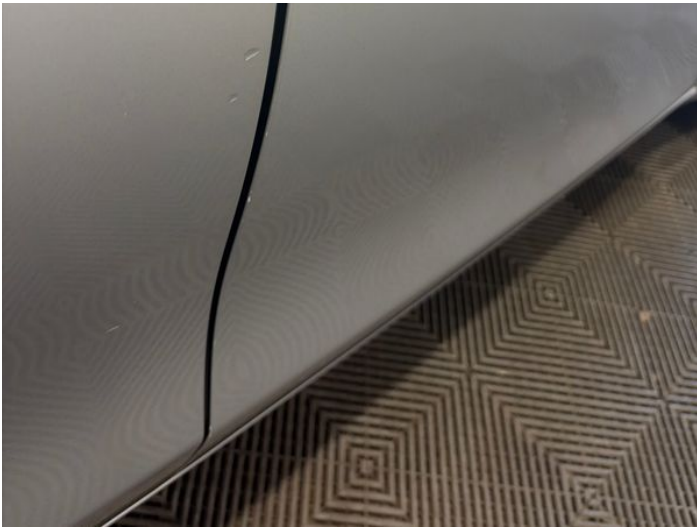
5: Door osf  
Chipped  
Edge Chip

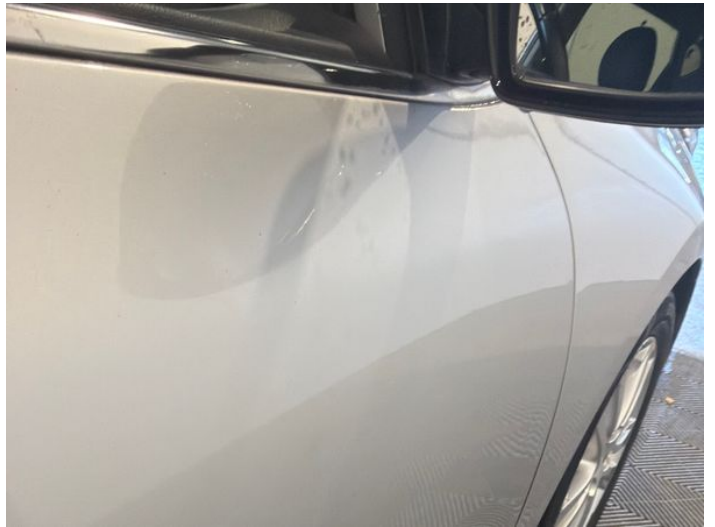
6: Door osf  
Dented  
Between 10mm + 30mm

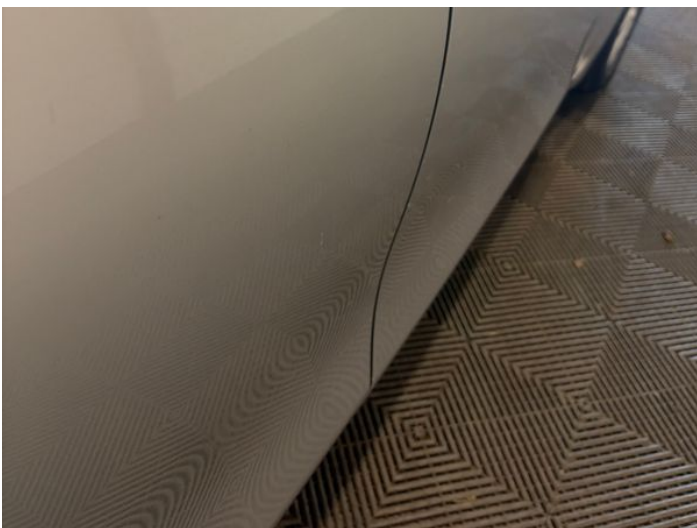
7: Door osr  
Dented  
2 Or Less UpTo 10mm

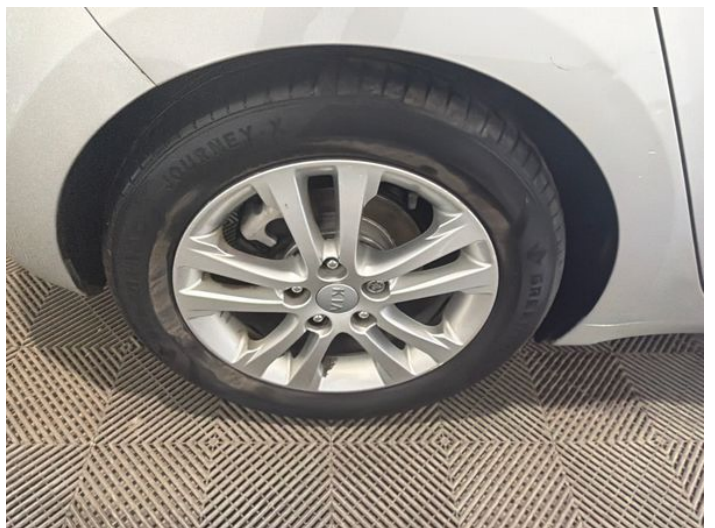
8: Wheel osr  
Scratched  
Up To 50mm

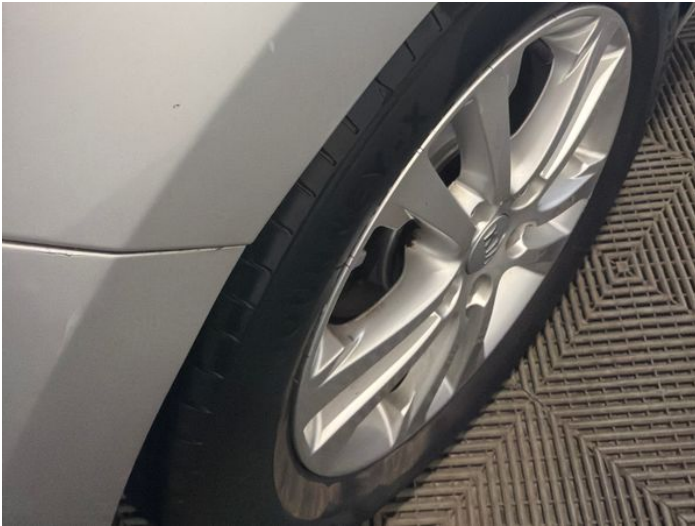
9: Qtr Panel osr  
Chipped  
1 To 5

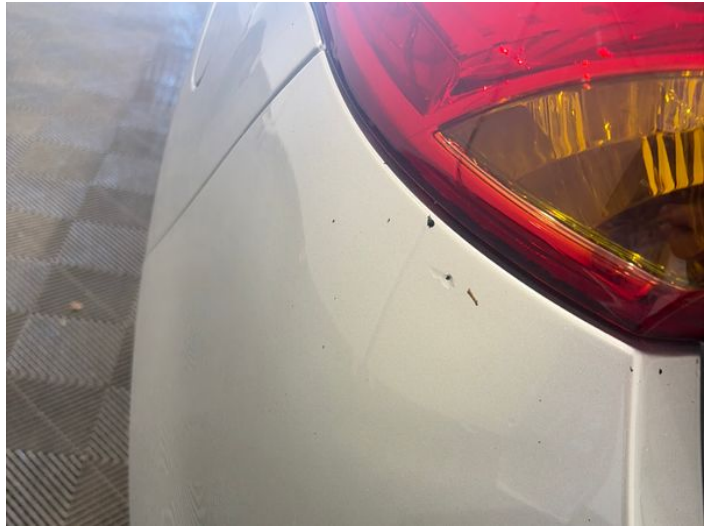
10: Bumper Rear  
Poor Previous Repair  
Poor Paint

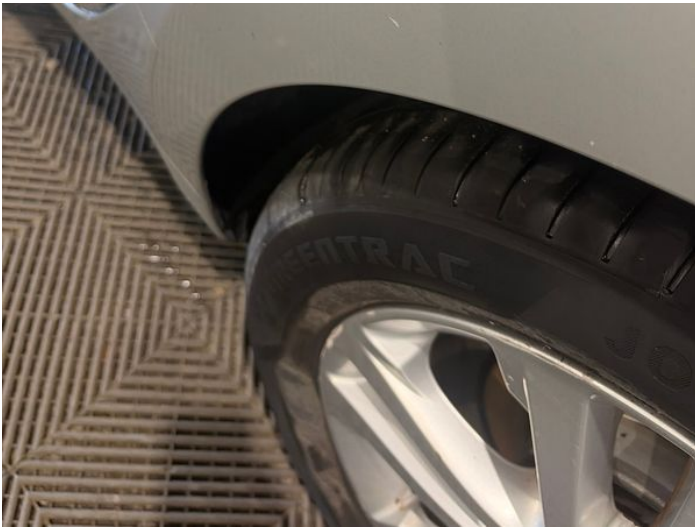
11: Qtr Panel nsr  
Dented  
Between 10mm + 30mm

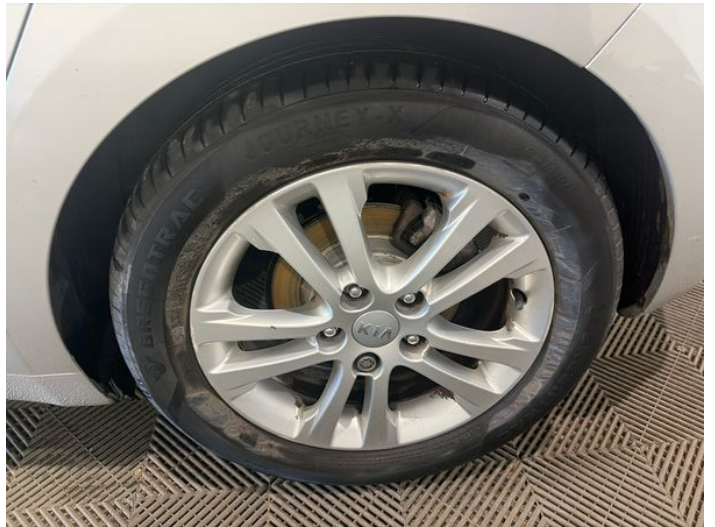
12: Wheel nsr  
Scratched  
Over 50mm

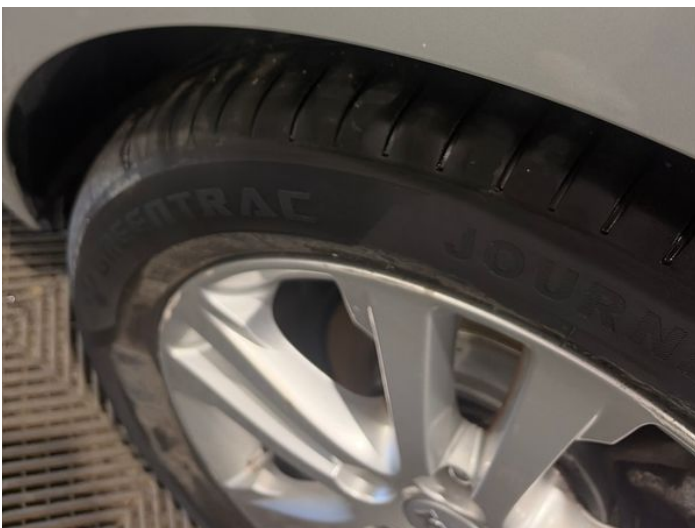
13: Qtr Panel nsr  
Chipped  
1 To 5

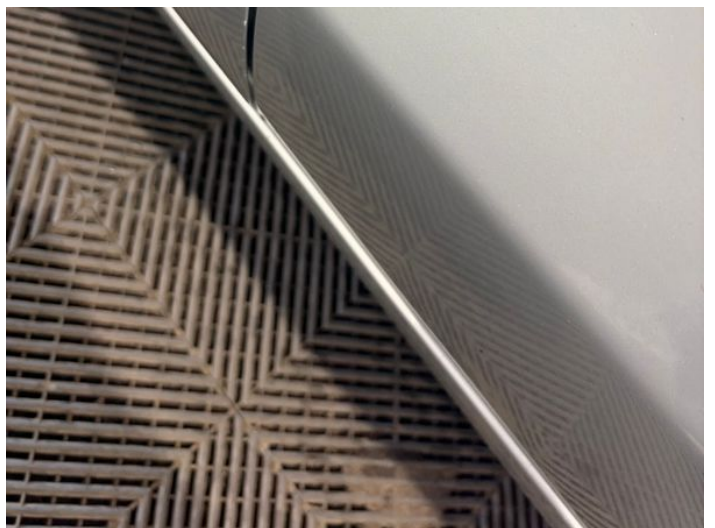
14: Door nsr  
Chipped  
1 To 5

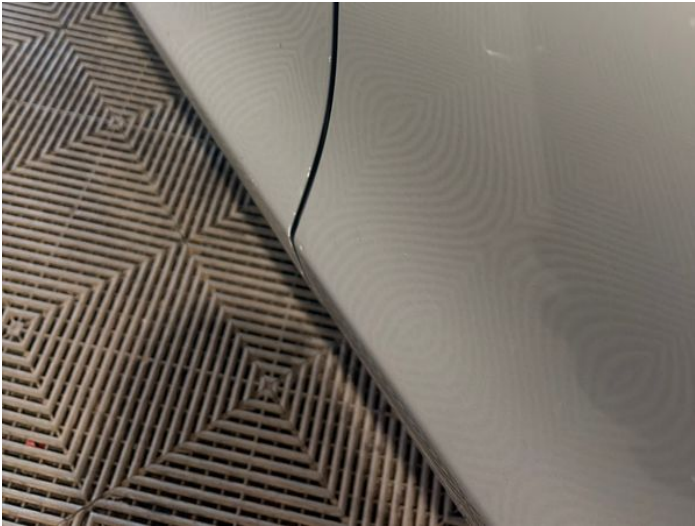
15: Door nsf  
Chipped  
Edge Chip

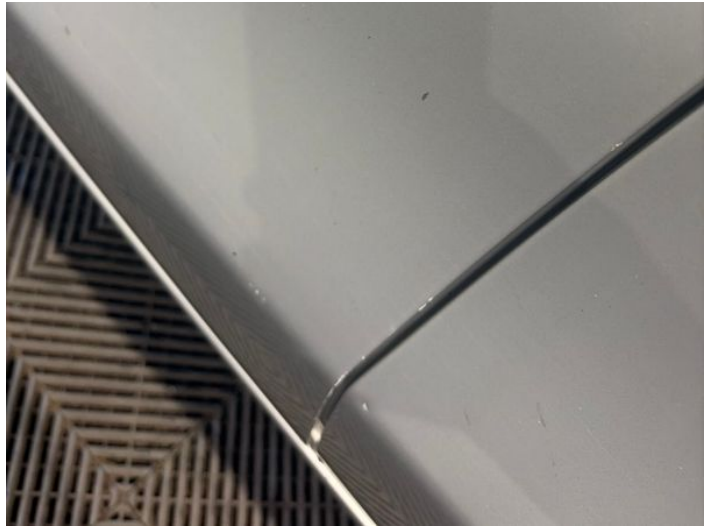
16: Door nsf  
Chipped  
1 To 5

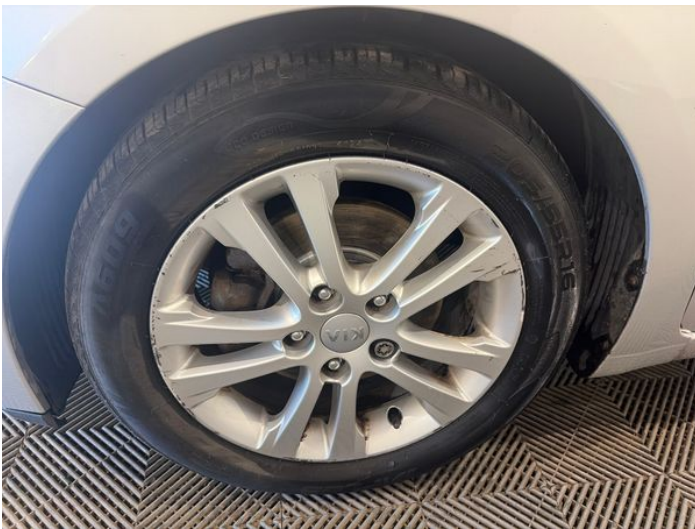
17: Wheel nsf  
Scratched  
Over 50mm

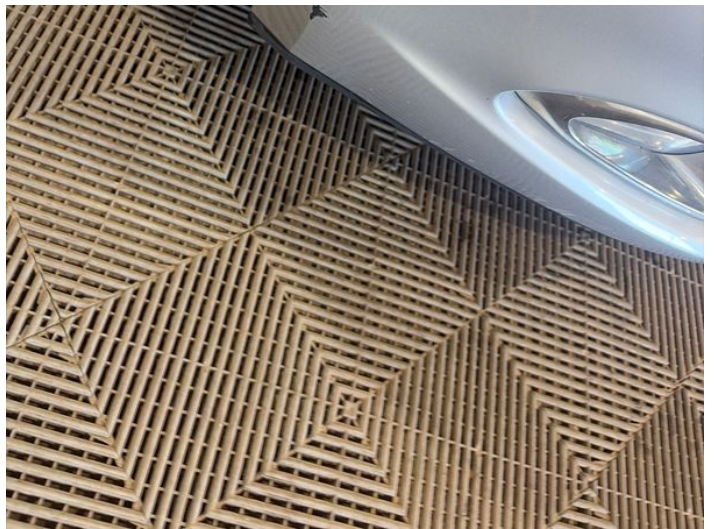
18: Bumper Front  
Scratched  
25 to 100mm Thru Paint

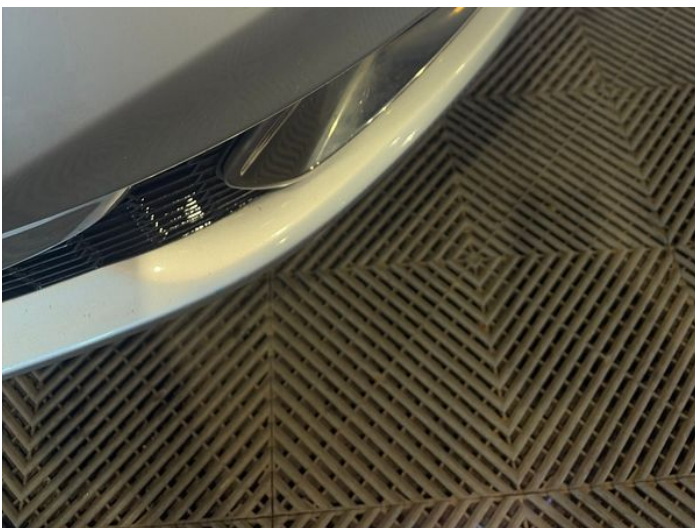
19: Bumper Front  
Chipped  
Multiple Chips

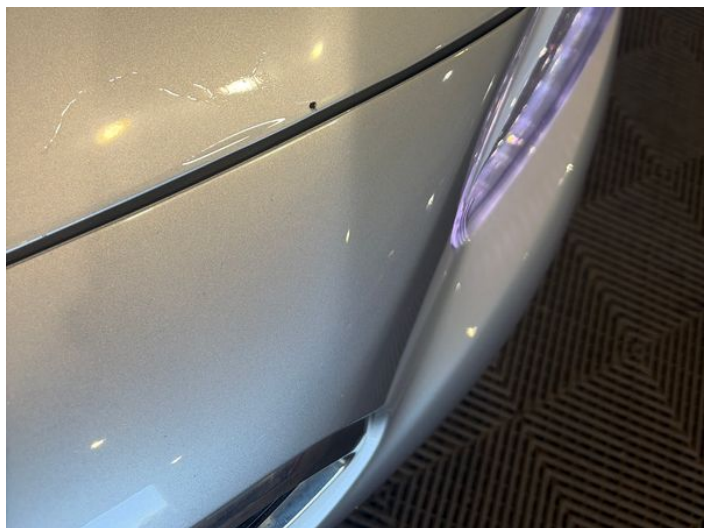
20: Bonnet  
Chipped  
1 To 5

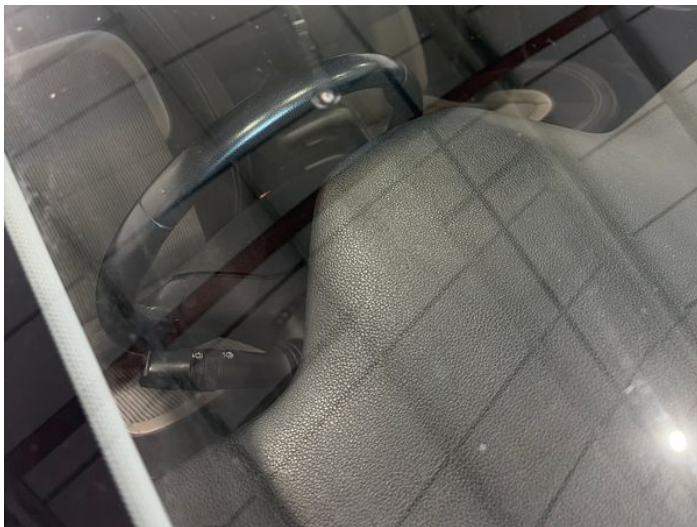
21: Screen Front  
Chipped  
UpTo 10mm

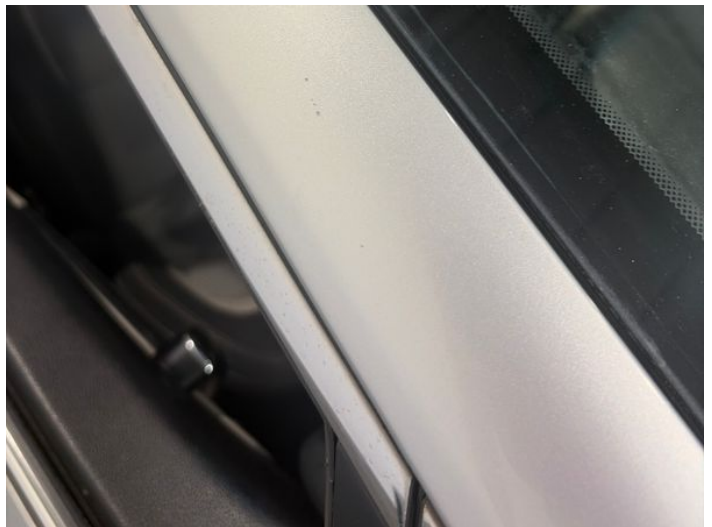
22: A Post os  
Chipped  
1 To 5
