# VEHICLE INSPECTION REPORT

**DN68XJP**

## Vauxhall Mokka X 1.4T ecoTEC Active 5dr

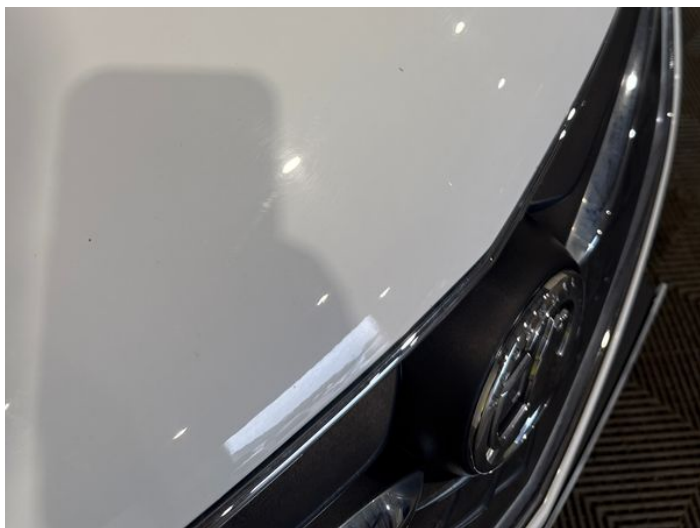
1: Bonnet  
Chipped  
1 To 5

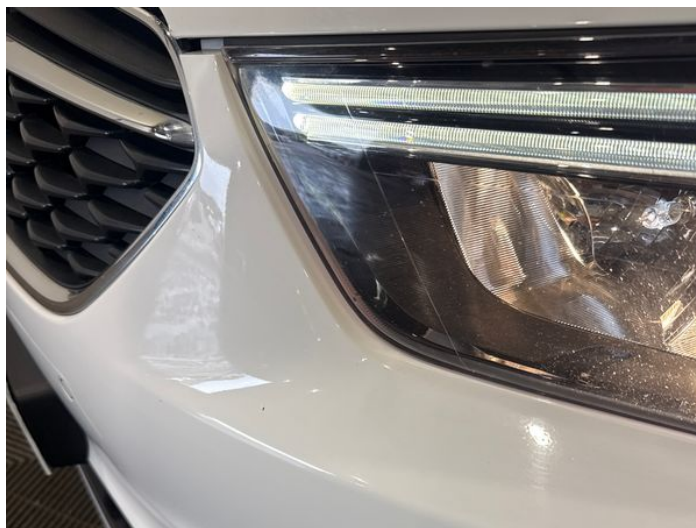
2: Bumper Front  
Chipped  
1 To 5

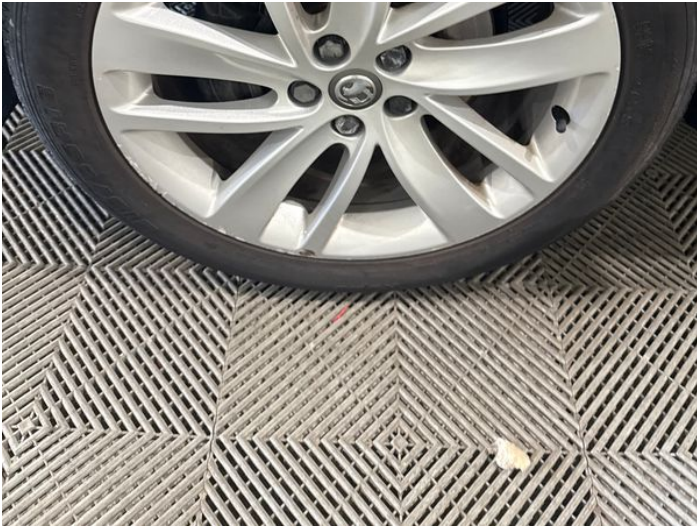
3: Wheel nsf  
Scratched  
Over 50mm

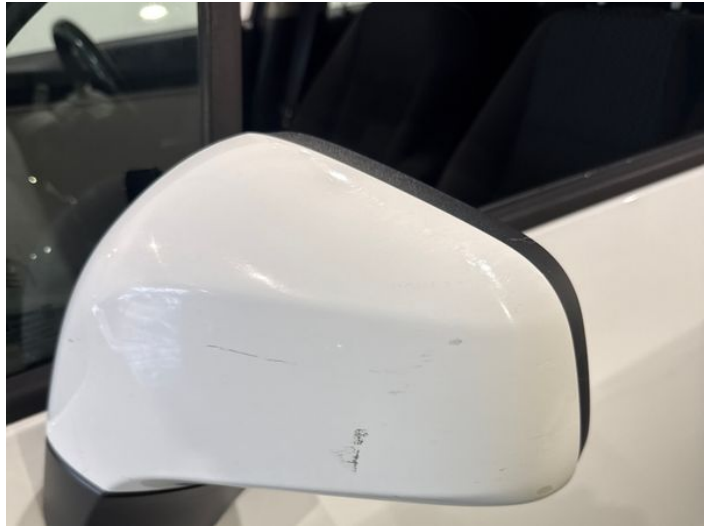
4: Door Mirror Assy nsf  
Scratched (Painted)  
UpTo 25mm Thru Paint

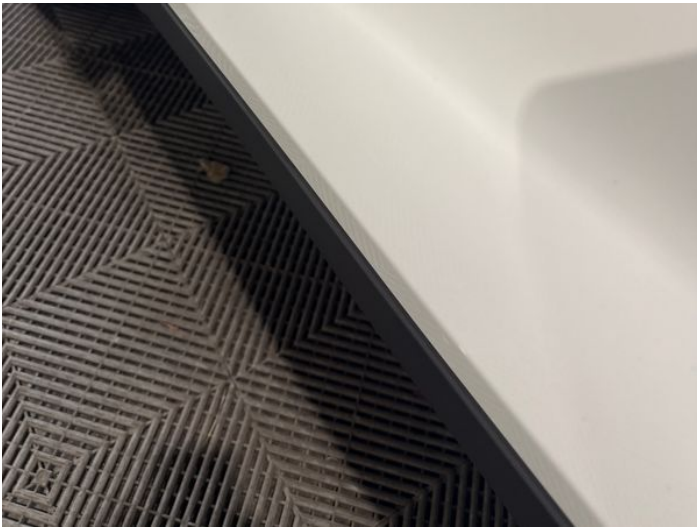
5: Door nsf  
Dented  
Over 30mm

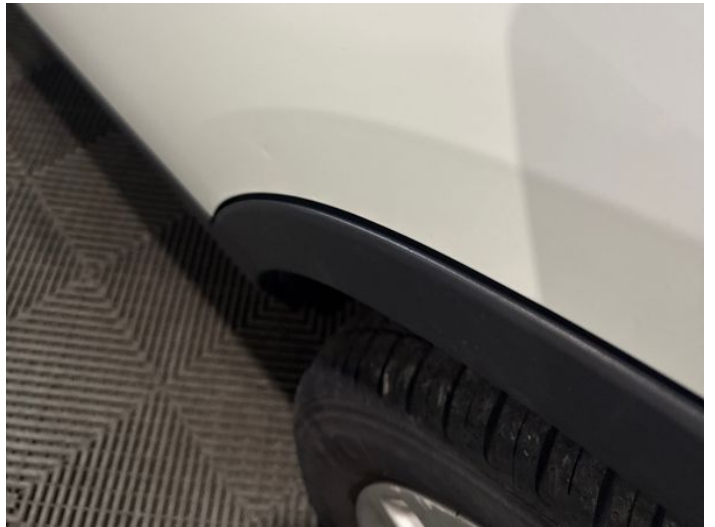
6: Door nsr  
Dented  
Between 10mm + 30mm

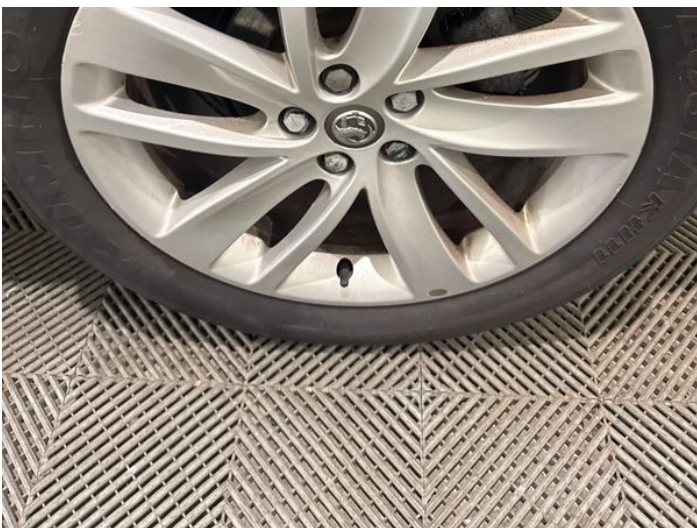
7: Wheel nsr  
Scratched  
Over 50mm

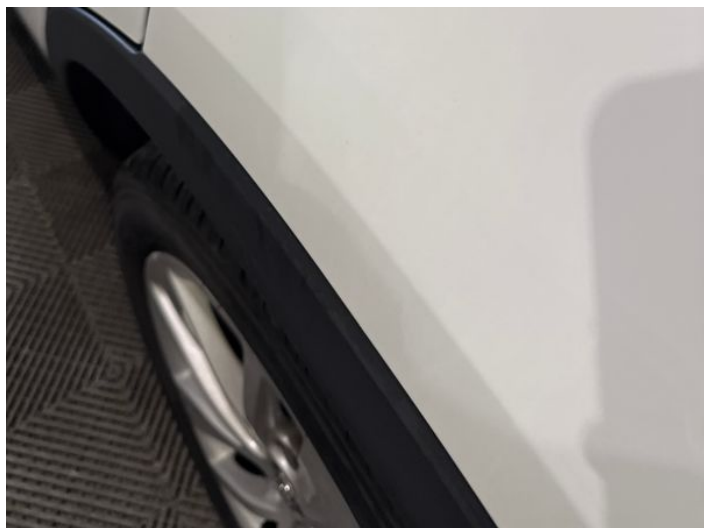
8: Qtr Panel nsr  
Dented  
2 Or Less UpTo 10mm

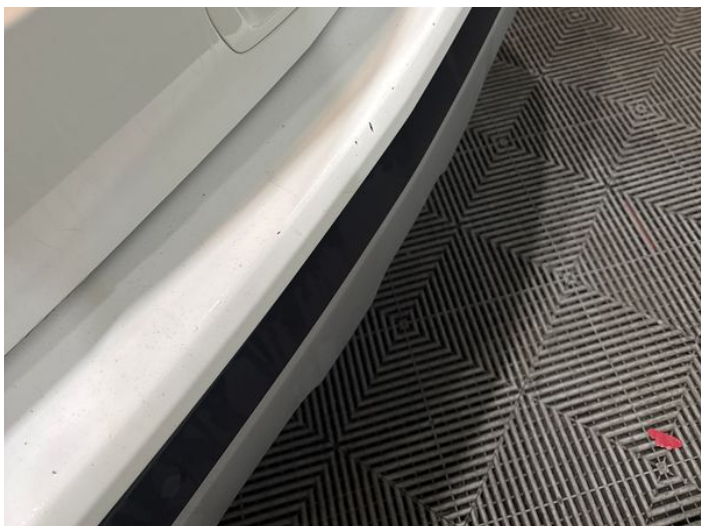
9: Bumper Rear  
Scratched  
25 to 100mm Thru Paint

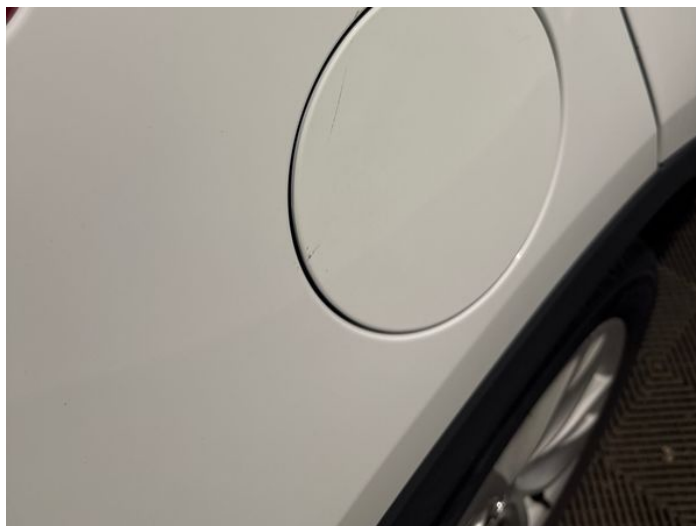
10: Qtr Panel osr  
Scratched  
UpTo 25mm Thru Paint

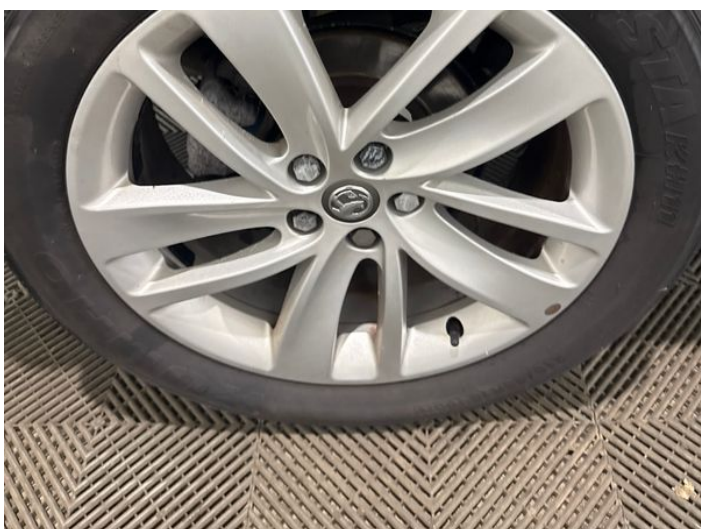
11: Wheel osr  
Scratched  
Over 50mm

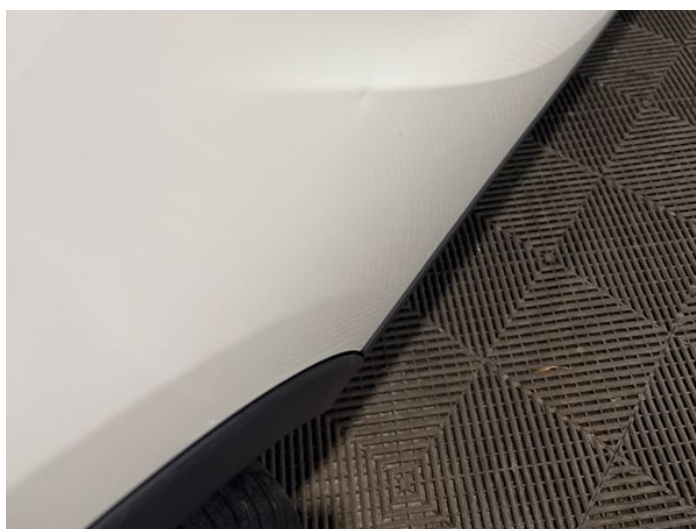
12: Door osr  
Dented  
Between 10mm + 30mm

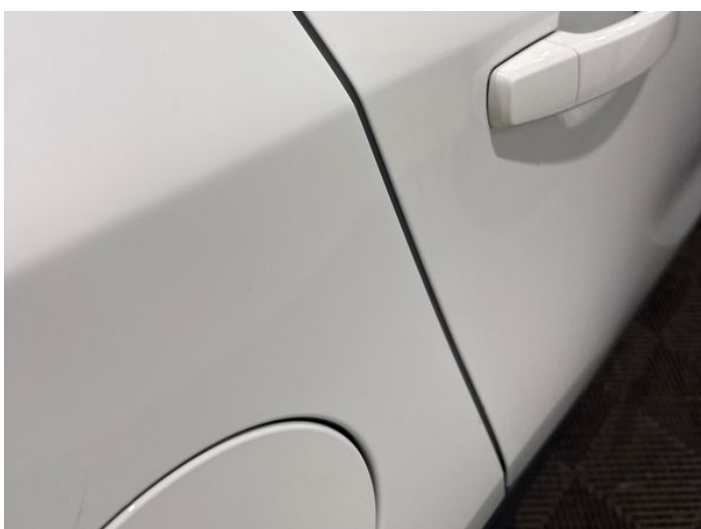
13: Door osr  
Chipped  
Edge Chip

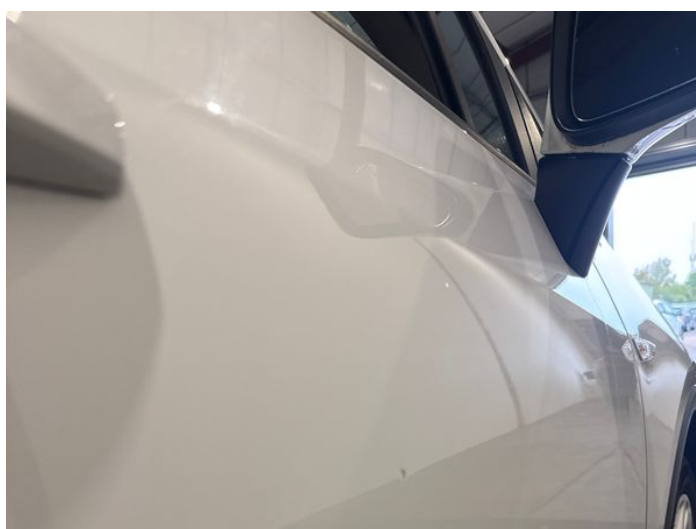
14: Door osf  
Dented  
Between 10mm + 30mm

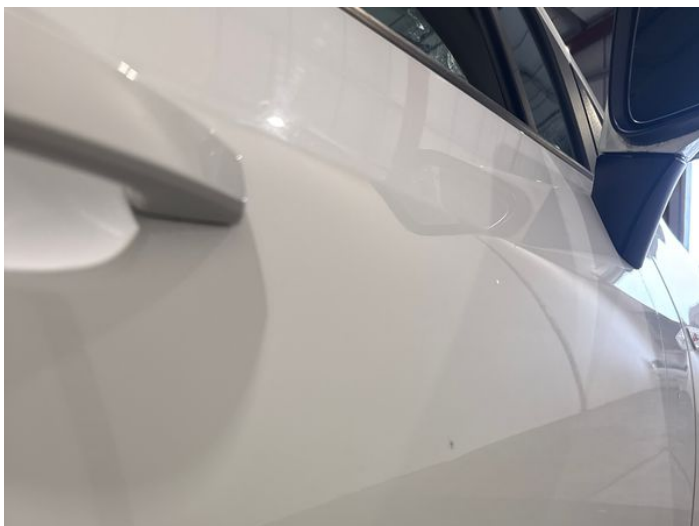
15: Door osf  
Chipped  
1 To 5

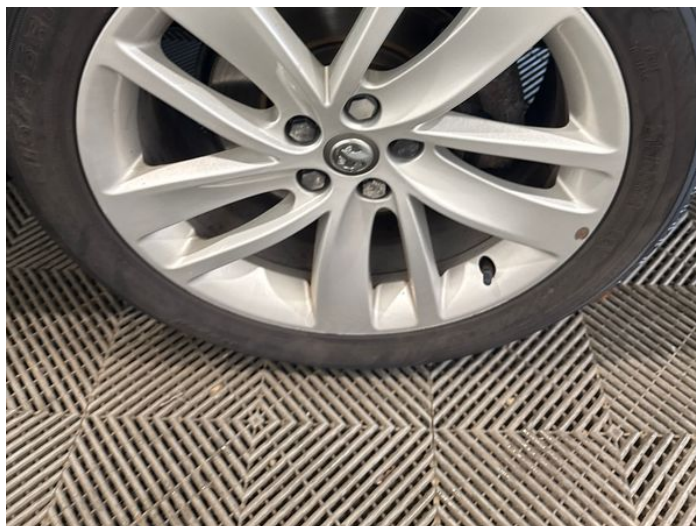
16: Wheel osf  
Scratched  
Up To 50mm

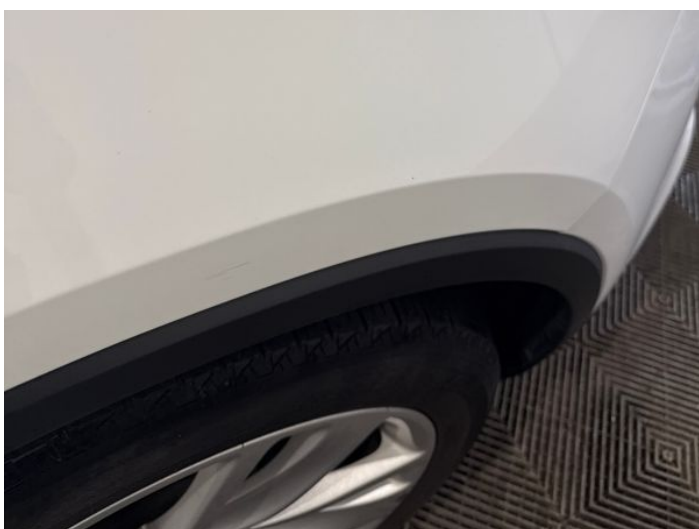
17: Wing osf  
Scratched  
UpTo 25mm Thru Paint

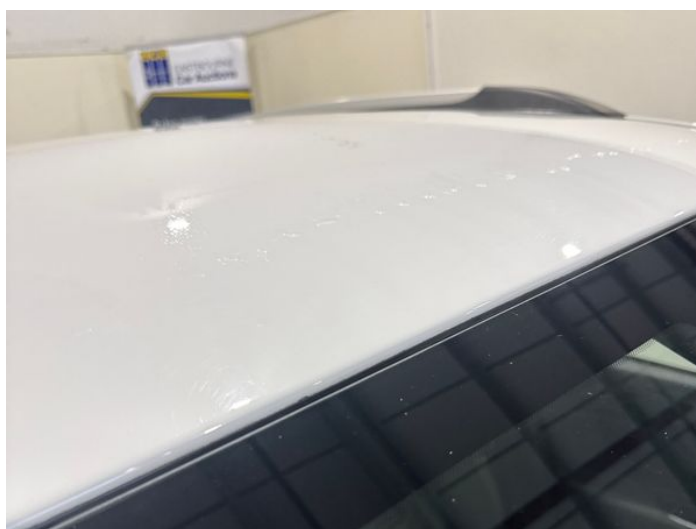
18: Roof  
Chipped  
Edge Chip
