VEHICLE INSPECTION REPORT

GY65VVF

Kia Venga 1.6 CRDi ISG 4 5dr

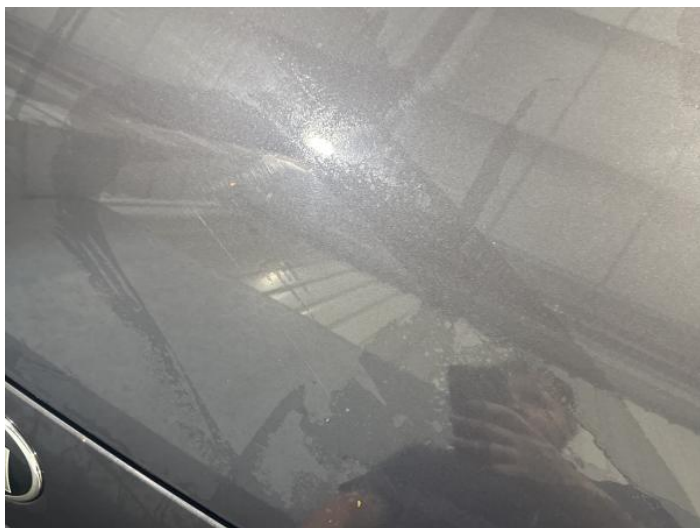
1: Bonnet
Chipped
1 To 5

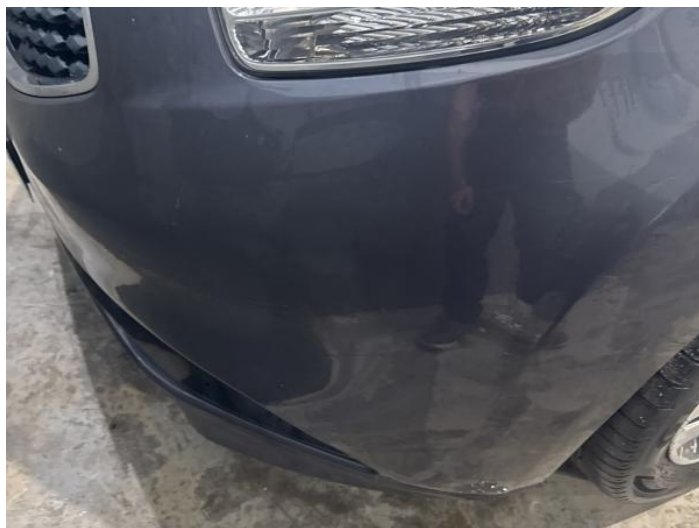
2: Bumper Front
Chipped
Multiple Chips

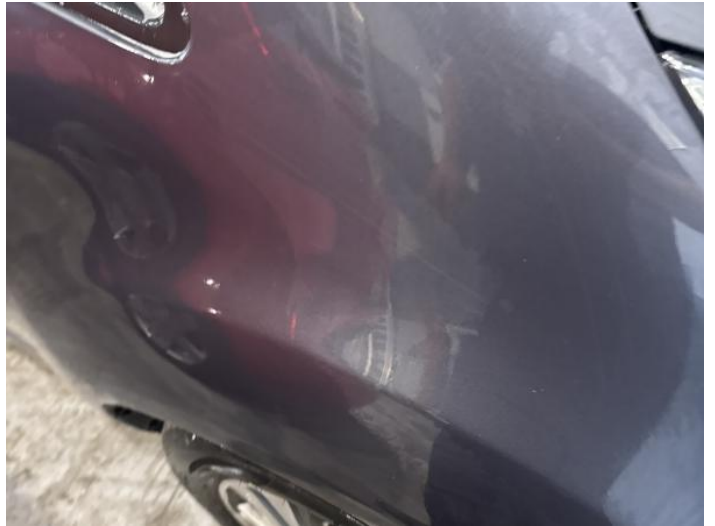
4: Wing osf
Chipped
1 To 5

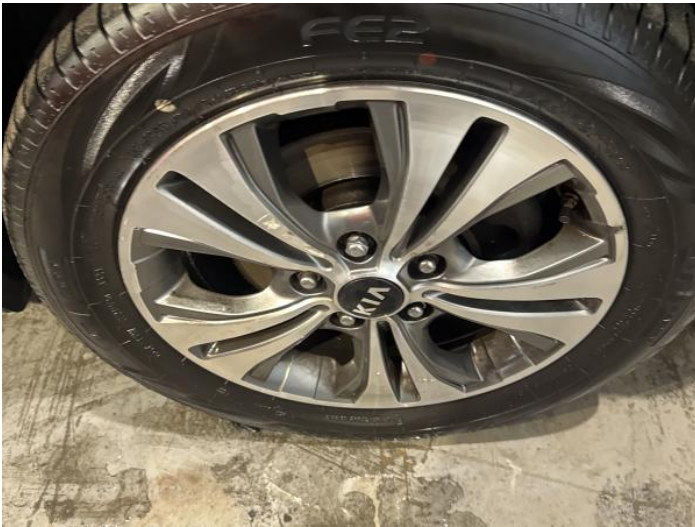
5: Wheel osf
Scratched
Over 50mm

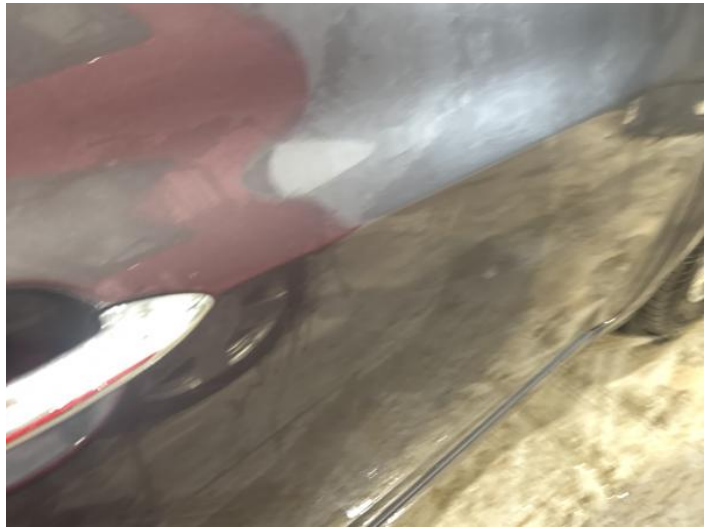
6: Door osf
Chipped
1 To 5

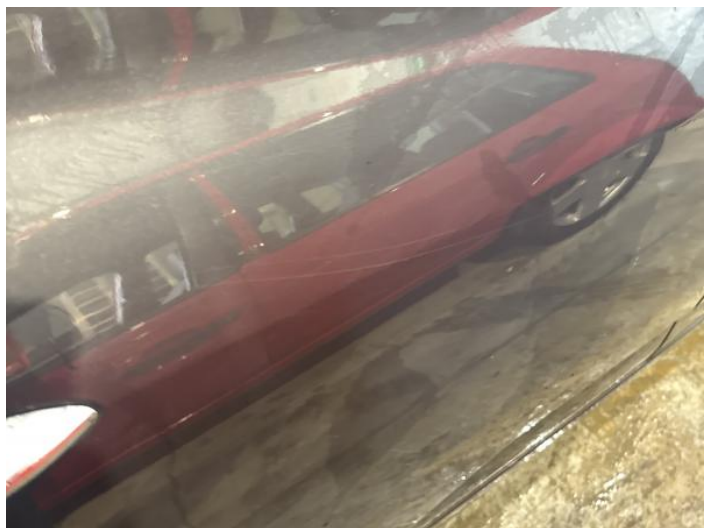
8: Door osr
Chipped
Multiple Chips

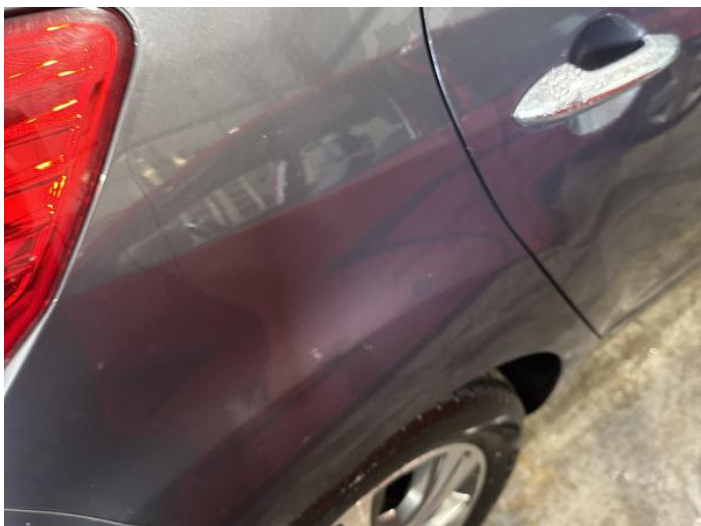
9: Qtr Panel osr
Chipped
1 To 5

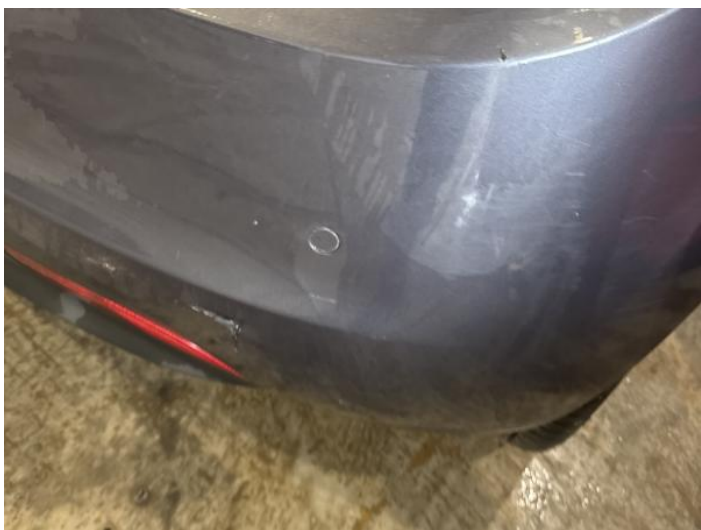
11: Bumper Rear
Cracked
UpTo 25mm

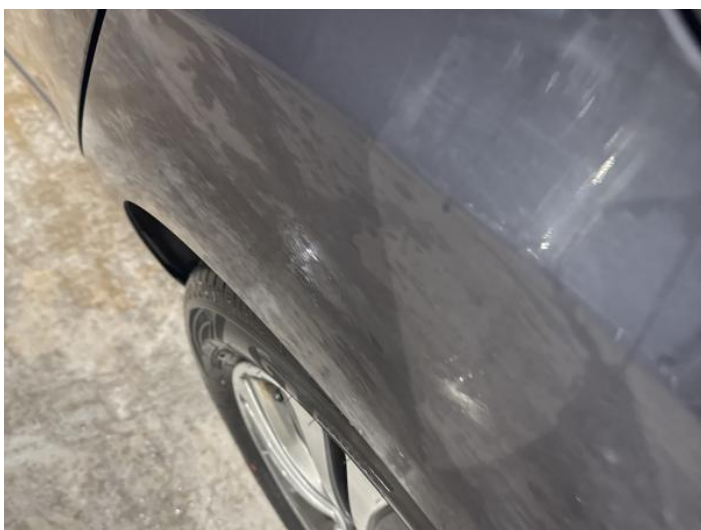
13: Qtr Panel nsr
Dented
Over 30mm

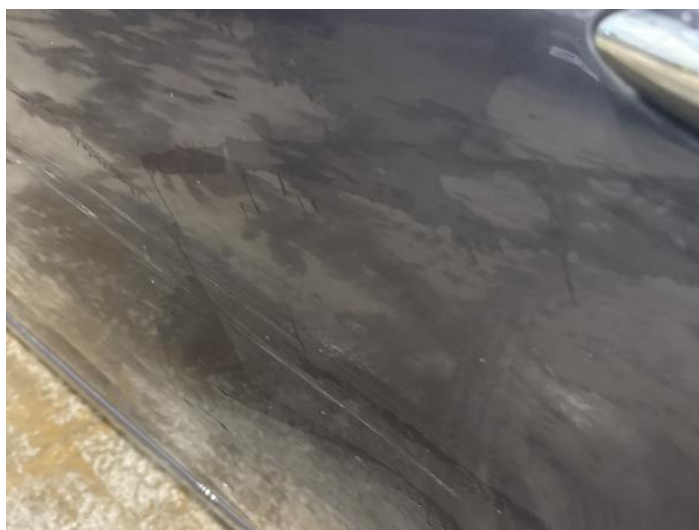
14: Door nsr
Scratched
Over 25mm Thru Paint

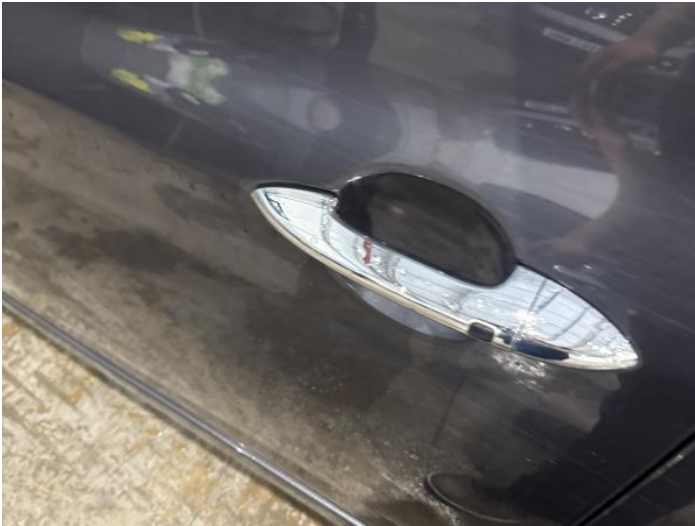
15: Door nsf
Chipped
1 To 5

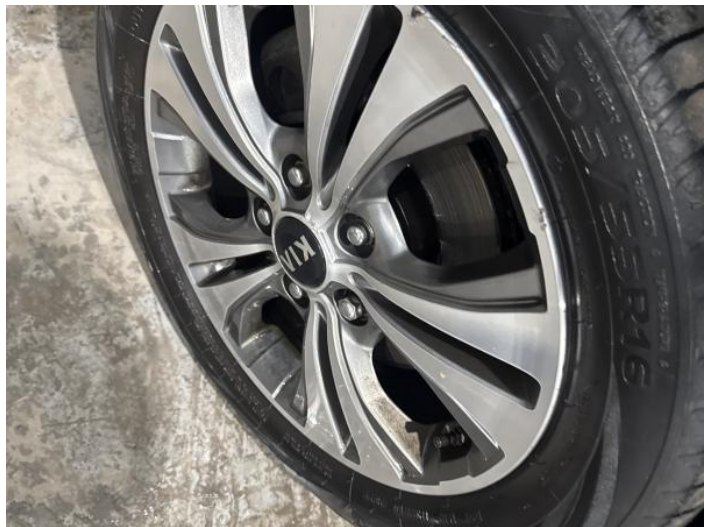
18: Wheel nsf
Scratched
Up To 50mm

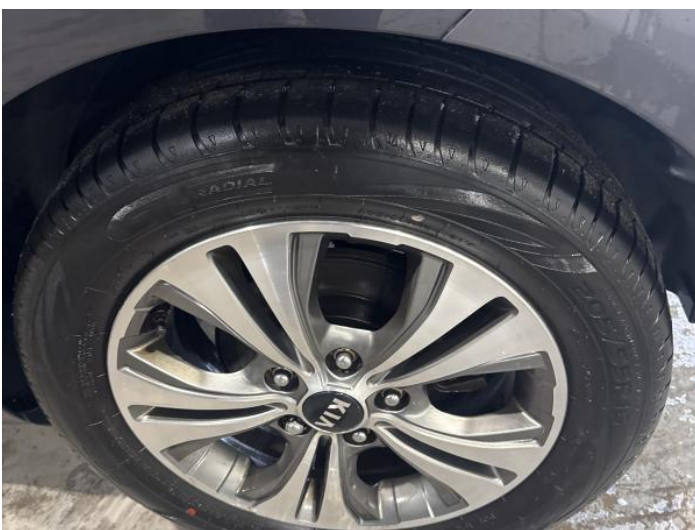
19: Wheel nsr
Scratched
Over 50mm

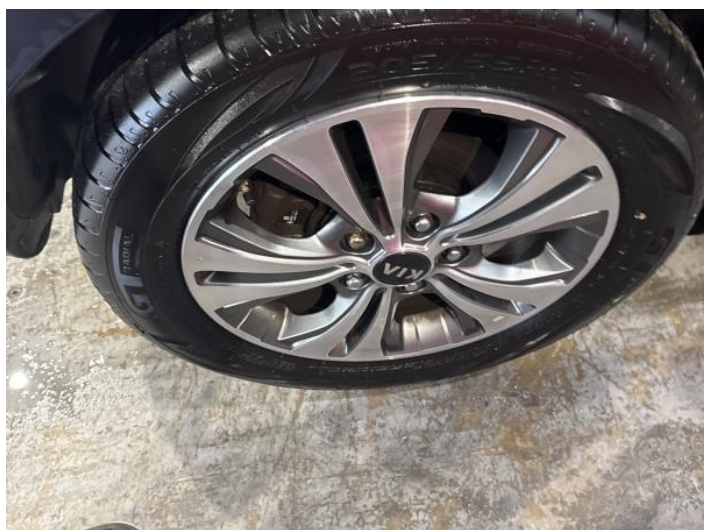
20: Wheel osr
Scratched
Up To 50mm
