# VEHICLE INSPECTION REPORT

**WR66XKX**

## Ford Kuga 2.0 TDCi 180 Titanium X Sport 5dr

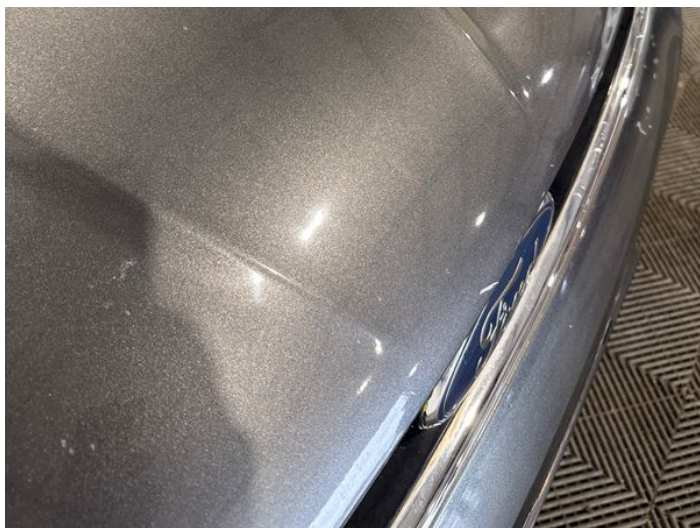
1: Bonnet  
Chipped  
Multiple Chips

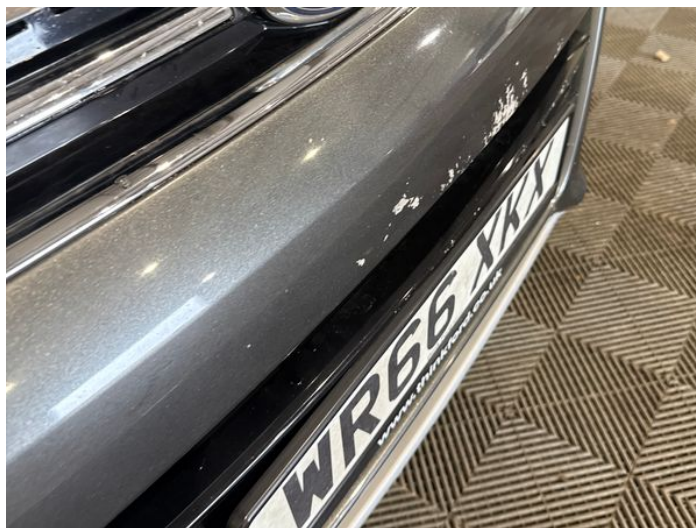
2: Bumper Front  
Poor Previous Repair  
Paint Flake

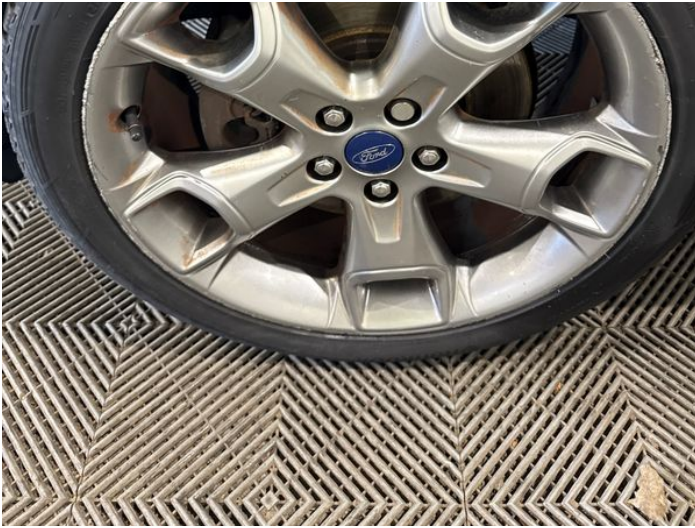
3: Wheel nsf  
Scratched  
Over 50mm

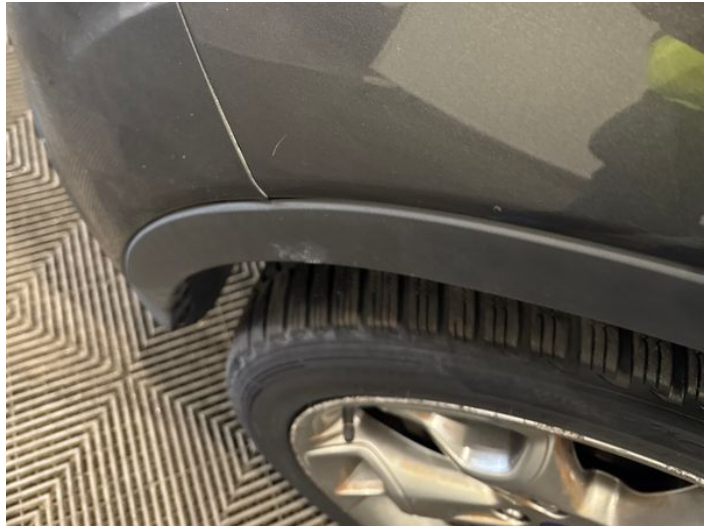
4: Wing nsf  
Scratched  
UpTo 25mm Thru Paint

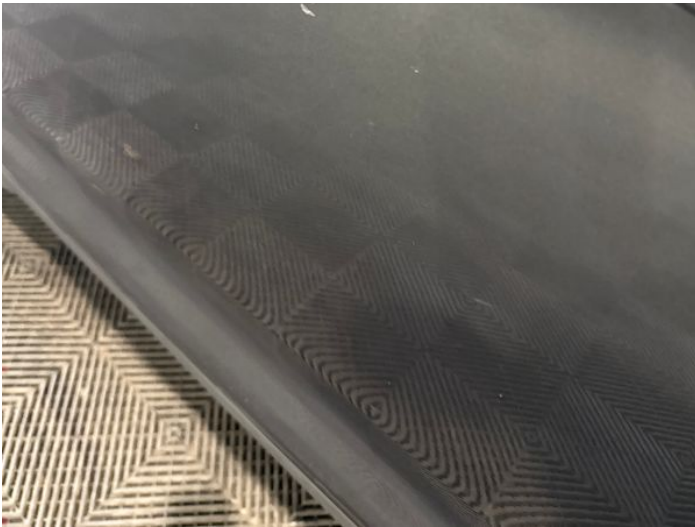
5: Door nsf  
Scratched  
UpTo 25mm Thru Paint

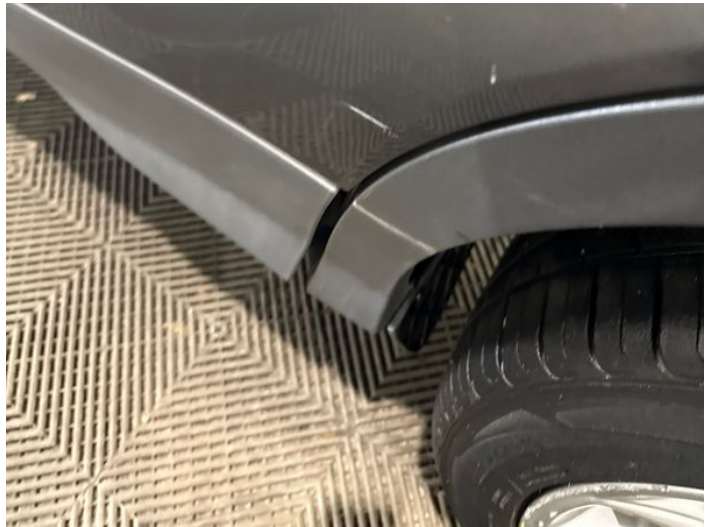
6: Door osr  
Scratched  
Over 25mm Thru Paint

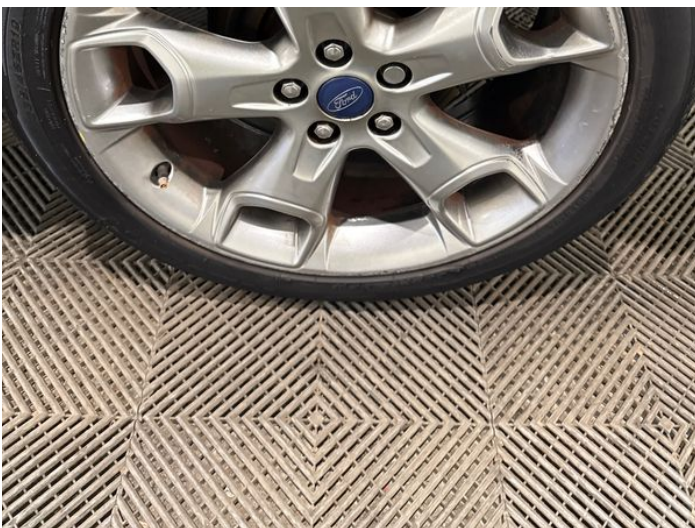
7: Wheel nsr  
Scratched  
Over 50mm

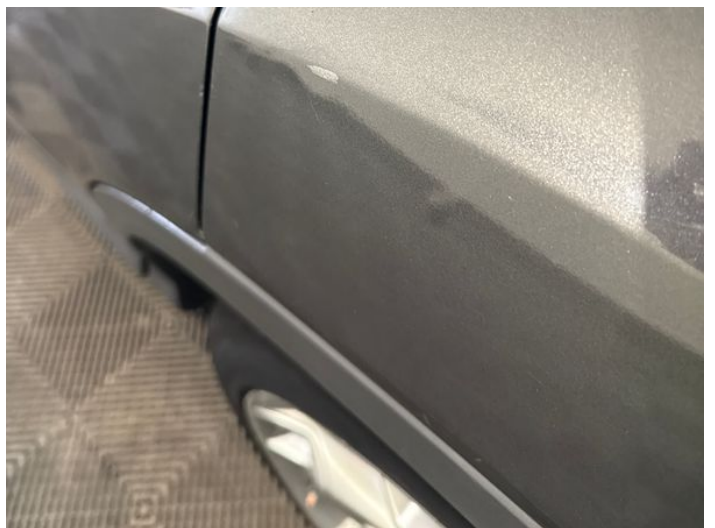
8: Qtr Panel nsr  
Dented  
Between 10mm + 30mm

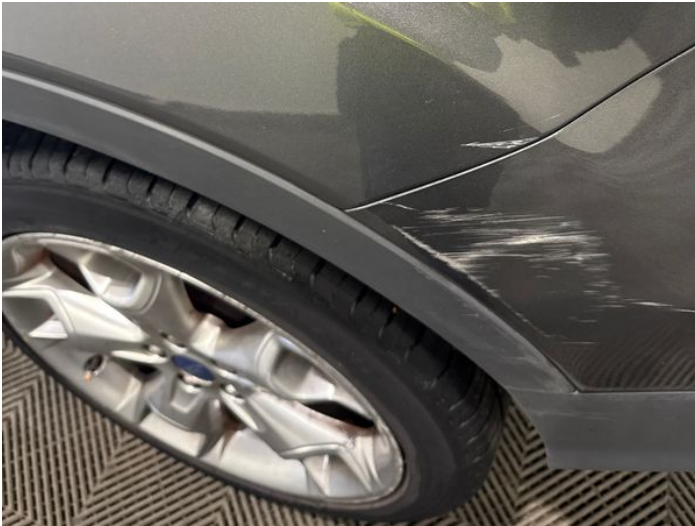
9: Qtr Panel nsr  
Scratched  
Over 25mm Thru Paint

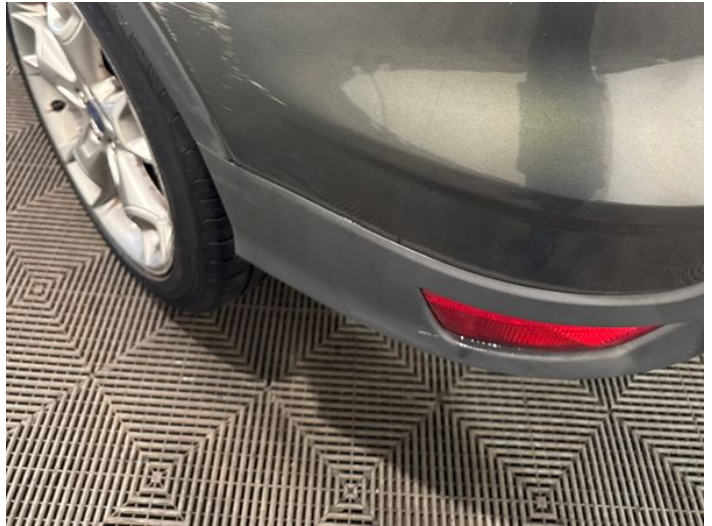
10: Bumper Rear  
Scratched  
Over 100mm Thru Paint

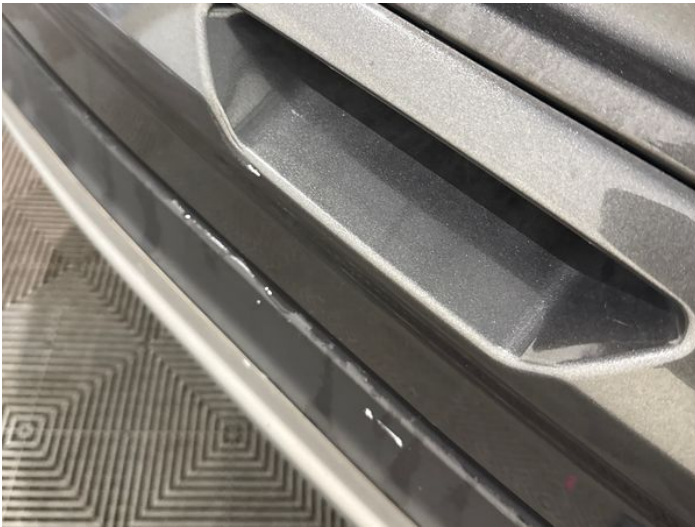
11: Tailgate Trim Panel  
Scratched (Painted)  
UpTo 25mm Thru Paint

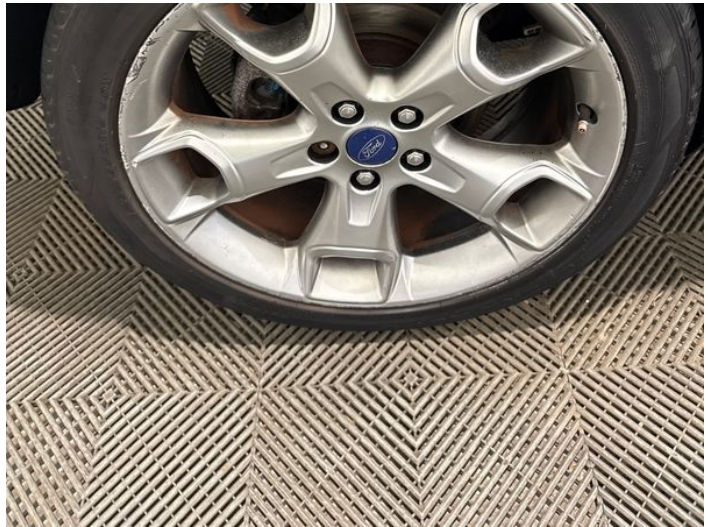
12: Wheel osr  
Scratched  
Over 50mm

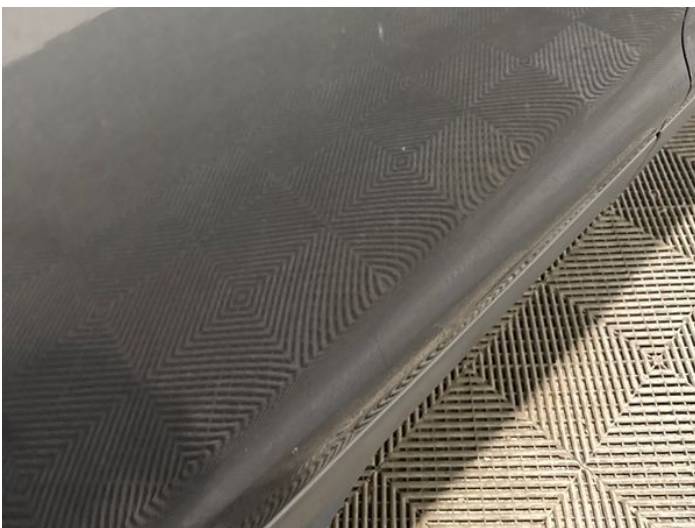
13: Door osr  
Chipped  
1 To 5

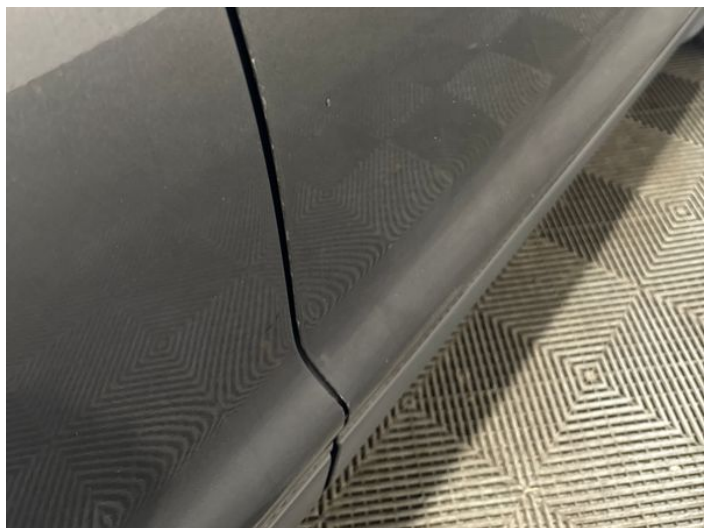
14: Door osf  
Chipped  
Edge Chip

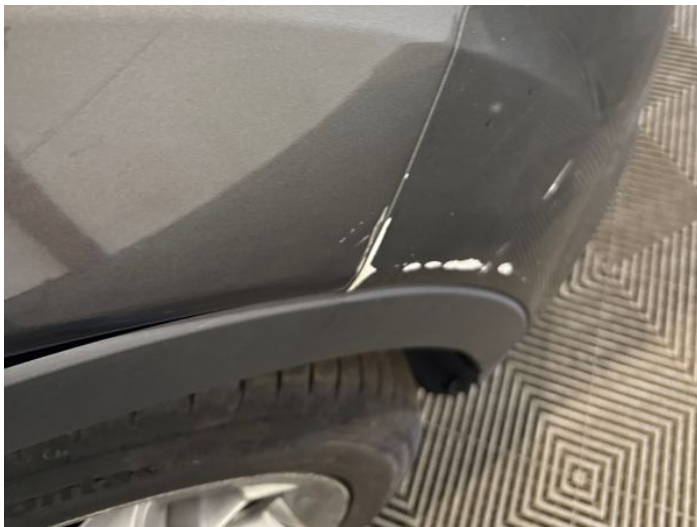
15: Wing osf  
Scratched  
Over 25mm Thru Paint

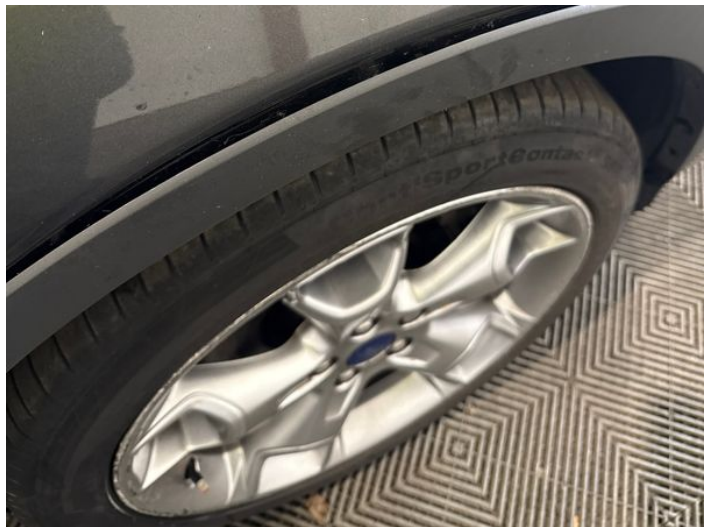
16: Wing Front Arch Extension os  
Scuffed (Unpainted)  
Over 100mm

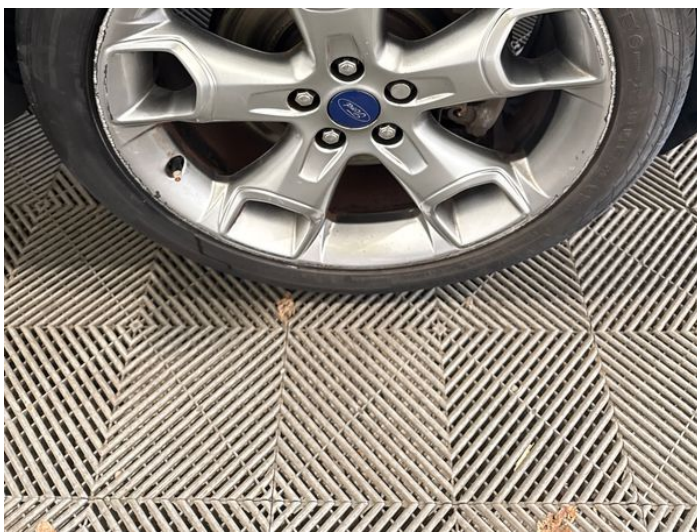
17: Wheel osf  
Scratched  
Over 50mm

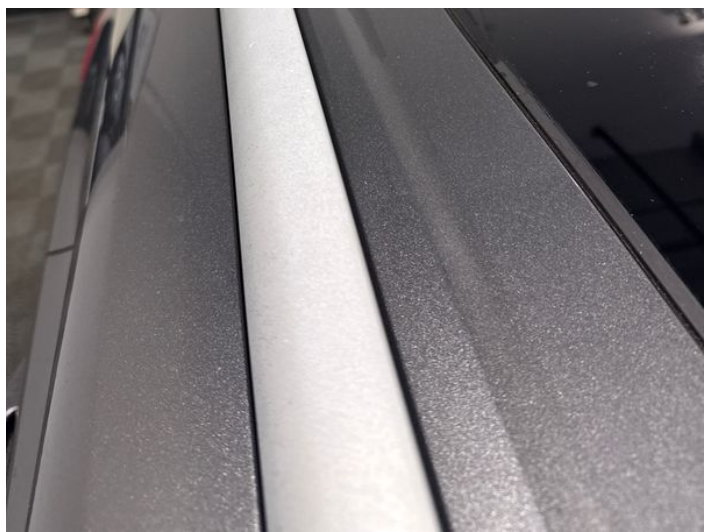
18: Roof  
Dented  
Between 10mm + 30mm
