# VEHICLE INSPECTION REPORT

**DX63ONM**

## Toyota Prius+ 1.8 VVTi T4 5dr CVT Auto

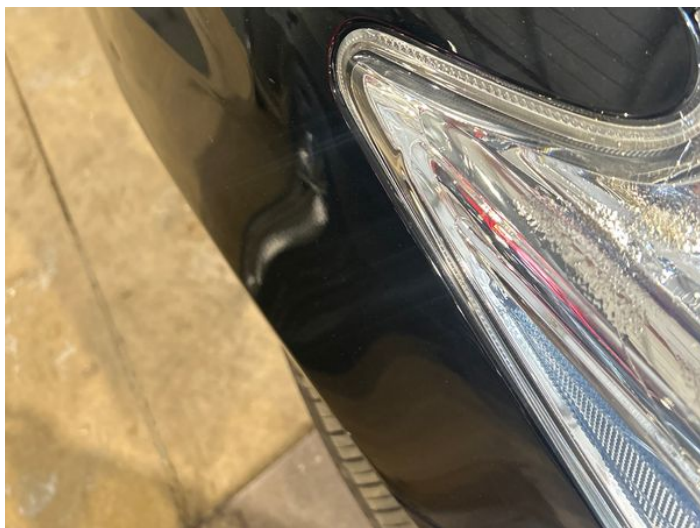
1: Wing of  
Chipped  
1 To 5

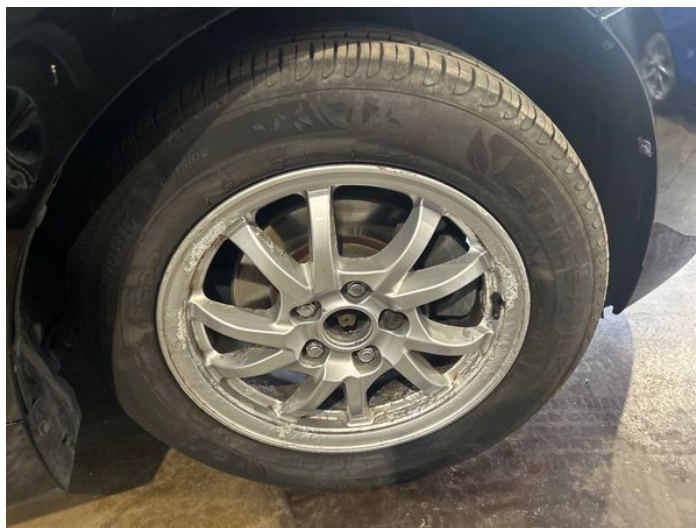
2: Wheel of  
Corroded  
Light

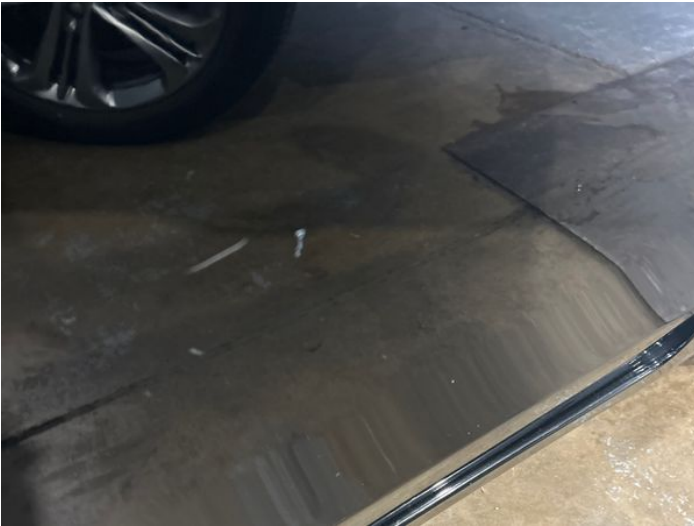
3: Door osf  
Scratched  
UpTo 25mm Thru Paint

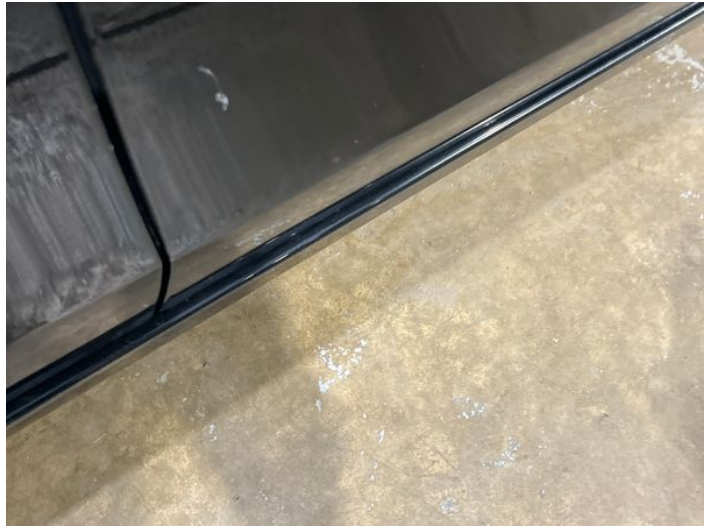
4: Door osf  
Chipped  
1 To 5

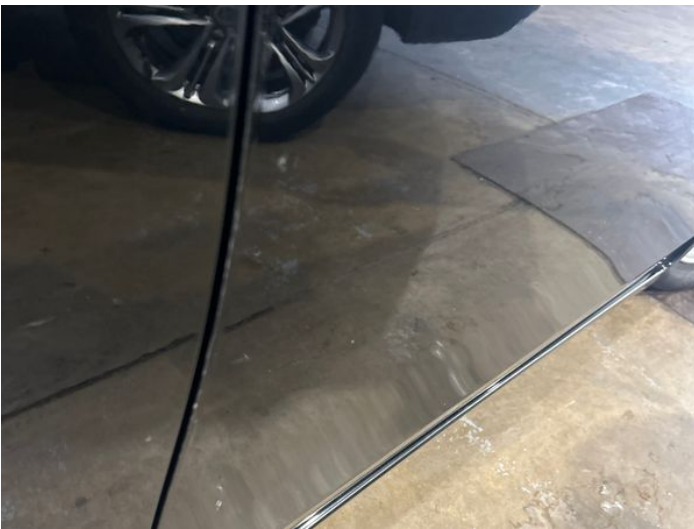
5: Door osf  
Chipped  
Edge Chip

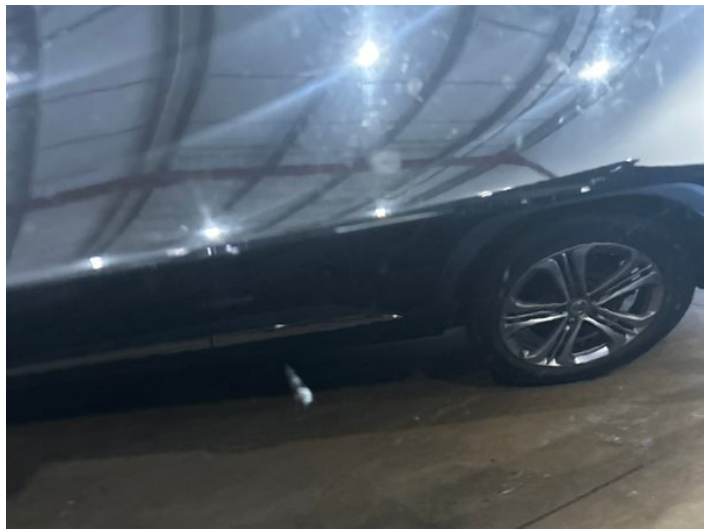
6: Door osr  
Chipped  
1 To 5

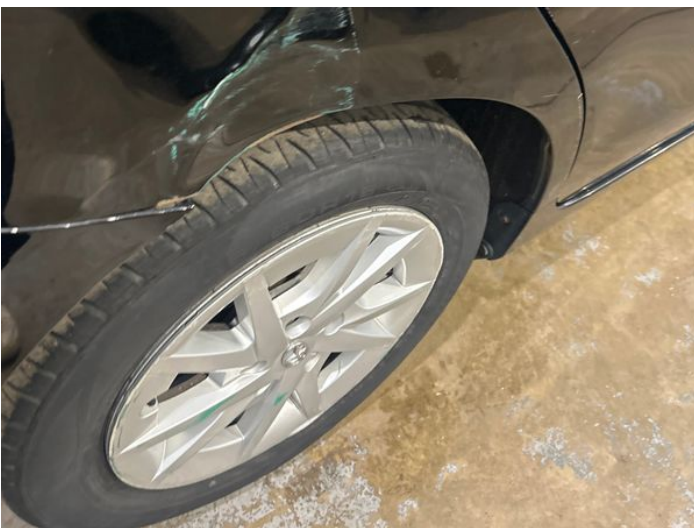
7: Qtr Panel osr  
Dented  
With Paint Damage

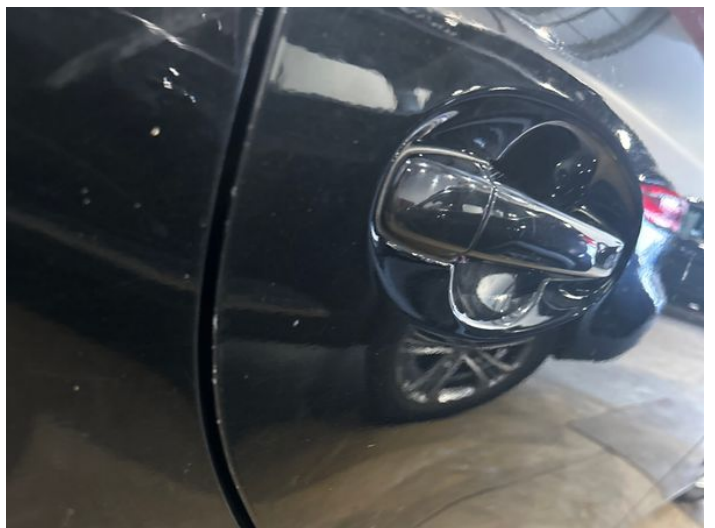
8: Door osr  
Chipped  
Edge Chip

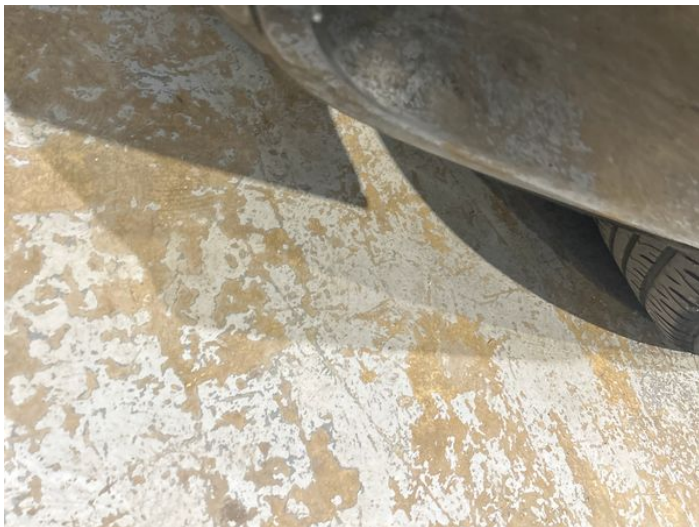
9: Bumper Rear  
Scratched  
Up To 25mm Thru Paint

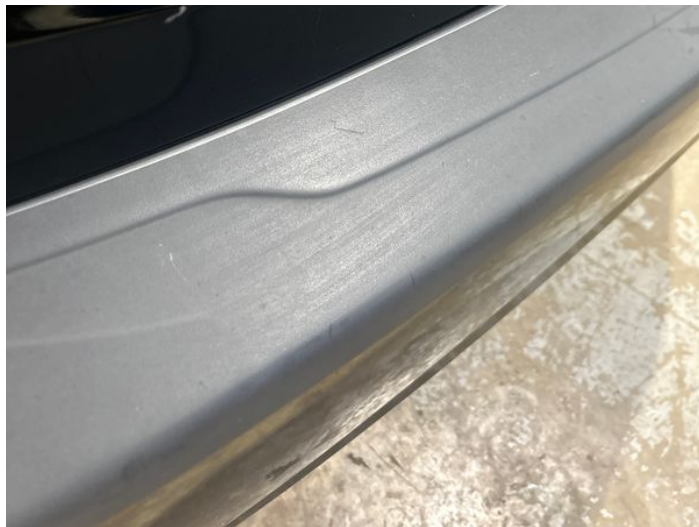
10: Tailgate  
Chipped  
1 To 5

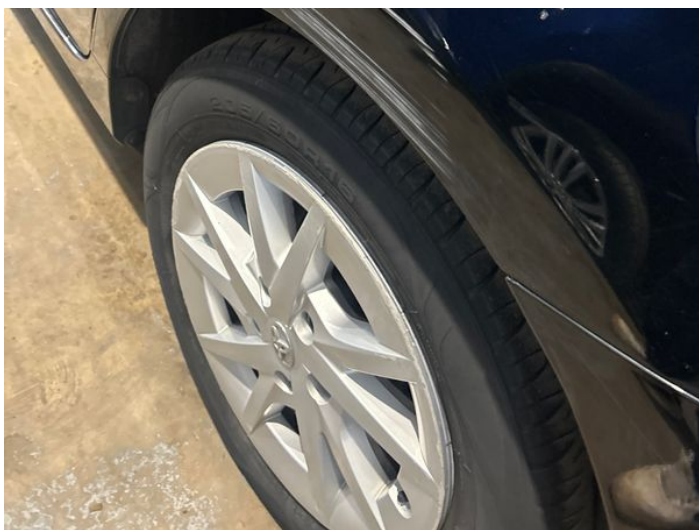
11: Qtr Panel nsr  
Scratched  
Over 25mm Thru Paint

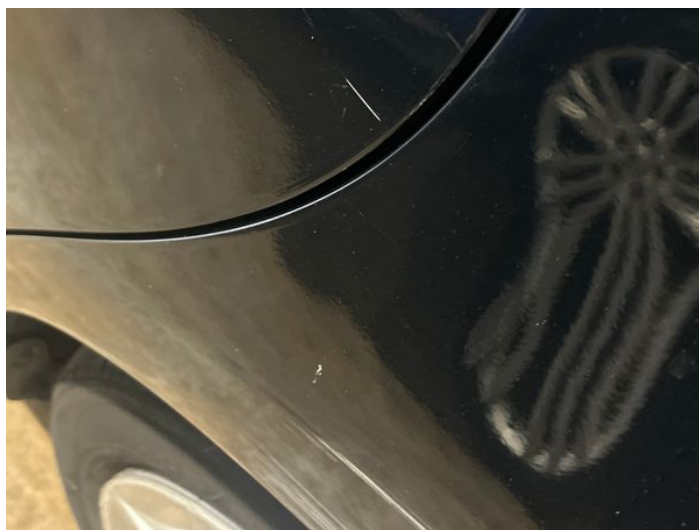
12: Door nsr  
Scratched  
UpTo 25mm Thru Paint

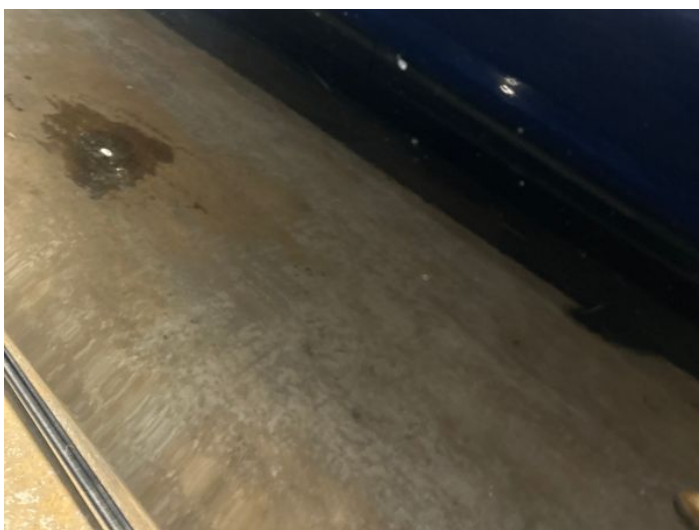
13: Door nsr  
Chipped  
1 To 5

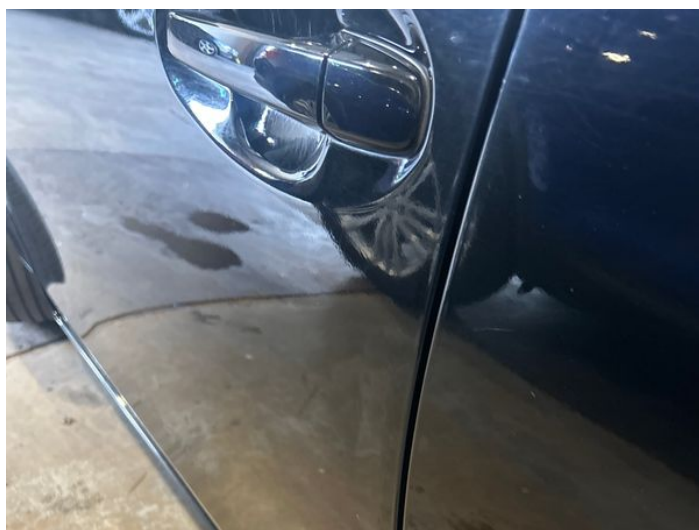
14: Door nsf  
Dented  
Over 30mm

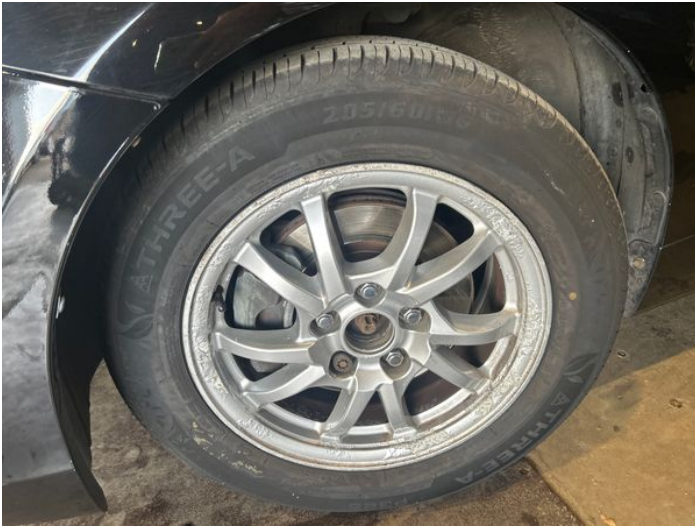
15: Wheel nsf  
Corroded  
Light

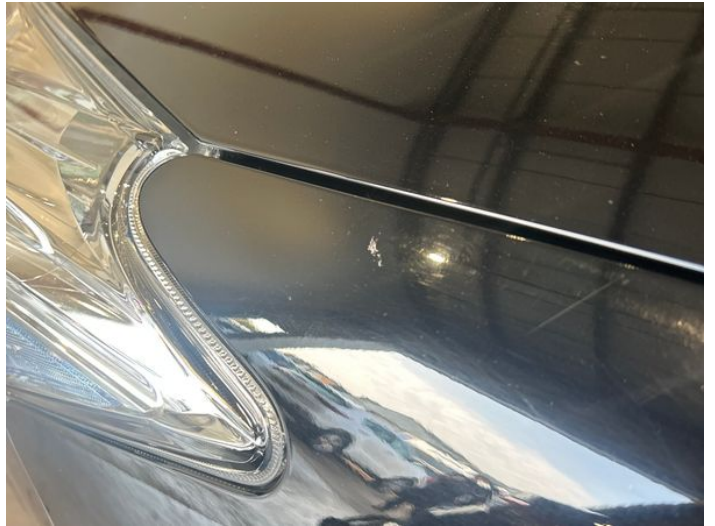
16: Wing nsf  
Chipped  
1 To 5

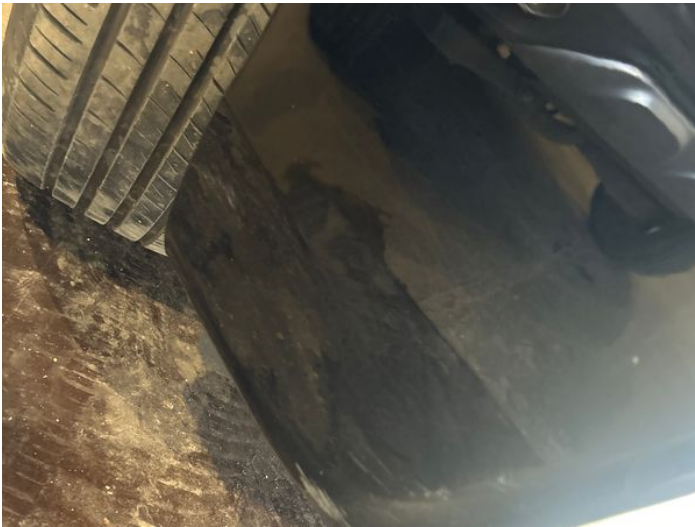
17: Bumper Front  
Scratched  
25 to 100mm Thru Paint

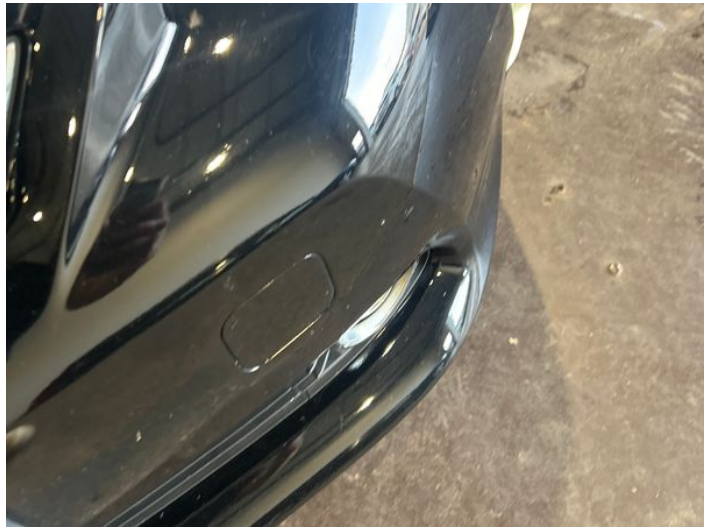
18: Bumper Front  
Chipped  
Multiple Chips

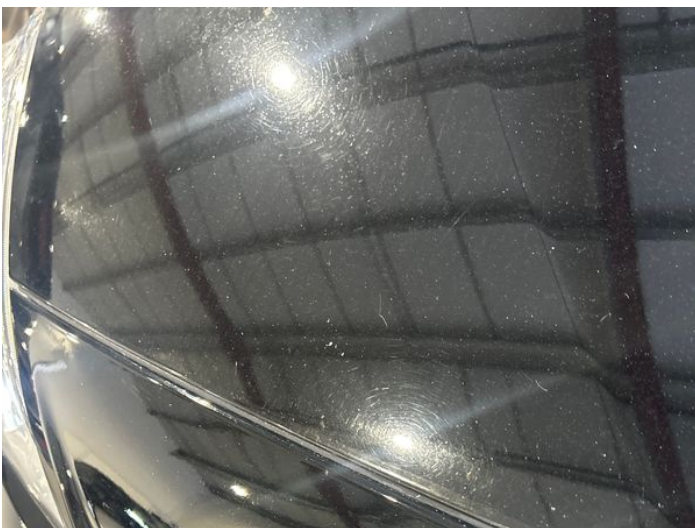
19: Bonnet  
Chipped  
1 To 5

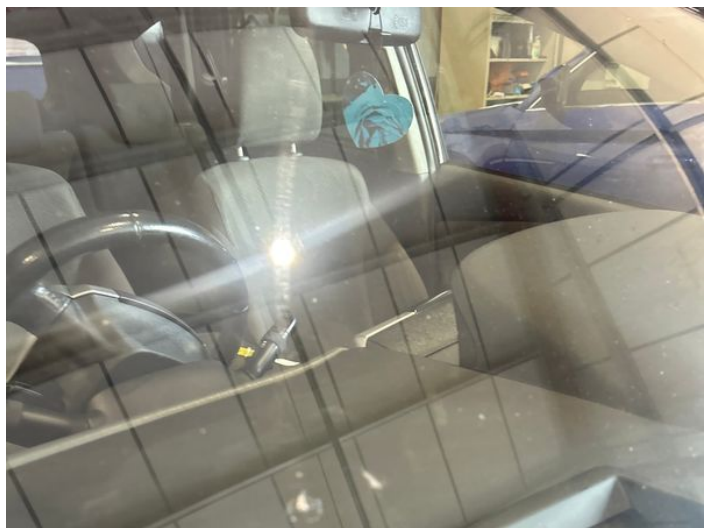
20: Screen Front  
Chipped  
Over 10mm

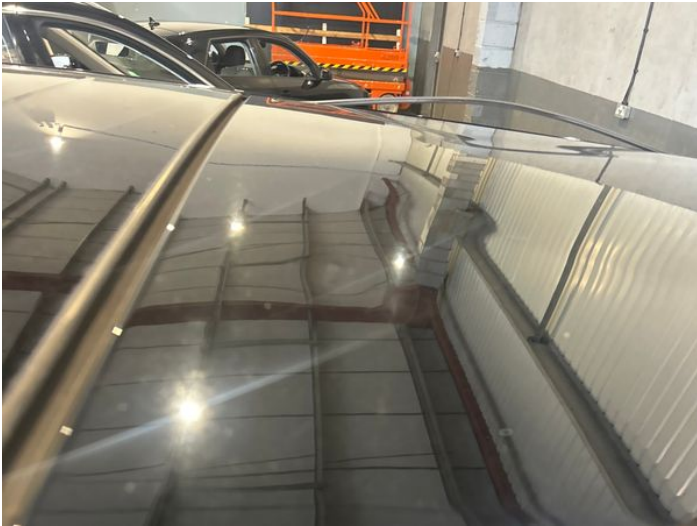
21: Roof  
Dented  
Over 30mm

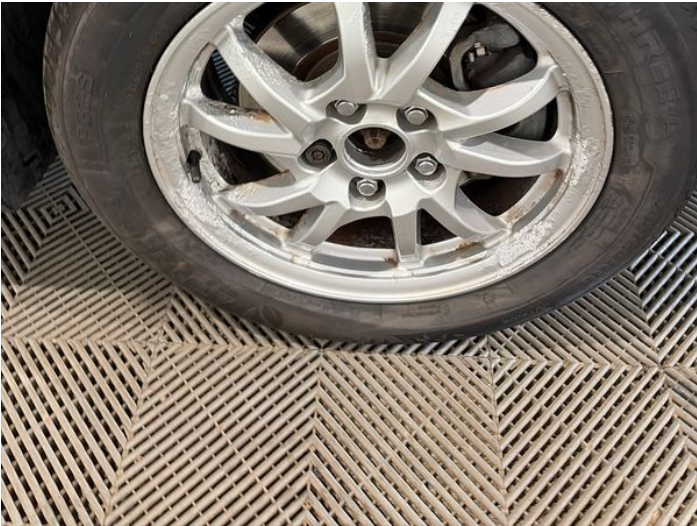
22: Wheel Trim osf  
Missing  
Replace

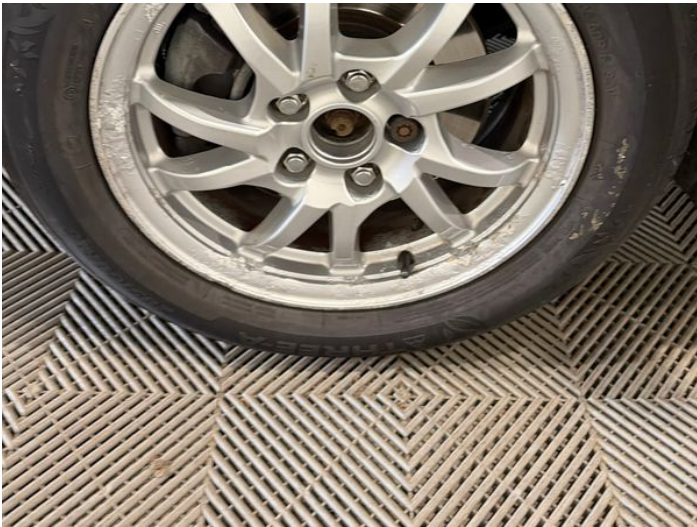
23: Wheel Trim nsf  
Missing  
Replace
