## VEHICLE INSPECTION REPORT

**LK21FGZ**

### Skoda Kodiaq 1.5 TSI SE Drive 5dr DSG [7 Seat]

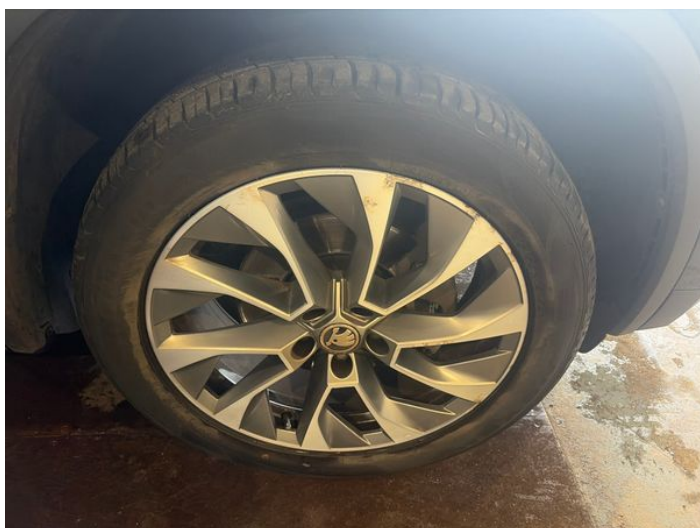
1: Wheel osf  
Corroded  
Light

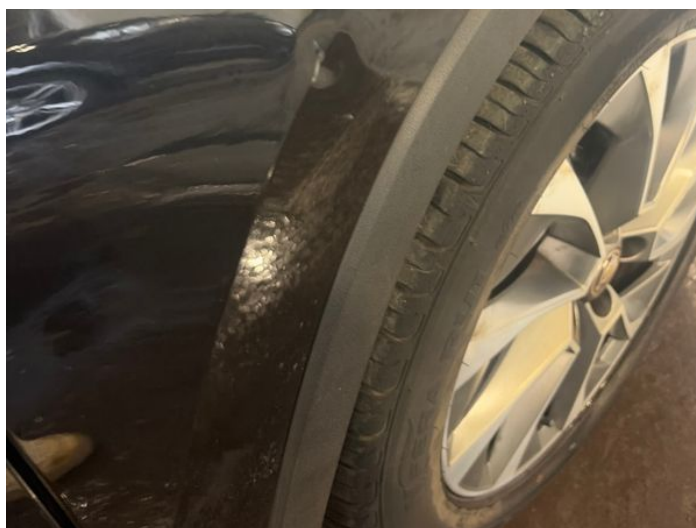
2: Wing osf  
Dented  
With Paint Damage

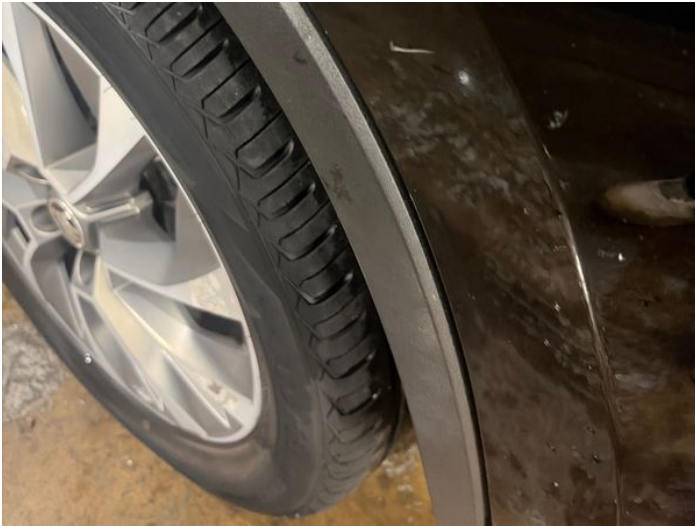
3: Door osr  
 Scratched  
 UpTo 25mm Thru Paint

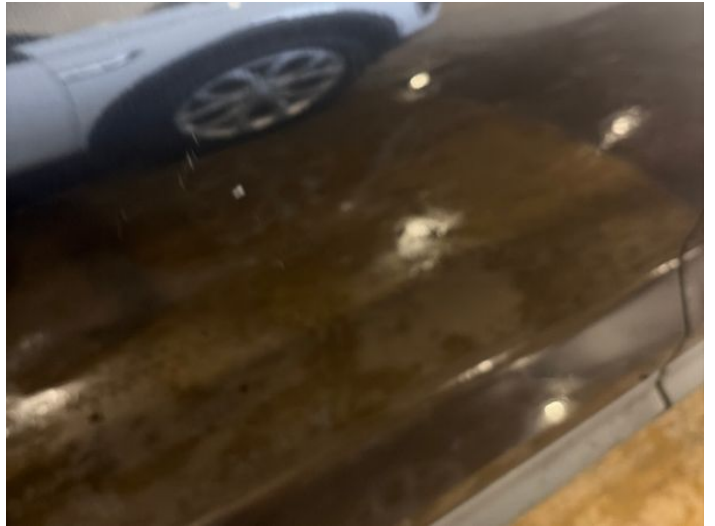
4: Door osr  
 Chipped  
 1 To 5

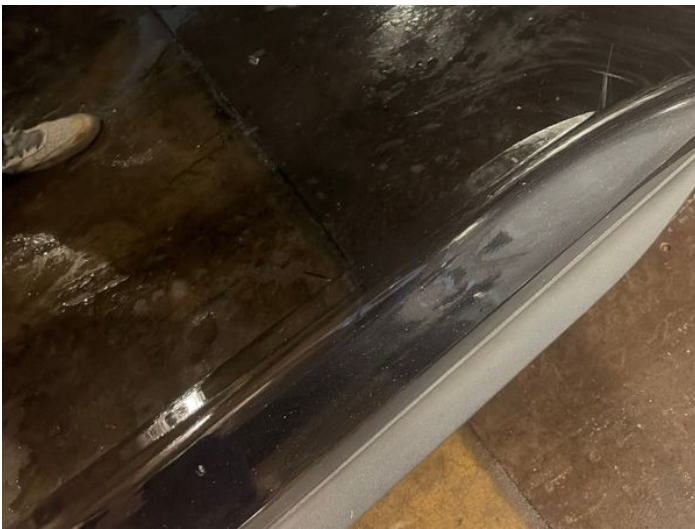
5: Door osf  
 Scratched  
 UpTo 25mm Thru Paint

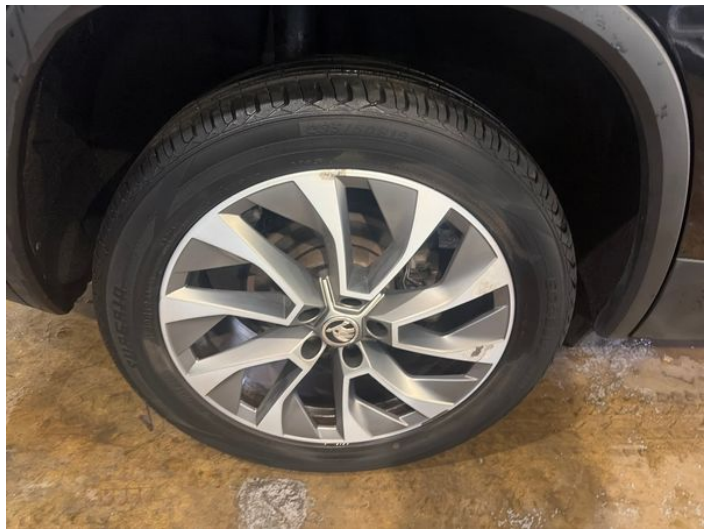
6: Wheel osr  
 Corroded  
 Light

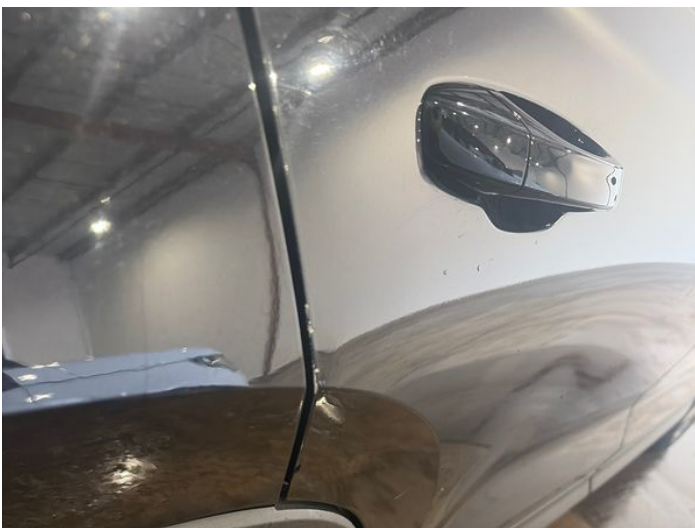
7: Door osr  
 Chipped  
 Edge Chip

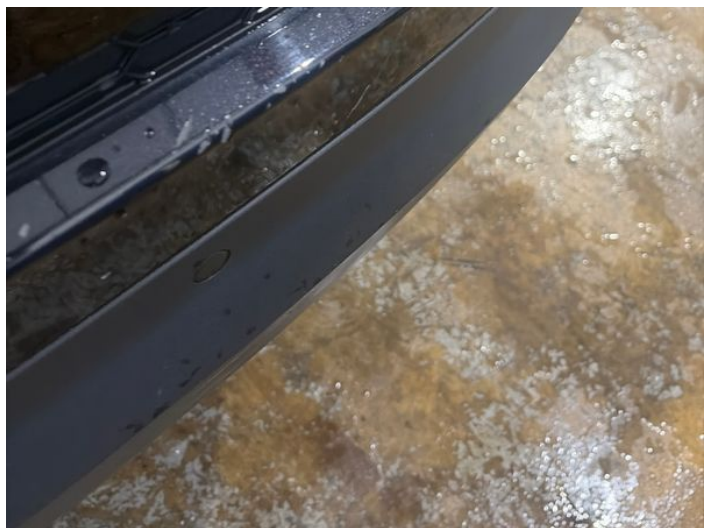
8: Bumper Rear  
 Chipped  
 Multiple Chips

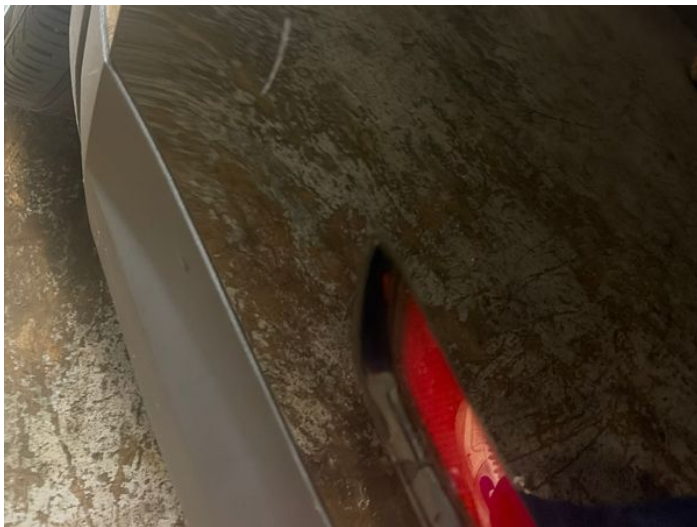
9: Bumper Rear  
Scratched  
Up To 25mm Thru Paint

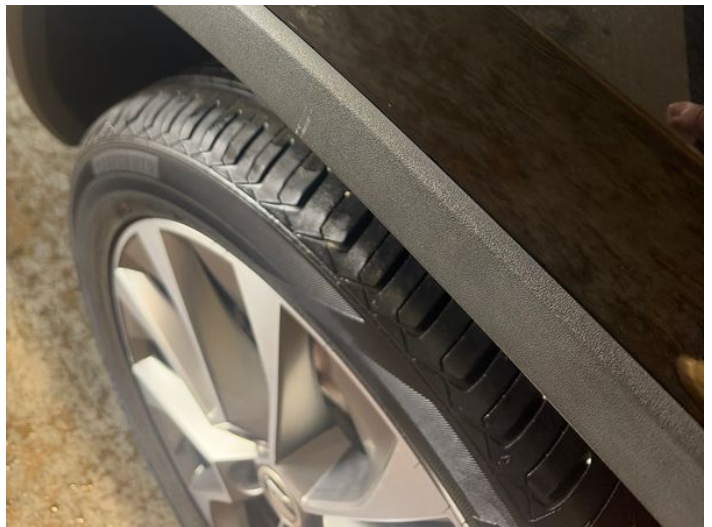
10: Qtr Panel nsr  
Chipped  
1 To 5

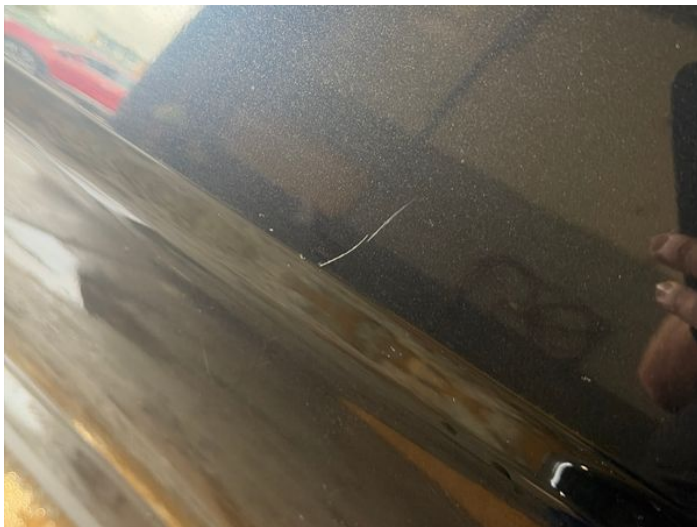
11: Door nsr  
Scratched  
Up To 25mm Thru Paint

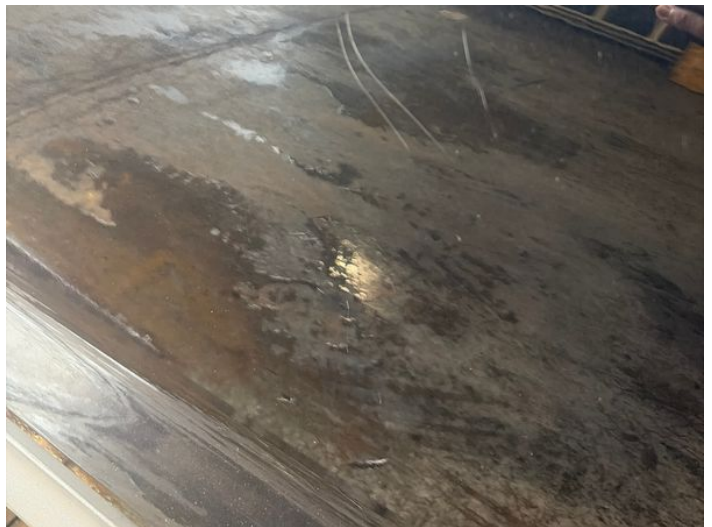
12: Door nsf  
Scratched  
Over 25mm Thru Paint

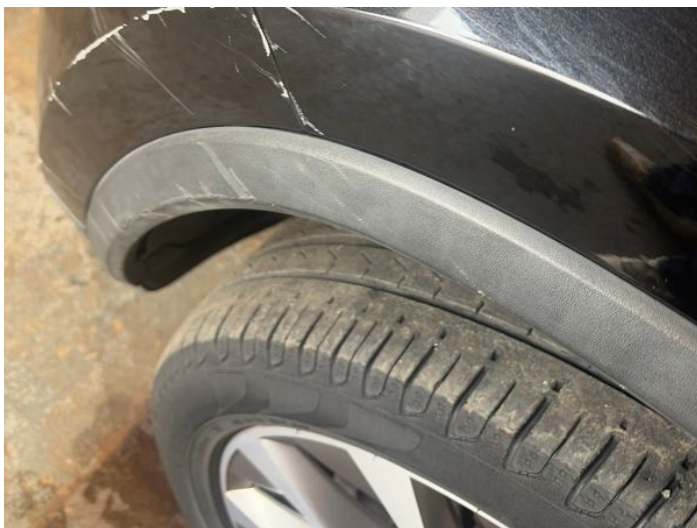
13: Wing nsf  
Scratched  
Over 25mm Thru Paint

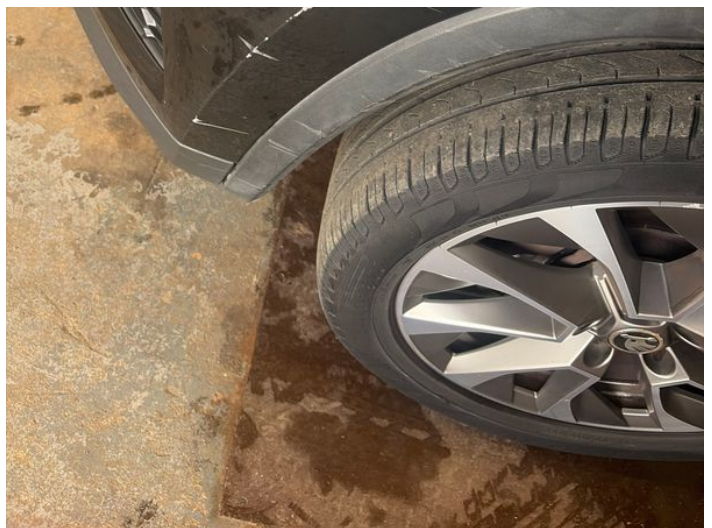
14: Bumper Front  
Scratched  
25 to 100mm Thru Paint

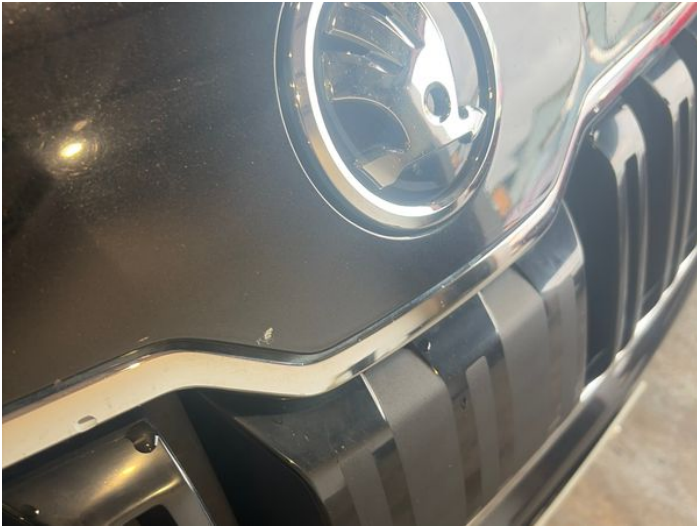
15: Bonnet  
Chipped  
1 To 5

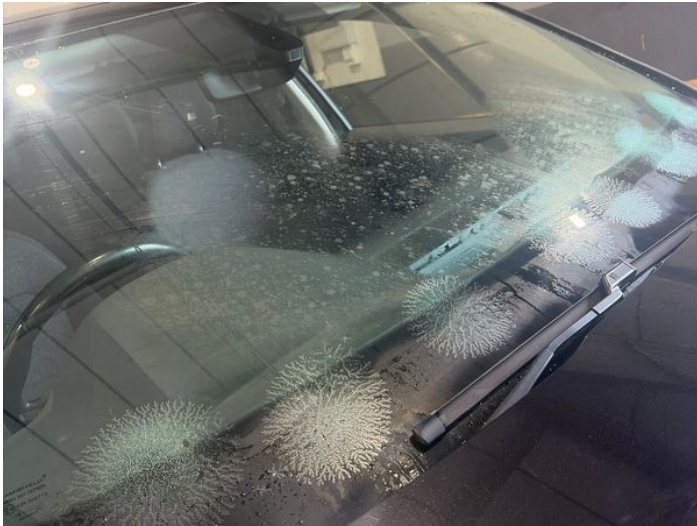
16: Screen Front  
Cracked  
Replace

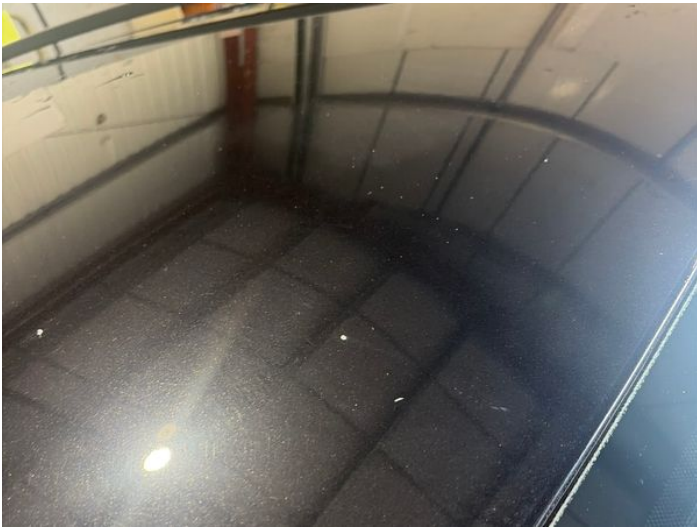
17: Roof  
Chipped  
1 To 5

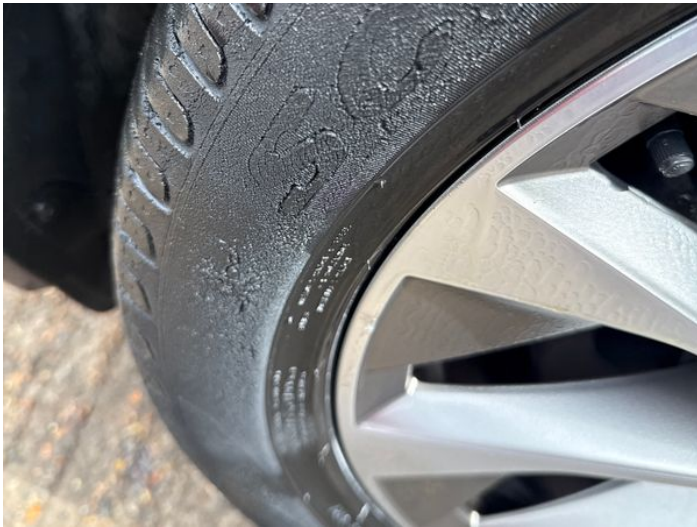
18: Tyre nsf  
Damaged  
Replace
