# VEHICLE INSPECTION REPORT

**GK16XRM**

## Ford Ecosport 1.5 TDCi 95 Titanium 5dr [17in]

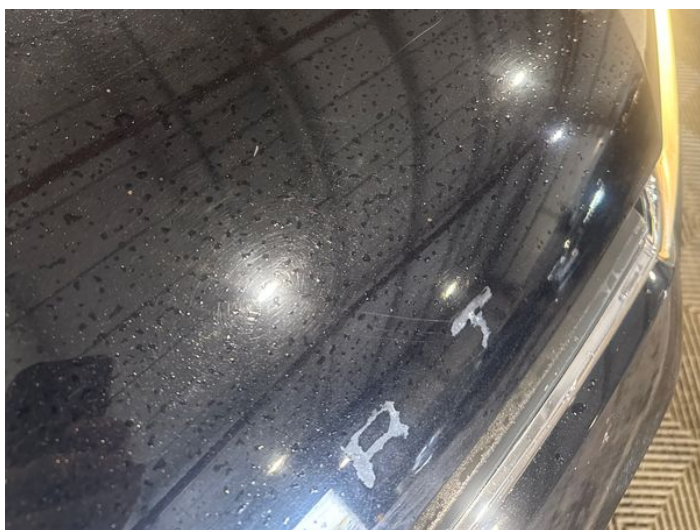
1: Bonnet  
Scratched  
Over 25mm Thru Paint

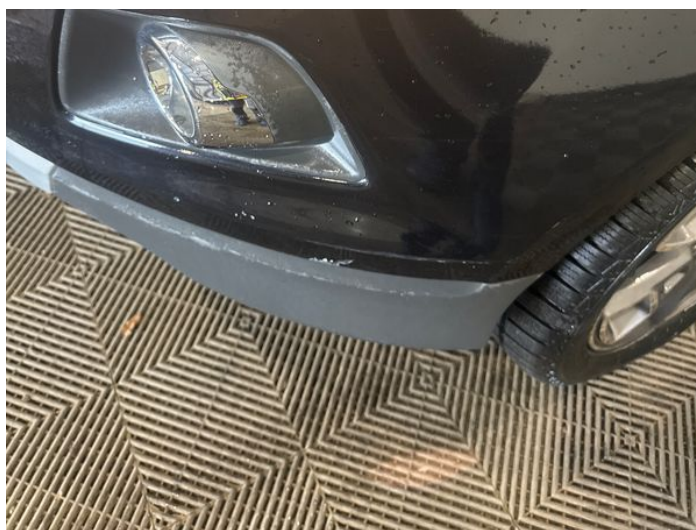
2: Bumper Front  
Scratched  
Over 100mm Thru Paint

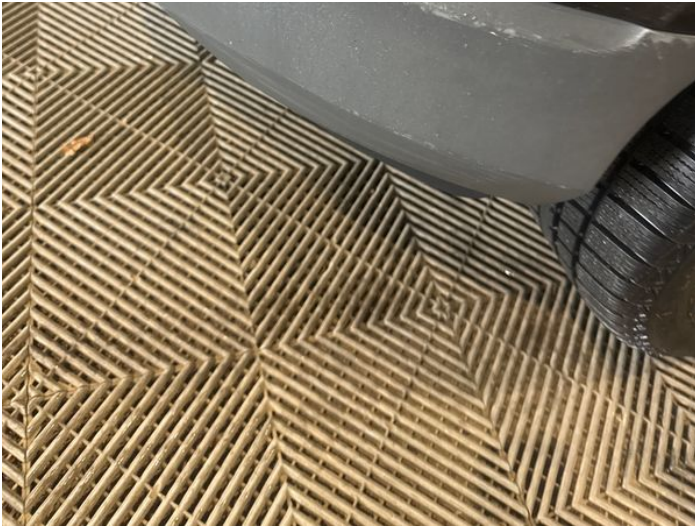
3: Bumper Front Moulding  
Scuffed (Unpainted)  
Over 100mm

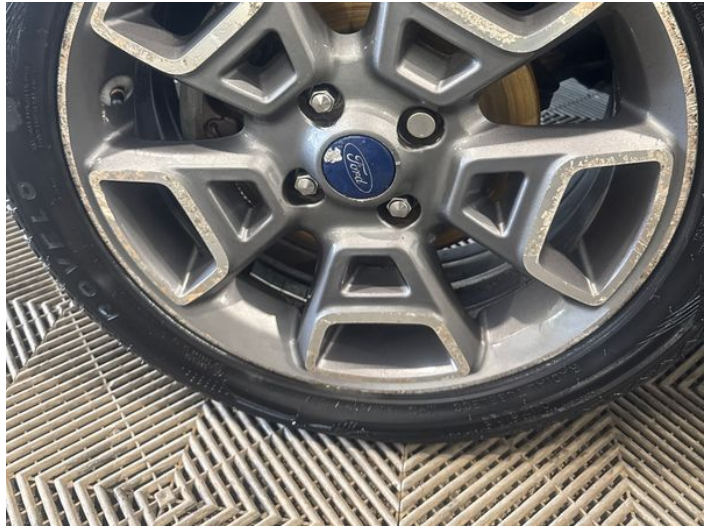
4: Wheel nsf  
Scratched  
Over 50mm

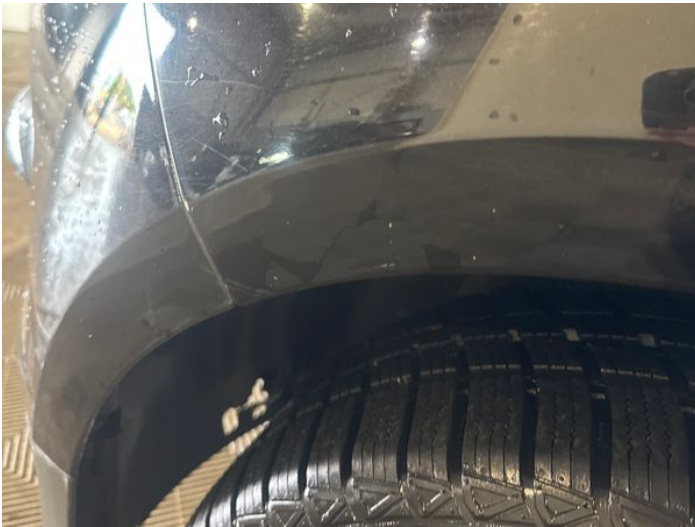
5: Wing nsf  
Scratched  
UpTo 25mm Thru Paint

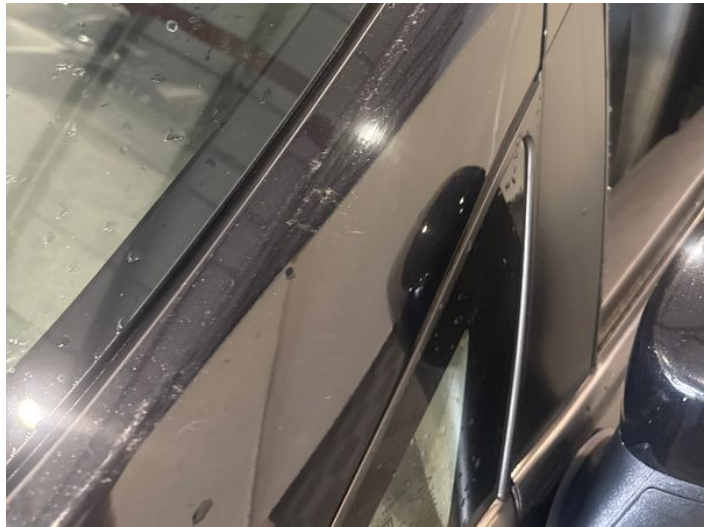
6: A Post ns  
Scratched  
Over 25mm Thru Paint

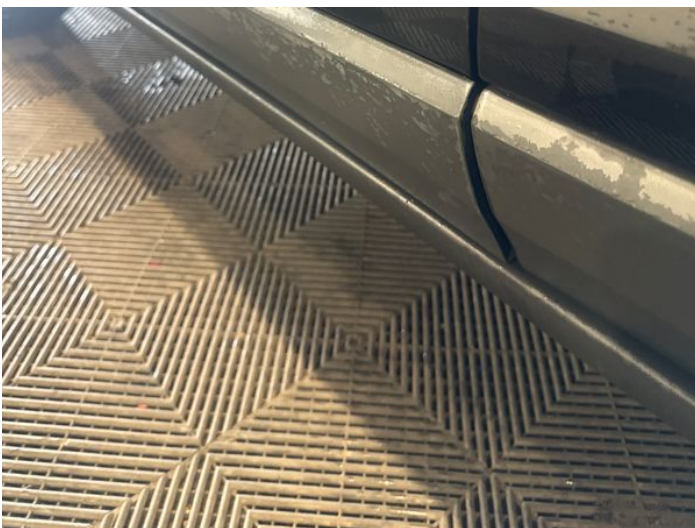
7: Door nsf  
Chipped  
1 To 5

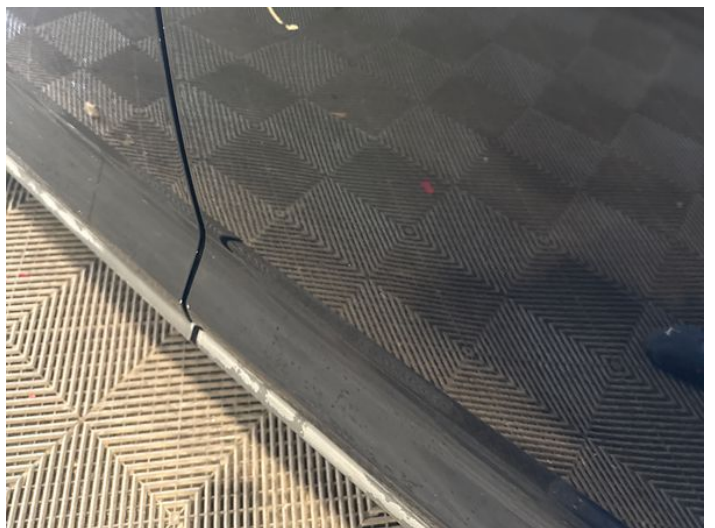
8: Door nsr  
Dented  
Between 10mm + 30mm

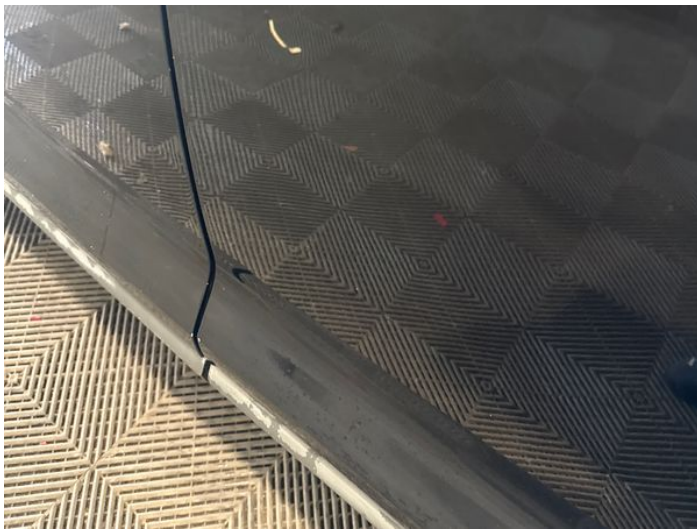
9: Door nsr  
Scratched  
UpTo 25mm Thru Paint

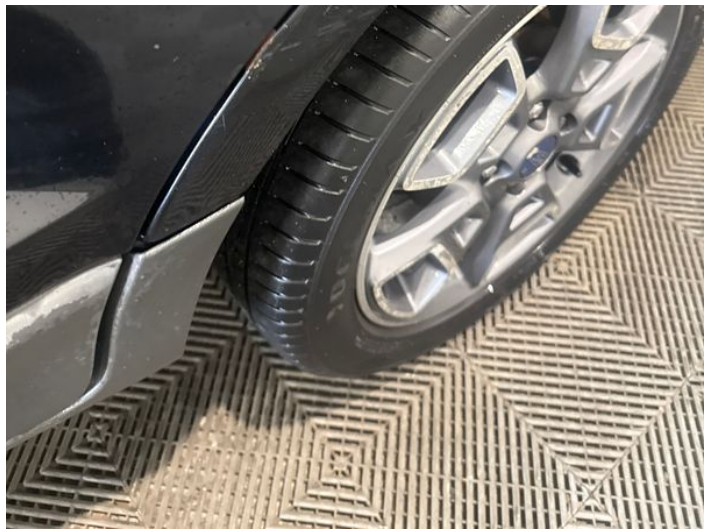
10: Qtr Panel nsr  
Dented  
With Paint Damage

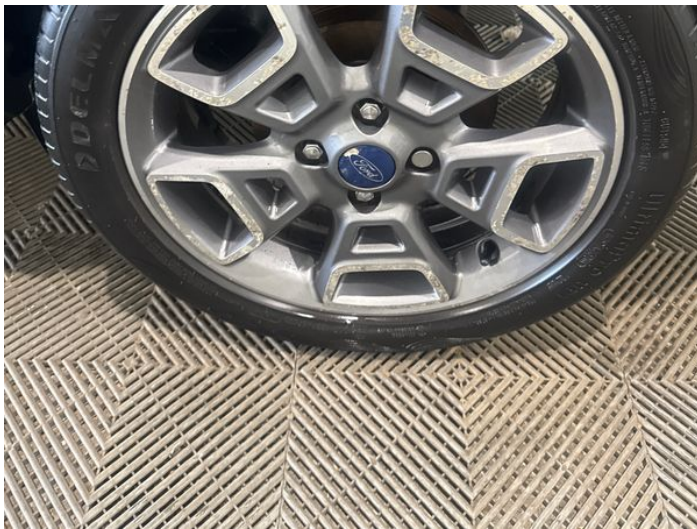
11: Wheel nsr  
Scratched  
Over 50mm

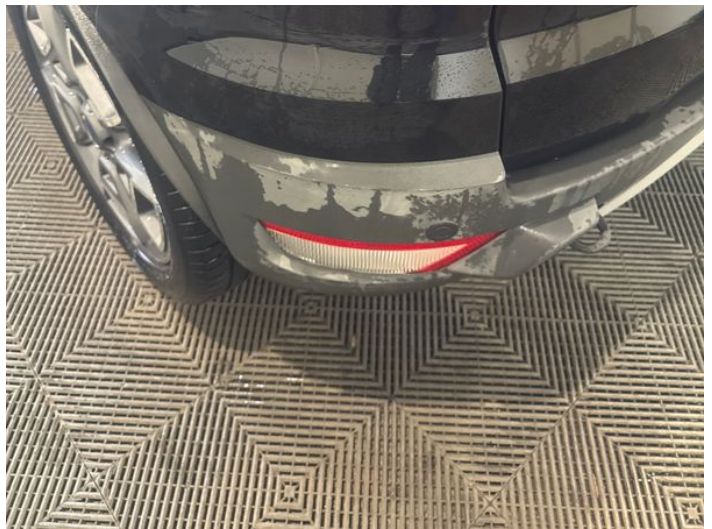
12: Bumper Rear  
Scratched  
25 to 100mm Thru Paint

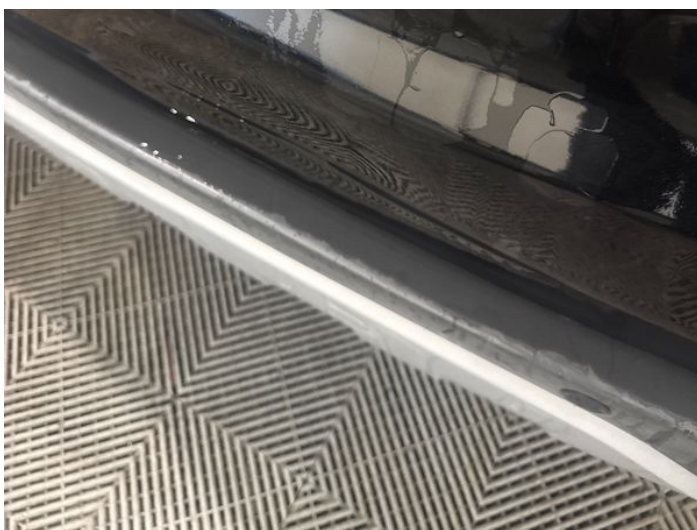
13: Tailgate  
Scratched  
Over 25mm Thru Paint

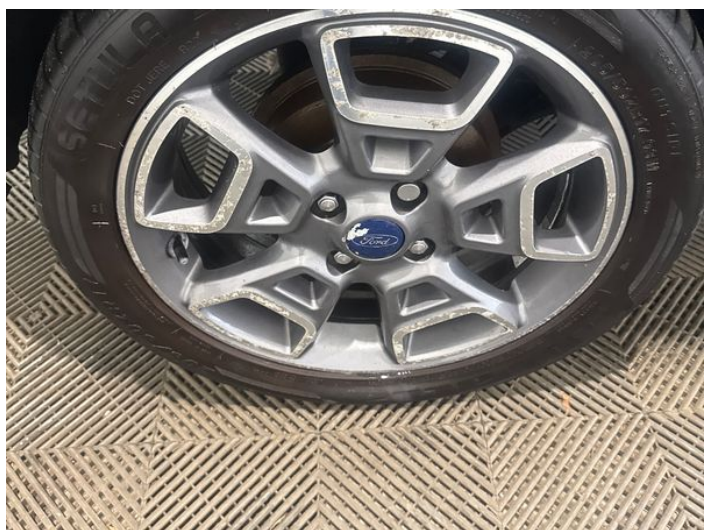
14: Wheel osr  
Scratched  
Over 50mm

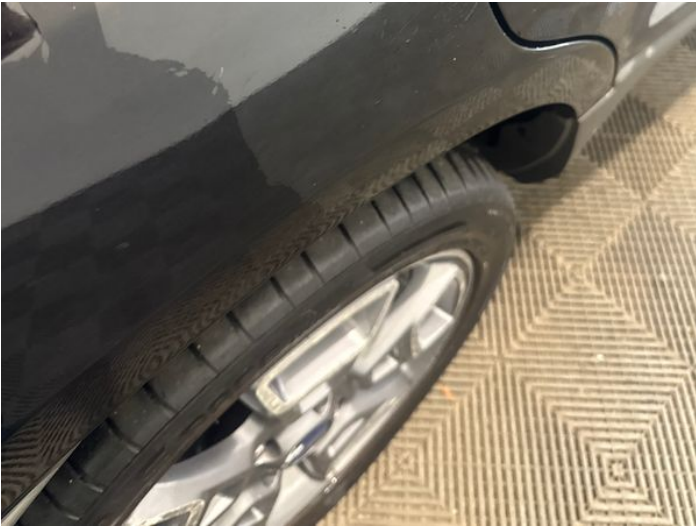
15: Qtr Panel osr  
Chipped  
1 To 5

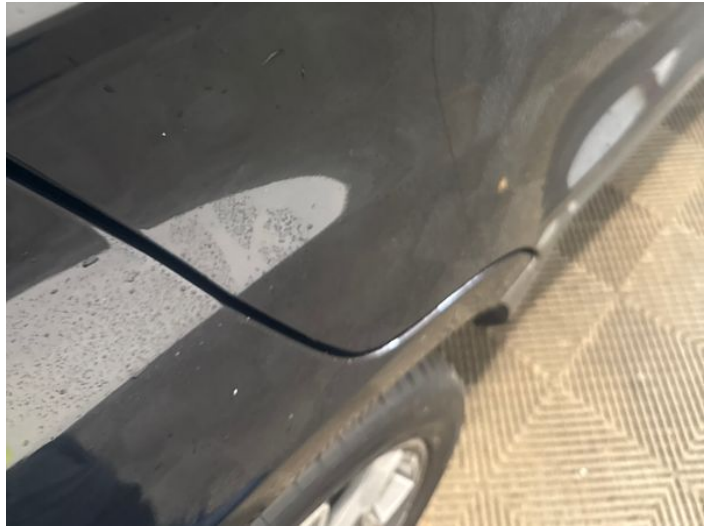
16: Door osr  
Chipped  
1 To 5

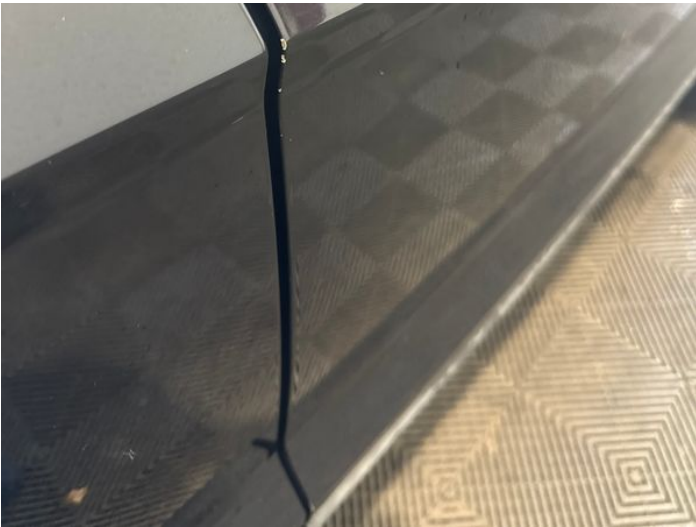
17: Door osf  
Scratched  
UpTo 25mm Thru Paint

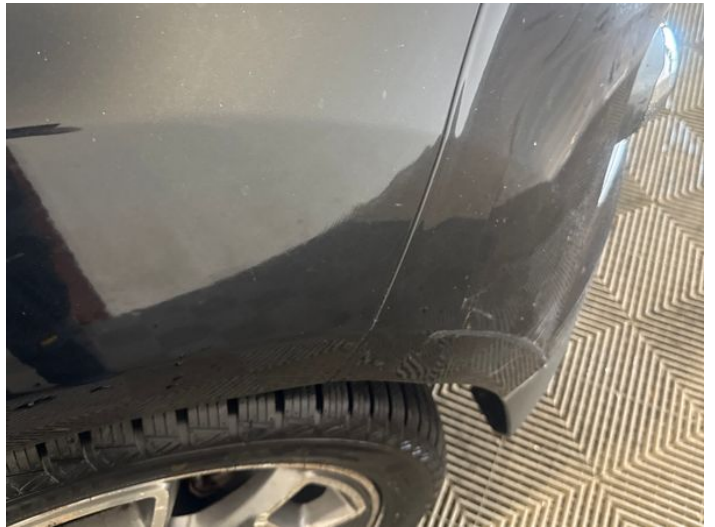
18: Wing osf  
Chipped  
1 To 5

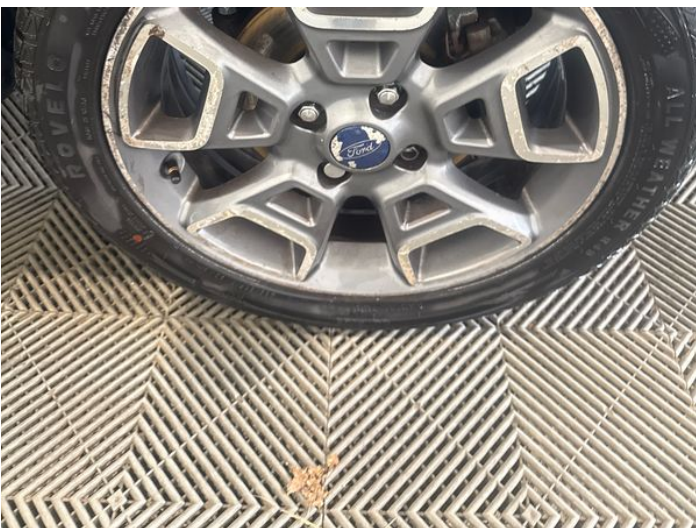
19: Wheel osf  
Scratched  
Over 50mm

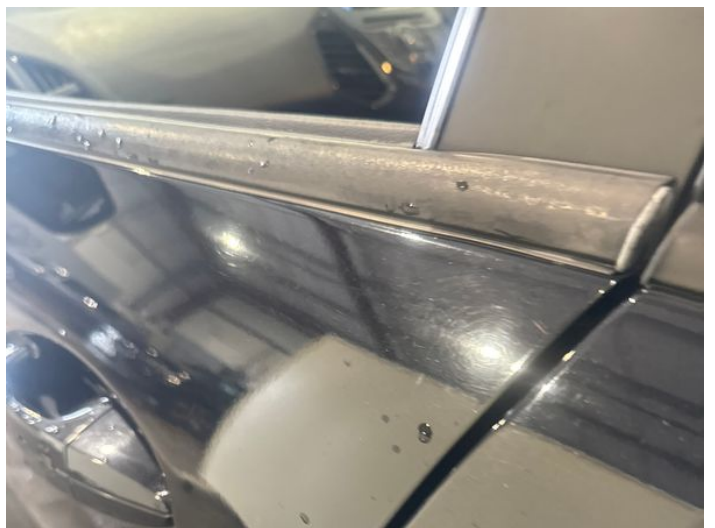
20: Door nsf  
Dented  
Between 10mm + 30mm
