VEHICLE INSPECTION REPORT

OU67YSJ

Fiat 500 1.2 Pop 3dr

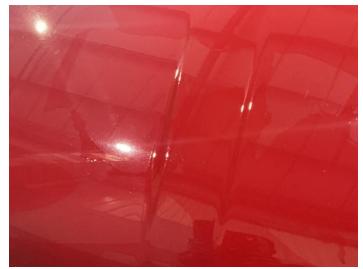
1: Bonnet Chipped 1 To 5

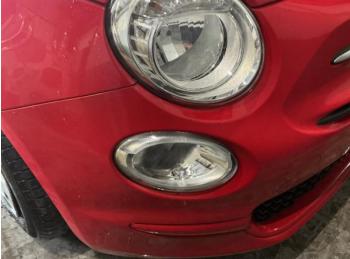
2: Bumper Front Scratched 25 to 100mm Thru Paint

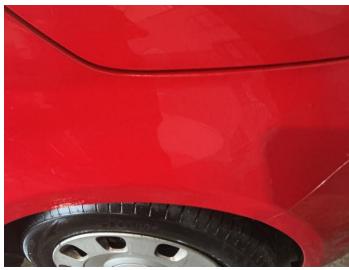
4: Wing osf Scratched UpTo 25mm Thru Paint

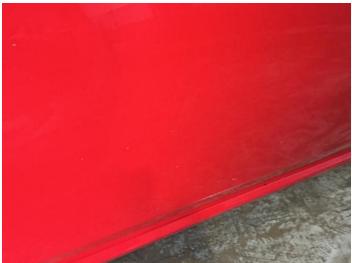
6: Door osf Chipped 1 To 5

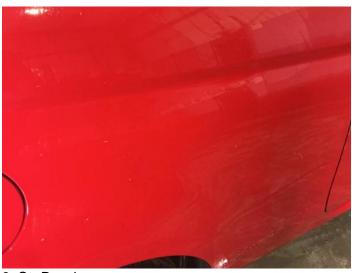
8: Qtr Panel osr Chipped 1 To 5

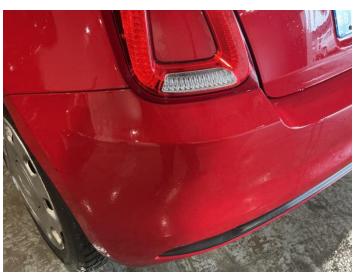
10: Bumper RearScratched25 to 100mm Thru Paint

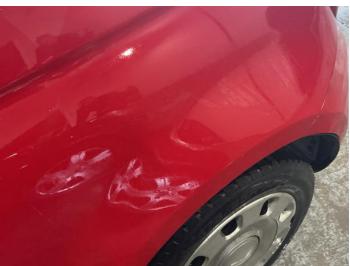
13: Qtr Panel nsr Dented Over 2 UpTo 10mm

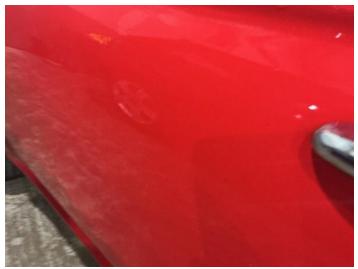
15: Door nsfChipped1 To 5

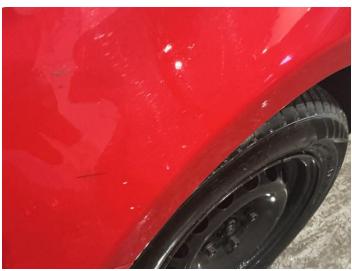
16: Wing nsf Scratched Over 25mm Thru Paint
