# VEHICLE INSPECTION REPORT

**GD64LZK**

## Lexus CT 200h 1.8 Luxury 5dr CVT Auto

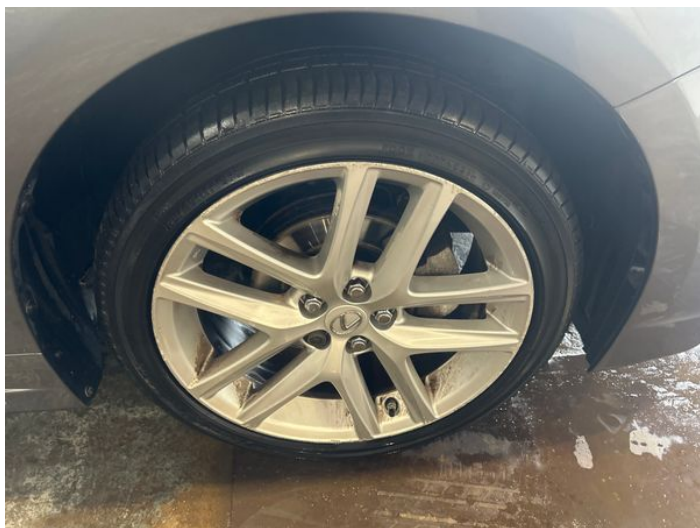
1: Wheel osf  
Scratched  
Over 50mm

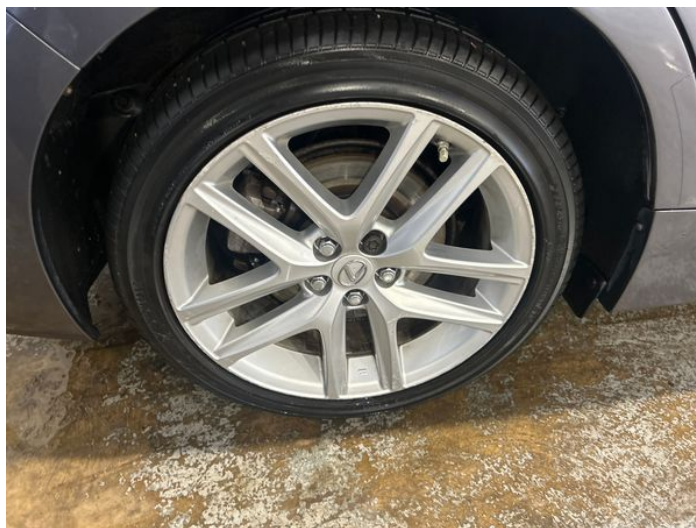
2: Wheel osr  
Scratched  
Over 50mm

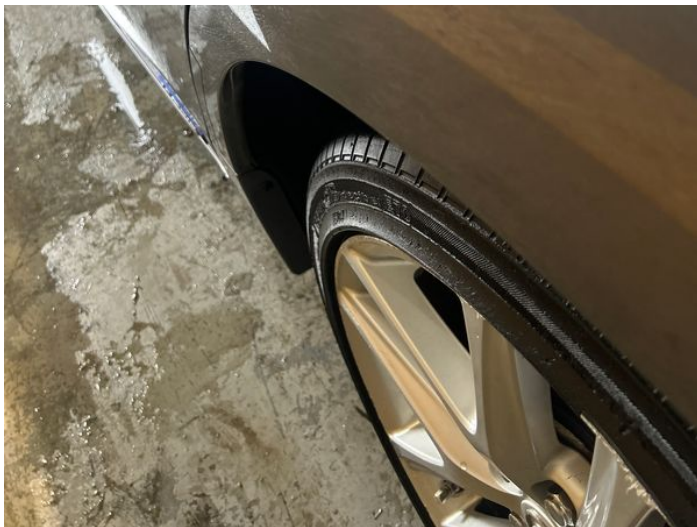
3: Qtr Panel nsr  
Dented  
Between 10mm + 30mm

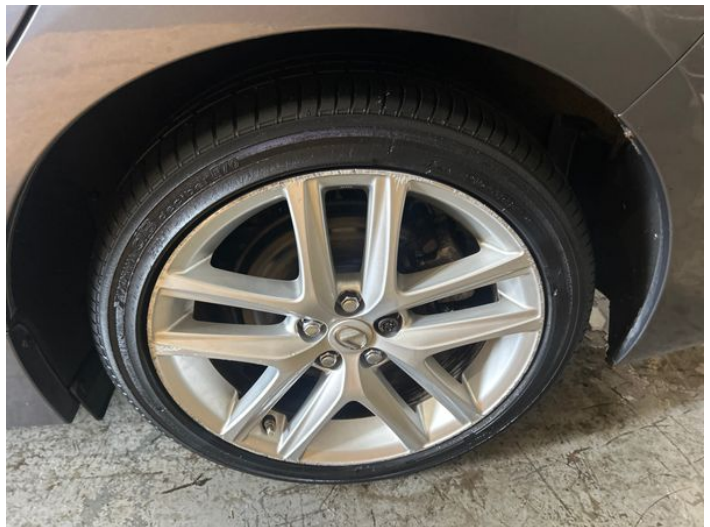
4: Wheel nsr  
Scratched  
Over 50mm

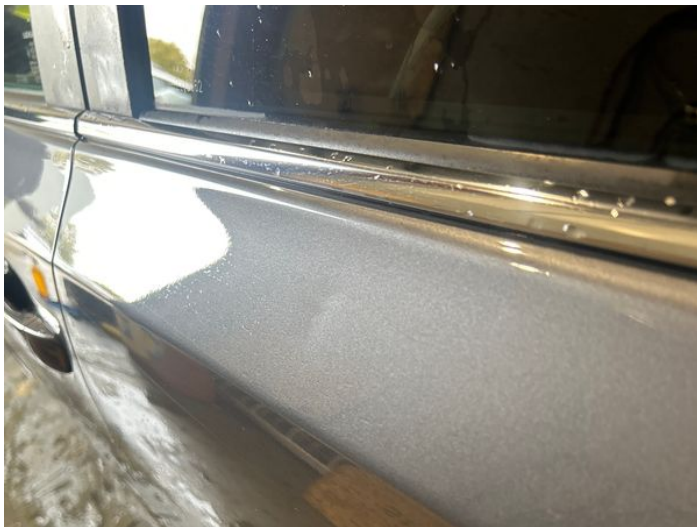
5: Door nsr  
Dented  
Between 10mm + 30mm

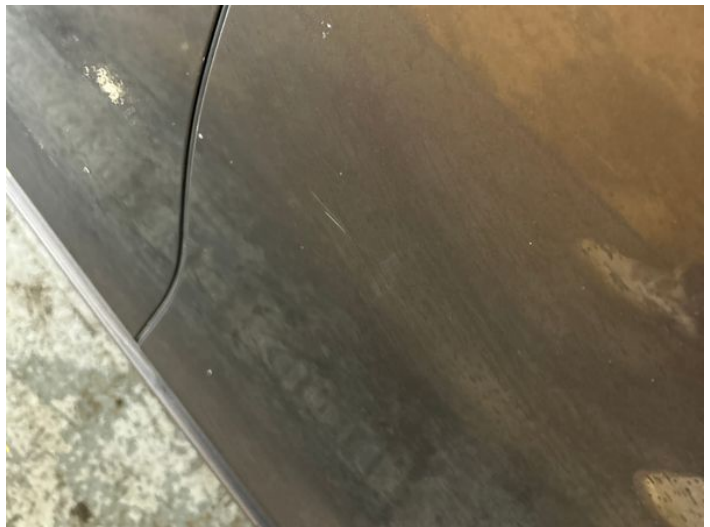
6: Door nsr  
Chipped  
1 To 5

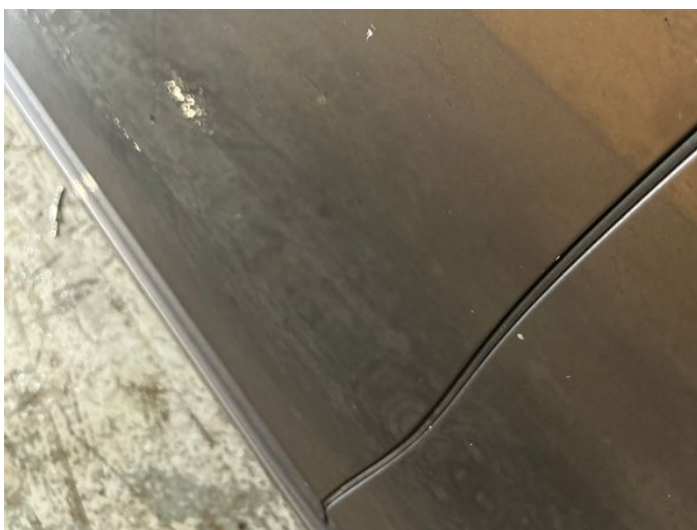
7: Door nsf  
Chipped  
1 To 5

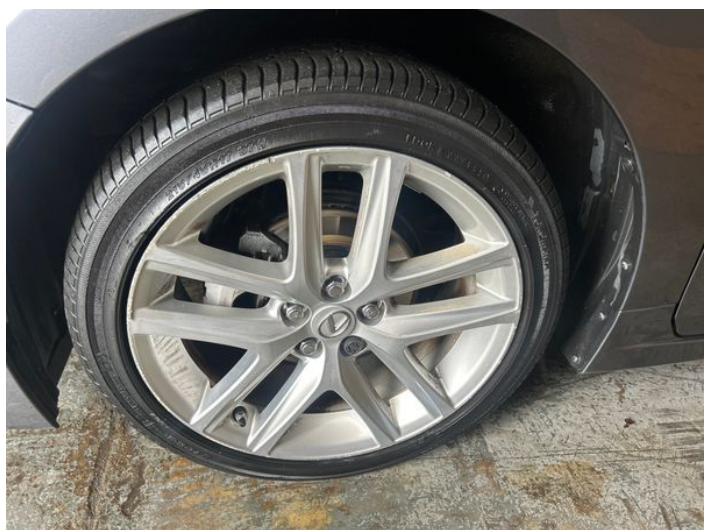
8: Wheel nsf  
Scratched  
Over 50mm

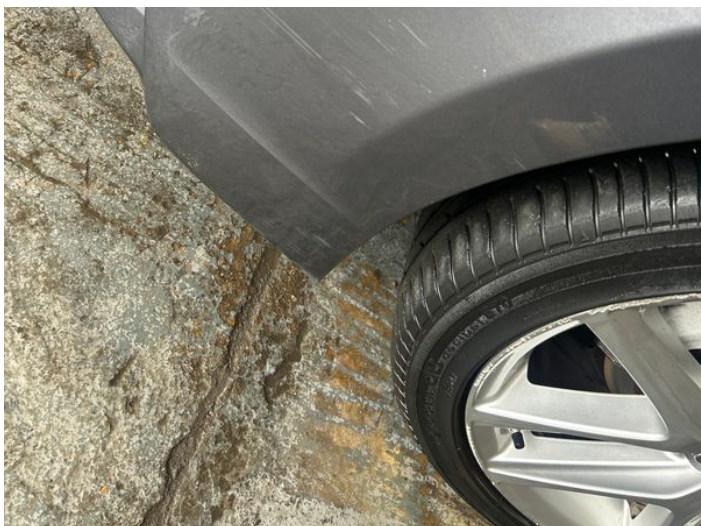
9: Bumper Front  
Scratched  
Over 100mm Thru Paint

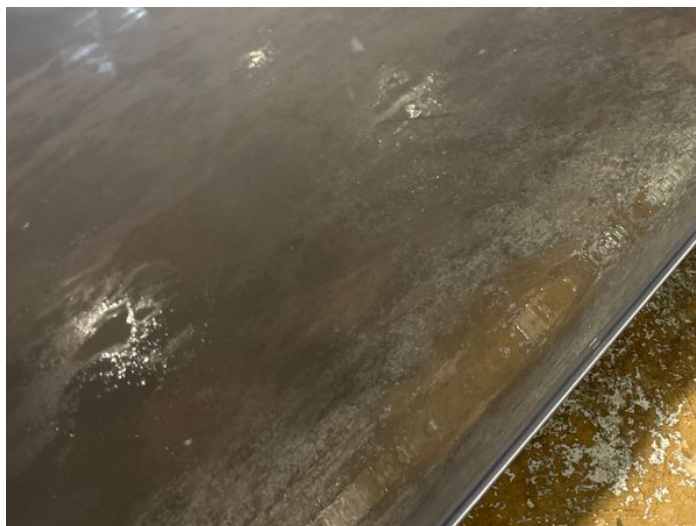
10: Door osf  
Chipped  
1 To 5

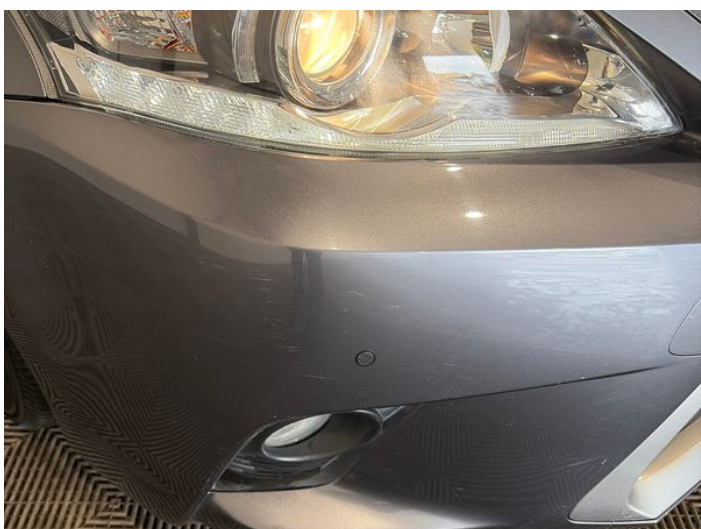
11: Bumper Front  
Scratched  
25 to 100mm Thru Paint

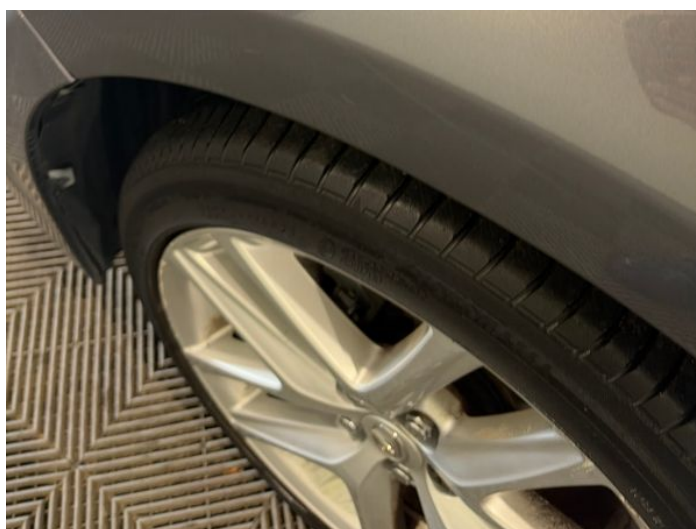
12: Wing nsf  
Scratched  
Over 25mm Thru Paint

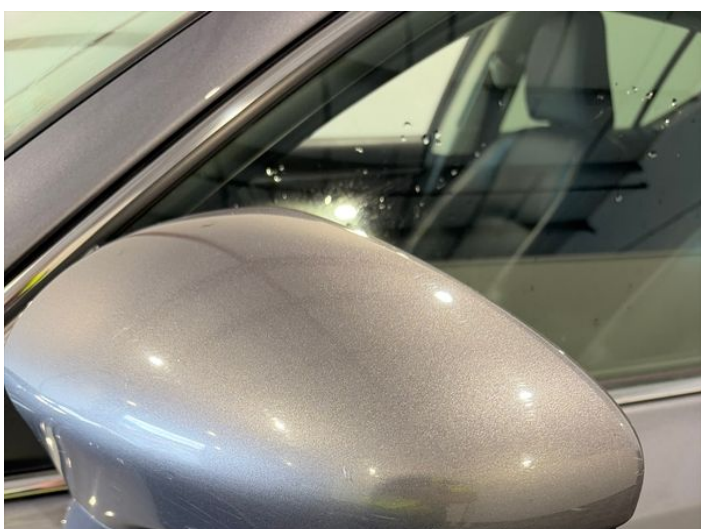
13: Door Mirror Assy nsf  
Scratched (Painted)  
Over 25mm Thru Paint

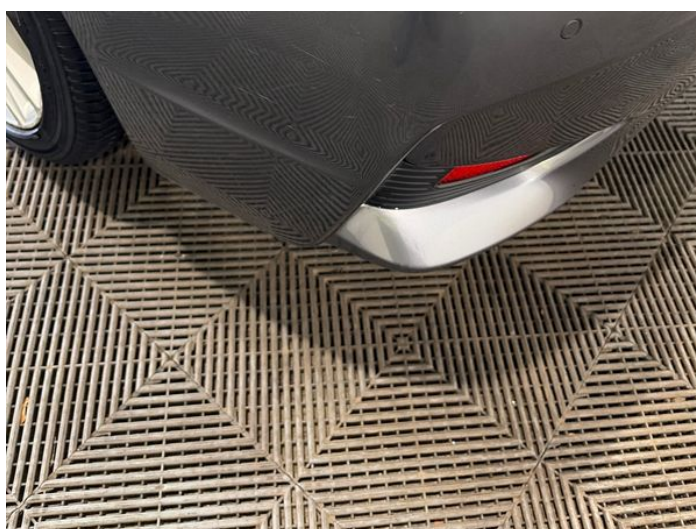
14: Bumper Rear  
Scratched  
25 to 100mm Thru Paint

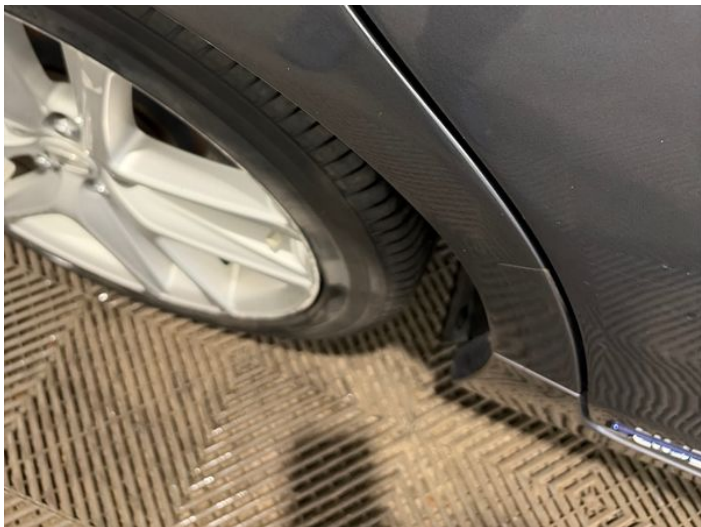
15: Qtr Panel osr  
Chipped  
1 To 5

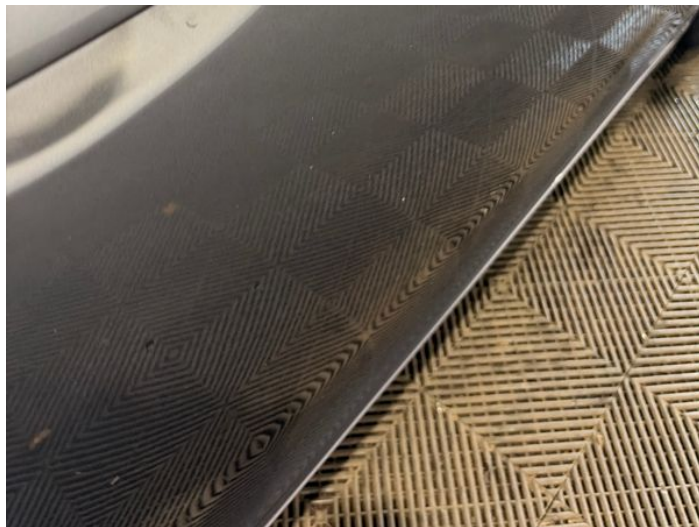
16: Door osf  
Dented  
Between 10mm + 30mm

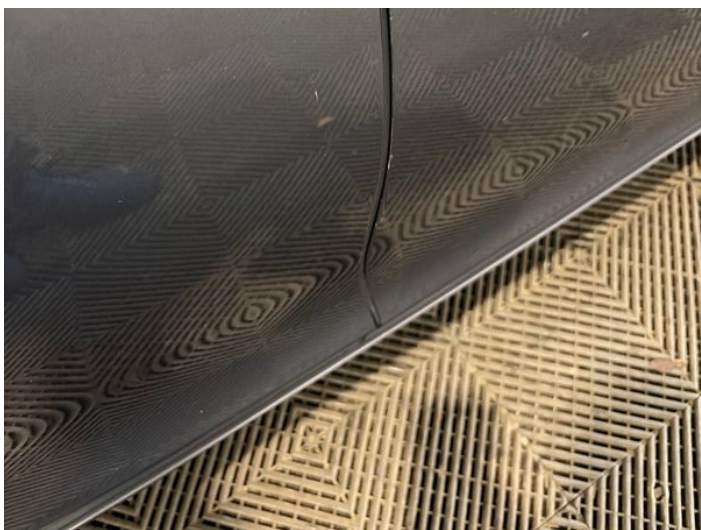
17: Door osr  
Chipped  
1 To 5

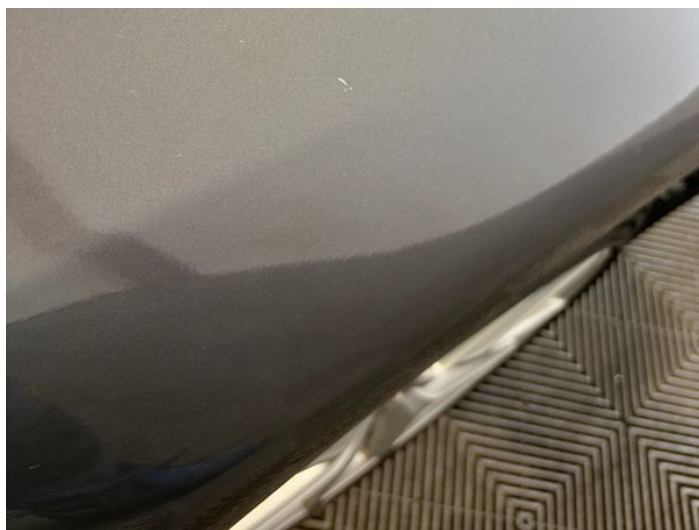
18: Wing osf  
Dented  
2 Or Less UpTo 10mm

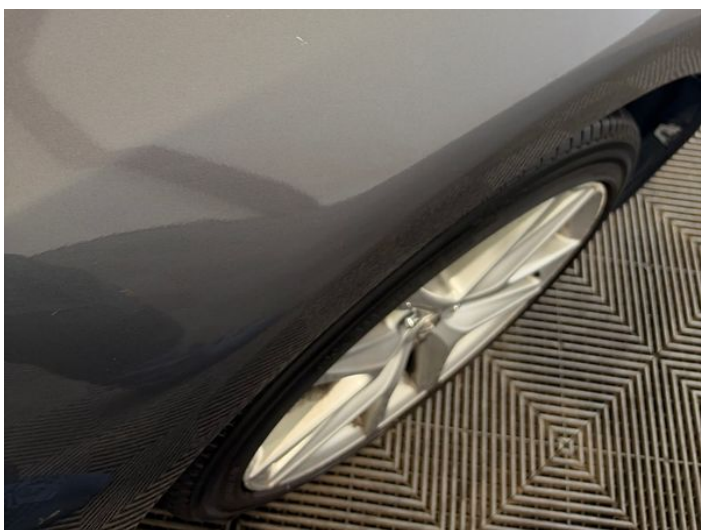
19: Wing osr  
Chipped  
1 To 5

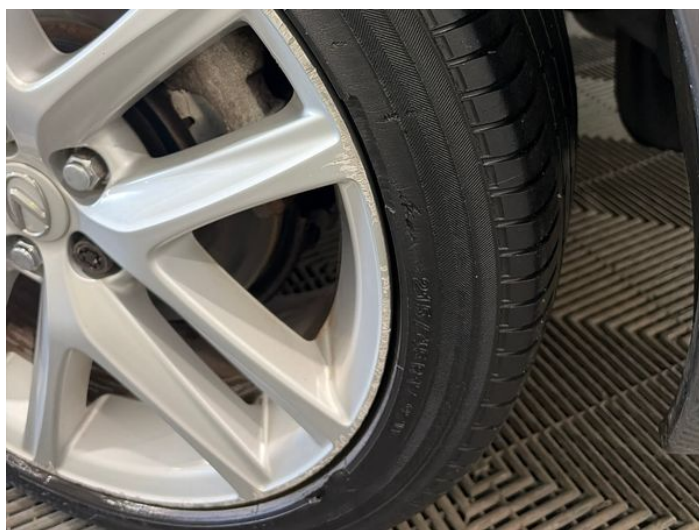
| NSR | YOKOHAMA | Damaged |

20: Tyre nsr  
Damaged  
Replace

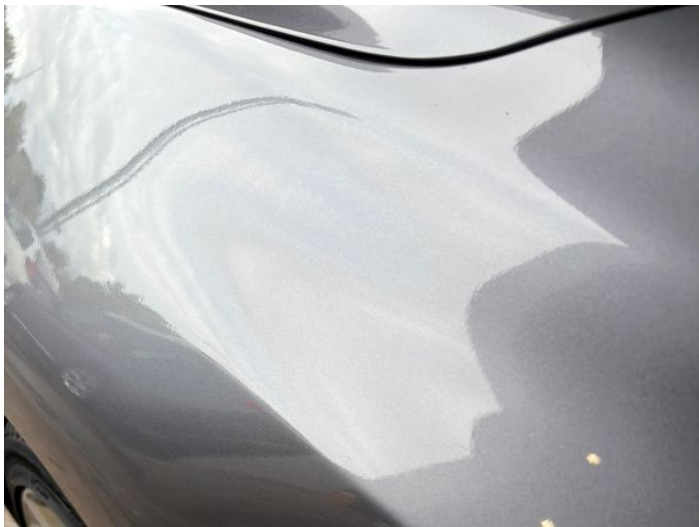
21: Wing nsf  
Dented  
Between 10mm + 30mm
