# VEHICLE INSPECTION REPORT

**GY10AAU**

## Volkswagen Touran 1.9 TDI Match 5dr

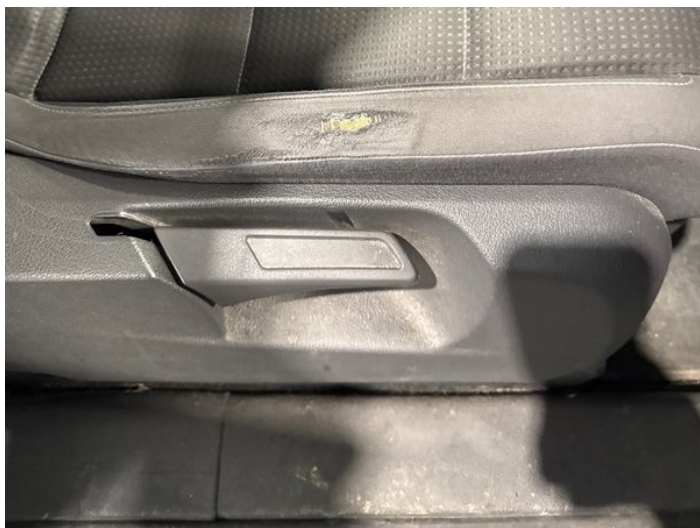
1: Seat Base Cover osf  
Scuffed  
Over 25mm

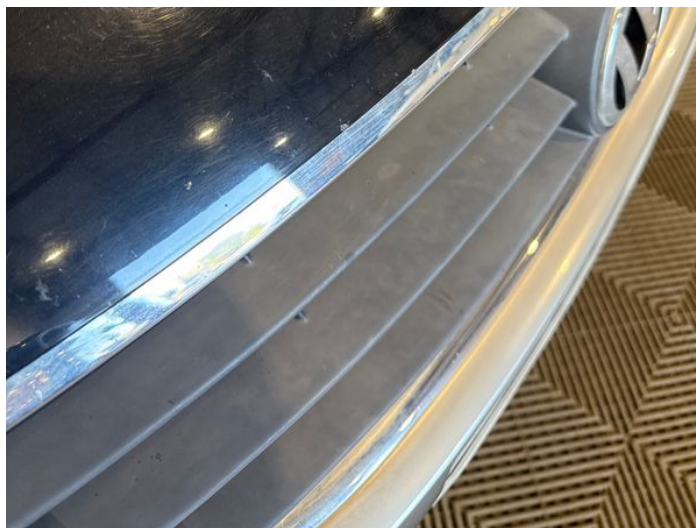
2: Bonnet  
Chipped  
Multiple Chips

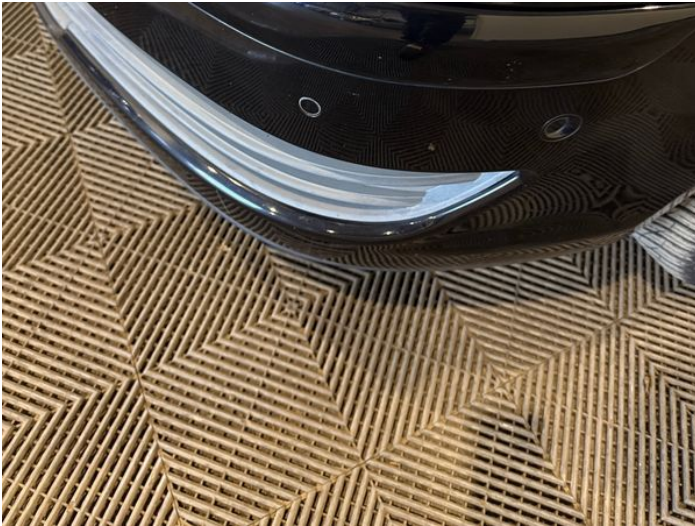
3: Bumper Front  
Chipped  
1 To 5

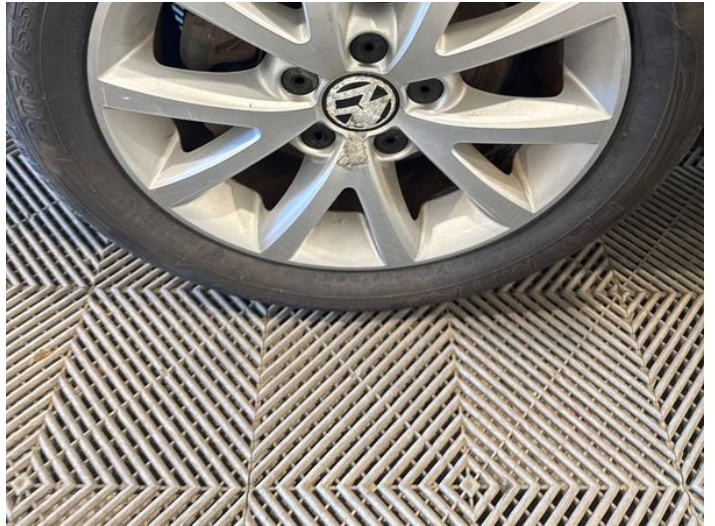
4: Wheel nsf  
Scratched  
Over 50mm

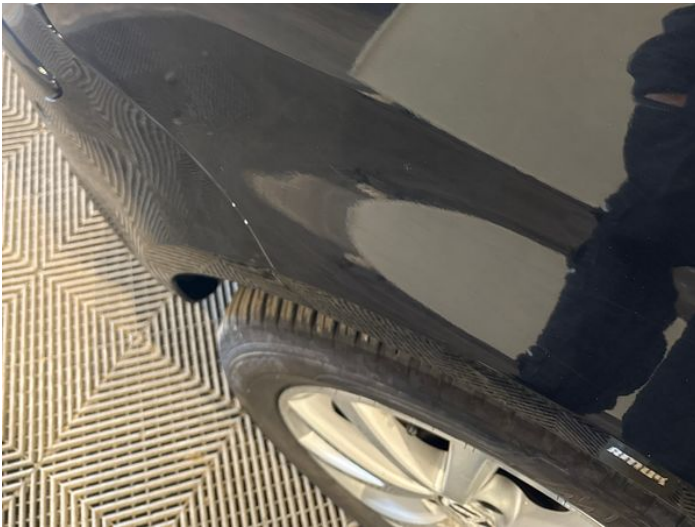
5: Wing nsf  
Chipped  
1 To 5

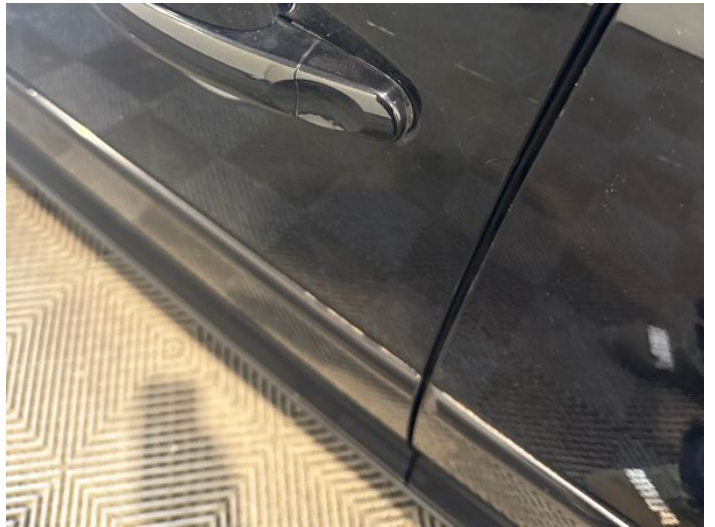
6: Door nsf  
Scratched  
UpTo 25mm Thru Paint

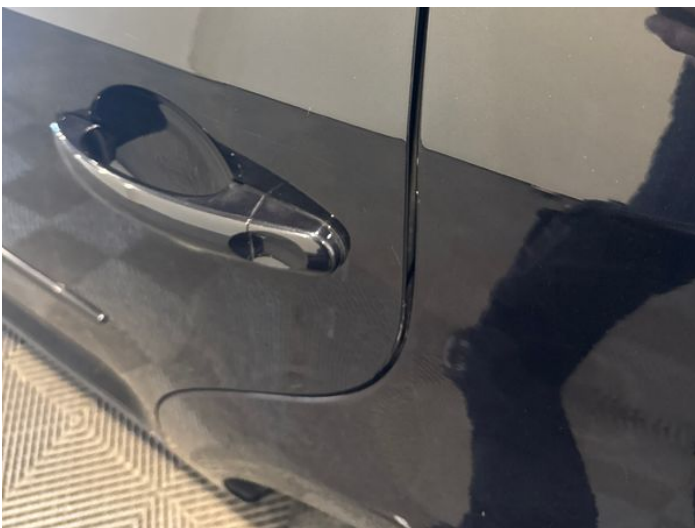
7: Door osr  
Chipped  
Edge Chip

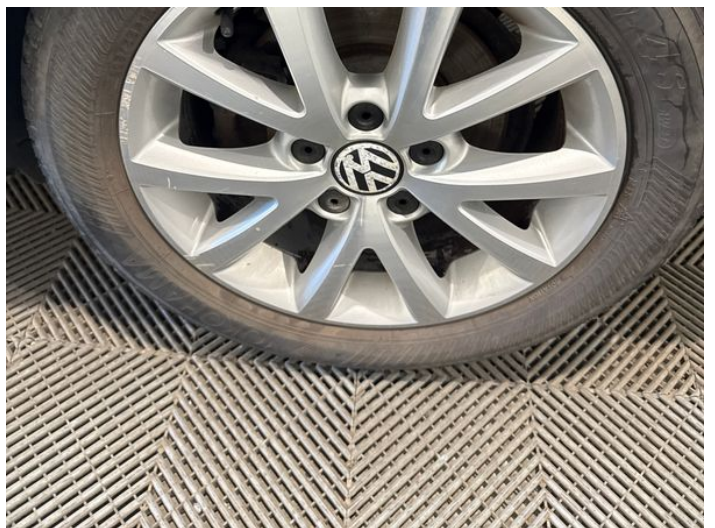
8: Wheel nsr  
Scratched  
Over 50mm

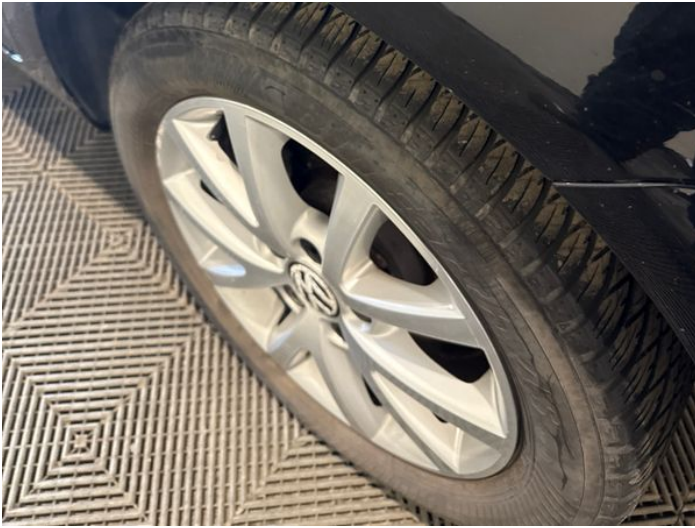
9: Qtr Panel nsr  
Scratched  
Over 25mm Thru Paint

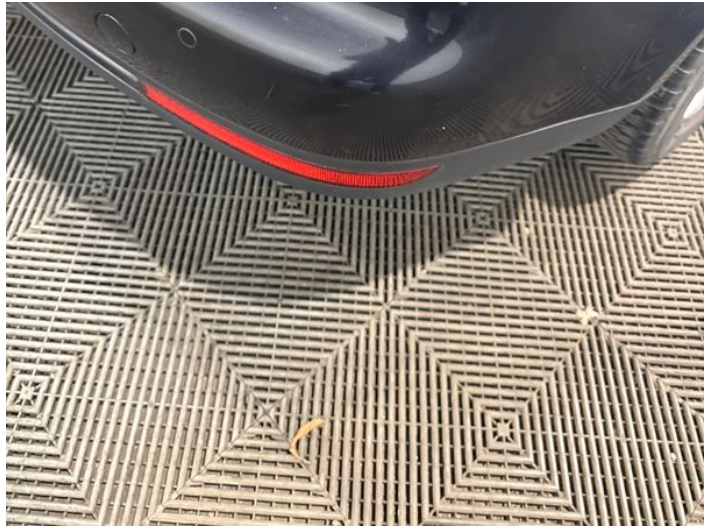
10: Bumper Rear  
Poor Previous Repair  
Poor Paint

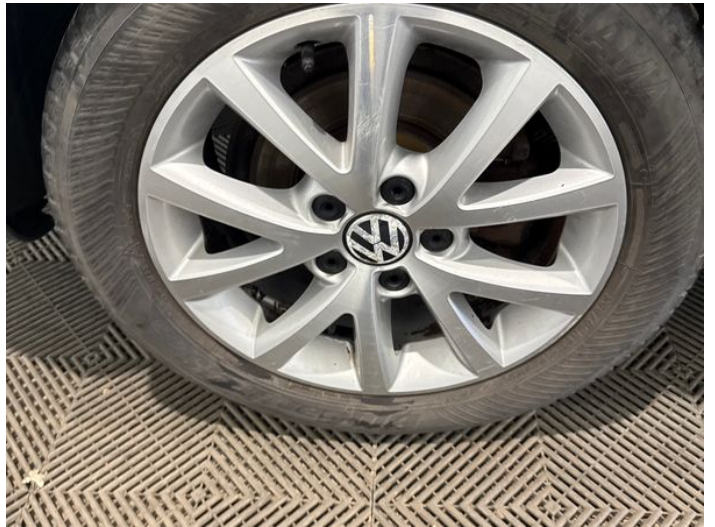
12: Wheel osr  
Scratched  
Over 50mm

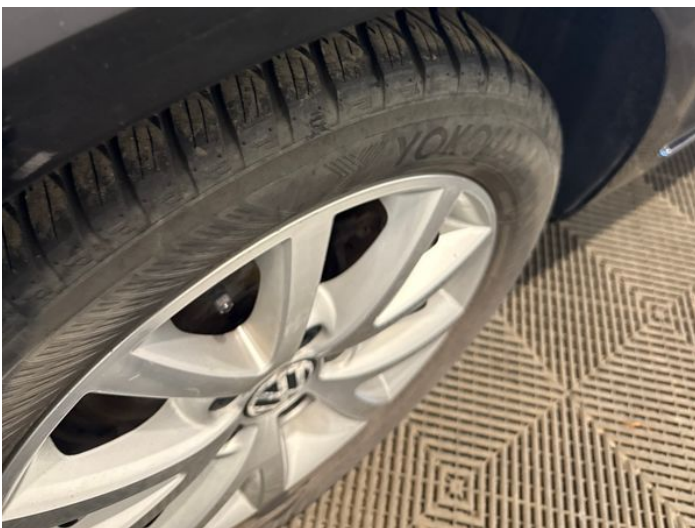
13: Qtr Panel osr  
Scratched  
Over 25mm Thru Paint

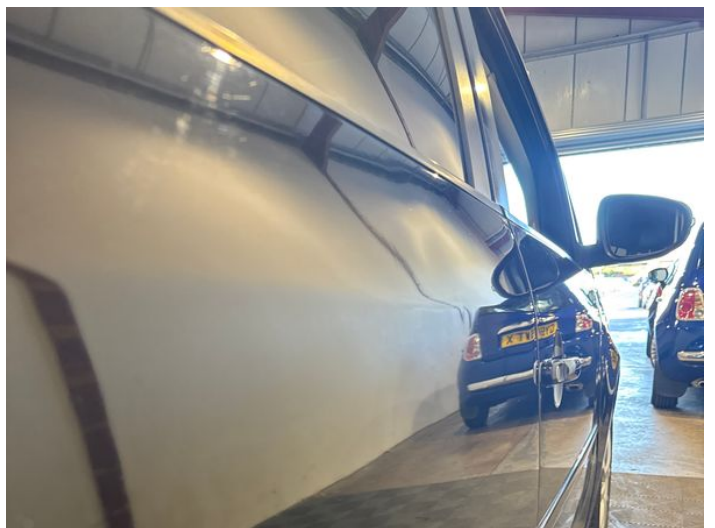
14: Door osr  
Dented  
Over 30mm

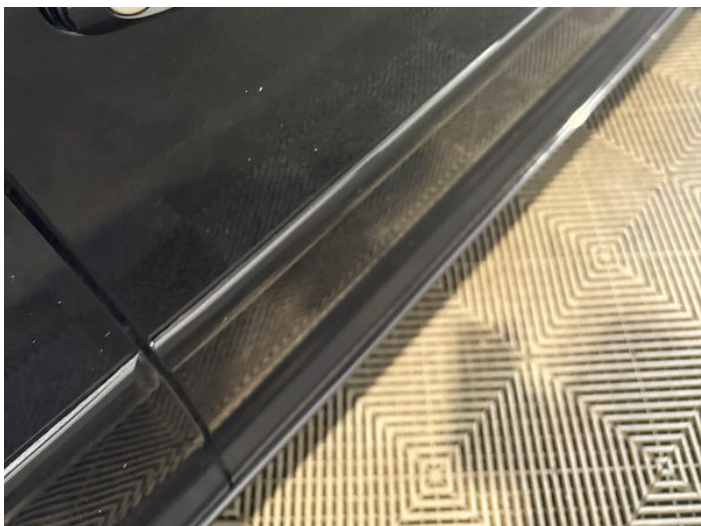
15: Door osf  
Chipped  
1 To 5

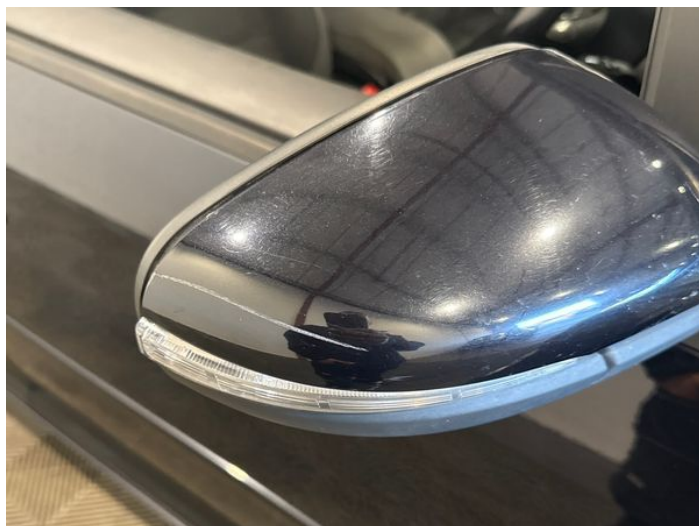
16: Door Mirror Assy osf  
Scratched (Painted)  
Over 25mm Thru Paint

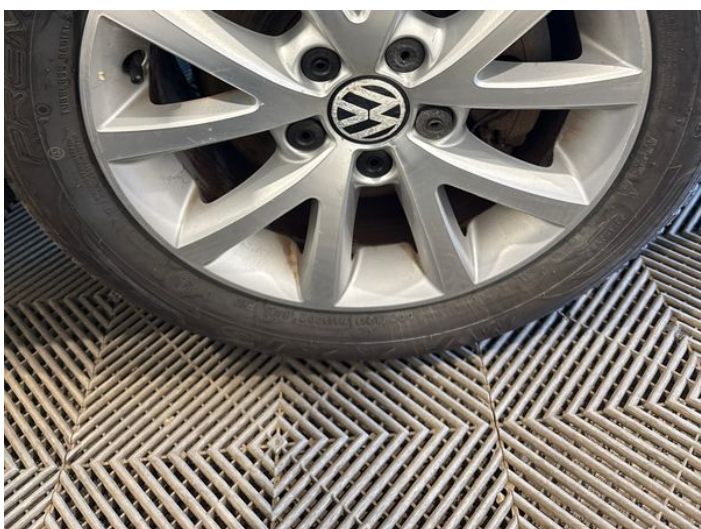
17: Wheel osf  
Scratched  
Over 50mm

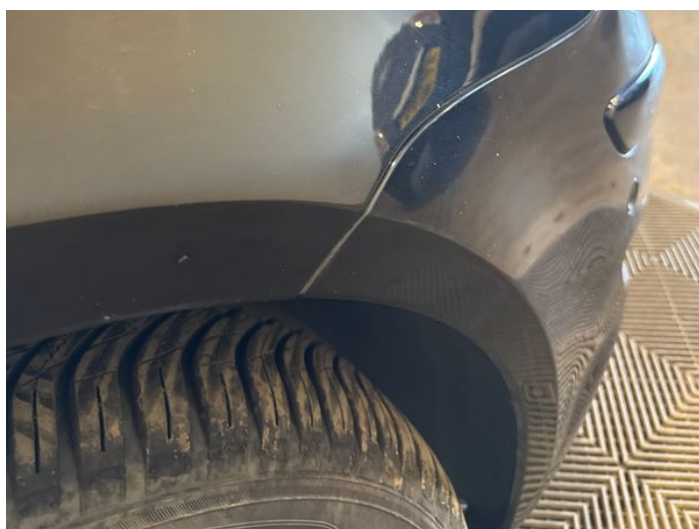
18: Wing osf  
Chipped  
1 To 5

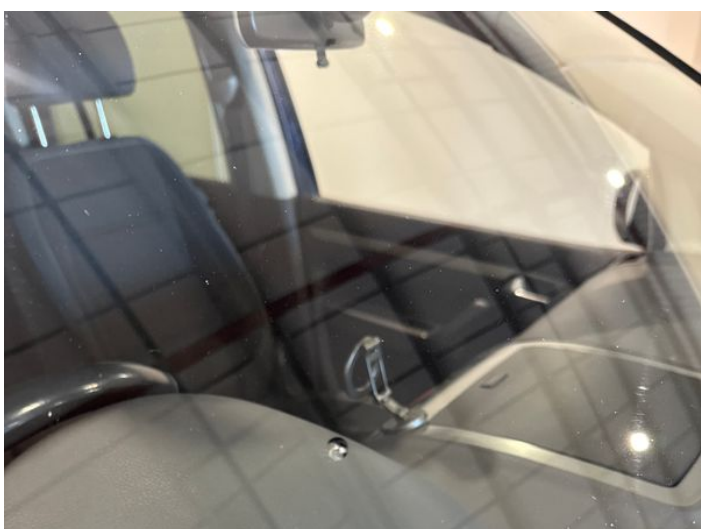
19: Screen Front  
Chipped  
UpTo 10mm

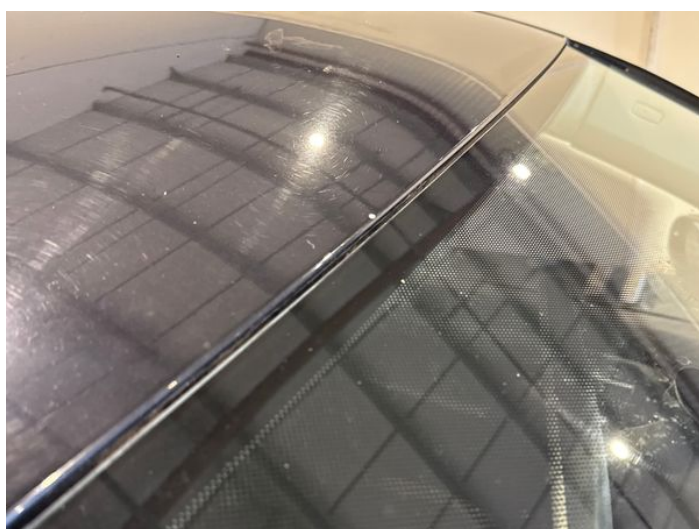
20: Roof  
Chipped  
Edge Chip
