## VEHICLE INSPECTION REPORT

**GY16HFL**

### Nissan Qashqai 1.6 DiG-T Tekna 5dr

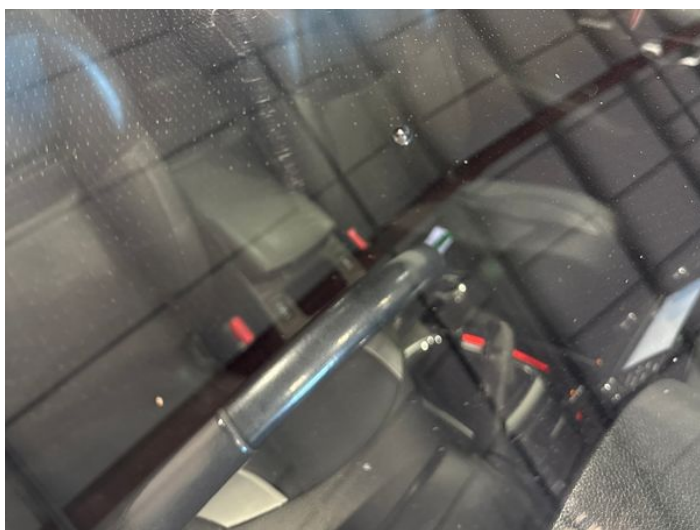
1: Screen Front  
Cracked  
Replace

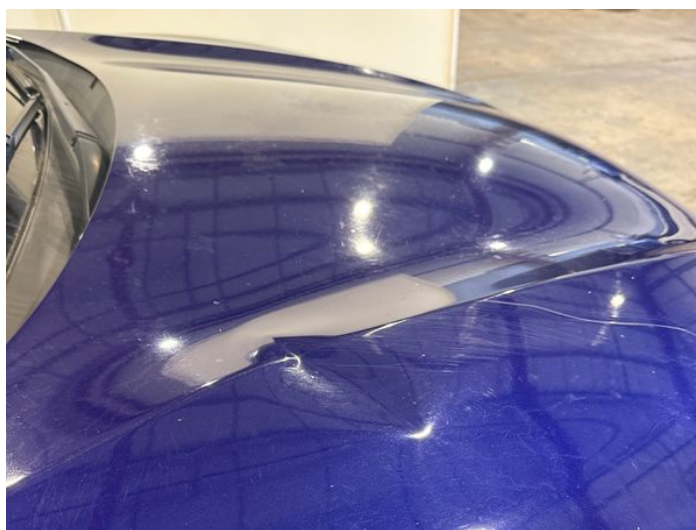
2: Bonnet  
Dented  
With Paint Damage

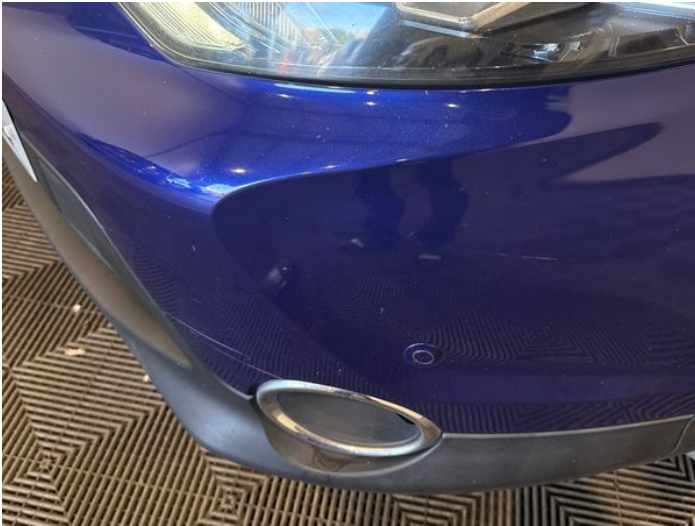
3: Bumper Front  
Scratched  
25 to 100mm Thru Paint

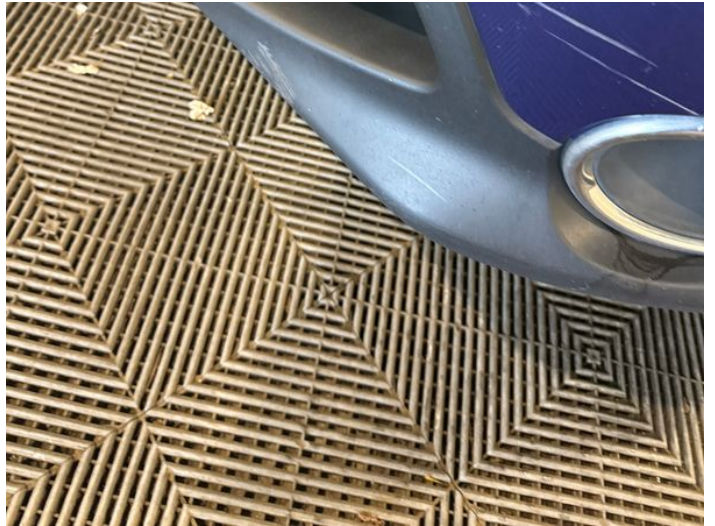
4: Bumper Front Moulding  
Scuffed (Unpainted)  
Over 100mm

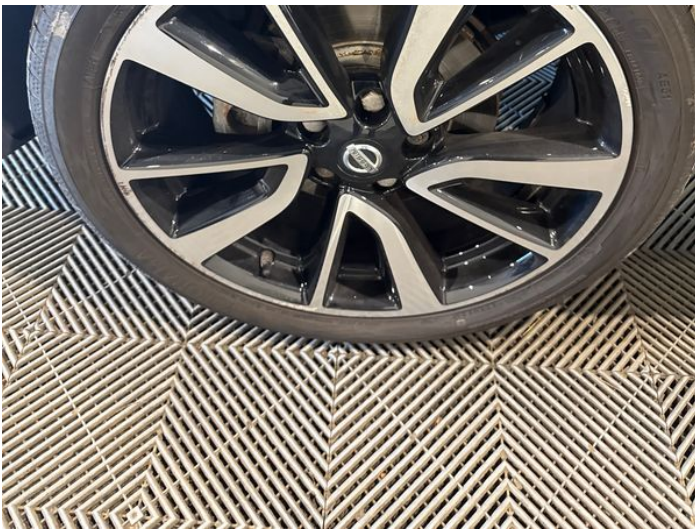
5: Wheel nsf  
Scratched  
Over 50mm

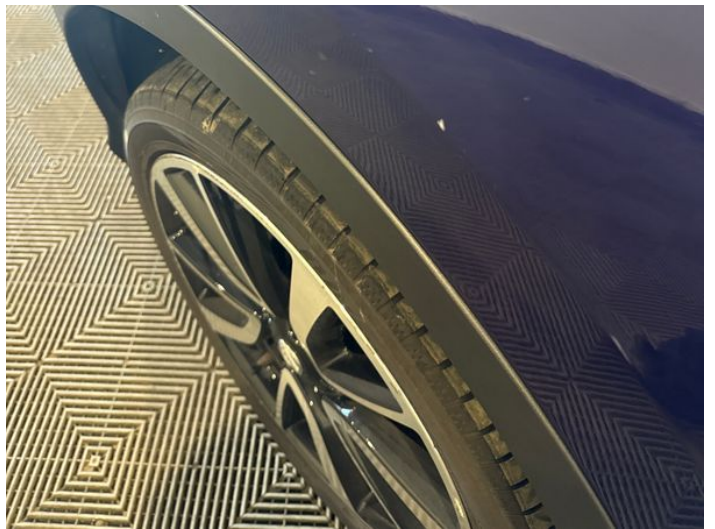
6: Door nsf  
Dented  
Between 10mm + 30mm

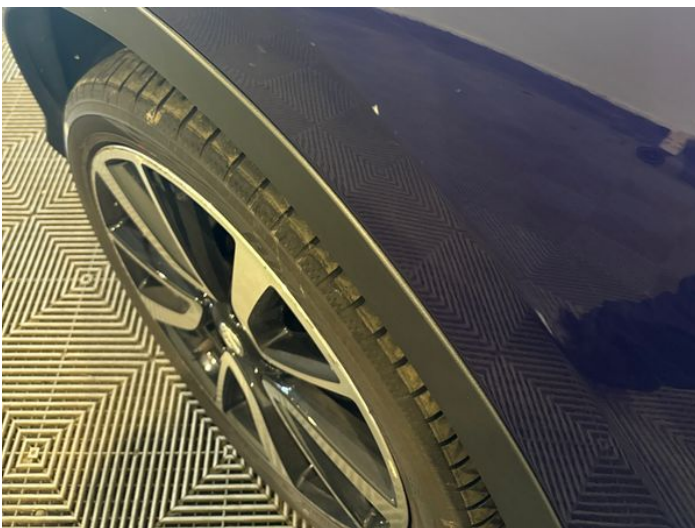
7: Wing nsf  
Chipped  
1 To 5

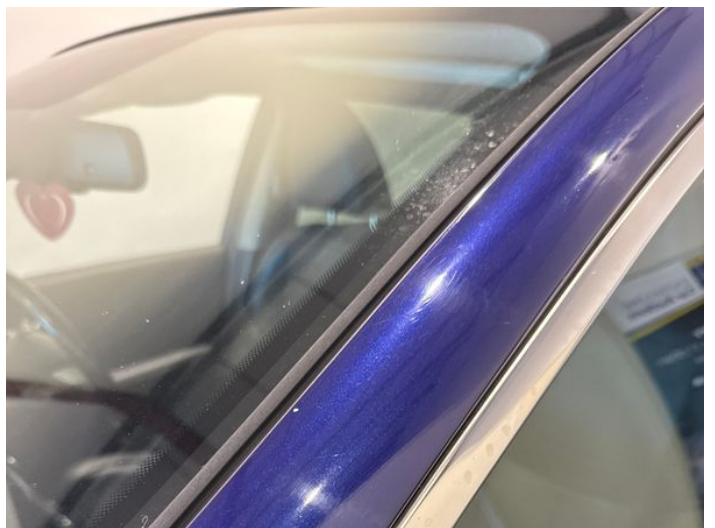
8: A Post ns  
Chipped  
1 To 5

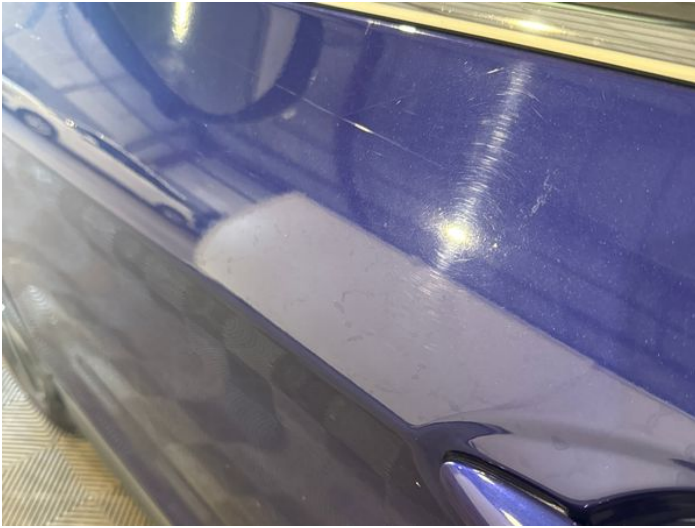
9: Door nsf  
Dented  
2 Or Less UpTo 10mm

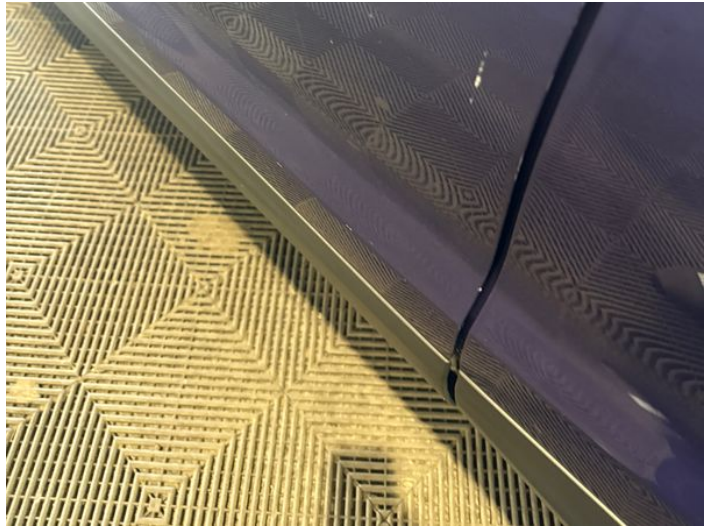
10: Door nsf  
Scratched  
Over 25mm Thru Paint

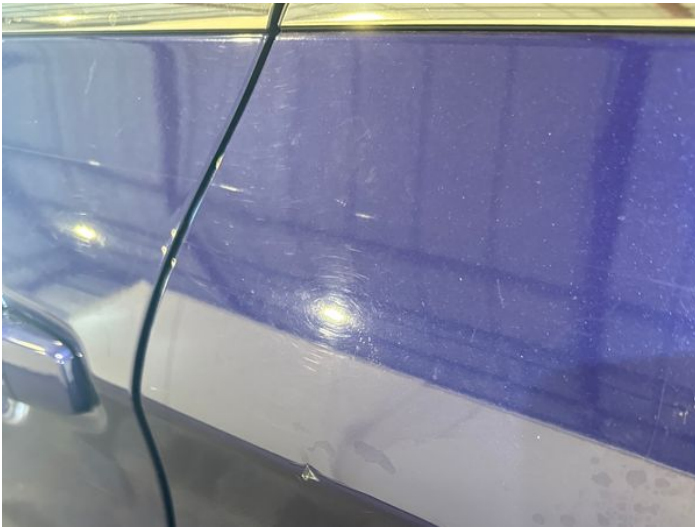
11: Door nsr  
Dented  
Between 10mm + 30mm

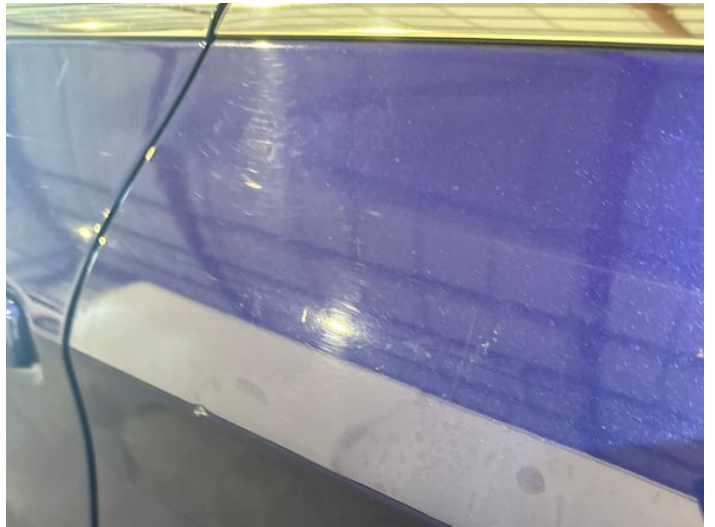
12: Door nsr  
Chipped  
1 To 5

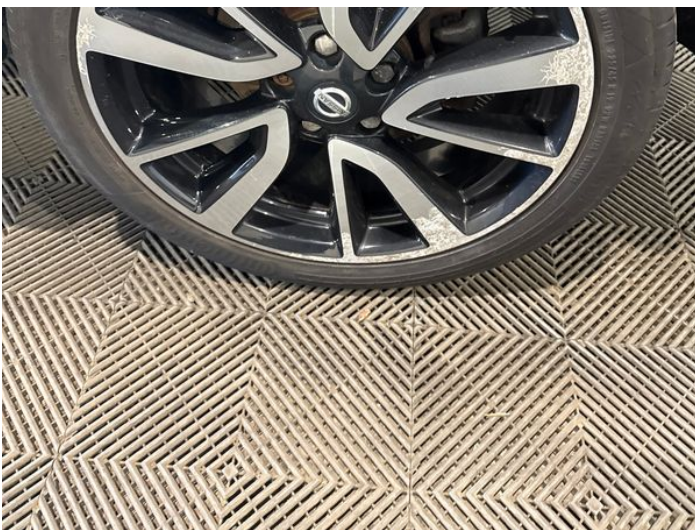
13: Wheel nsr  
Scratched  
Over 50mm

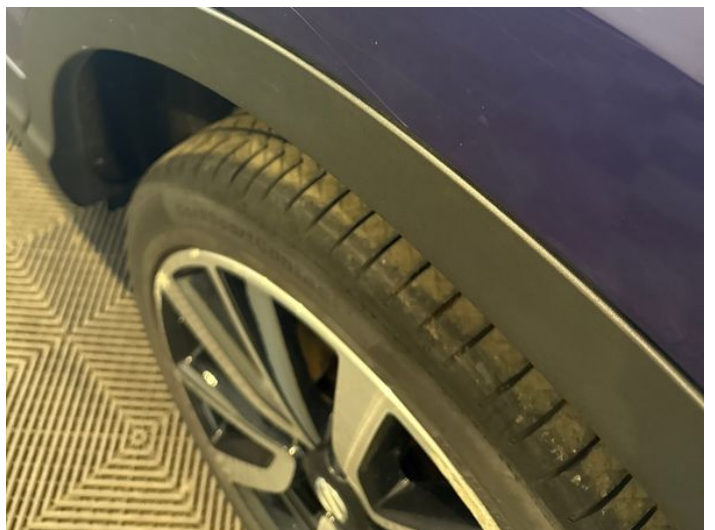
14: Qtr Panel nsr  
Scratched  
Over 25mm Thru Paint

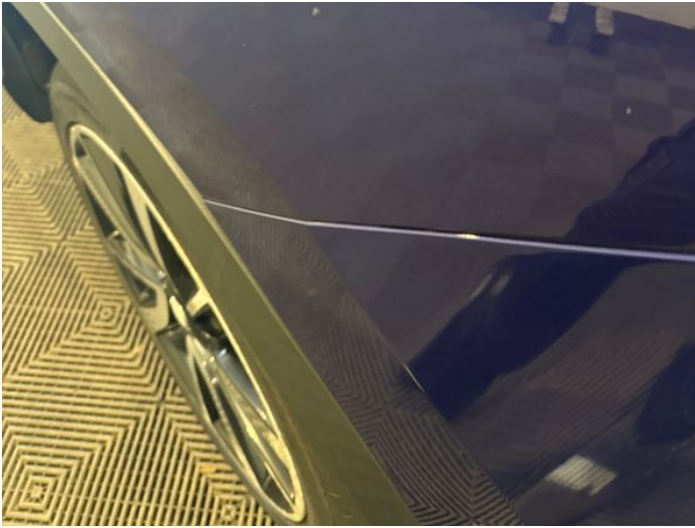
15: Qtr Panel nsr  
Dented  
2 Or Less UpTo 10mm

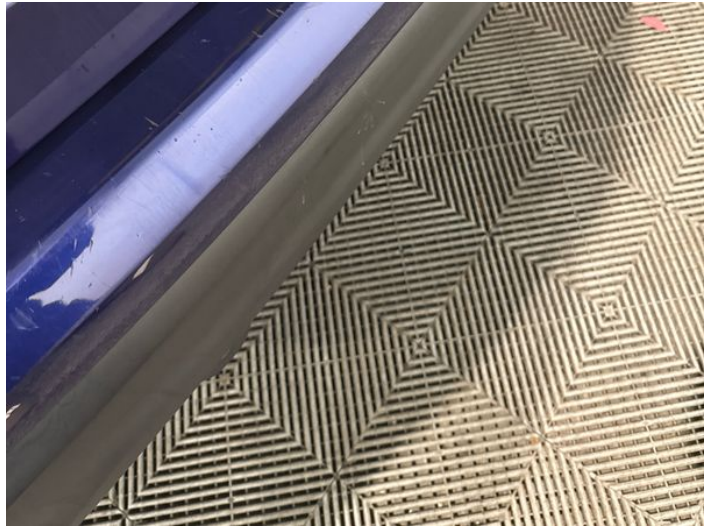
16: Bumper Rear  
Scratched  
25 to 100mm Thru Paint

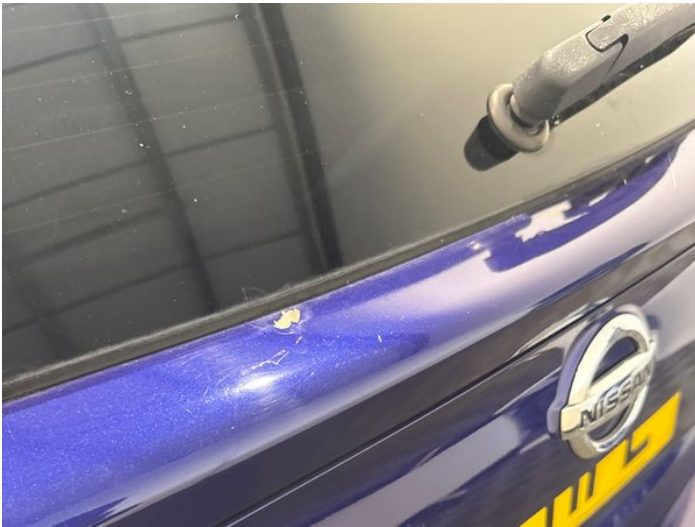
17: Tailgate  
Scratched  
Over 25mm Thru Paint

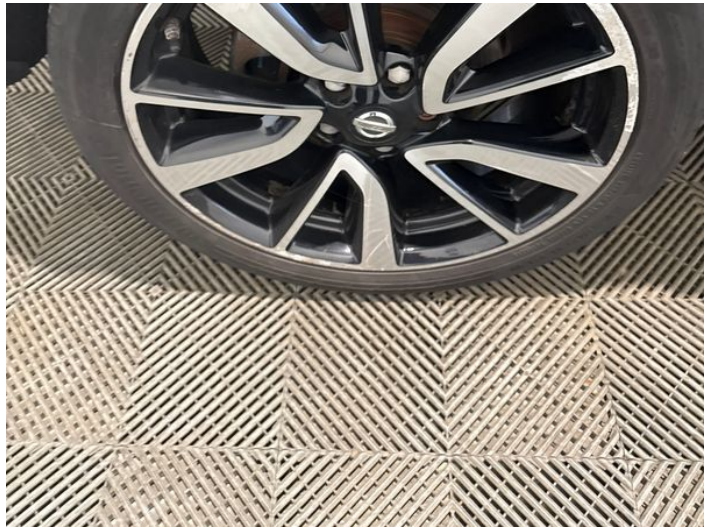
18: Wheel osr  
Corroded  
Light

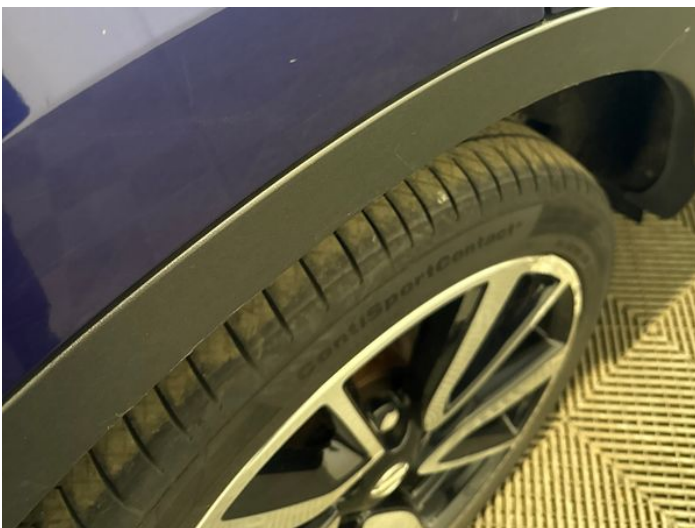
19: Qtr Panel osr  
Chipped  
1 To 5

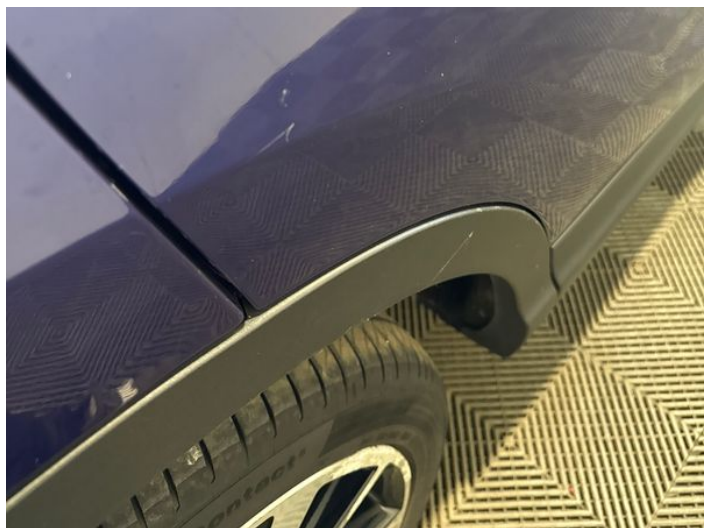
20: Door osr  
Scratched  
Over 25mm Thru Paint

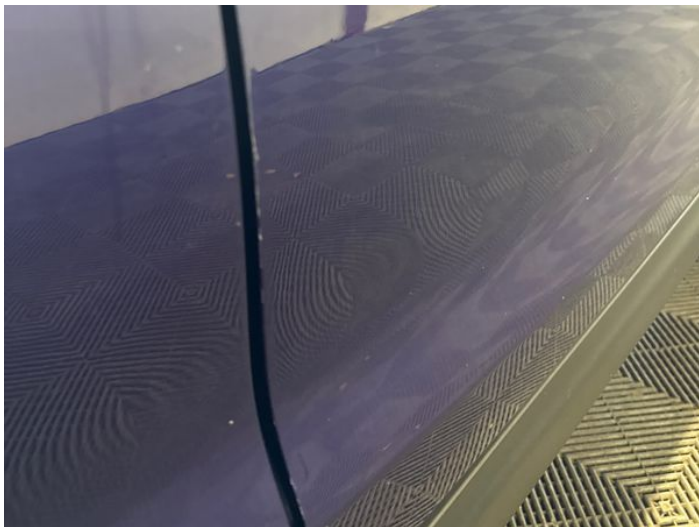
21: Door osf  
Chipped  
Edge Chip

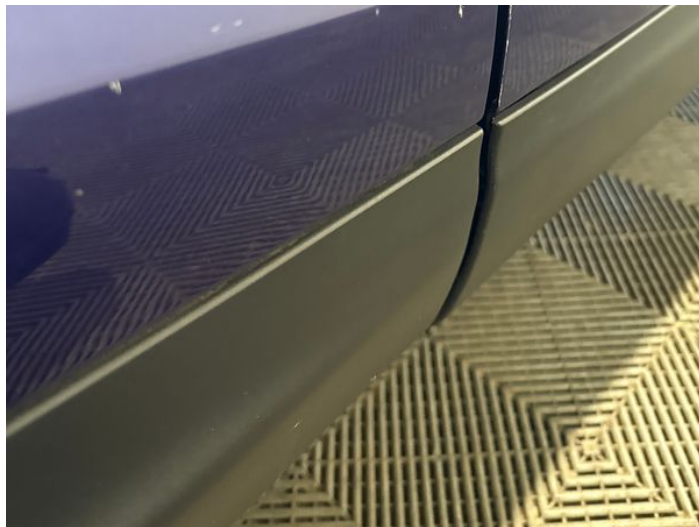
22: Door osr  
Dented  
2 Or Less UpTo 10mm

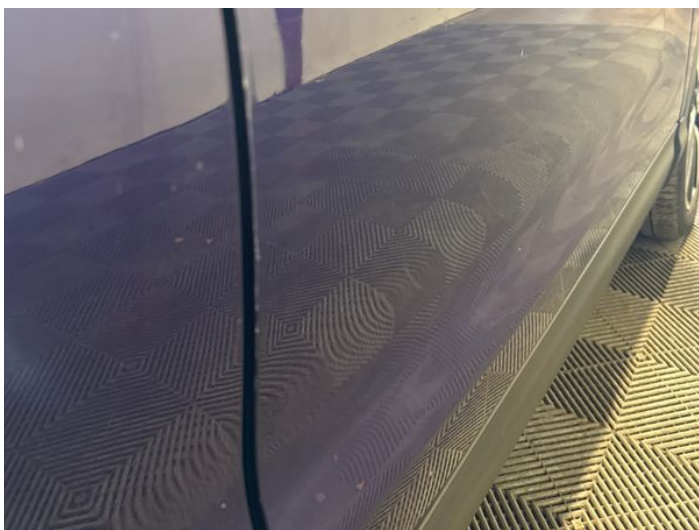
23: Door osf  
Dented  
Between 10mm + 30mm

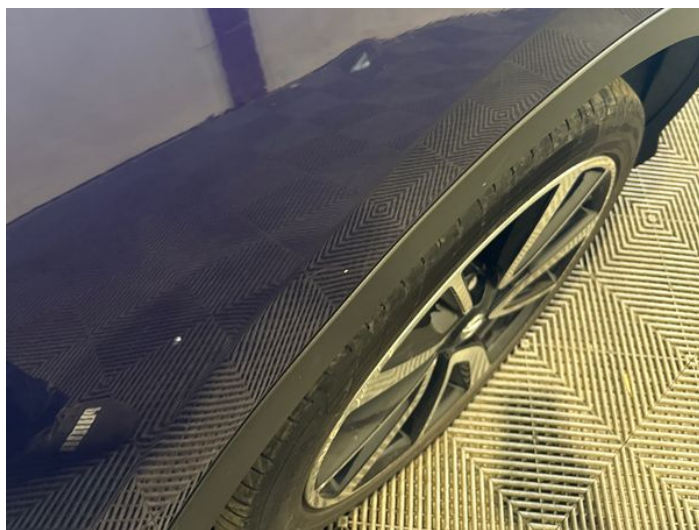
24: Wing osf  
Dented  
Over 30mm

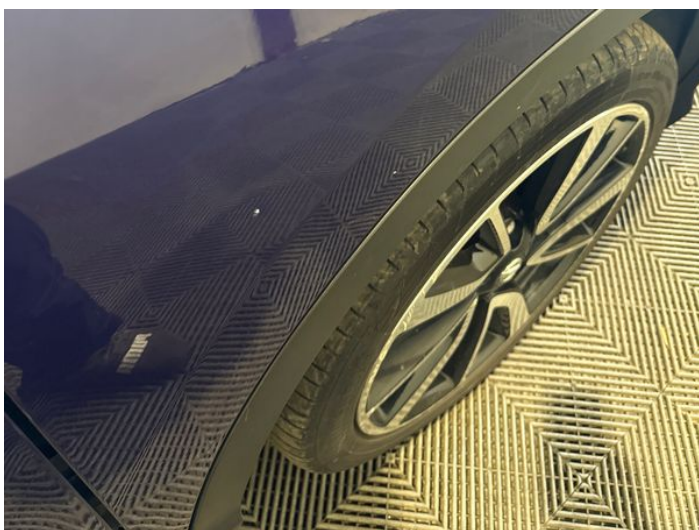
25: Wing osf  
Scratched  
UpTo 25mm Thru Paint

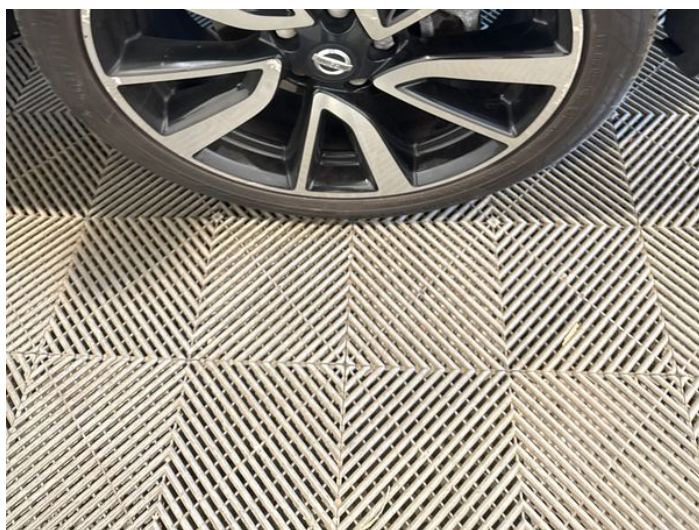
26: Wheel osf  
Scratched  
Over 50mm

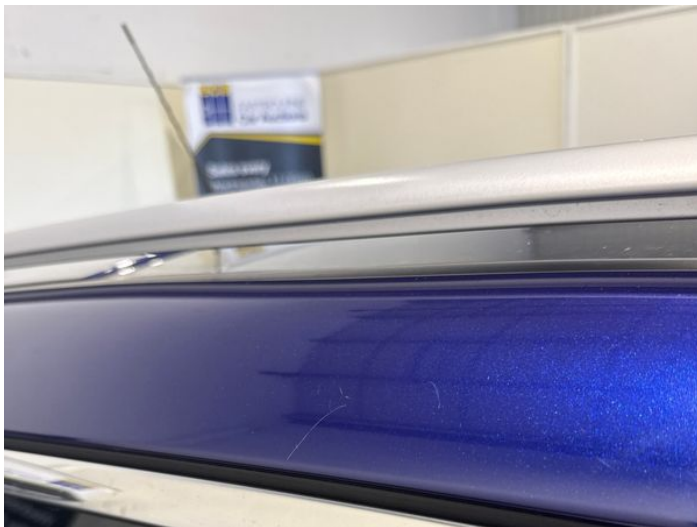
27: B Post os  
Scratched  
UpTo 25mm Thru Paint

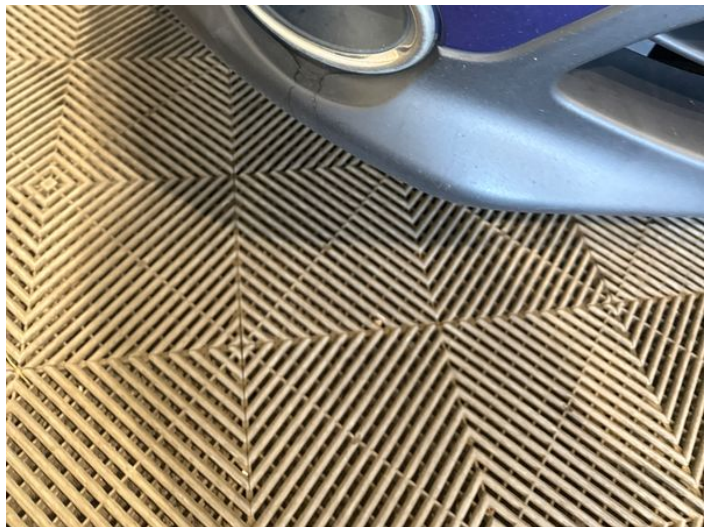
28: Fogdriving Lamp osf  
Broken  
Replace
