# VEHICLE INSPECTION REPORT

**SL67ZGM**

## Hyundai I20 1.4 SE 5dr Auto

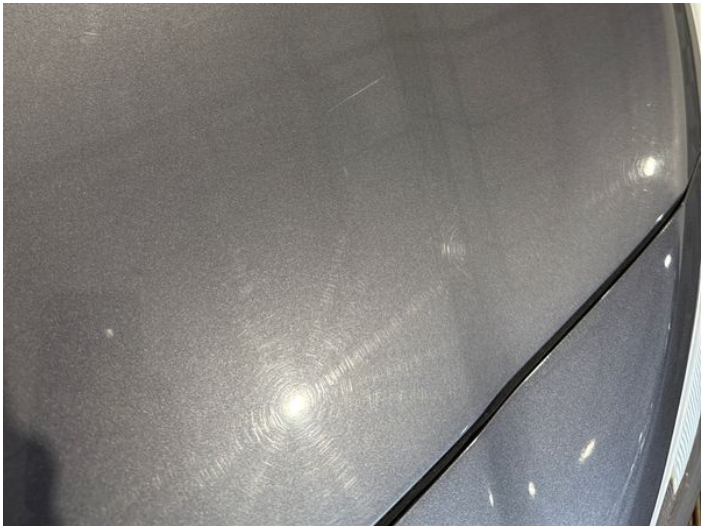
2: Bonnet  
Scratched  
Over 25mm Thru Paint

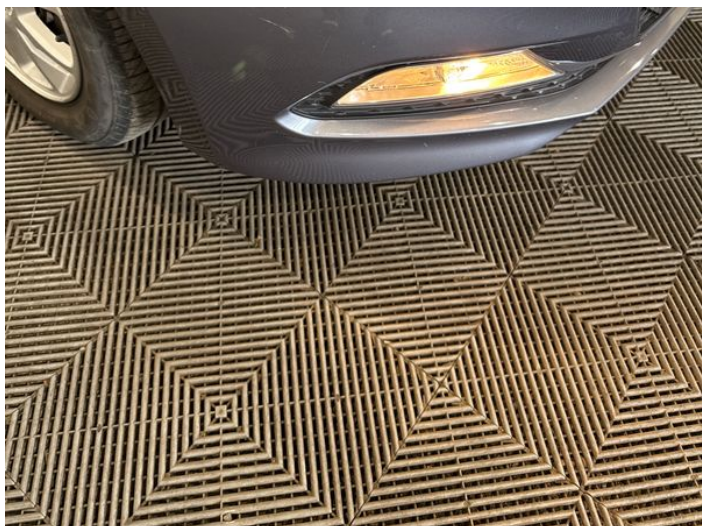
3: Bumper Front  
Scratched  
Over 100mm Thru Paint

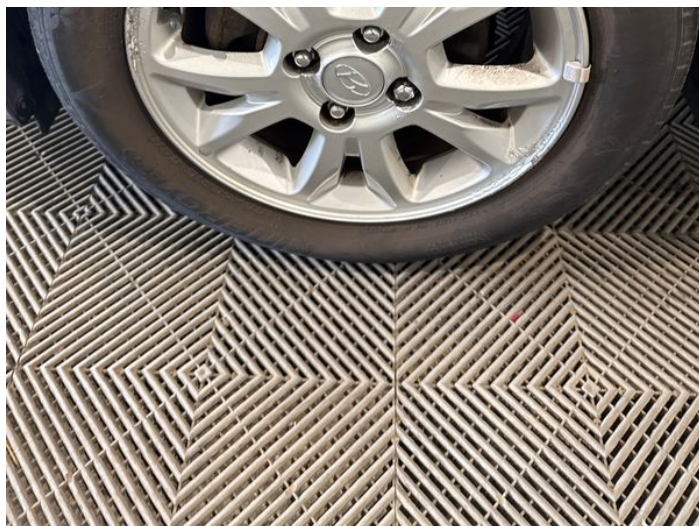
4: Wheel nsf  
Scratched  
Over 50mm

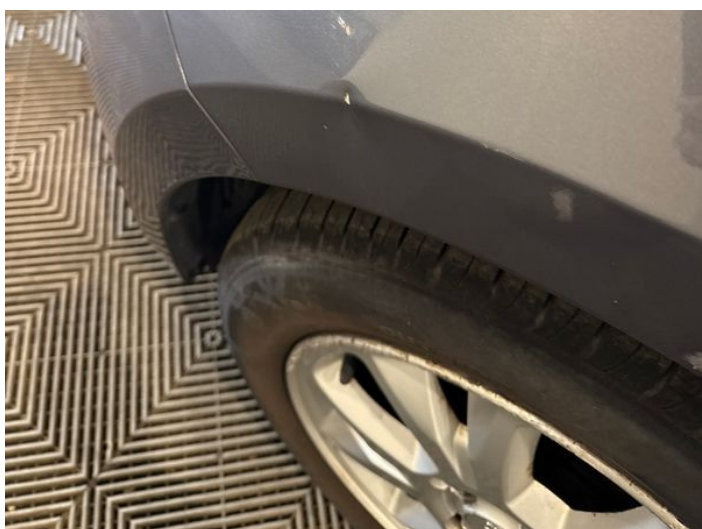
5: Wing nsf  
Dented  
Between 10mm + 30mm

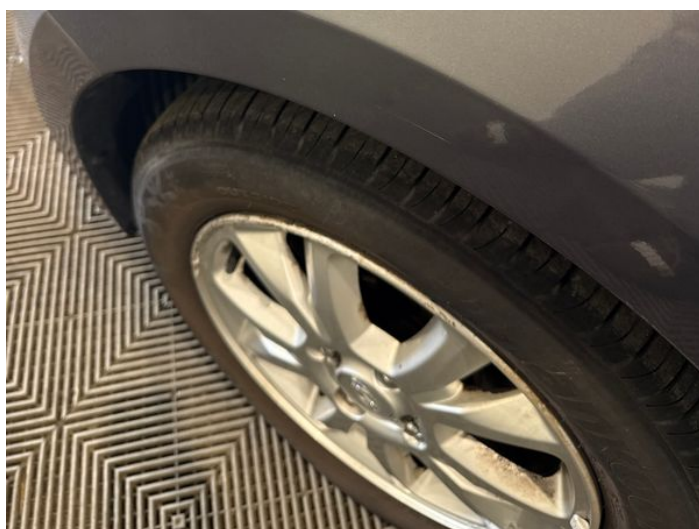
6: Wing nsf  
Scratched  
Over 25mm Thru Paint

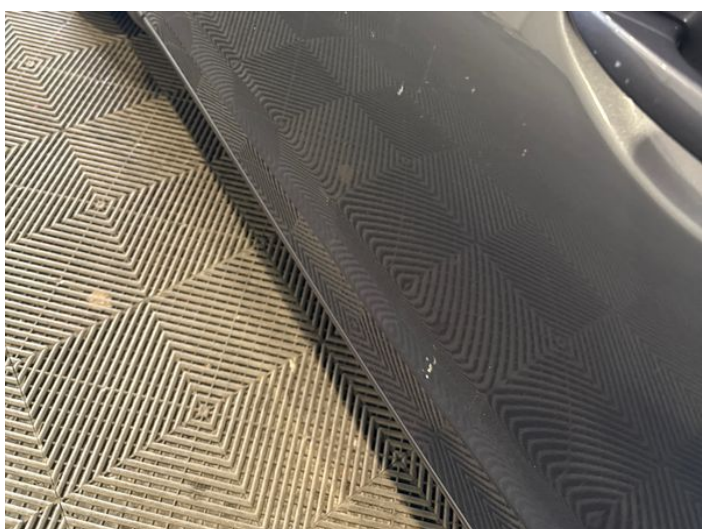
7: Door nsf  
Dented  
With Paint Damage

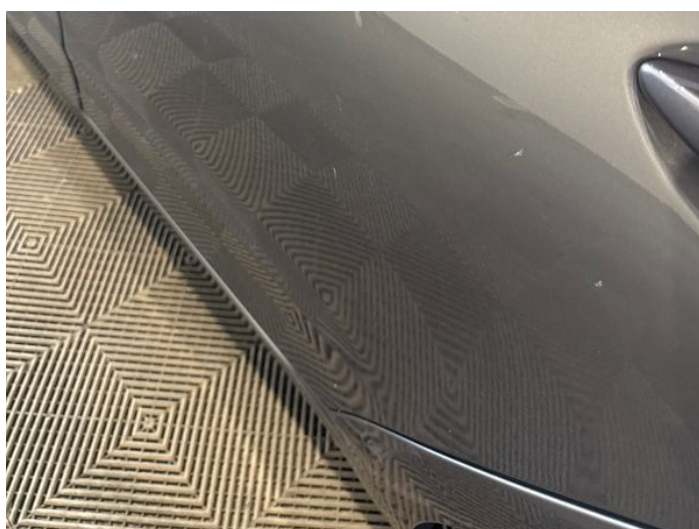
8: Door nsr  
Dented  
Between 10mm + 30mm

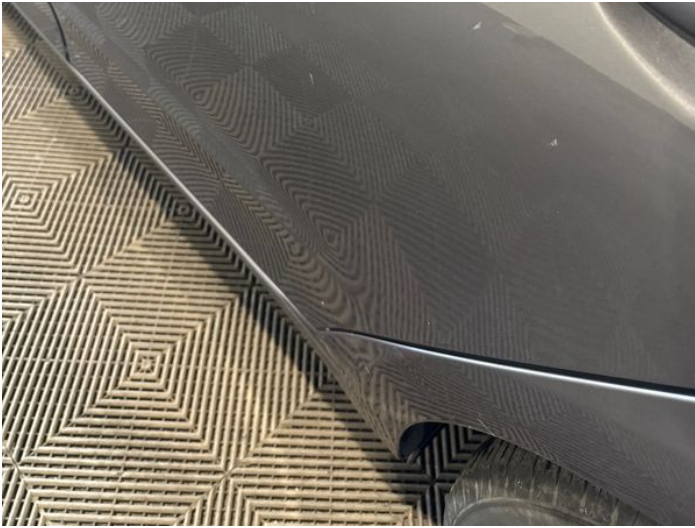
9: Door nsr  
Scratched  
Over 25mm Thru Paint

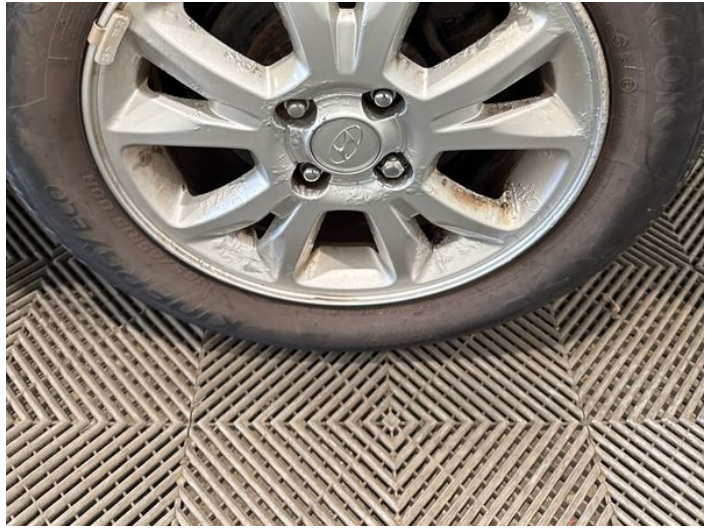
10: Wheel nsr  
Scratched  
Over 50mm

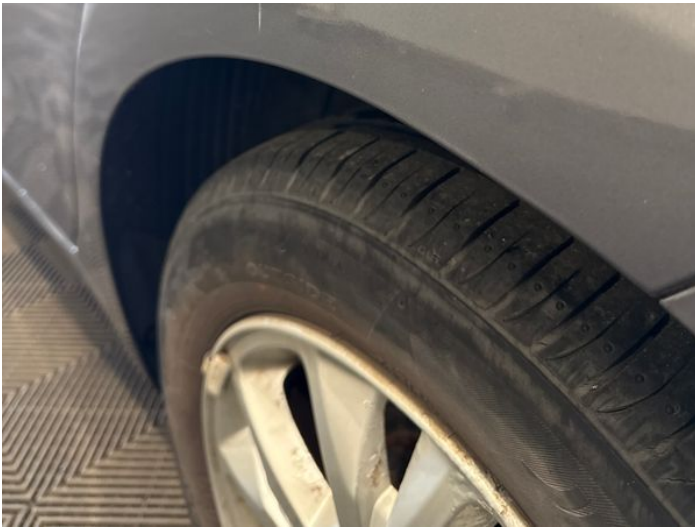
11: Qtr Panel nsr  
Dented  
Between 10mm + 30mm

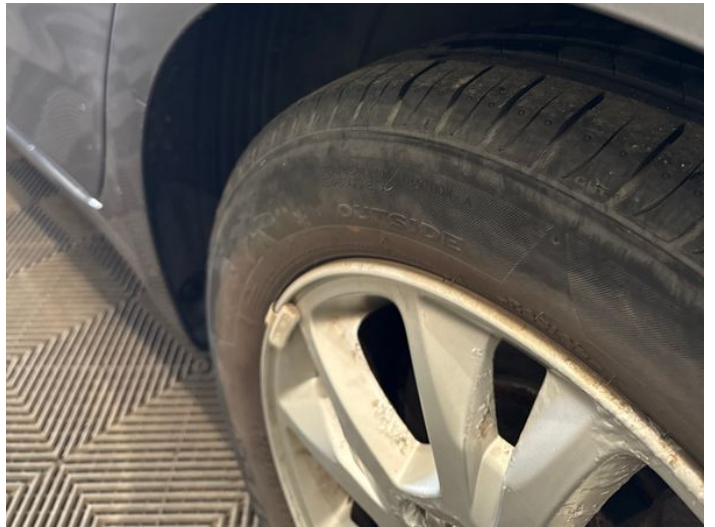
12: Qtr Panel nsr  
Scratched  
Over 25mm Thru Paint

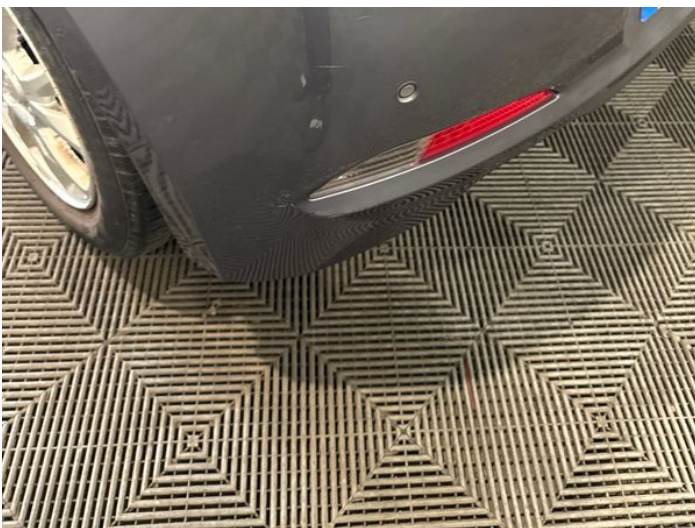
13: Bumper Rear  
Scratched  
25 to 100mm Thru Paint

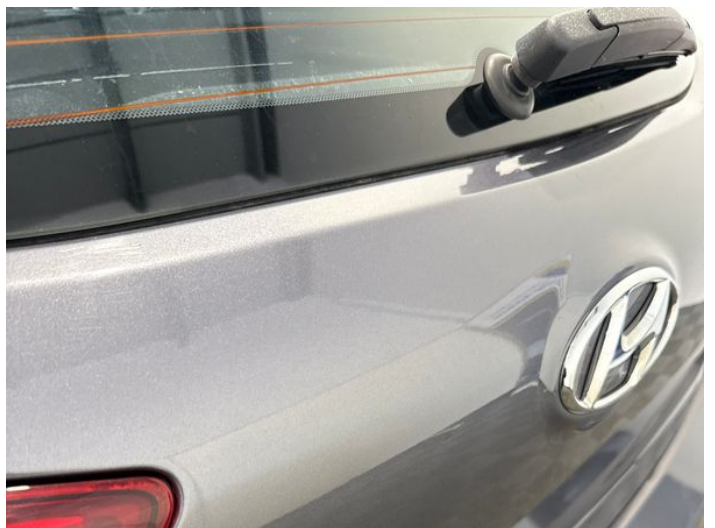
14: Tailgate  
Dented  
Between 10mm + 30mm

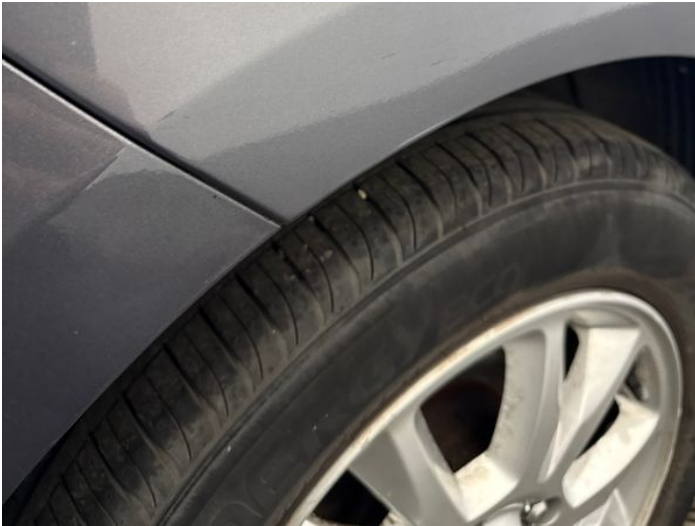
15: Qtr Panel osr  
Chipped  
1 To 5

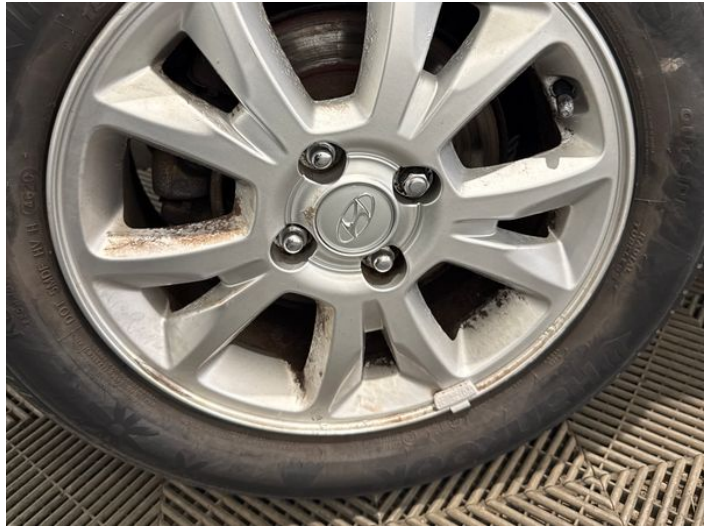
16: Wheel osr  
Scratched  
Over 50mm

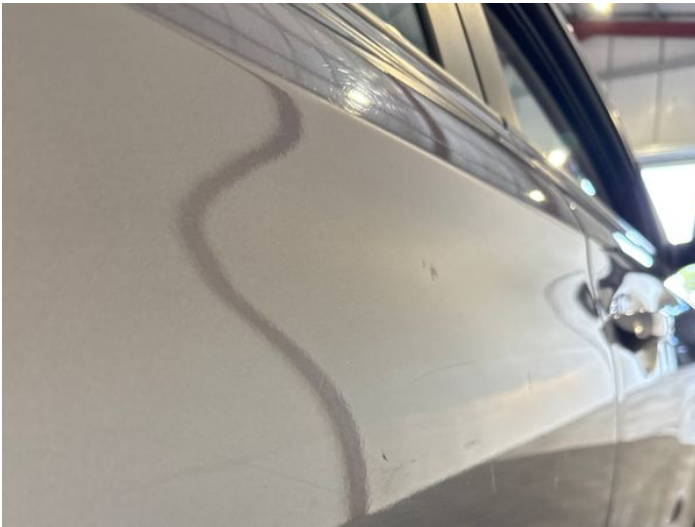
17: Door osr  
Dented  
Between 10mm + 30mm

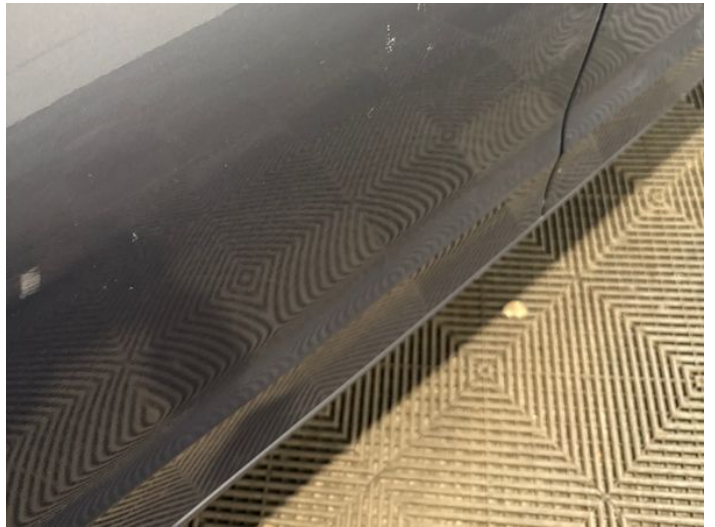
18: Door osr  
Scratched  
Over 25mm Thru Paint

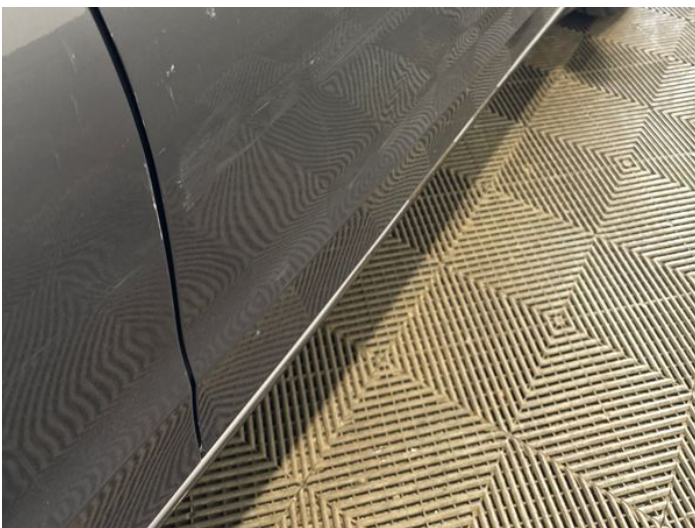
19: Door osf  
Dented  
With Paint Damage

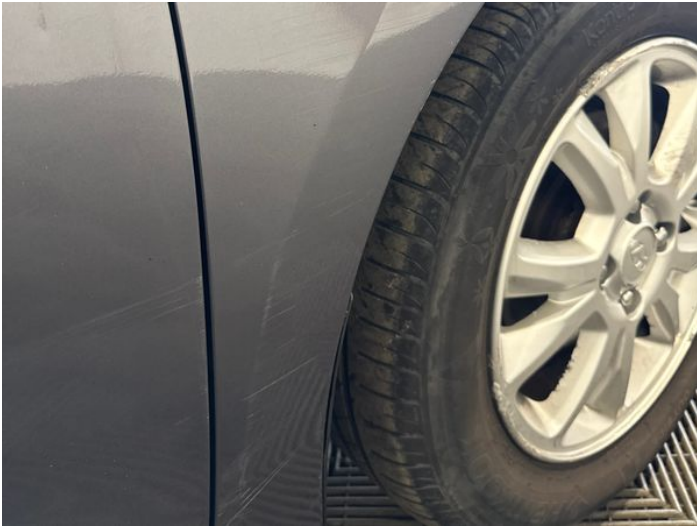
21: Wing osf  
Dented  
With Paint Damage

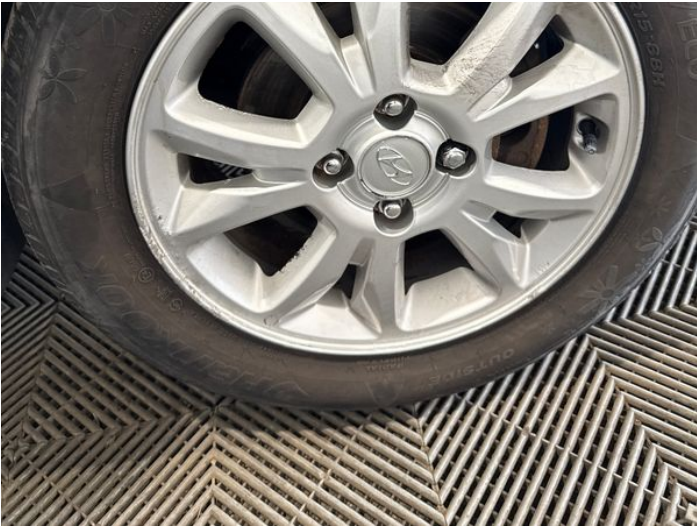
22: Wheel osf  
Scratched  
Over 50mm

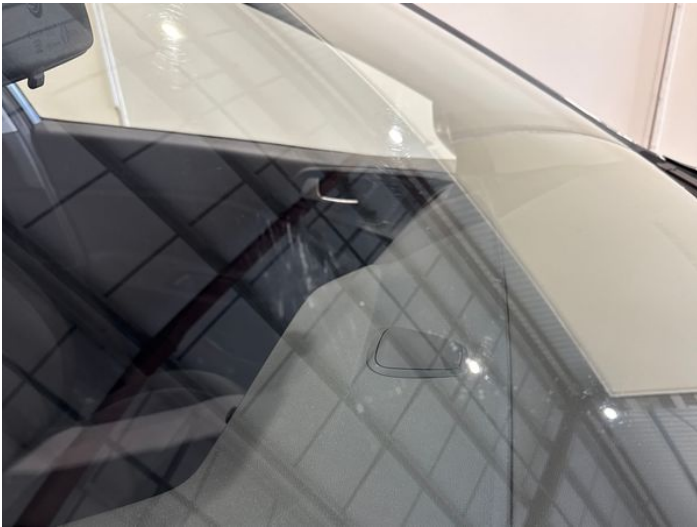
23: Screen Front  
Scratched  
Over 30mm
