## VEHICLE INSPECTION REPORT

**GN71NEJ**

### Mazda CX-30 2.0 e-Skyactiv X MHEV GT Sport Tech 5dr Auto

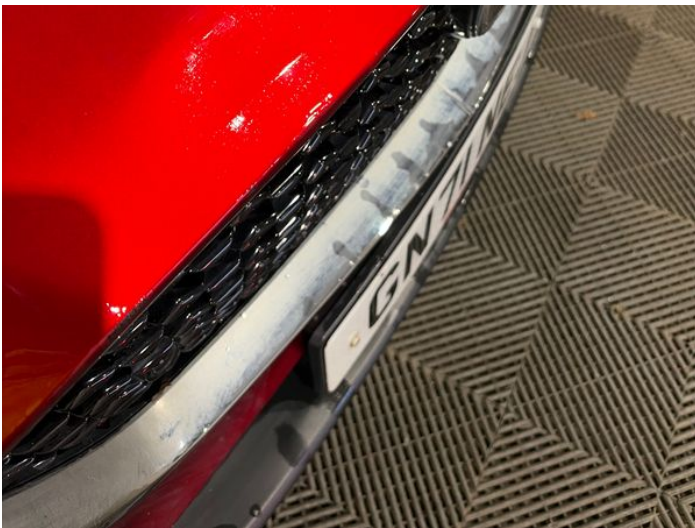
1: Bumper Front  
Dented  
With Paint Damage

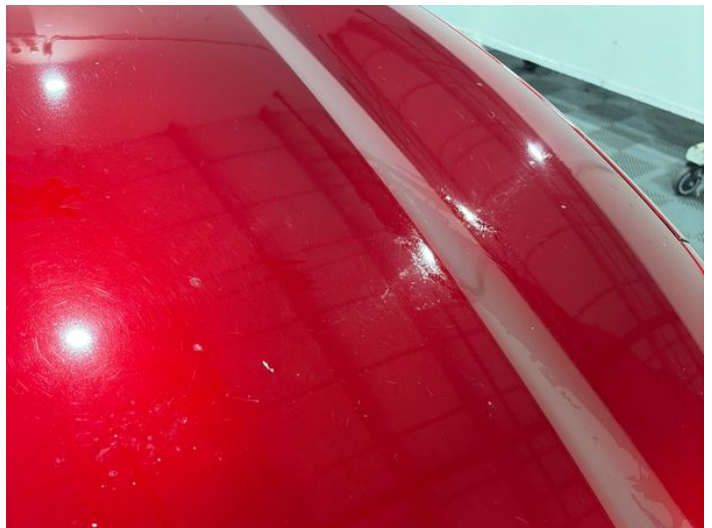
2: Bonnet  
Chipped  
Multiple Chips

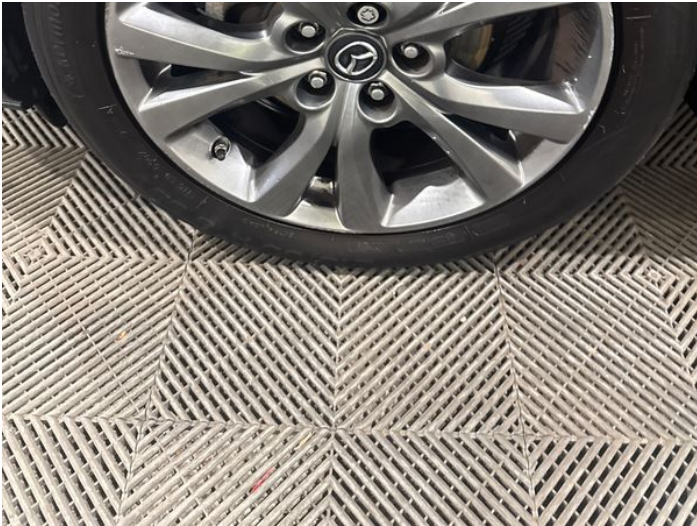
3: Wheel nsf  
Scratched  
Over 50mm

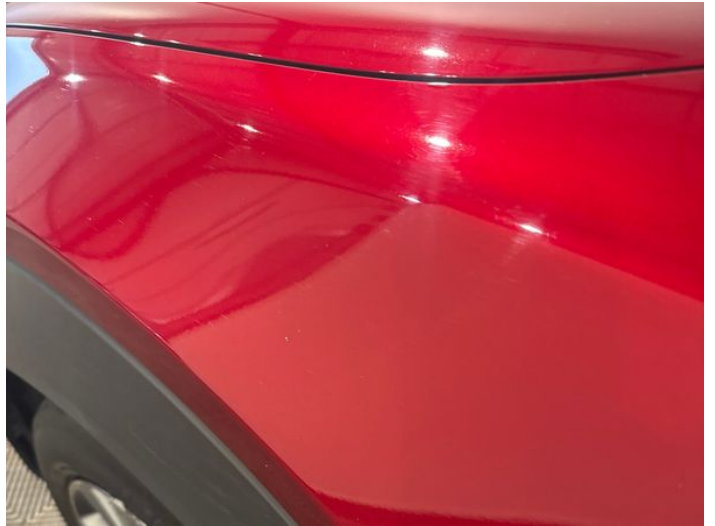
4: Wing nsf  
Chipped  
1 To 5

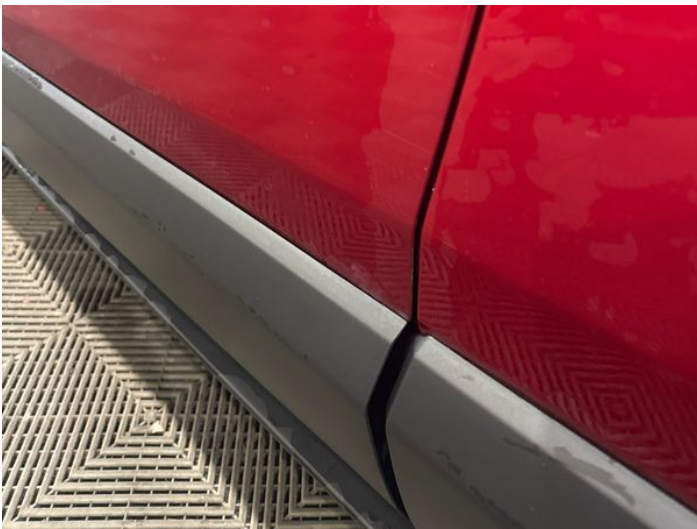
5: Door nsf  
Scratched  
UpTo 25mm Thru Paint

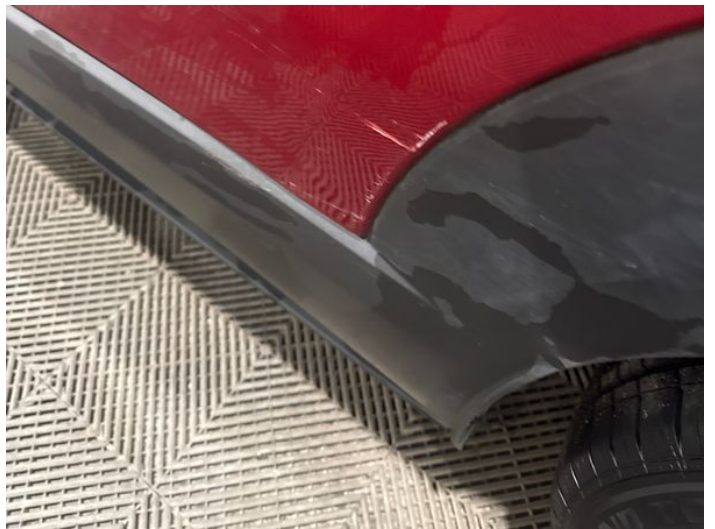
6: Door nsr  
Dented  
With Paint Damage

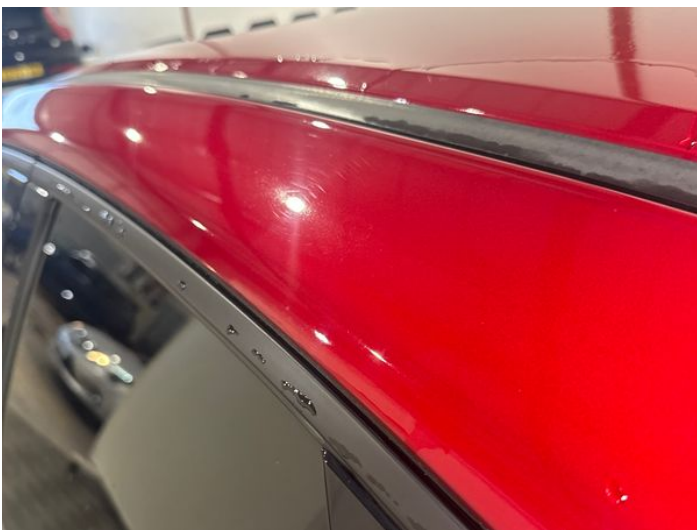
7: B Post ns  
Dented  
Between 10mm + 30mm

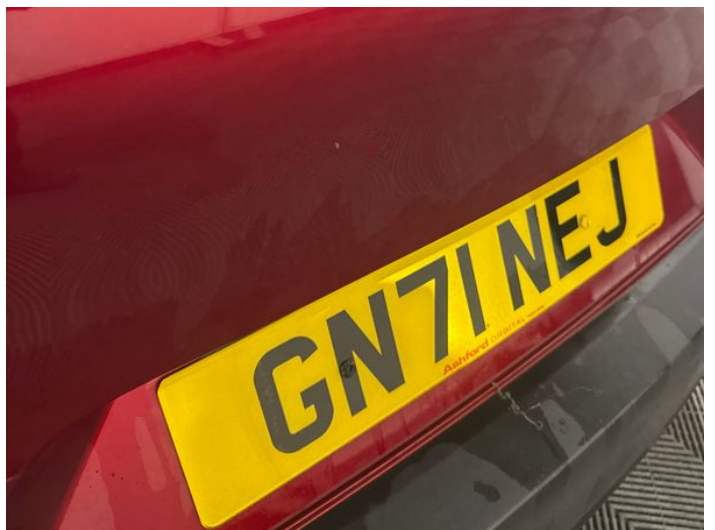
8: Tailgate  
Chipped  
1 To 5

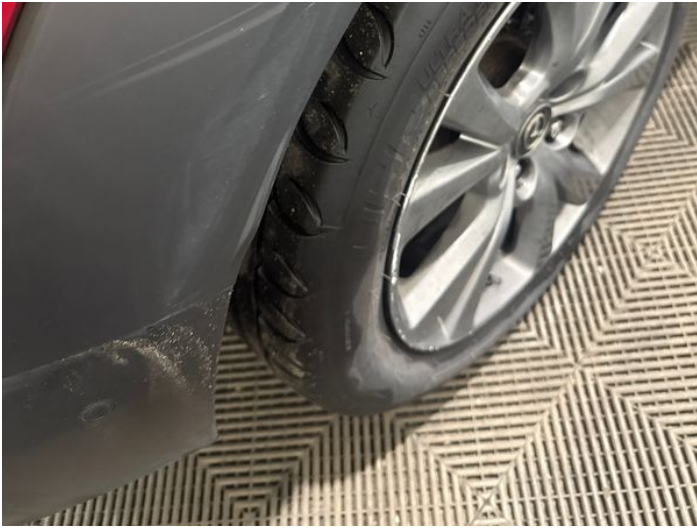
9: Qtr Panel Arch Extension os  
Scuffed (Unpainted)  
Over 100mm

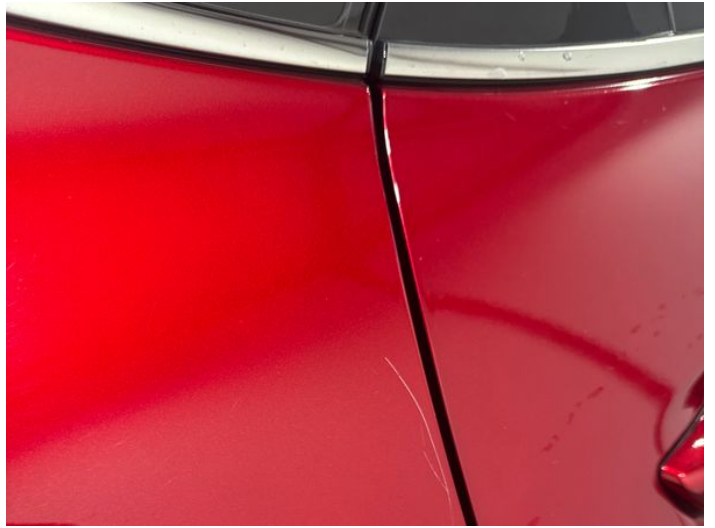
10: Qtr Panel osr  
Scratched  
Over 25mm Thru Paint

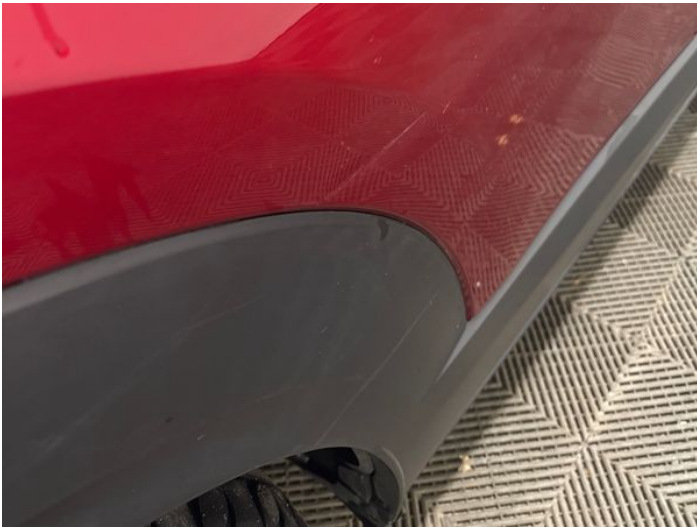
11: Door osr  
Scratched  
Over 25mm Thru Paint

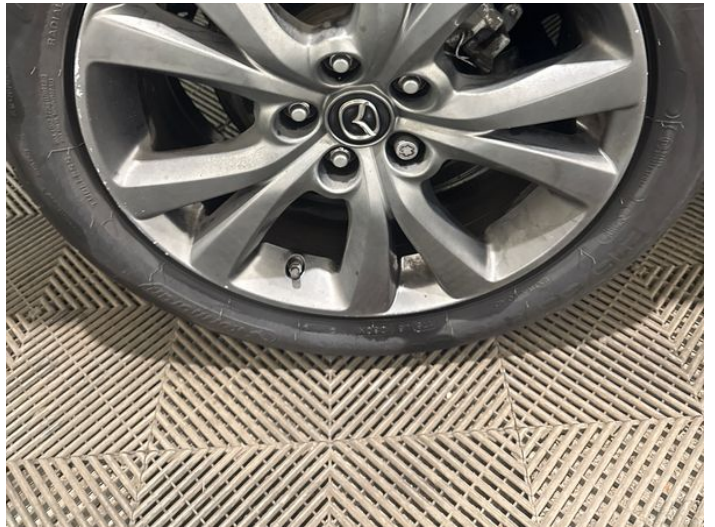
12: Wheel osr  
Scratched  
Over 50mm

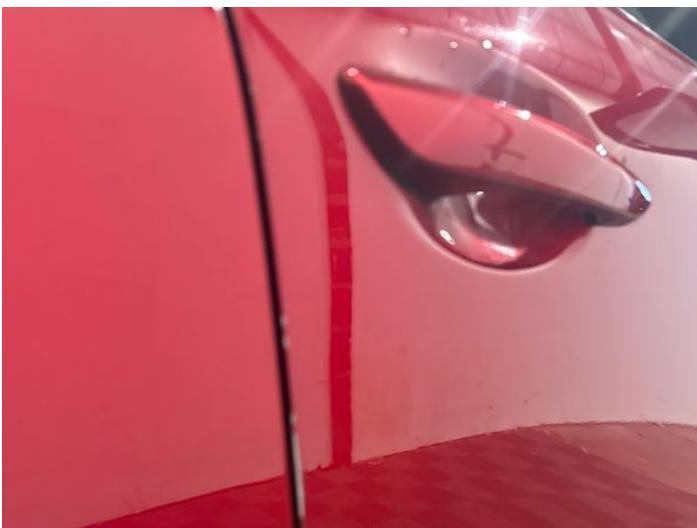
13: Door osf  
Chipped  
Edge Chip

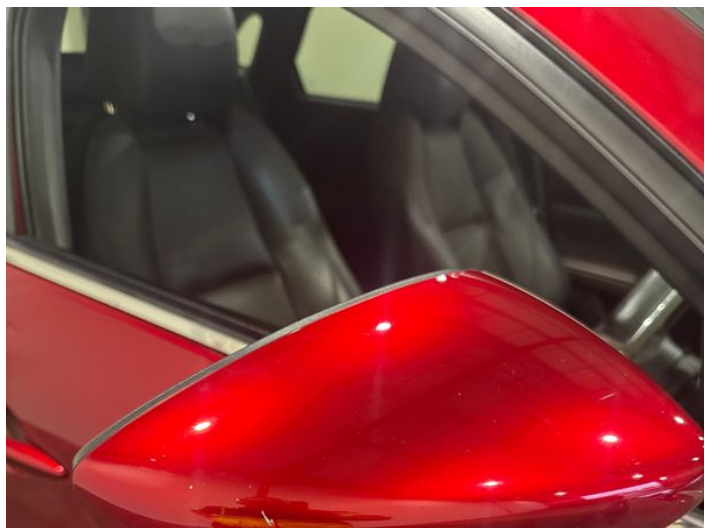
14: Door Mirror Assy osf  
Broken  
Replace

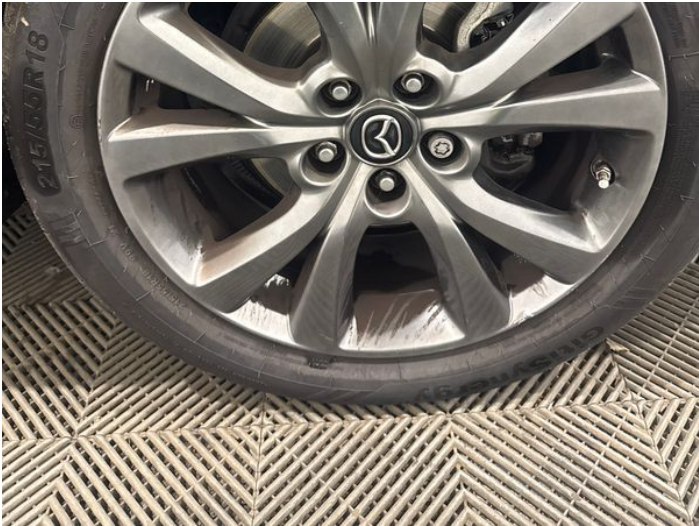
15: Wheel osf  
Dented  
UpTo 30mm (Alloy)

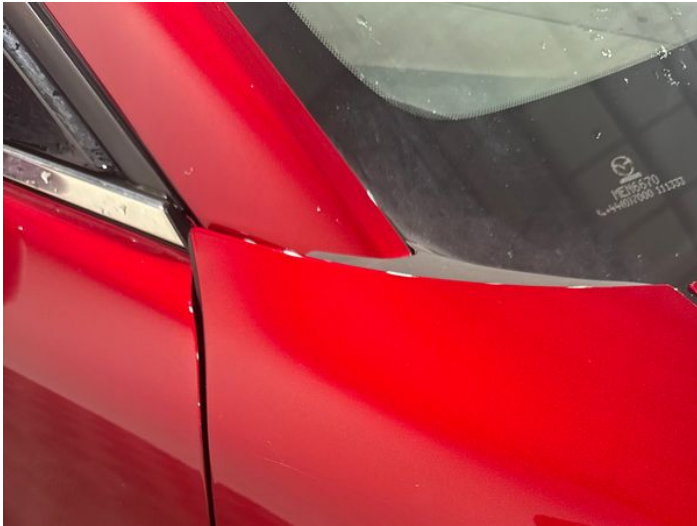
16: Wing osf  
Scratched  
UpTo 25mm Thru Paint

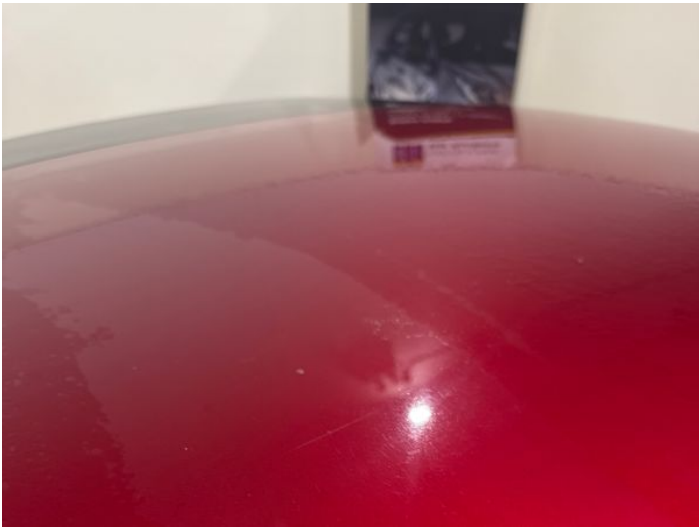
17: Roof  
Scratched  
UpTo 25mm Thru Paint

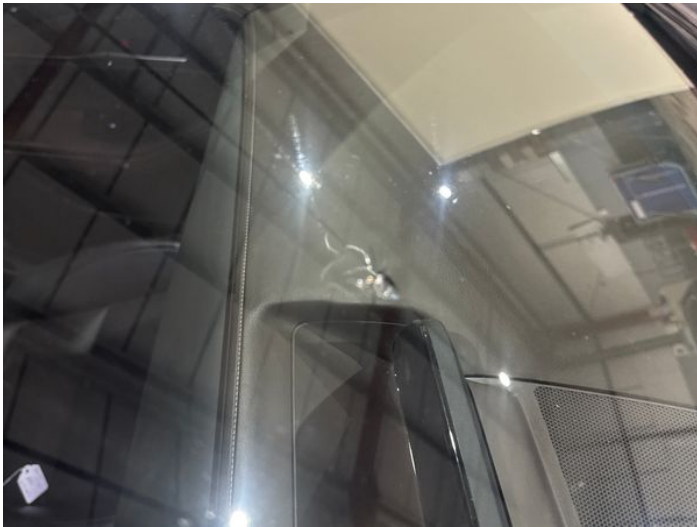
18: Screen Front  
Cracked  
Replace
