# VEHICLE INSPECTION REPORT

**GX17ODV**

## Vauxhall Viva 1.0 SE 5dr

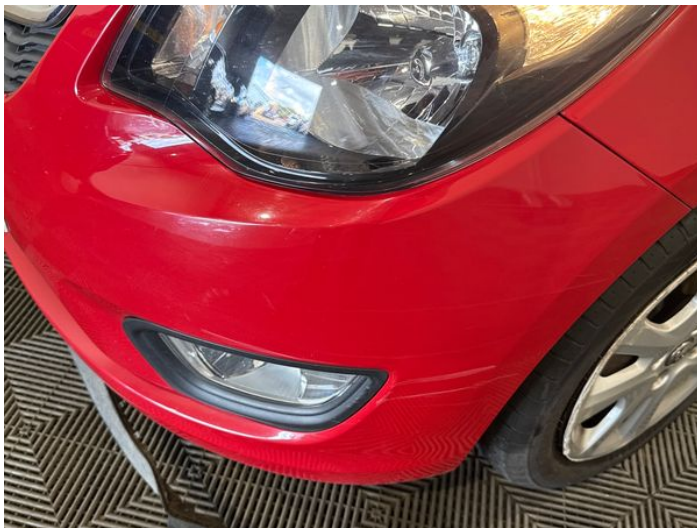
1: Bumper Front  
Scratched  
25 to 100mm Thru Paint

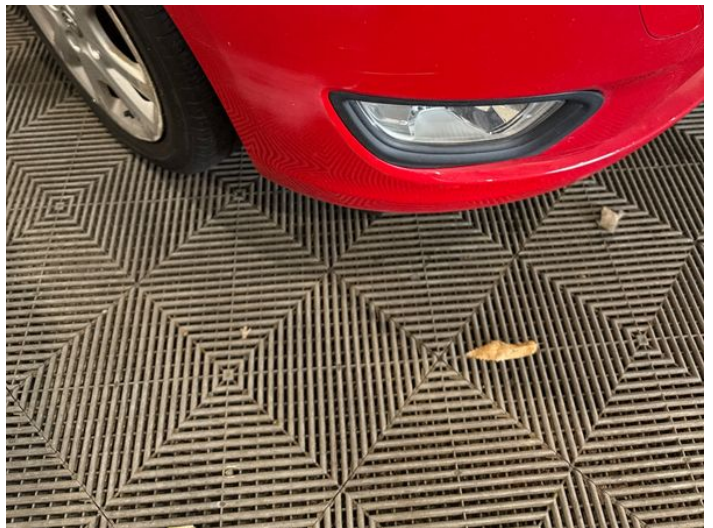
2: Bumper Front  
Scratched  
25 to 100mm Thru Paint

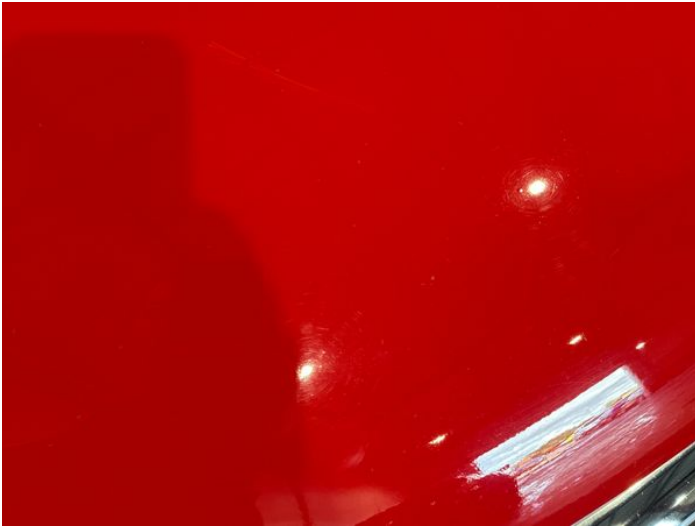
3: Bonnet  
Scratched  
Over 25mm Thru Paint

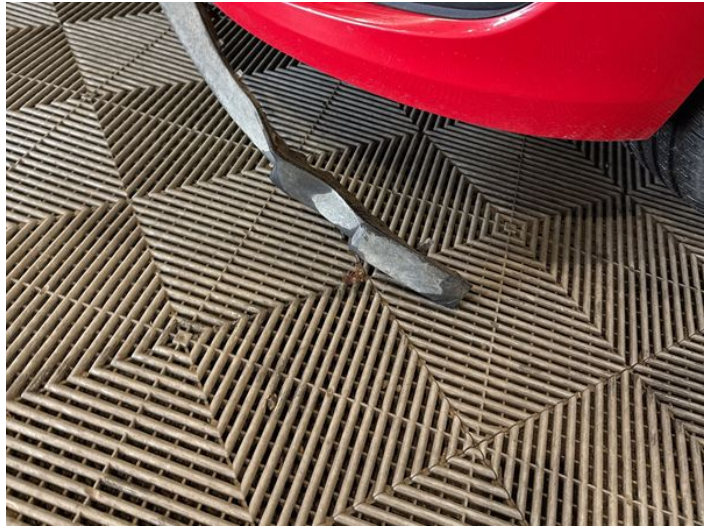
4: Bumper Front Moulding  
Broken  
Replace

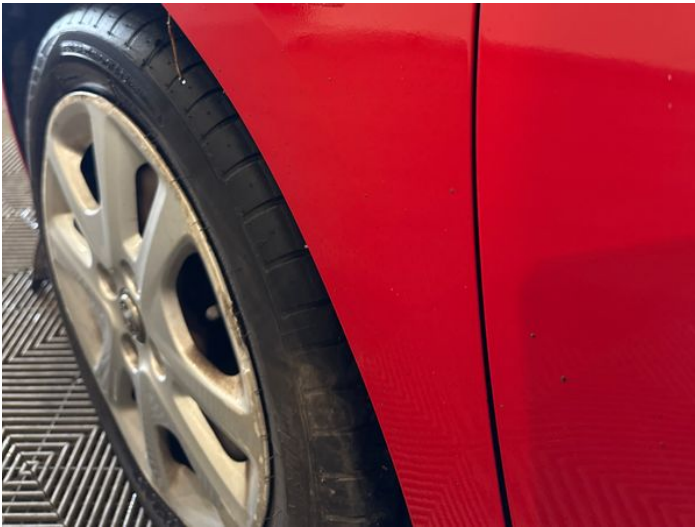
5: Wing nsf  
Poor Previous Repair  
Poor Paint

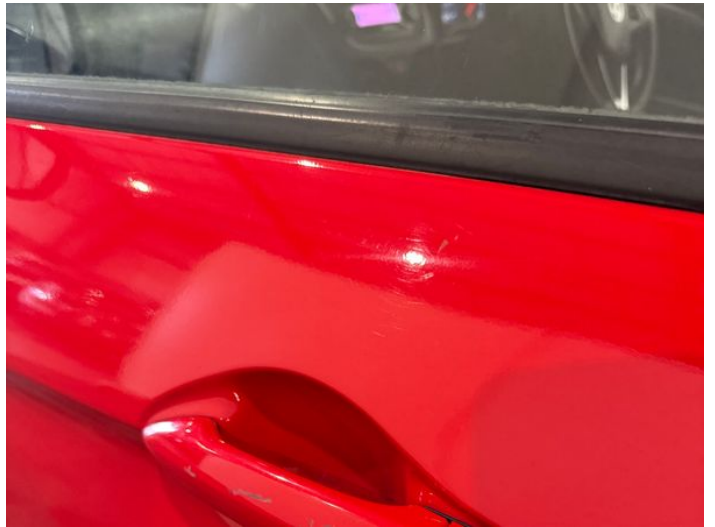
6: Handle Outer nsf  
Scratched (Painted)  
Over 25mm Thru Paint

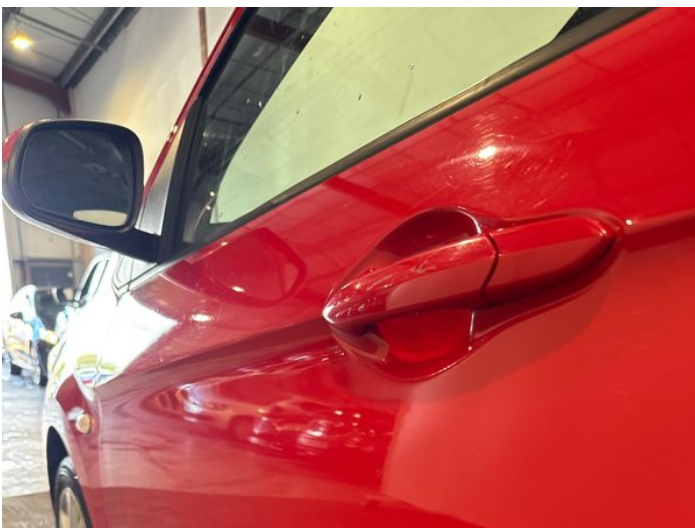
7: Door nsr  
Dented  
Over 30mm

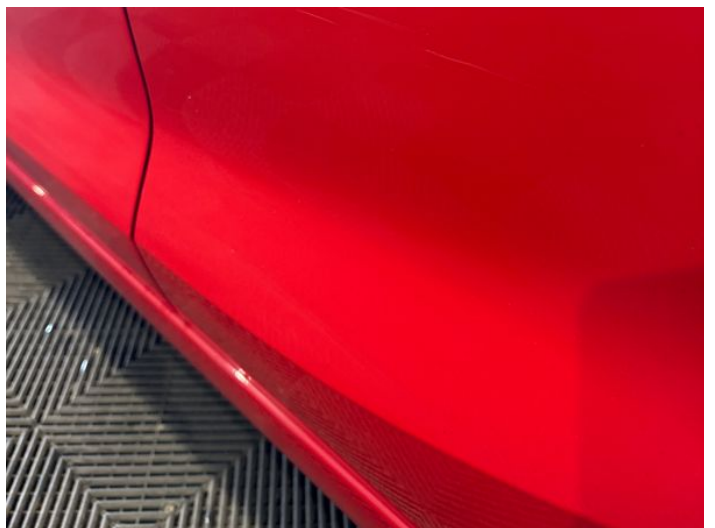
8: Door nsr  
Scratched  
Over 25mm Thru Paint

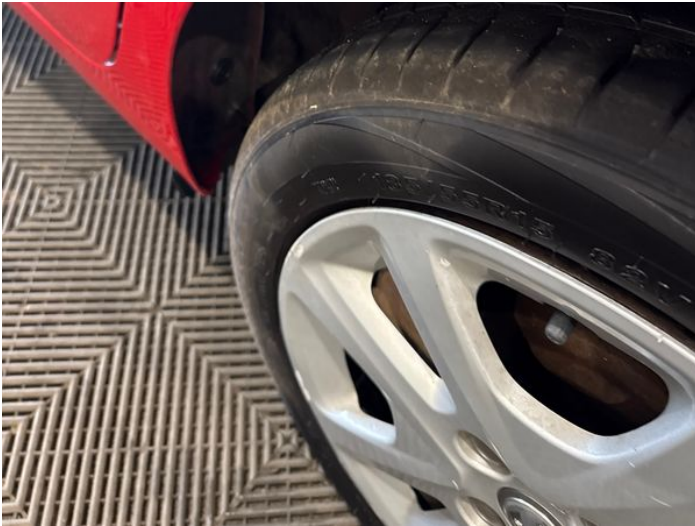
9: Qtr Panel nsr  
Scratched  
Over 25mm Thru Paint

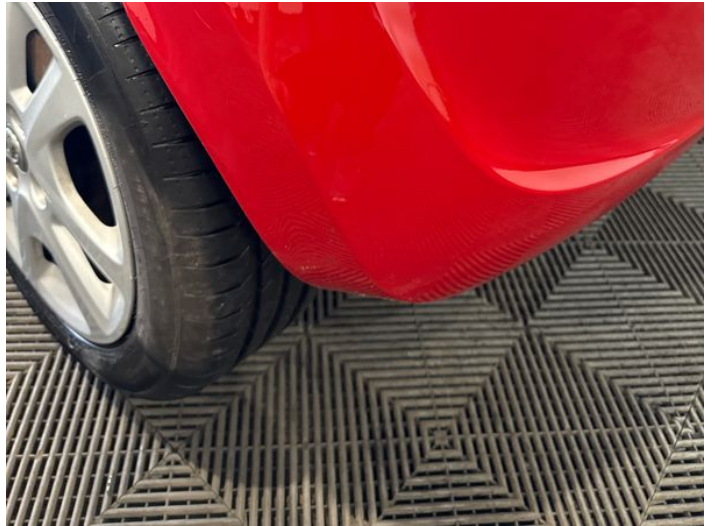
10: Bumper Rear  
Scratched  
Up To 25mm Thru Paint

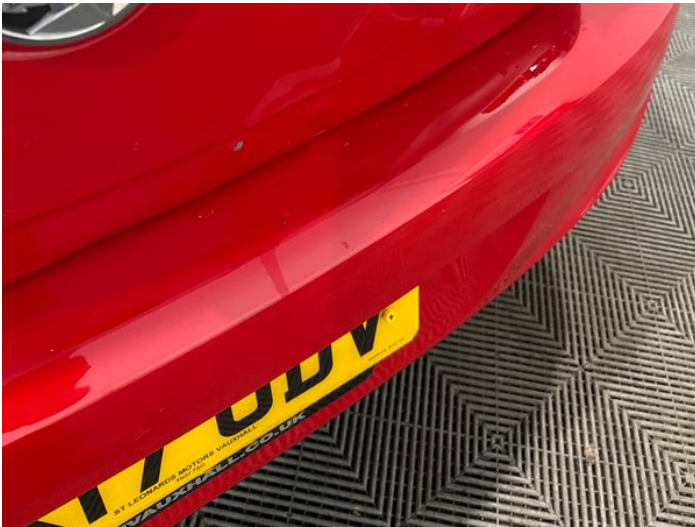
11: Tailgate  
Dented  
Over 30mm

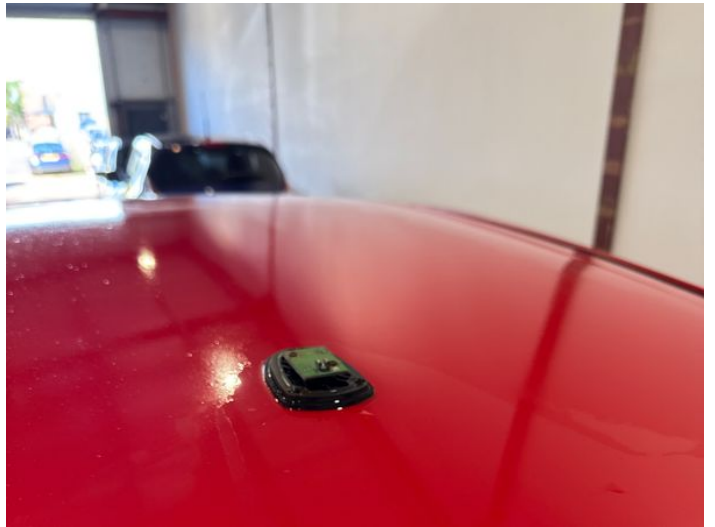
12: Aerial  
Broken  
Replace

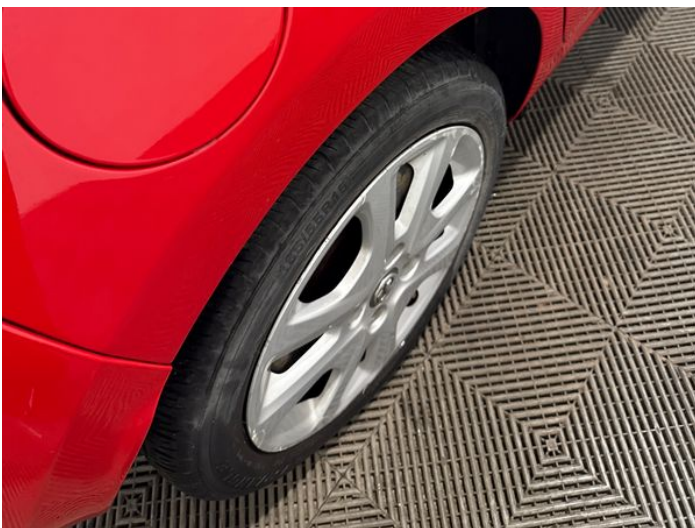
13: Qtr Panel osr  
Scratched  
Over 25mm Thru Paint

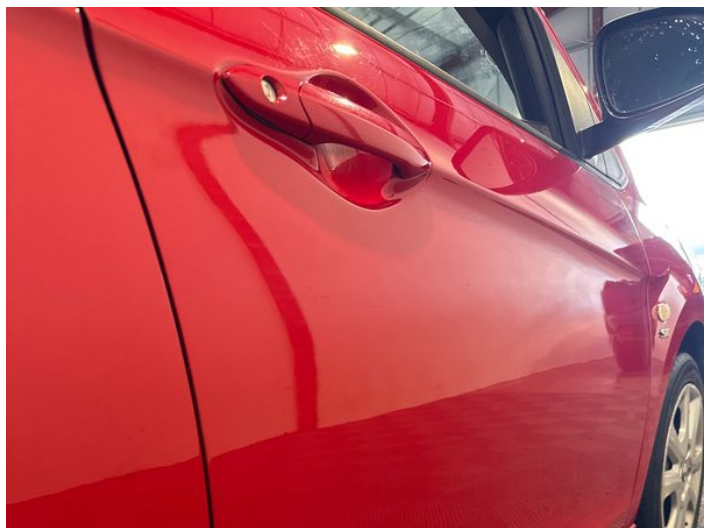
14: Door osf  
Scratched  
Over 25mm Thru Paint

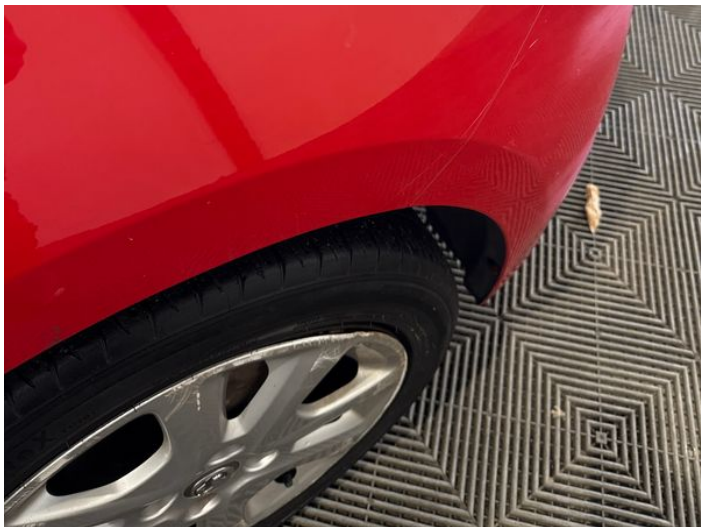
15: Wing osf  
Scratched  
Over 25mm Thru Paint
