# VEHICLE INSPECTION REPORT

**KM64VDE**

## Citroen C4 Picasso 1.6 HDi VTR+ 5dr

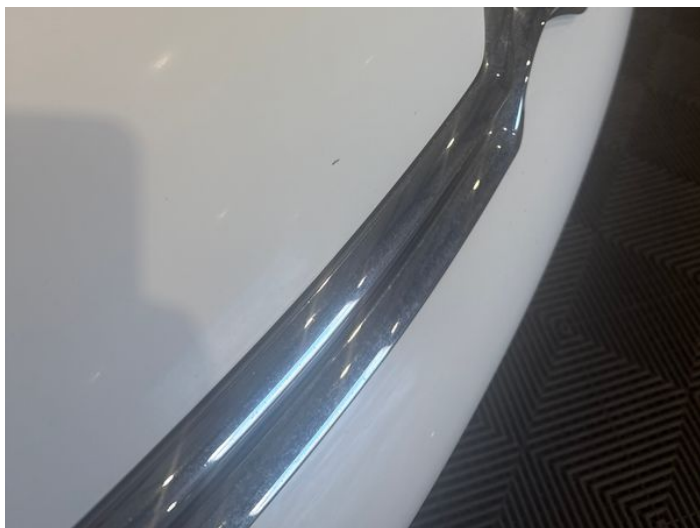
1: Bonnet  
Chipped  
1 To 5

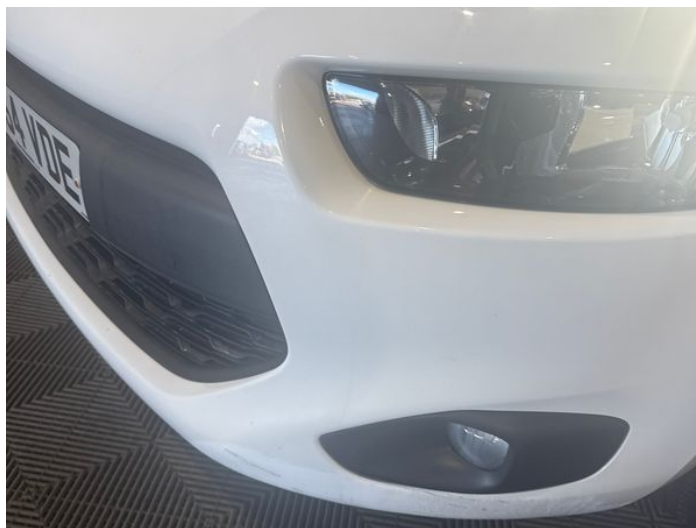
2: Bumper Front  
Scratched  
25 to 100mm Thru Paint

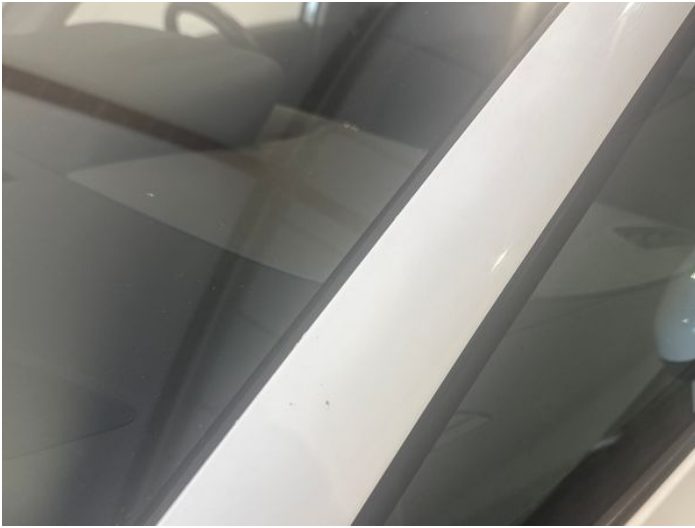
3: A Post ns  
Chipped  
1 To 5

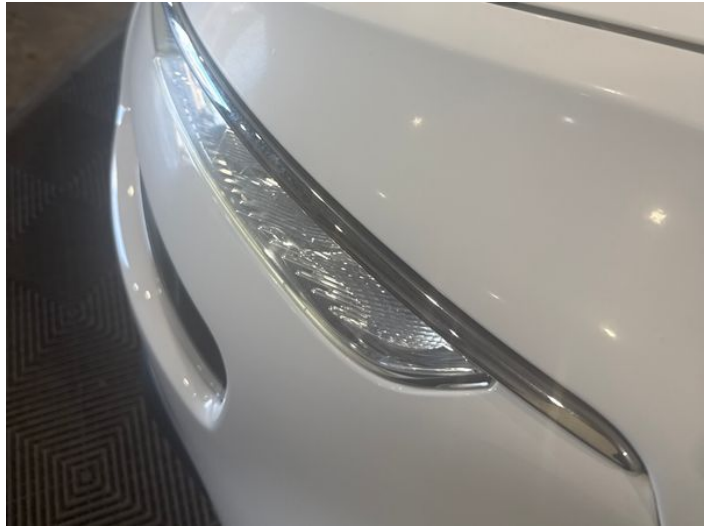
4: Wing nsf  
Chipped  
1 To 5

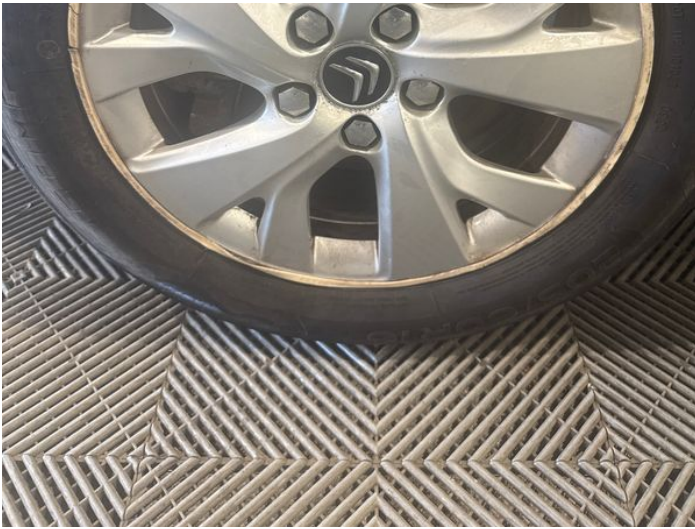
5: Wheel nsf  
Scratched  
Over 50mm

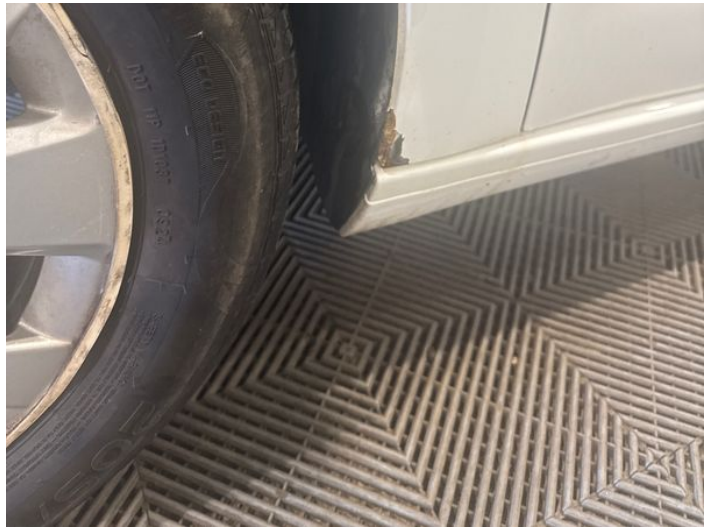
6: Wing nsf  
Rusted  
Over 5mm

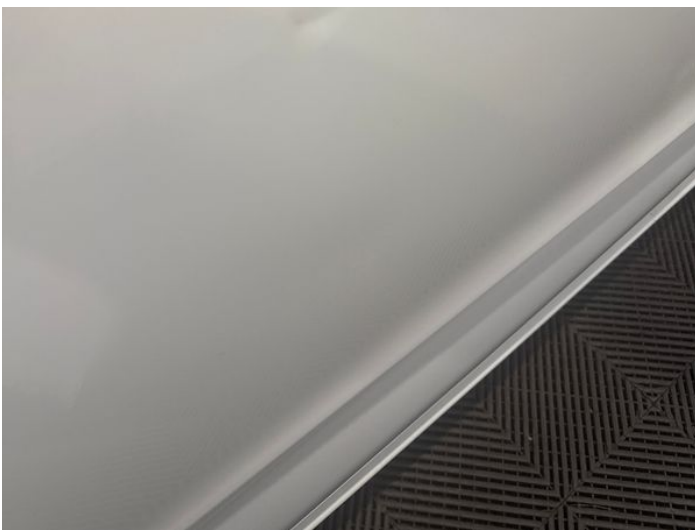
7: Door osf  
Dented  
Between 10mm + 30mm

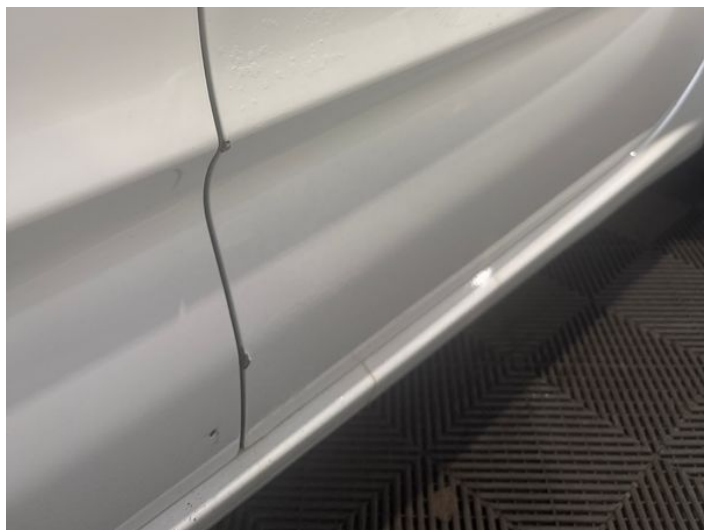
8: Door nsr  
Dented  
With Paint Damage

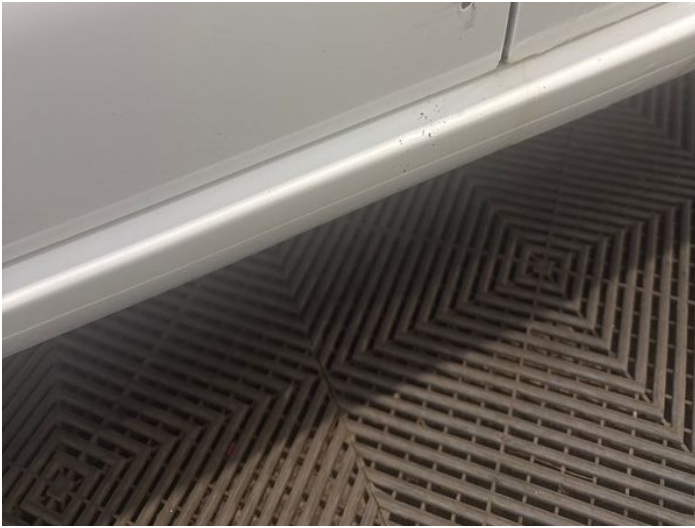
9: Door nsf  
Chipped  
Over 5mm

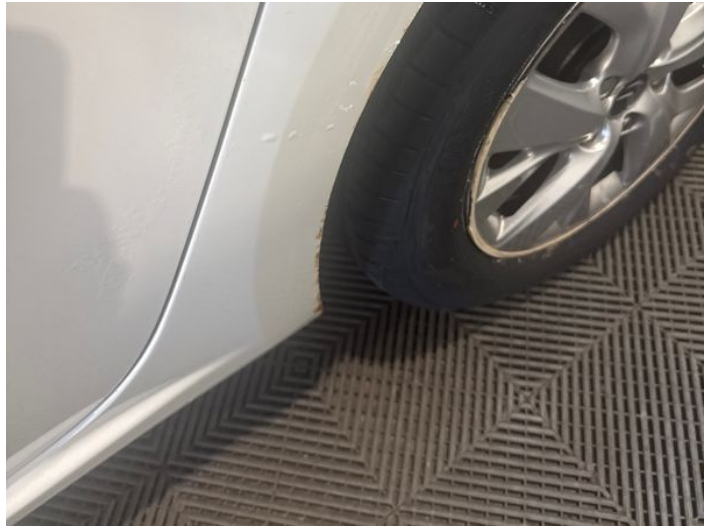
10: Qtr Panel nsr  
Rusted  
Over 5mm

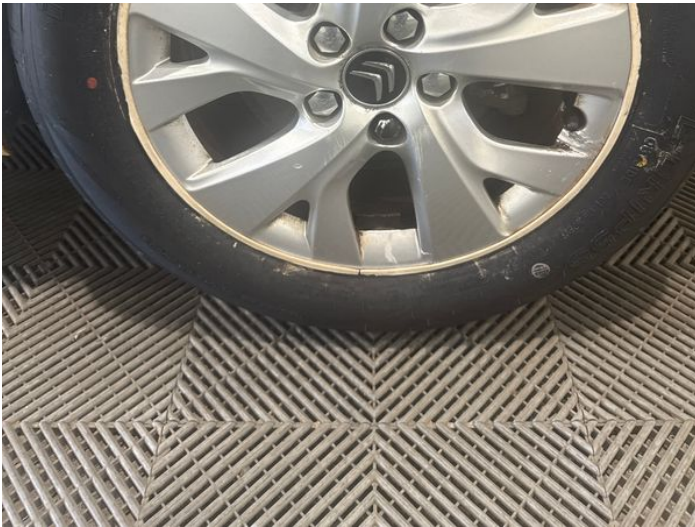
11: Wheel nsr  
Corroded  
Light

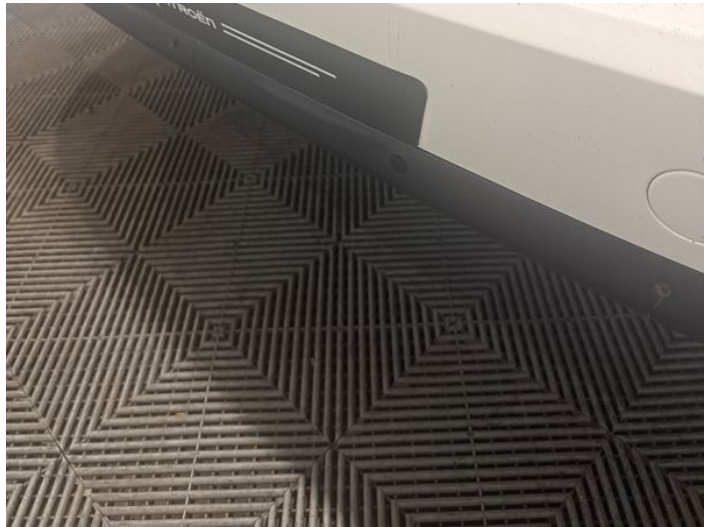
12: Bumper Rear  
Dented  
With Paint Damage

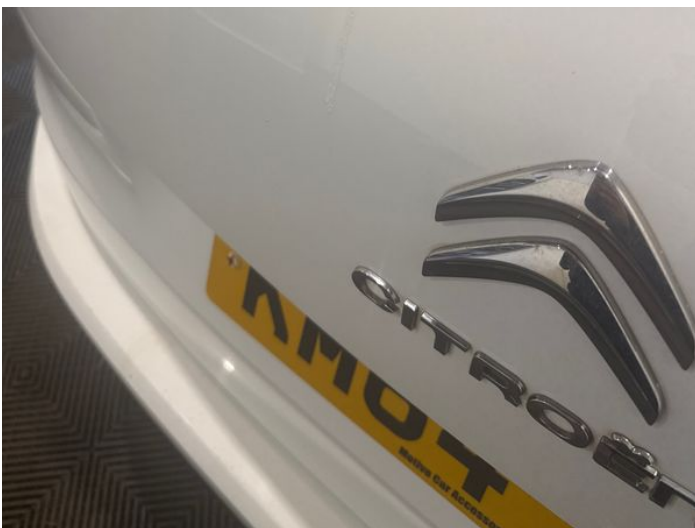
13: Tailgate  
Scratched  
Over 25mm Thru Paint

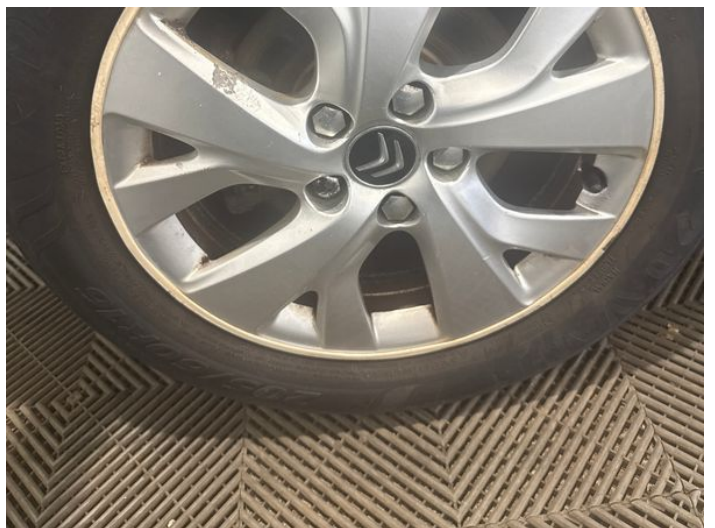
14: Wheel osr  
Corroded  
Light

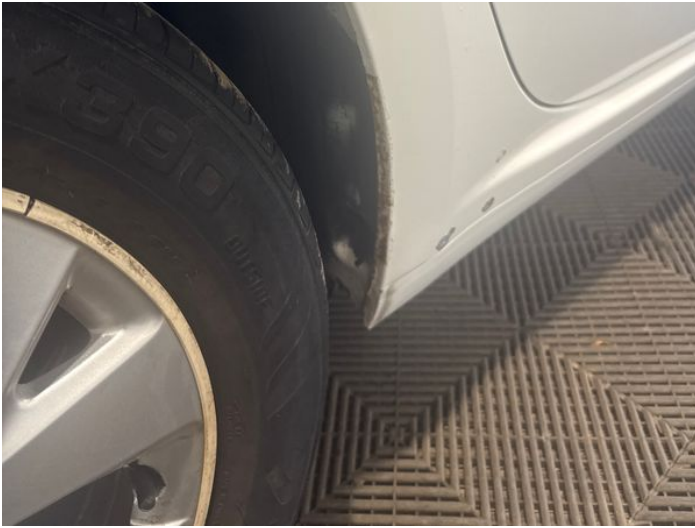
15: Qtr Panel osr  
Rusted  
Over 5mm

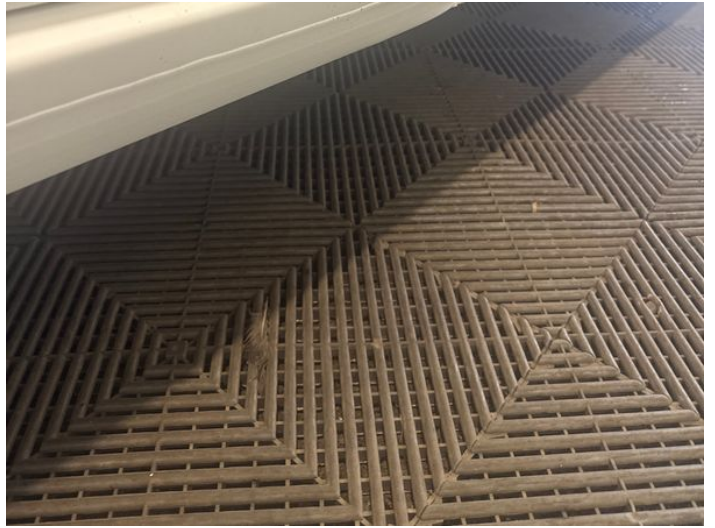
16: Sill os  
Dented  
Over 30mm

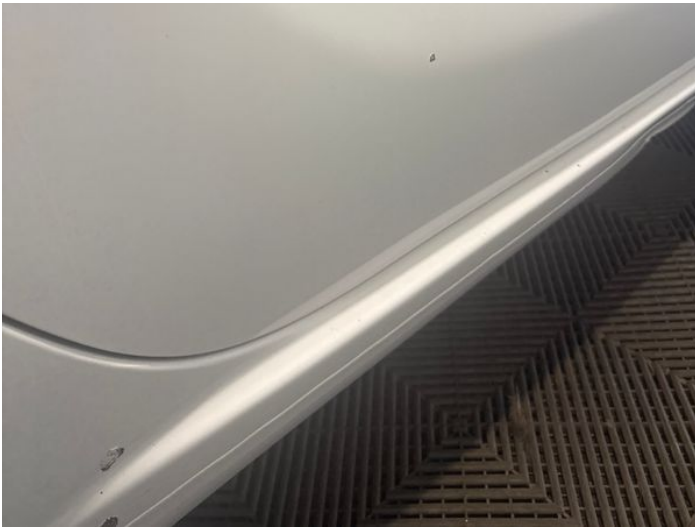
17: Door osr  
Chipped  
Over 5mm

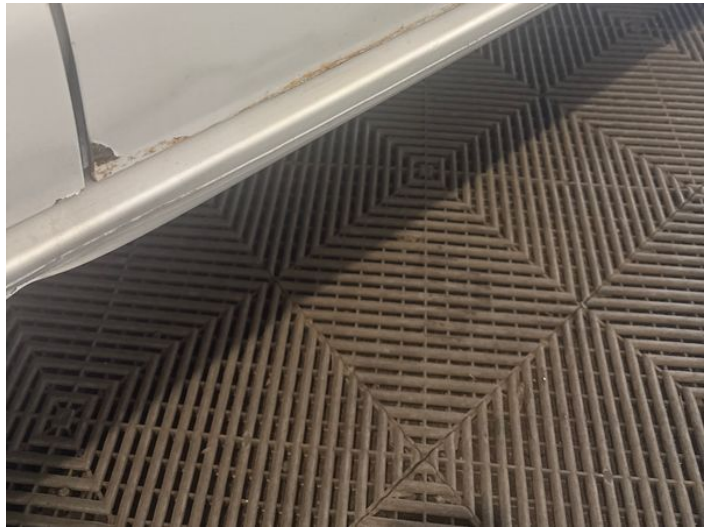
18: Door osf  
Rusted  
Over 5mm

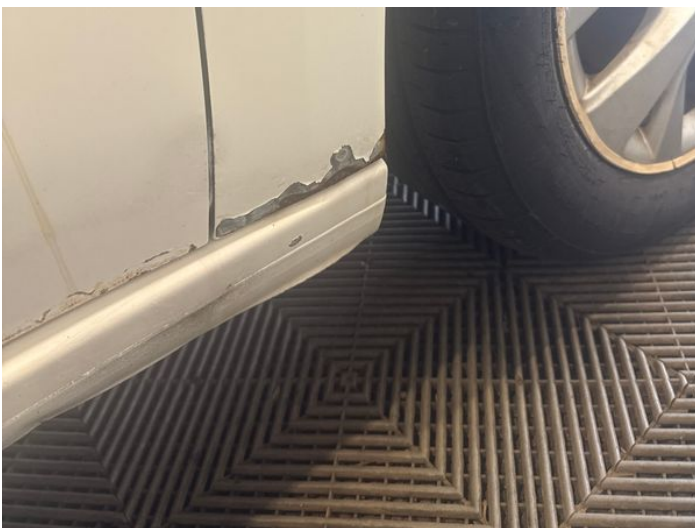
19: Wing osf  
Scratched  
Rusted

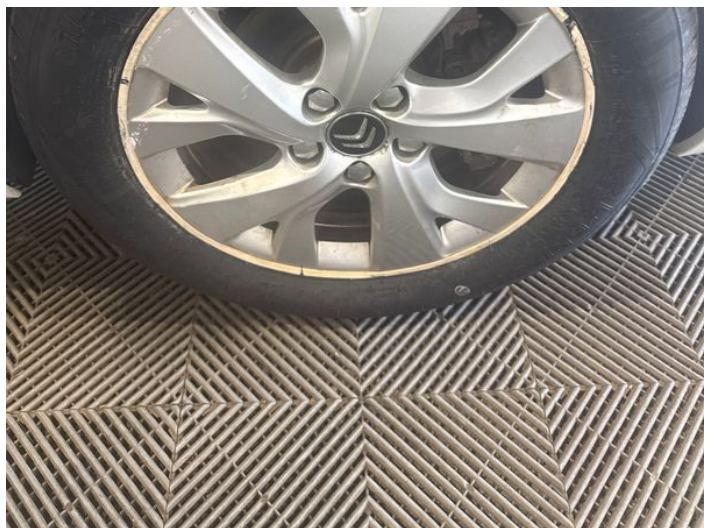
20: Wheel osf  
Scratched  
Over 50mm

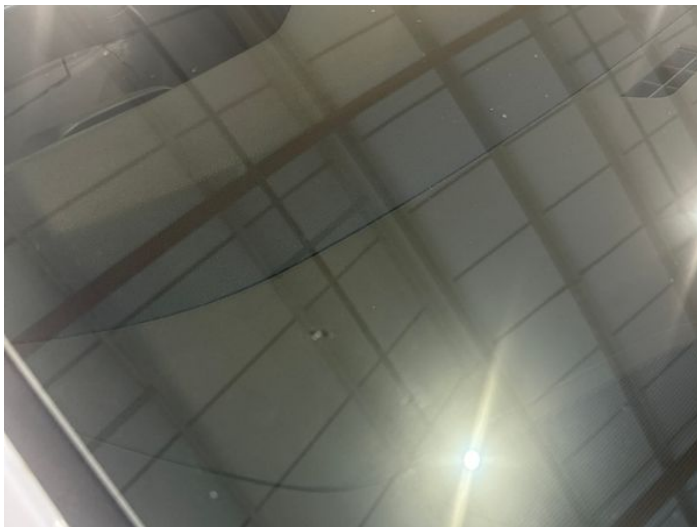
21: Screen Front  
Chipped  
UpTo 10mm

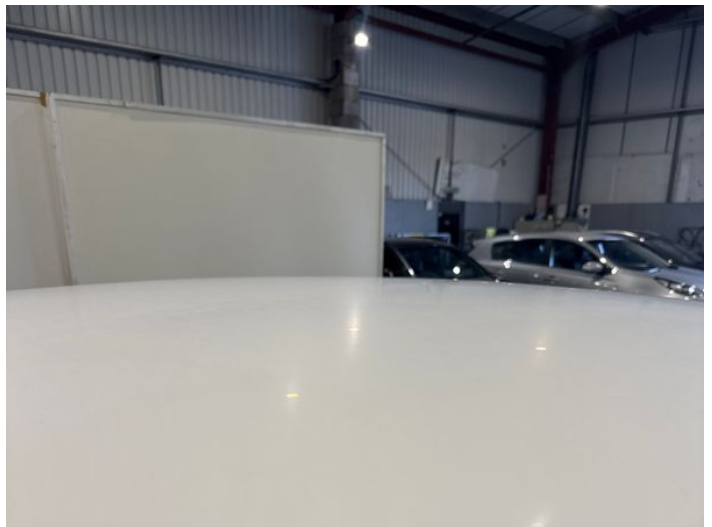
22: Roof  
Dented  
Over 30mm
