## VEHICLE INSPECTION REPORT

**CA15FMK**

### BMW 3 Series 335d xDrive M Sport 5dr Step Auto [Business Media]

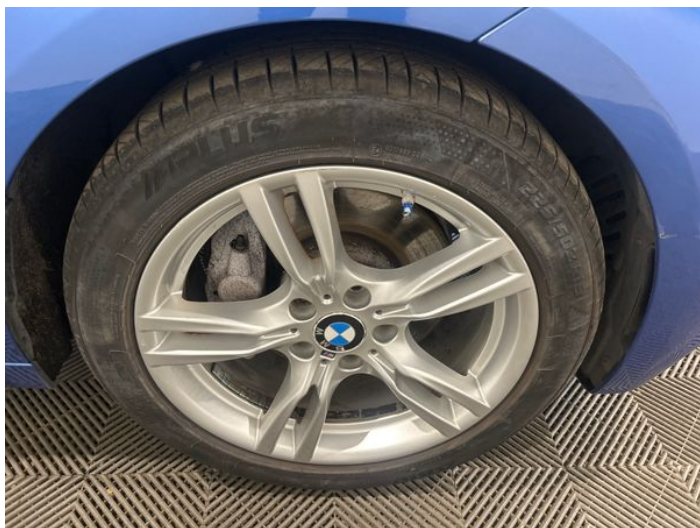
1: Wheel osf  
Scratched  
Up To 50mm

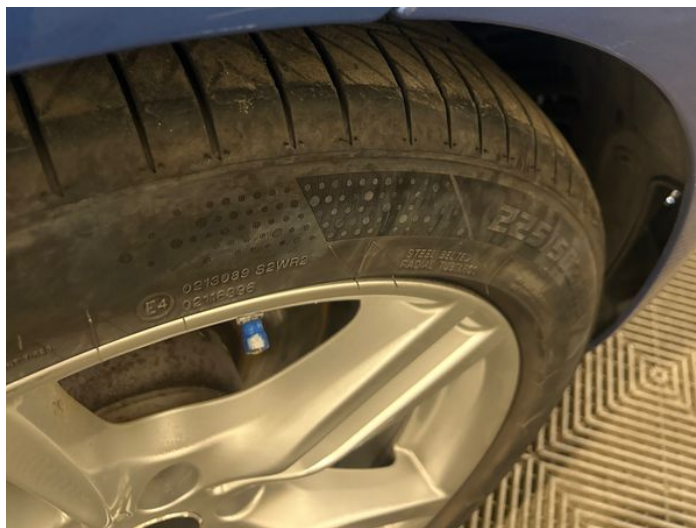
2: Wing osf  
Scratched  
Over 25mm Thru Paint

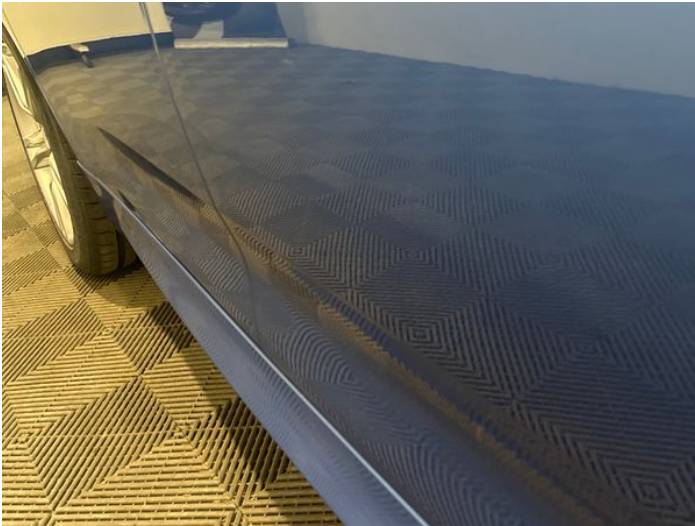
3: Door osf  
Dented  
Over 30mm

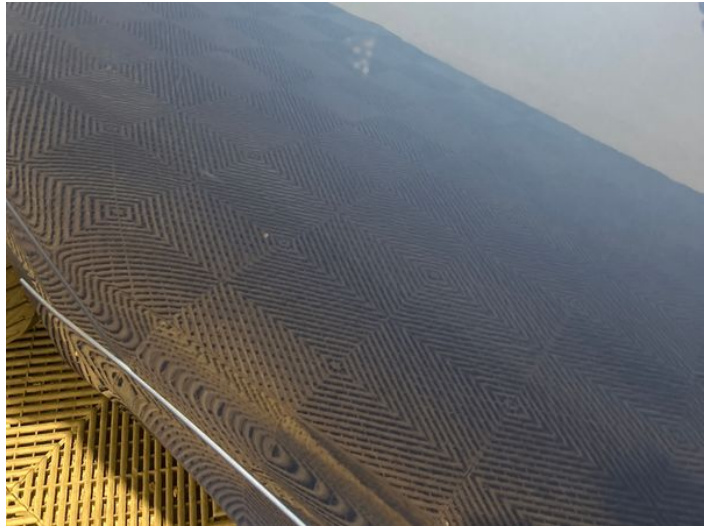
4: Door osr  
Chipped  
1 To 5

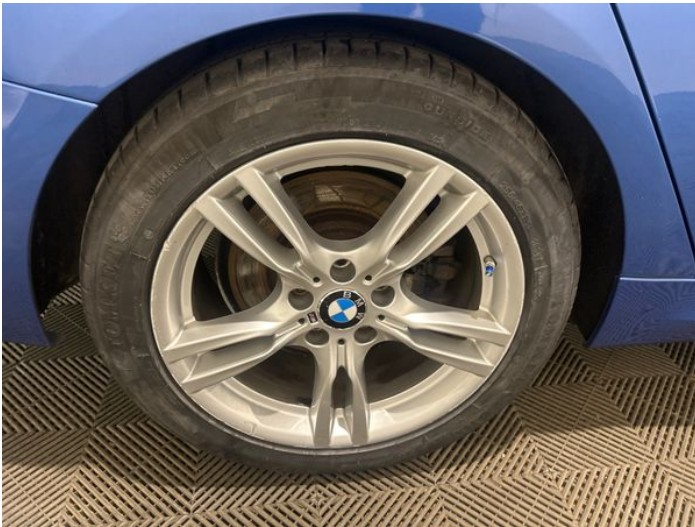
5: Wheel osr  
Scratched  
Over 50mm

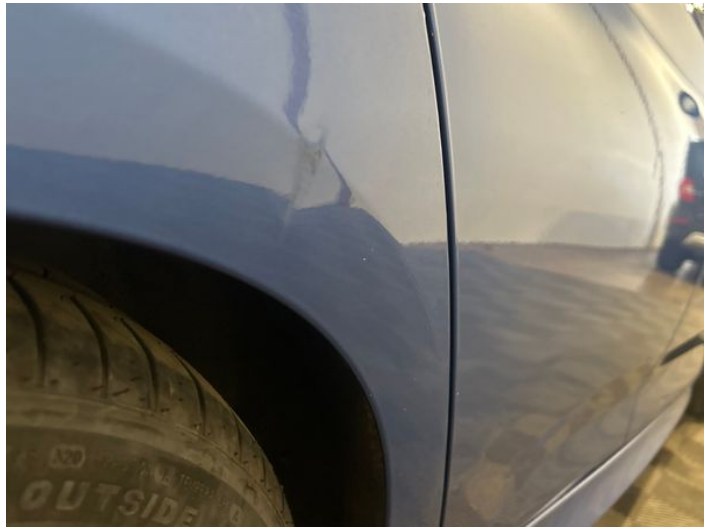
6: Qtr Panel osr  
Dented  
With Paint Damage

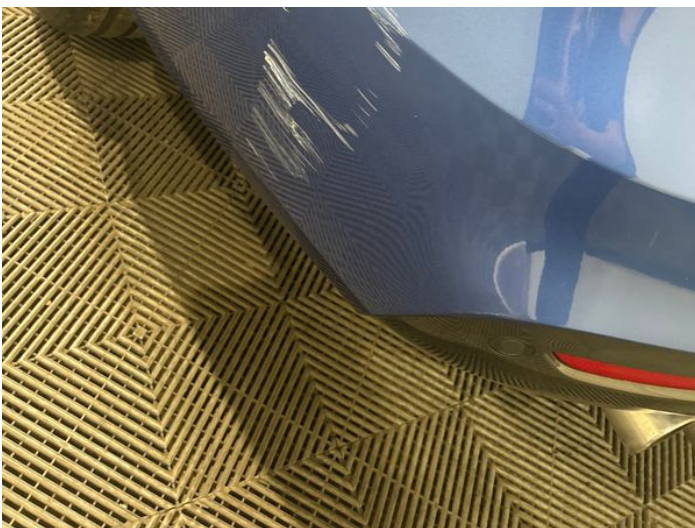
7: Bumper Rear  
Dented  
With Paint Damage

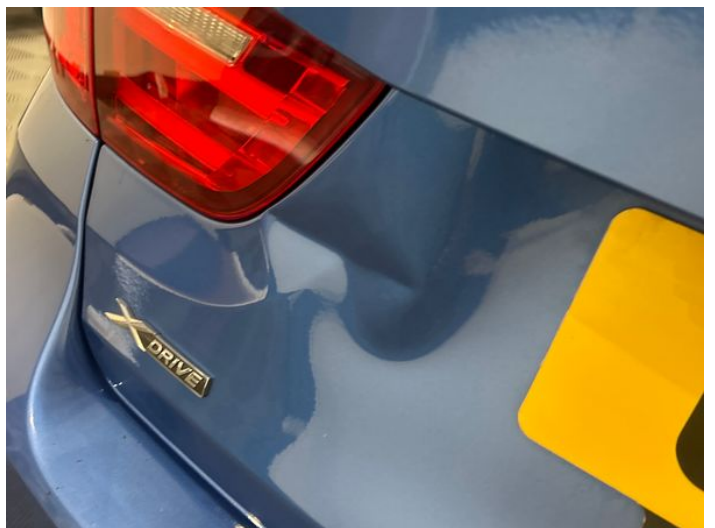
8: Tailgate  
Dented  
Over 30mm

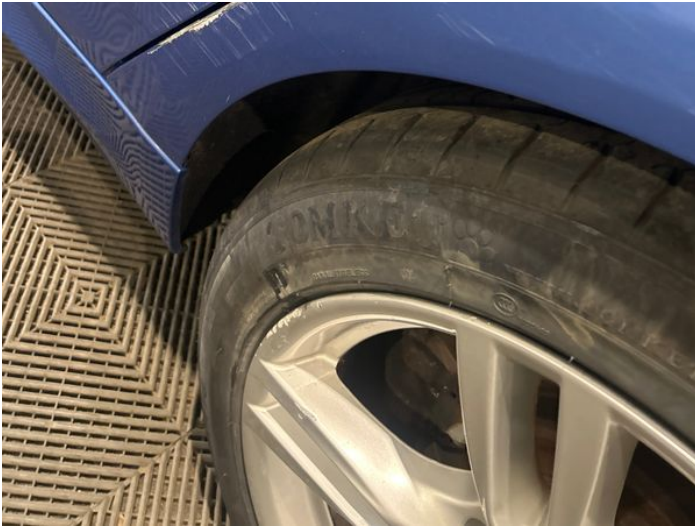
9: Qtr Panel nsr  
Dented  
With Paint Damage

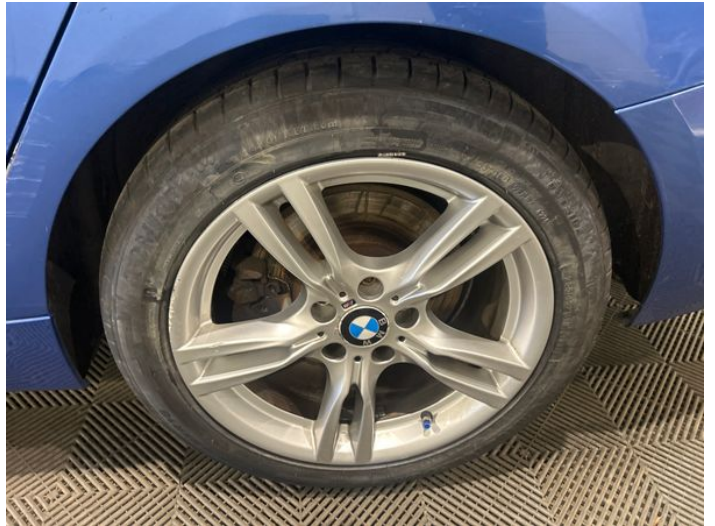
10: Wheel nsr  
Scratched  
Over 50mm

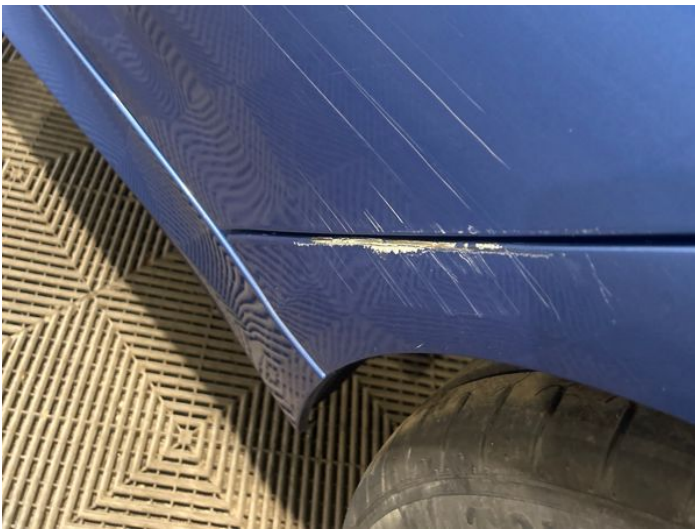
11: Door nsr  
Scratched  
Over 25mm Thru Paint

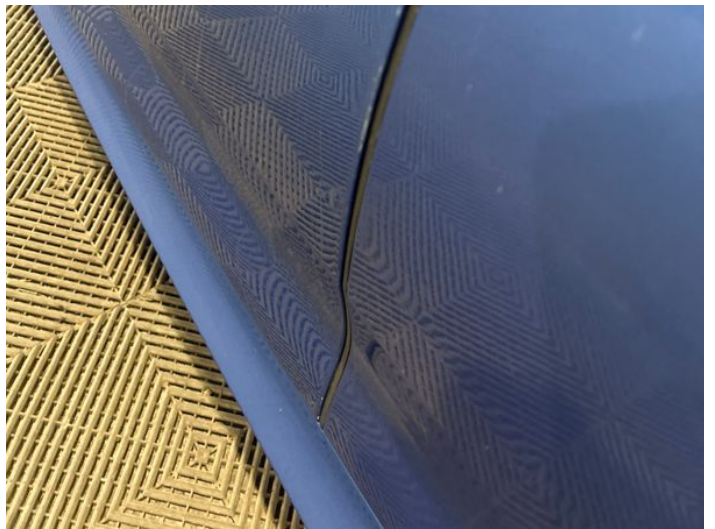
12: Door nsf  
Chipped  
Edge Chip

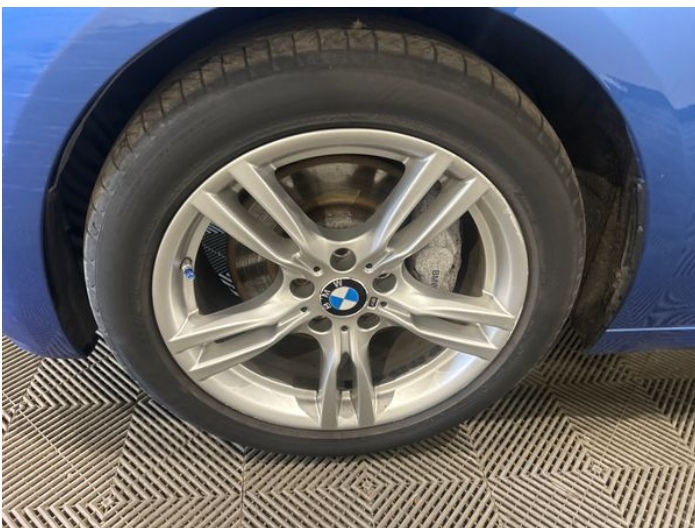
13: Wheel nsf  
Scratched  
Over 50mm

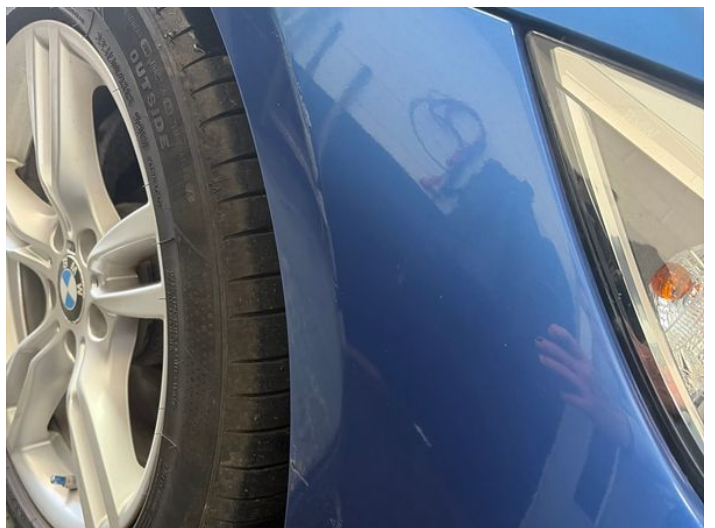
14: Bumper Front  
Scratched  
Over 100mm Thru Paint

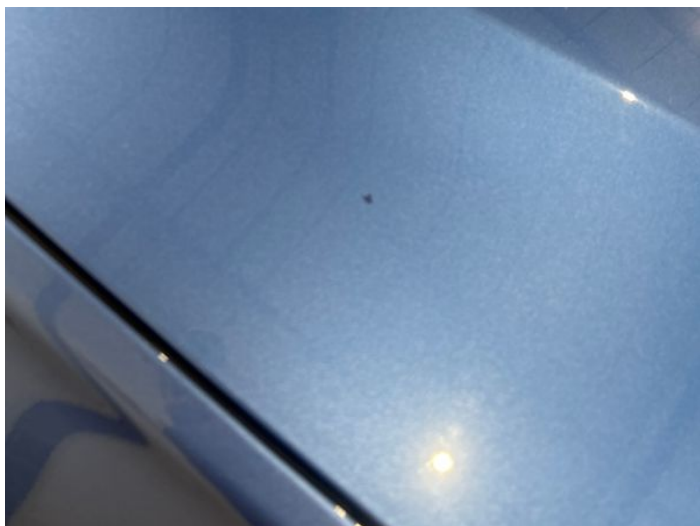
15: Bonnet  
Chipped  
1 To 5

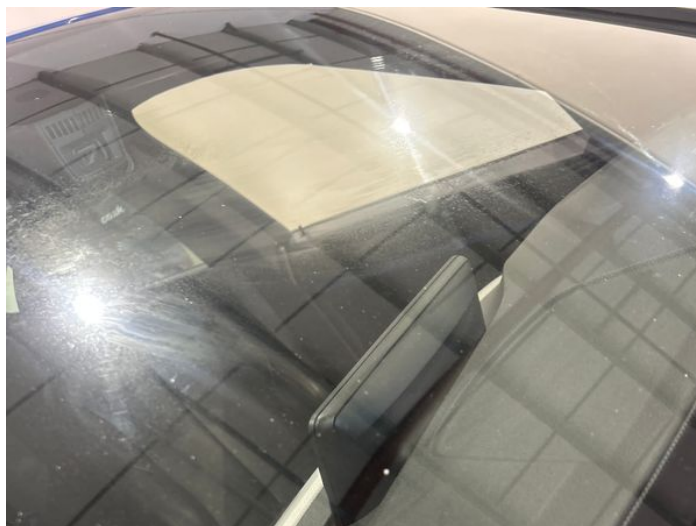
16: Screen Front  
Chipped  
UpTo 10mm

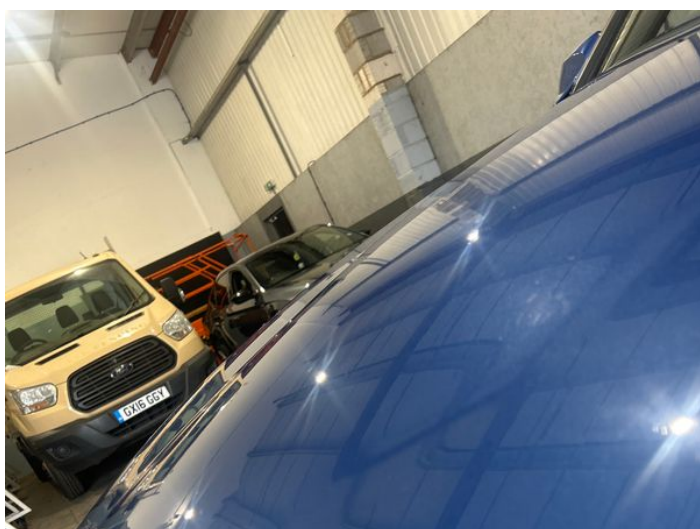
17: Bonnet  
Dented  
2 Or Less UpTo 10mm
