## VEHICLE INSPECTION REPORT

**RO69VTG**

### Nissan Qashqai 1.5 dCi 115 N-Connecta 5dr

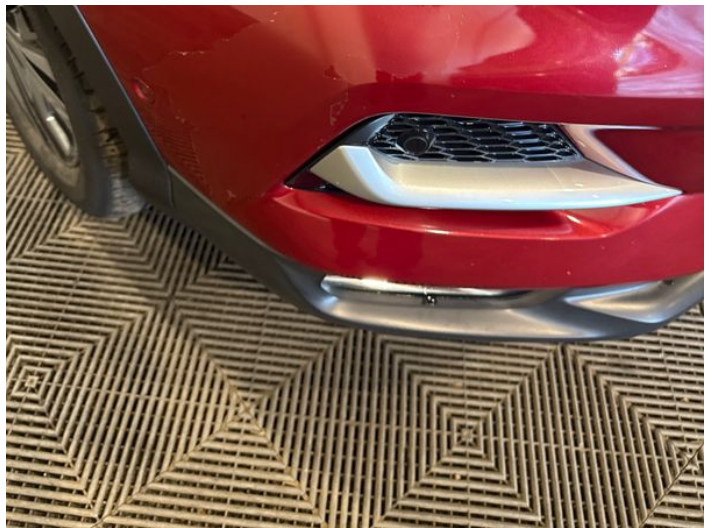
2: Bumper Front  
Poor Previous Repair  
Paint Flake

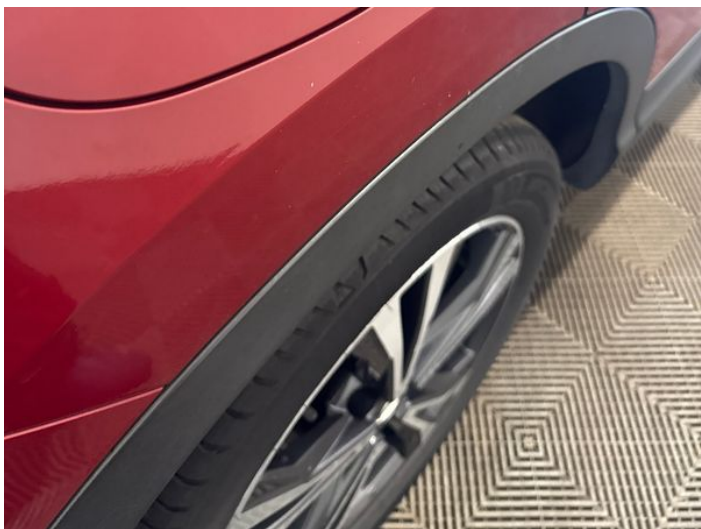
9: Qtr Panel osr  
Chipped  
1 To 5

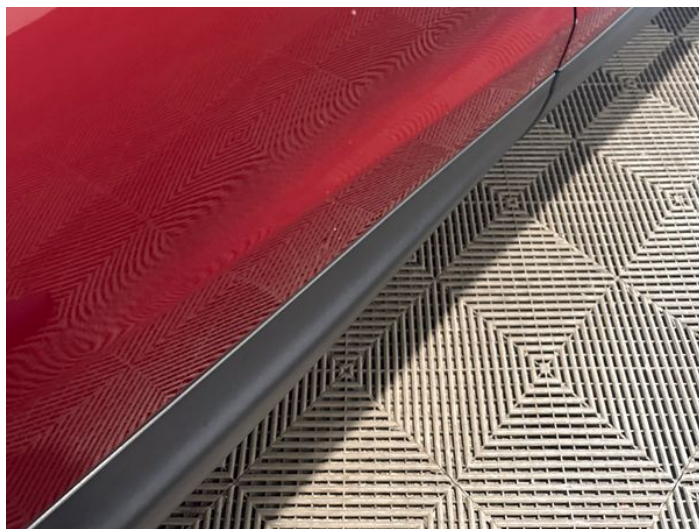
10: Door osr  
Chipped  
Multiple Chips

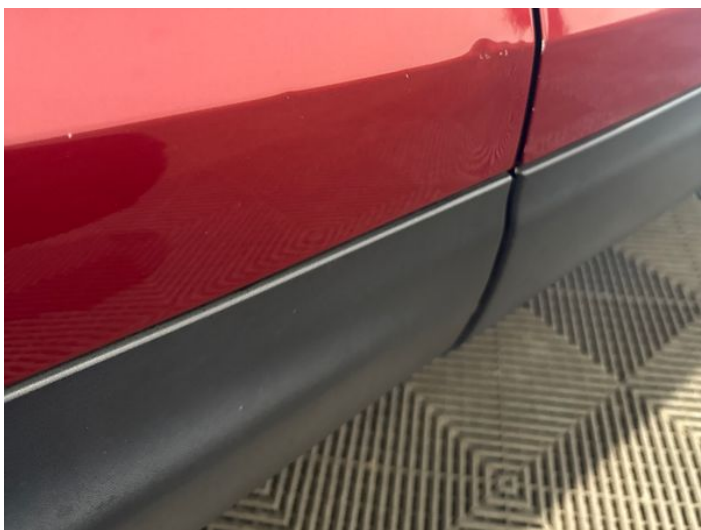
11: Door osr  
Dented  
Between 10mm + 30mm

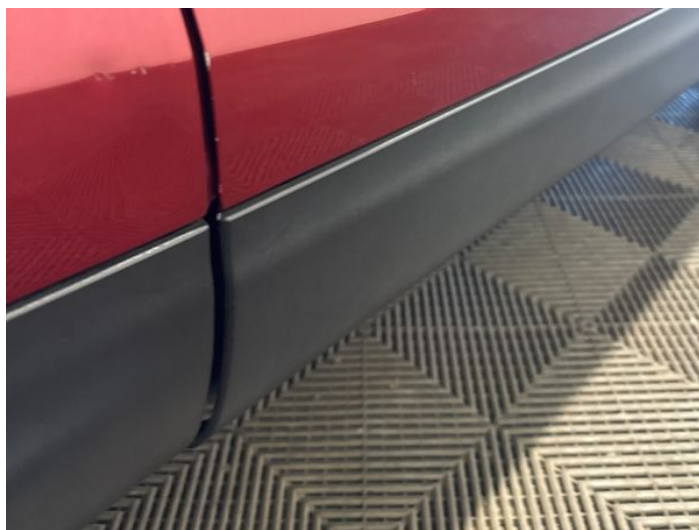
12: Door osf  
Chipped  
Edge Chip

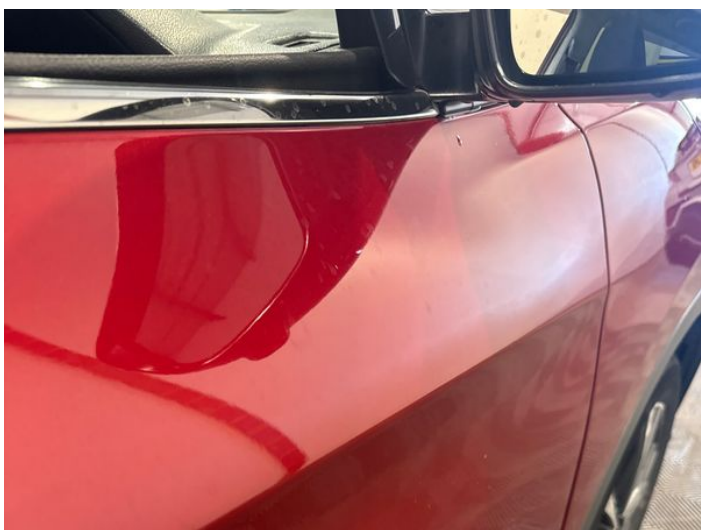
13: Door osf  
Dented  
2 Or Less UpTo 10mm

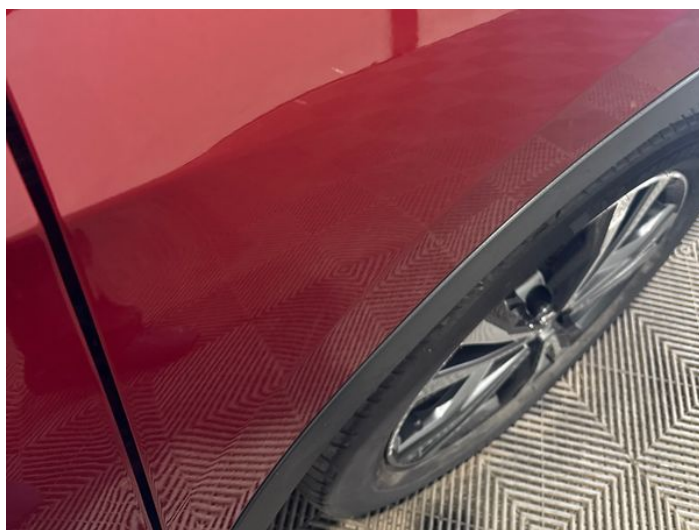
14: Wing osf  
Scratched  
UpTo 25mm Thru Paint

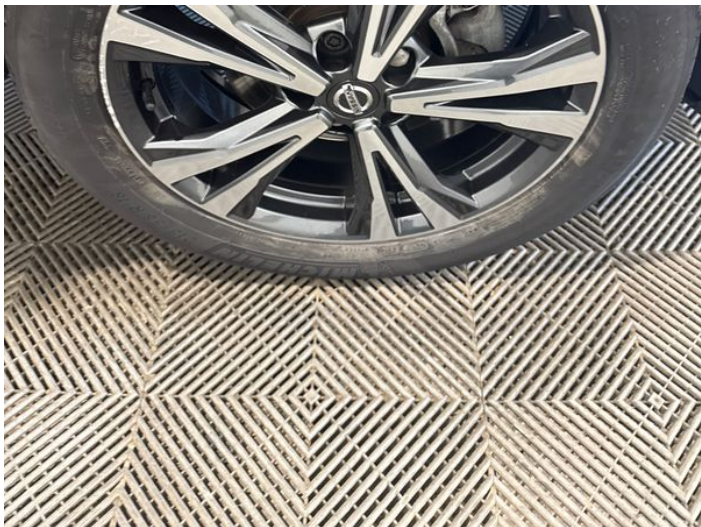
15: Wheel nsf  
Scratched  
Over 50mm
