# VEHICLE INSPECTION REPORT

**LC65BWL**

## Volvo XC60 D4 [190] SE Lux Nav 5dr

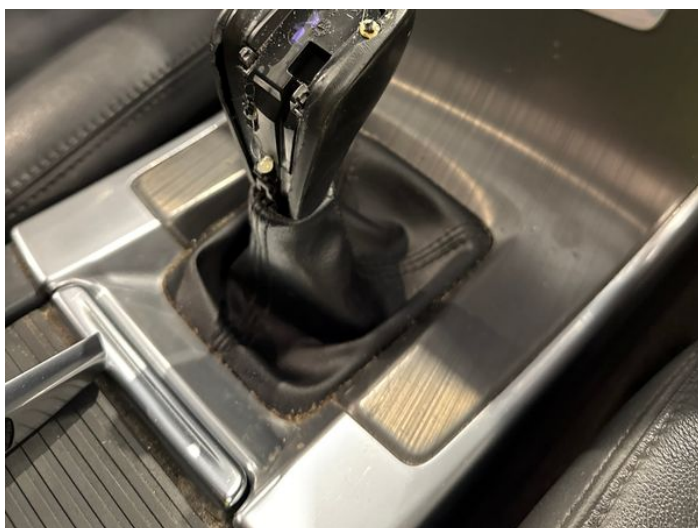
1: Switches And Controls  
Broken  
Replace

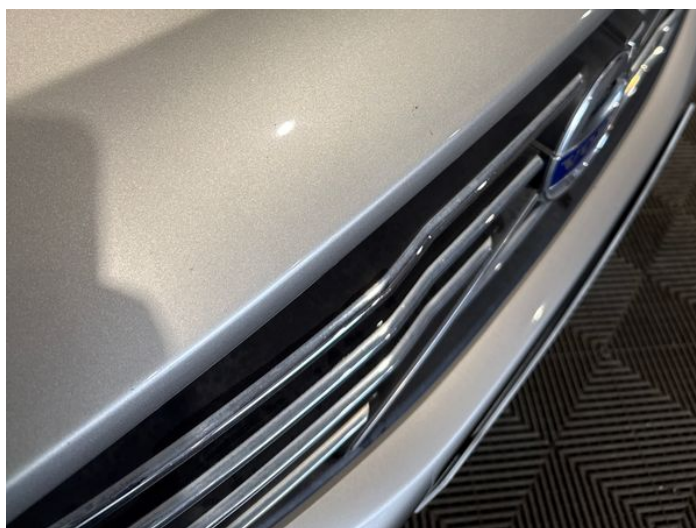
2: Bonnet  
Chipped  
1 To 5

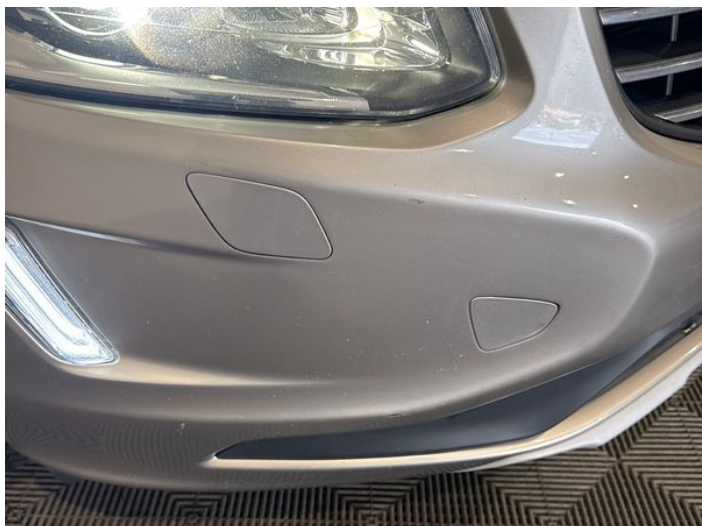
3: Bumper Front  
Scratched  
25 to 100mm Thru Paint

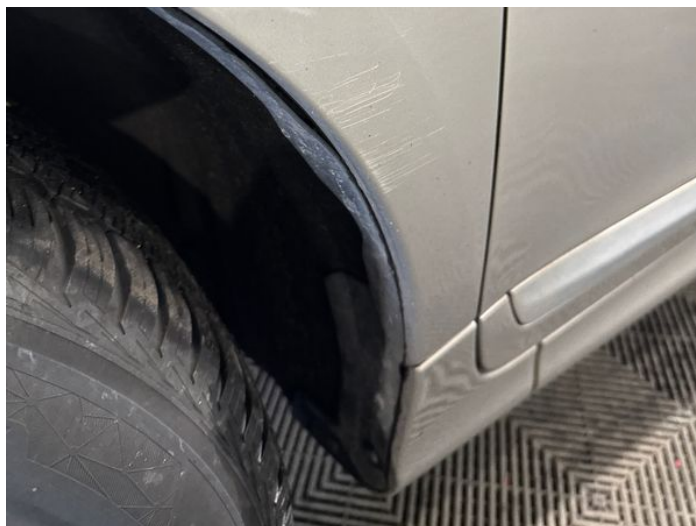
4: Wing nsf  
Scratched  
Over 25mm Thru Paint

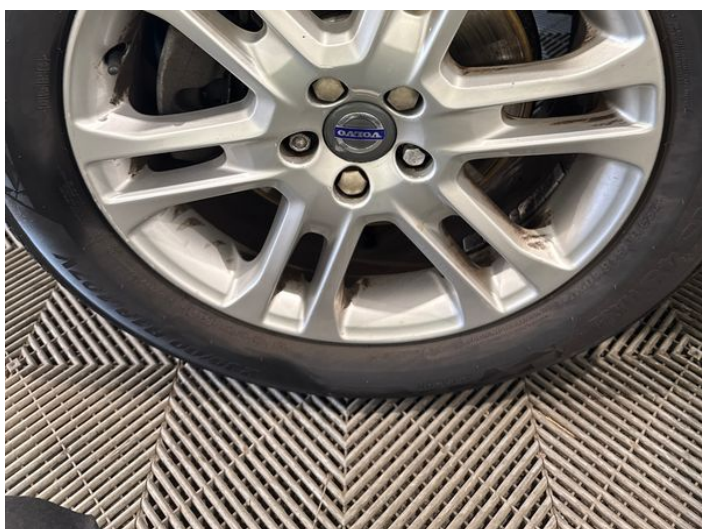
5: Wheel nsf  
Scratched  
Over 50mm

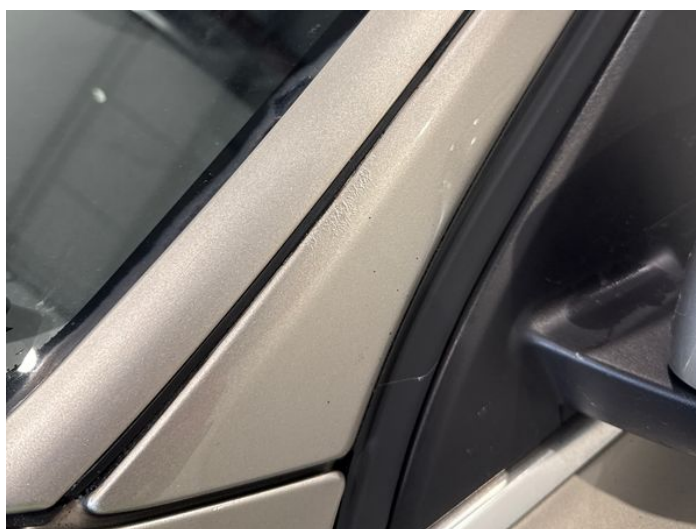
6: A Post ns  
Rusted  
Over 5mm

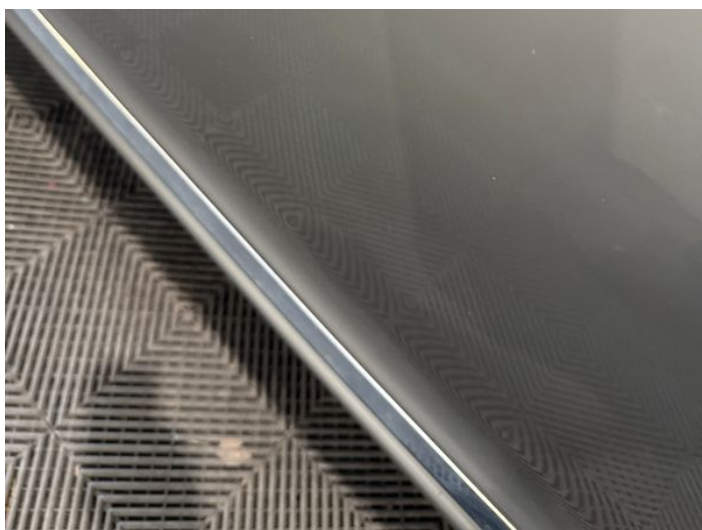
7: Door nsf  
Chipped  
1 To 5

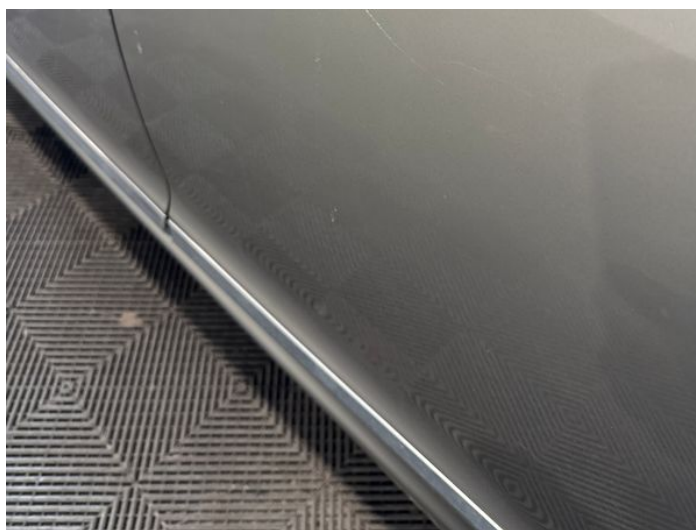
8: Door nsr  
Scratched  
Over 25mm Thru Paint

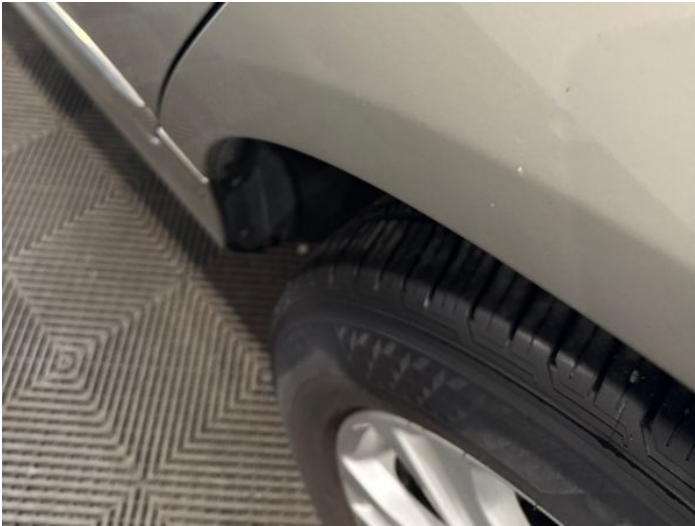
9: Qtr Panel nsr  
Dented  
Between 10mm + 30mm

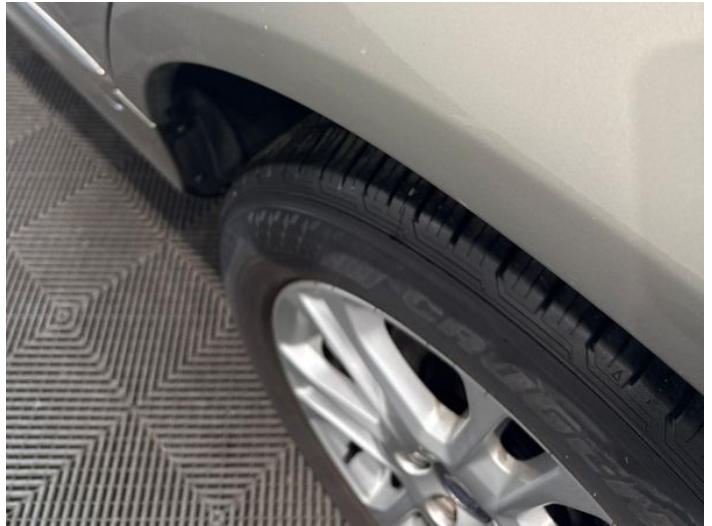
10: Qtr Panel nsr  
Chipped  
1 To 5

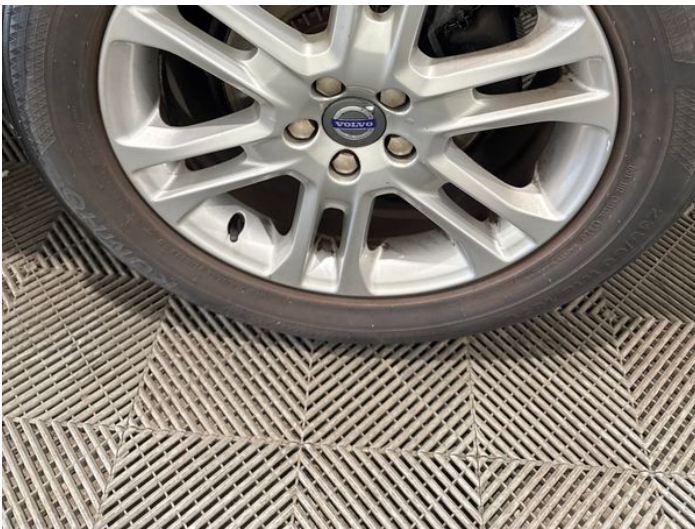
11: Wheel nsr  
Scratched  
Up To 50mm

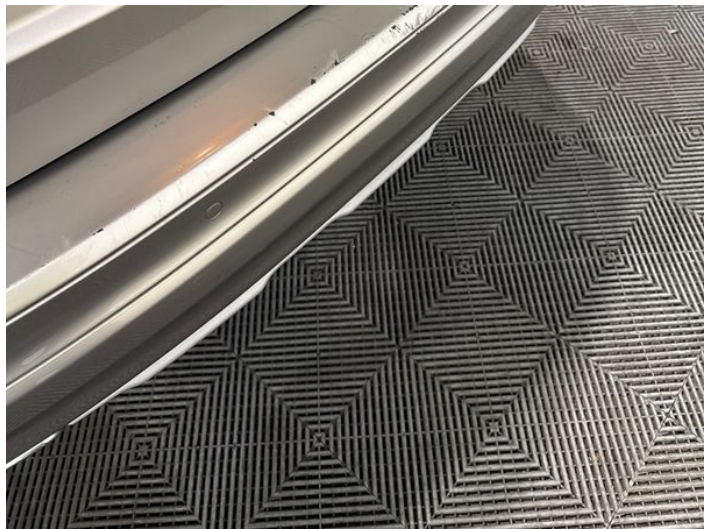
12: Bumper Rear  
Scratched  
25 to 100mm Thru Paint

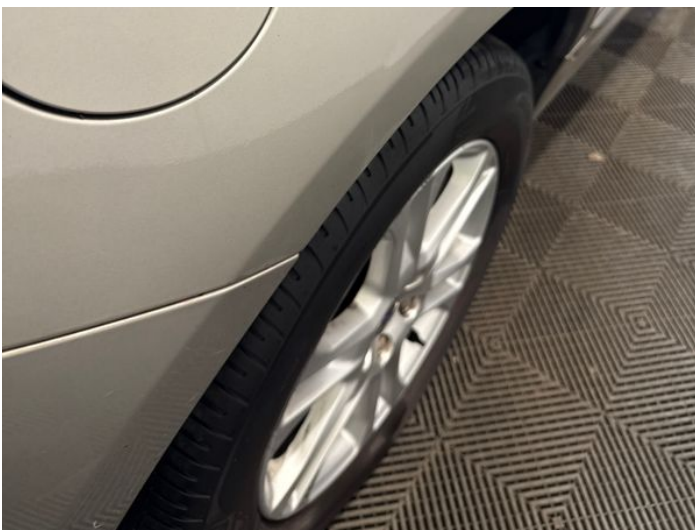
13: Qtr Panel osr  
Dented  
Between 10mm + 30mm

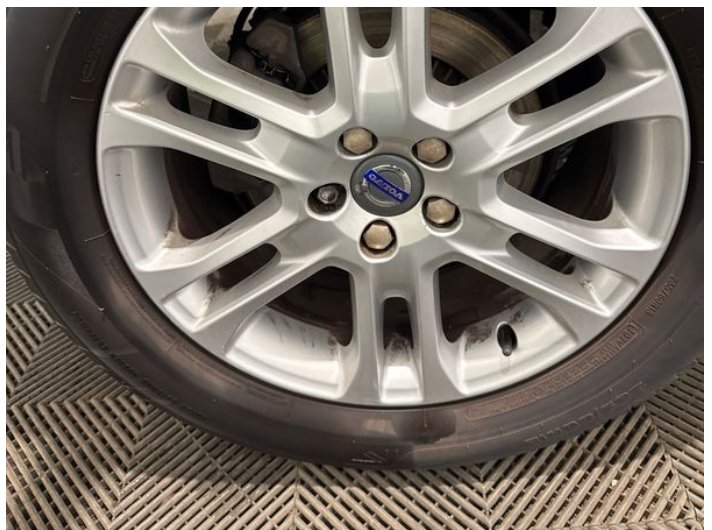
14: Wheel osr  
Scratched  
Over 50mm

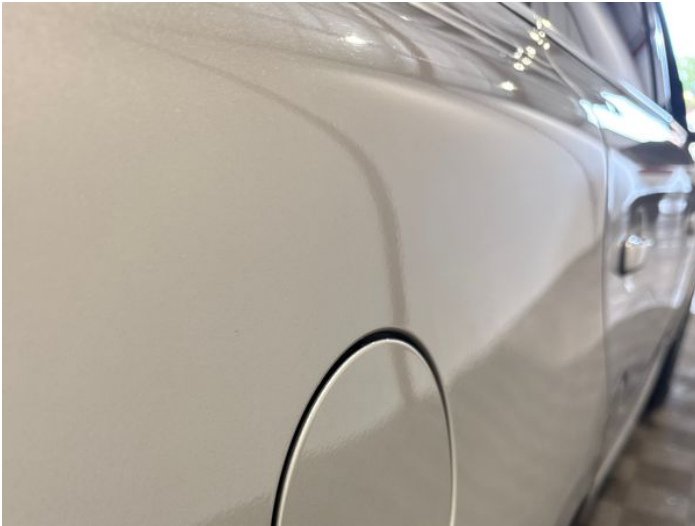
15: Qtr Panel osr  
Poor Previous Repair  
Rippled UpTo 30%

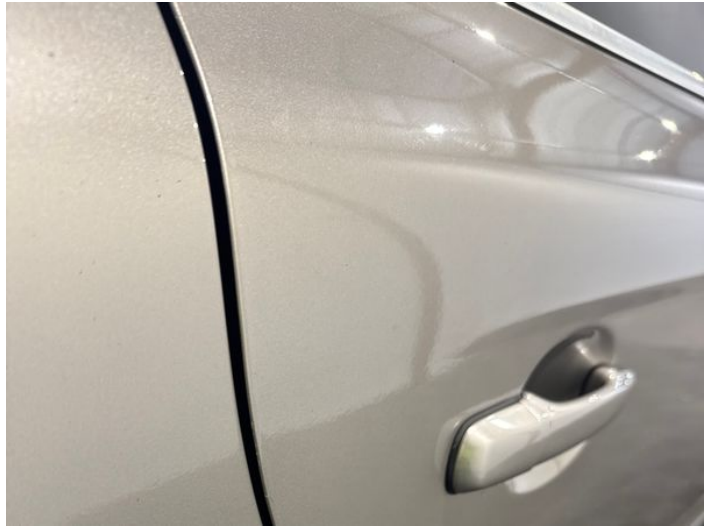
16: Door osr  
Poor Previous Repair  
Poor Paint

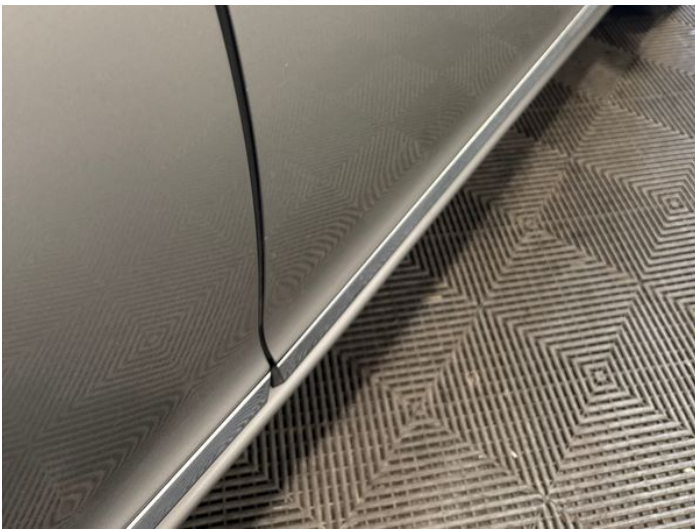
17: Door osf  
Chipped  
Edge Chip

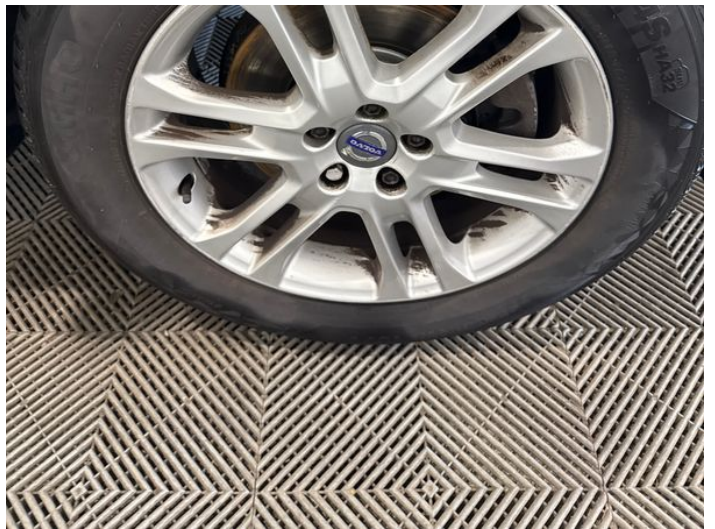
18: Wheel osf  
Scratched  
Over 50mm

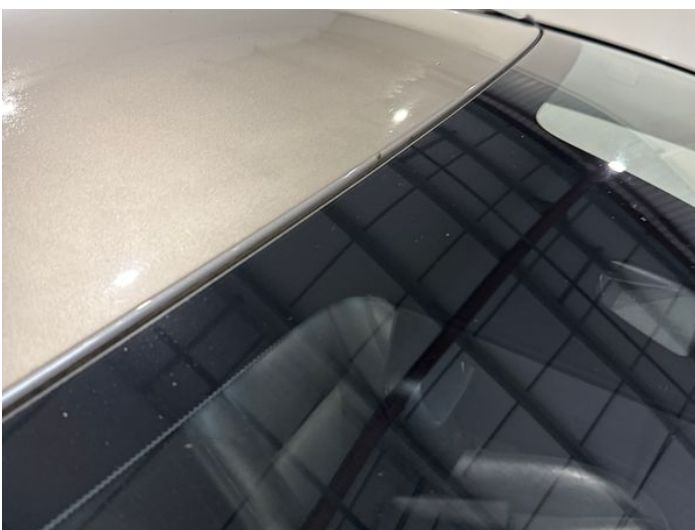
19: Roof  
Chipped  
Edge Chip
