# VEHICLE INSPECTION REPORT

**GU70WHC**

## BMW 3 Series 330e M Sport 4dr Step Auto

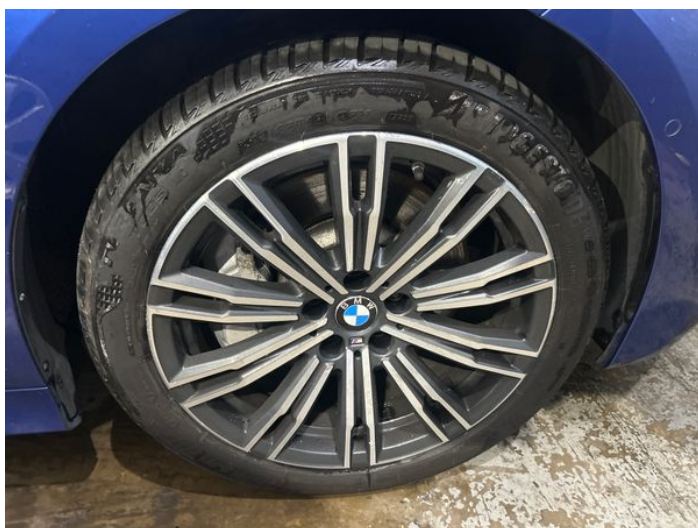
1: Wheel osf  
Corroded  
Light

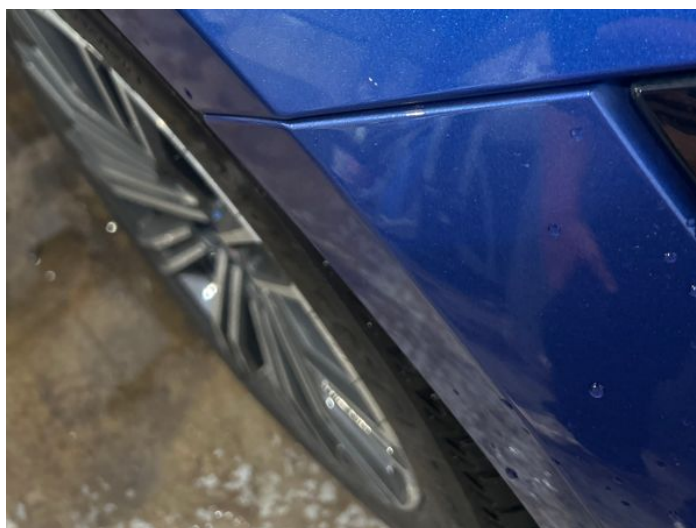
2: Wing osf  
Chipped  
1 To 5

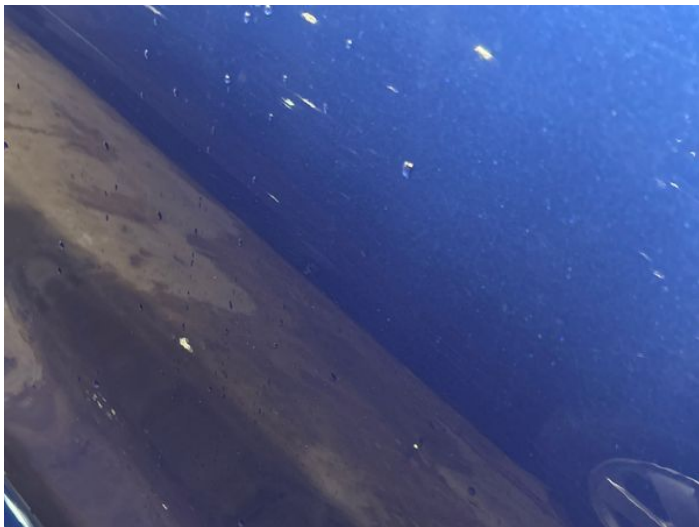
3: Door osf  
Chipped  
1 To 5

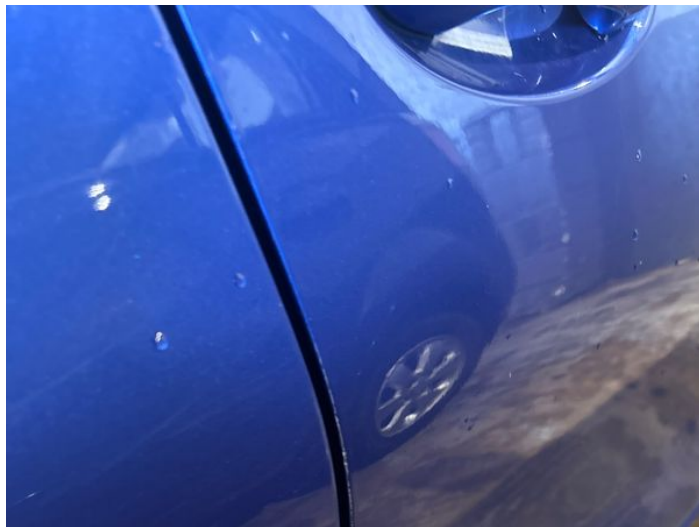
4: Door osf  
Chipped  
Edge Chip

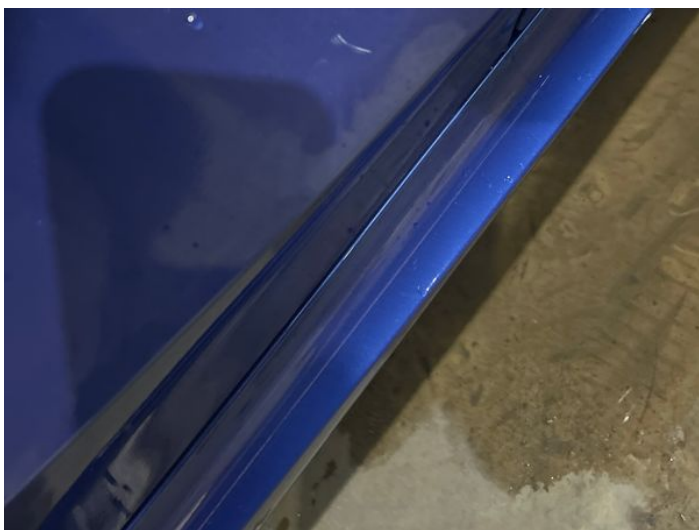
5: Door osr  
Scratched  
UpTo 25mm Thru Paint

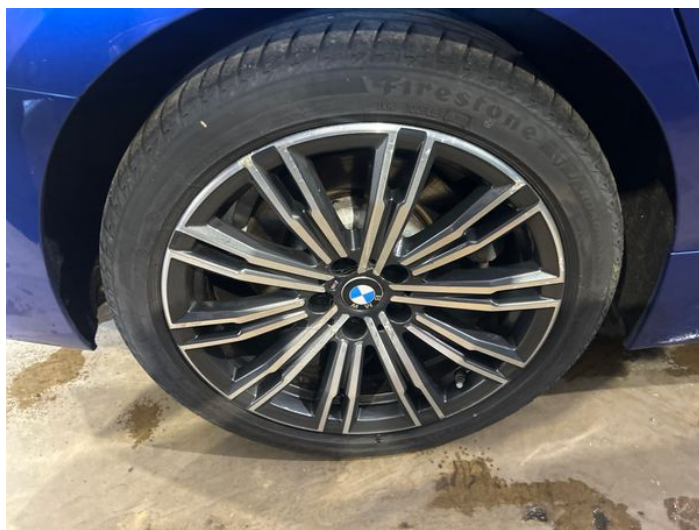
6: Wheel osr  
Corroded  
Light

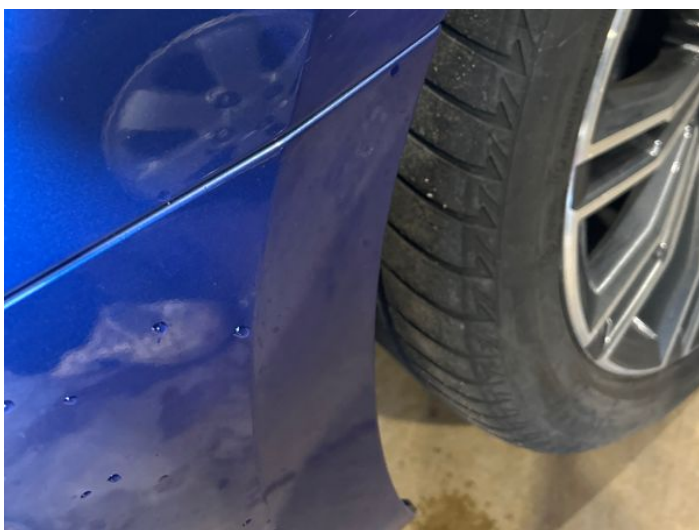
7: Qtr Panel osr  
Chipped  
1 To 5

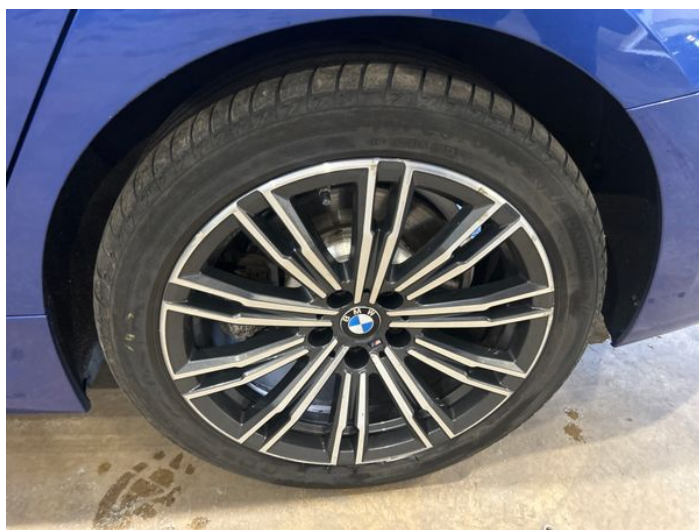
8: Wheel nsr  
Corroded  
Light

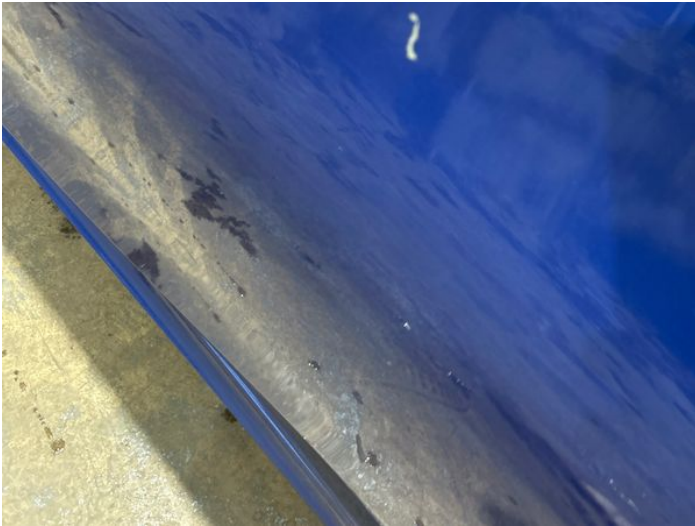
9: Door nsr  
Scratched  
UpTo 25mm Thru Paint

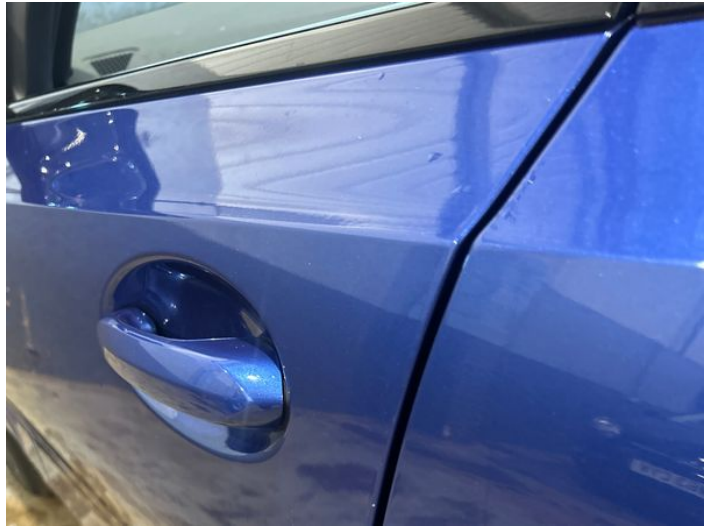
10: Door nsf  
Chipped  
Edge Chip

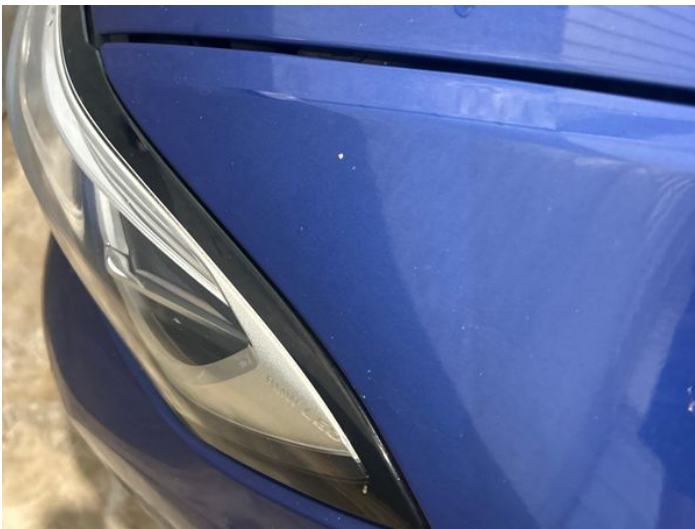
11: Wing nsf  
Chipped  
1 To 5

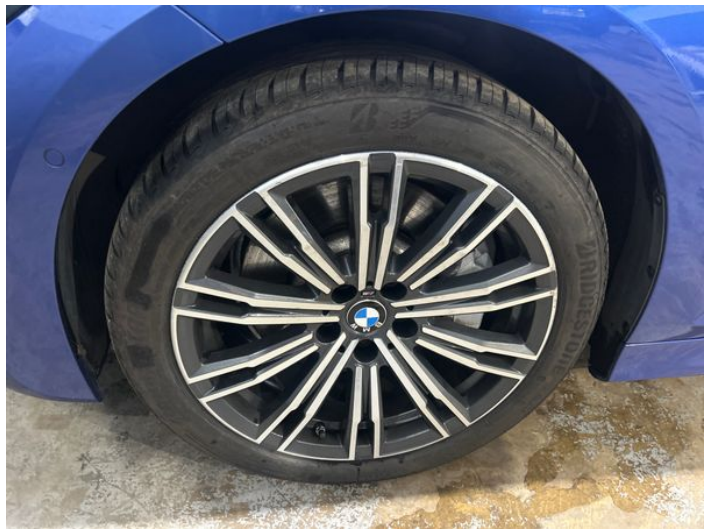
12: Wheel nsf  
Corroded  
Light

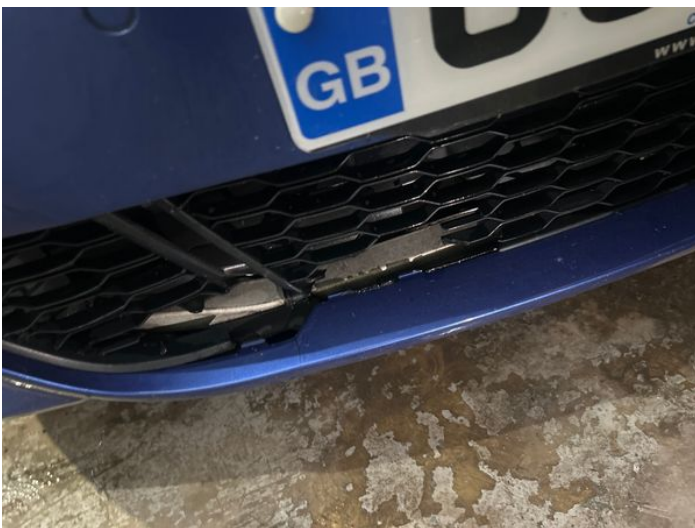
13: Bumper Front Grill  
Broken  
Replace

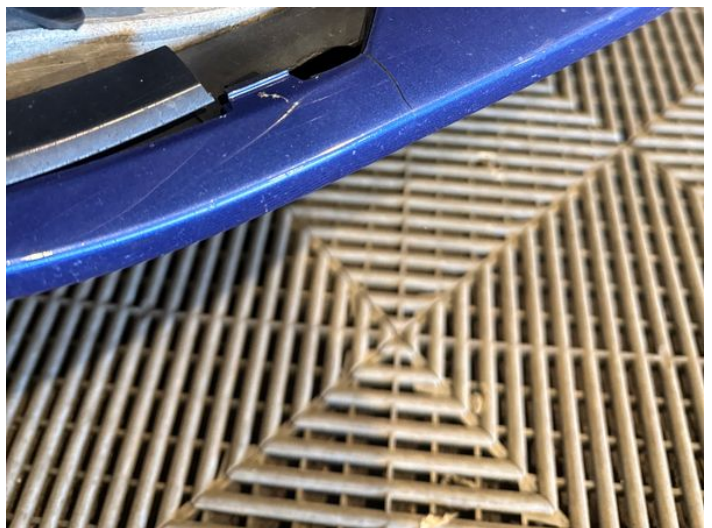
14: Bumper Front  
Cracked  
UpTo 25mm

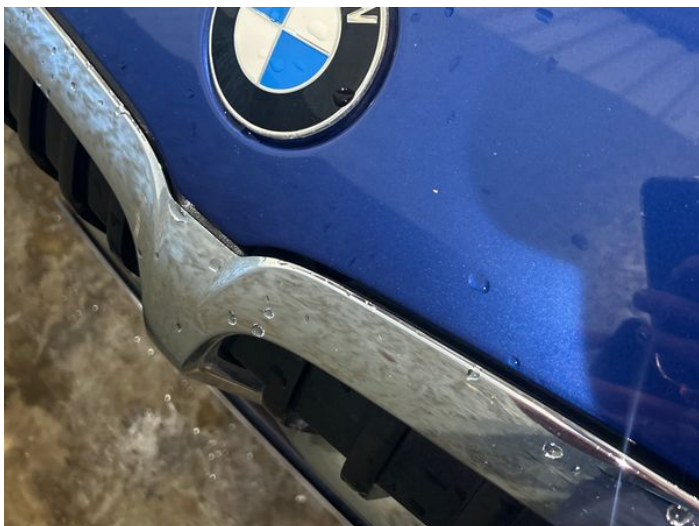
15: Bonnet  
Chipped  
1 To 5

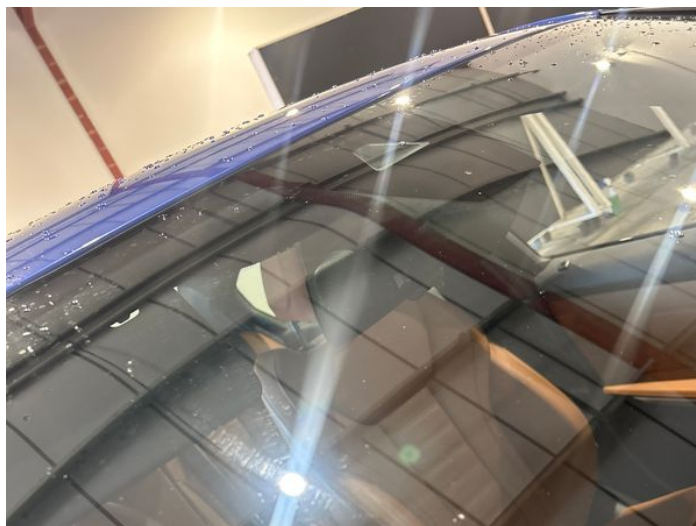
16: Screen Front  
Chipped  
UpTo 10mm
