# VEHICLE INSPECTION REPORT

**KH05YYD**

## Ford Fiesta 1.4 Style 5dr

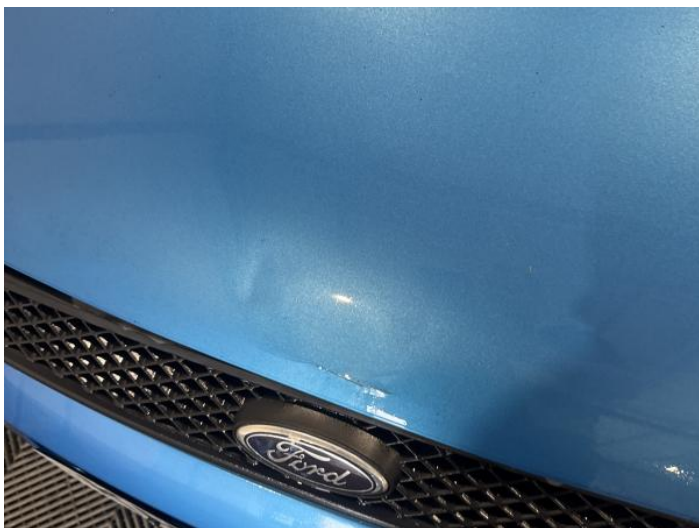
1: Bonnet  
Dented  
With Paint Damage

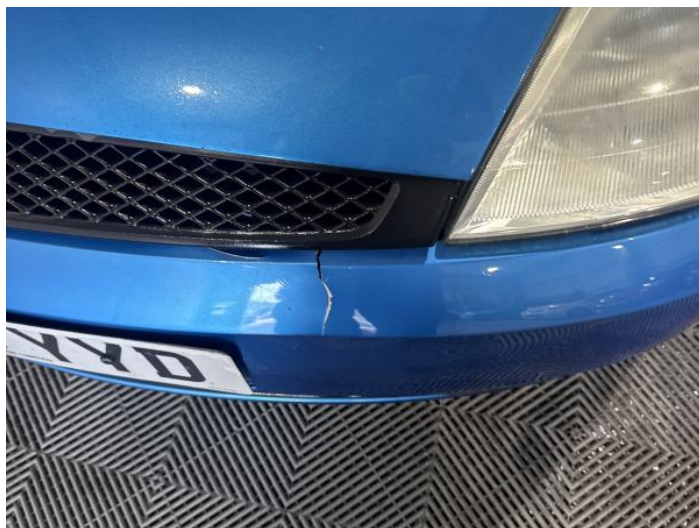
2: Bumper Front  
Cracked  
Over 25mm

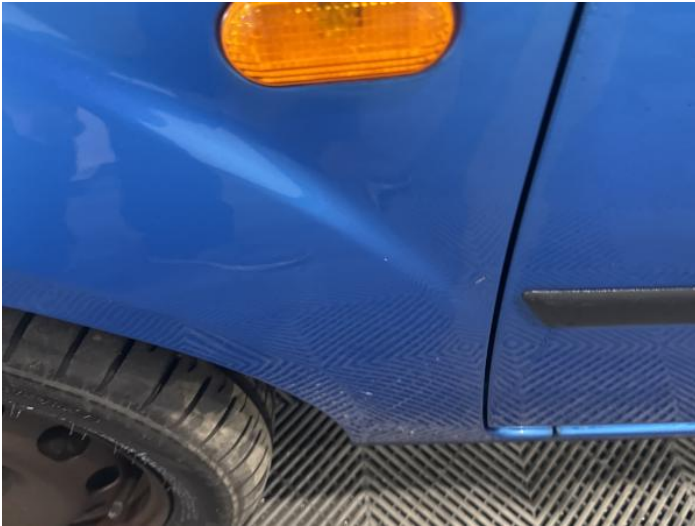
3: Wing nsf  
Chipped  
1 To 5

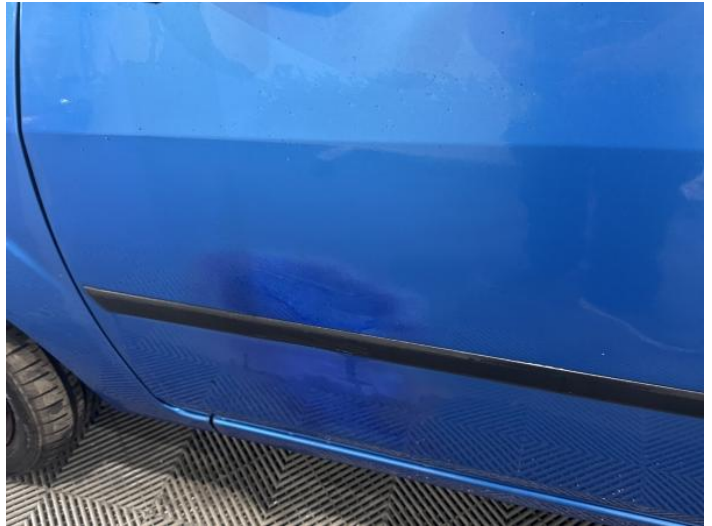
4: Door nsf  
Poor Previous Repair  
Poor Paint

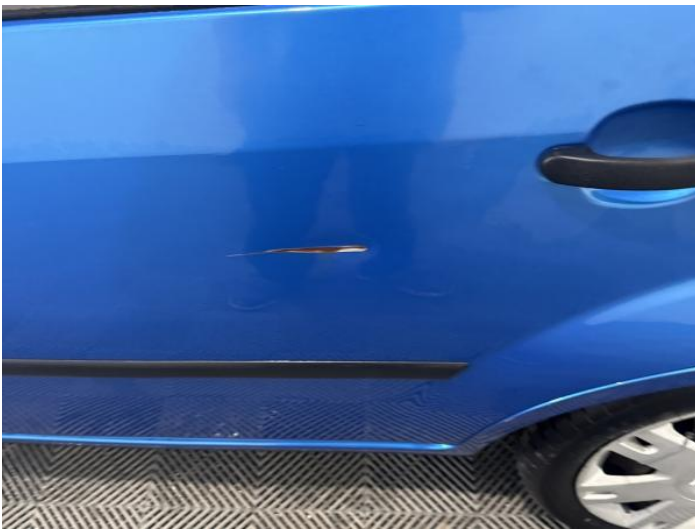
5: Door nsr  
Dented  
With Paint Damage

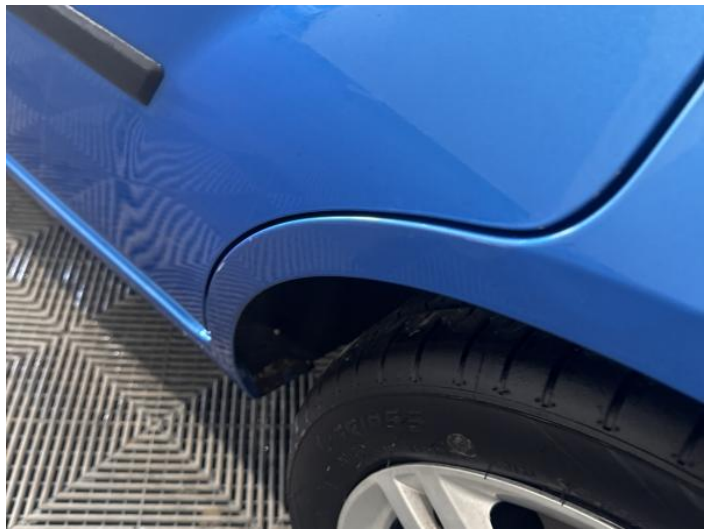
6: Qtr Panel osr  
Chipped  
1 To 5

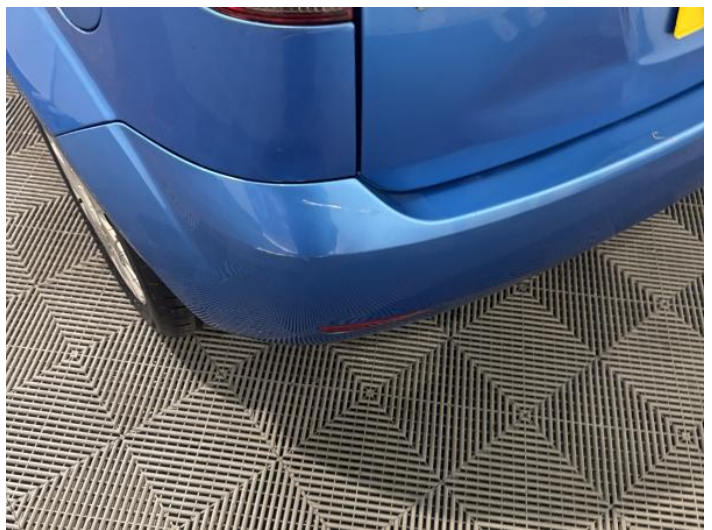
8: Bumper Rear  
Poor Previous Repair  
Rippled Up To 30%

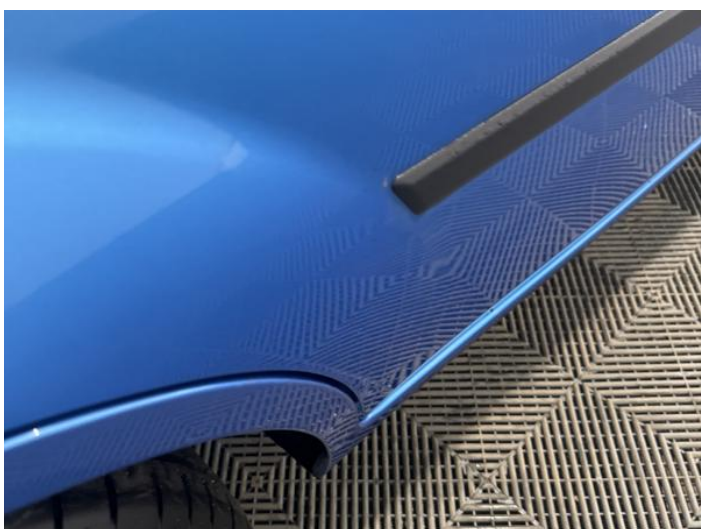
12: Door osr  
Scratched  
Over 25mm Not Thru Paint

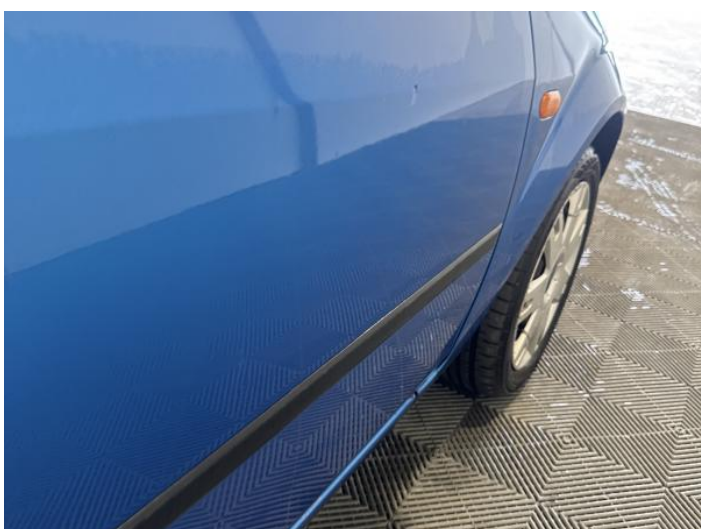
14: Door osf  
Scratched  
Over 25mm Not Thru Paint

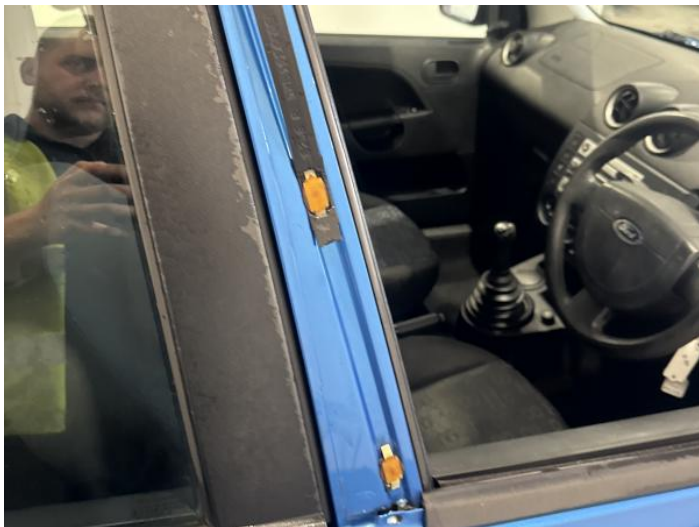
15: Door Moulding osf  
Missing  
Replace

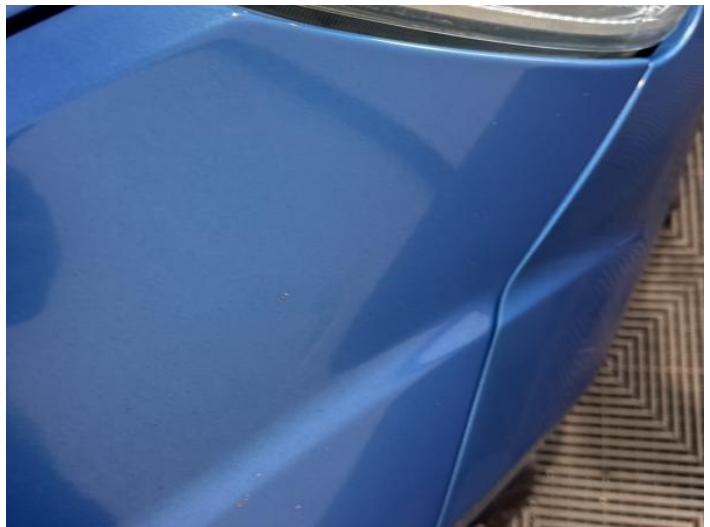
16: Wing osf  
Chipped  
1 To 5

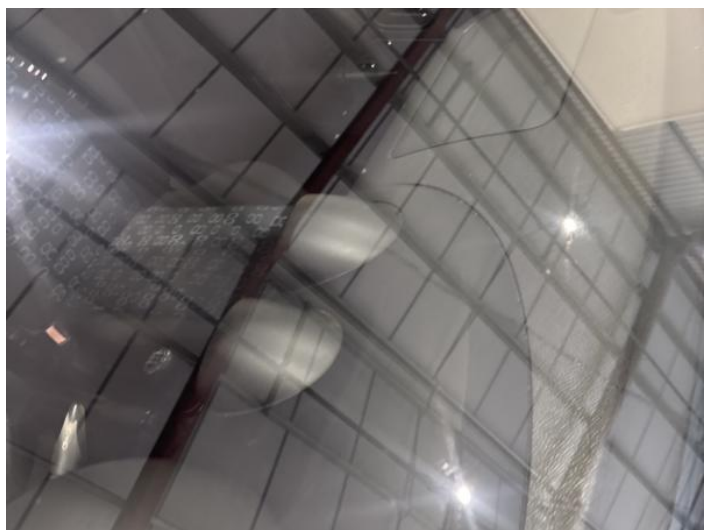
18: Screen Front  
Chipped  
UpTo 10mm
