# VEHICLE INSPECTION REPORT

**BF66PUA**

## Vauxhall Astra 1.4T 16V 150 SRi 5dr

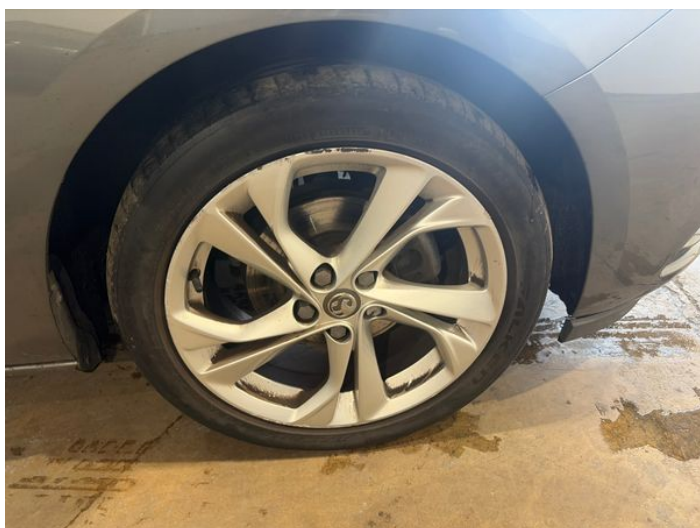
1: Wheel osf  
Scratched  
Over 50mm

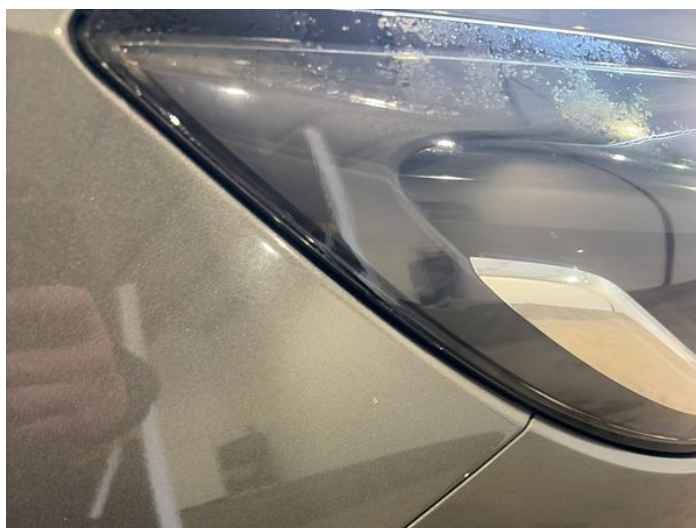
2: Wing osf  
Chipped  
1 To 5

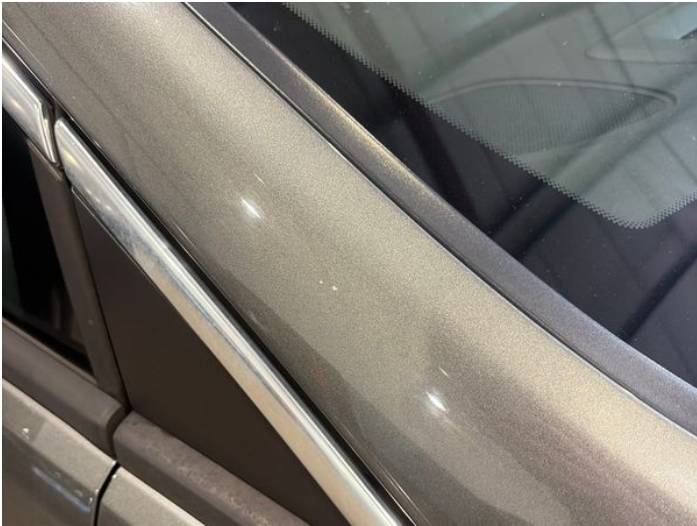
3: A Post os  
Chipped  
1 To 5

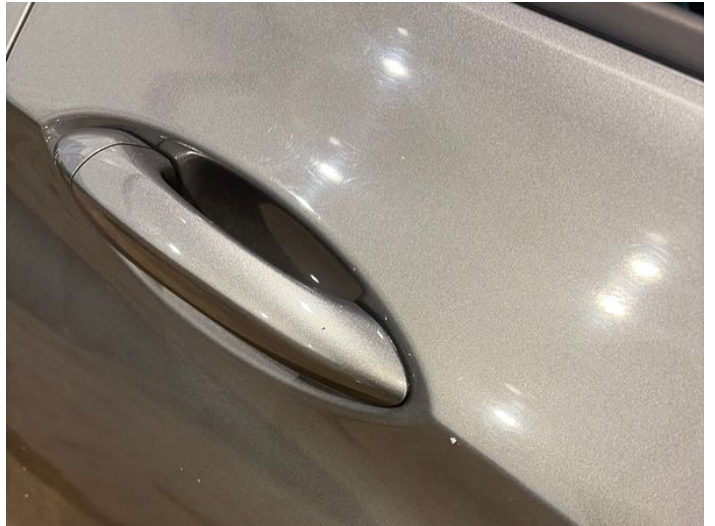
4: Door osf  
Chipped  
1 To 5

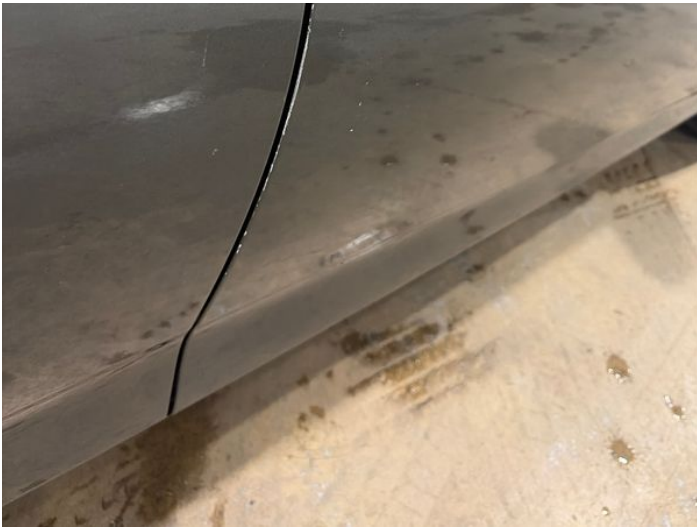
5: Door osf  
Chipped  
Edge Chip

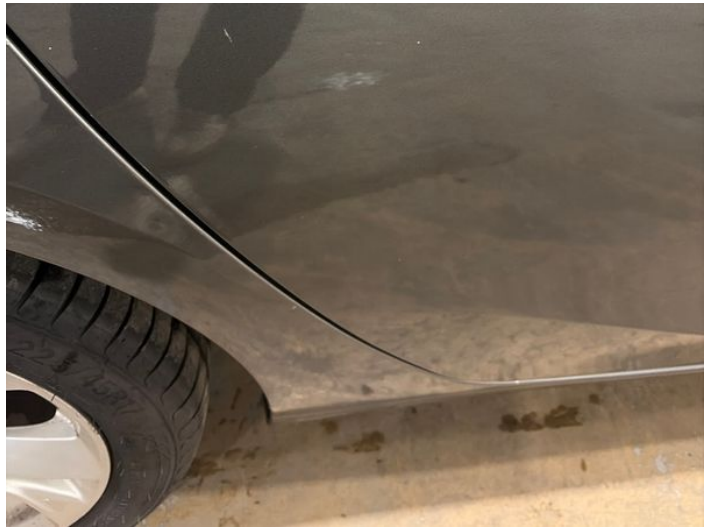
6: Door osr  
Chipped  
1 To 5

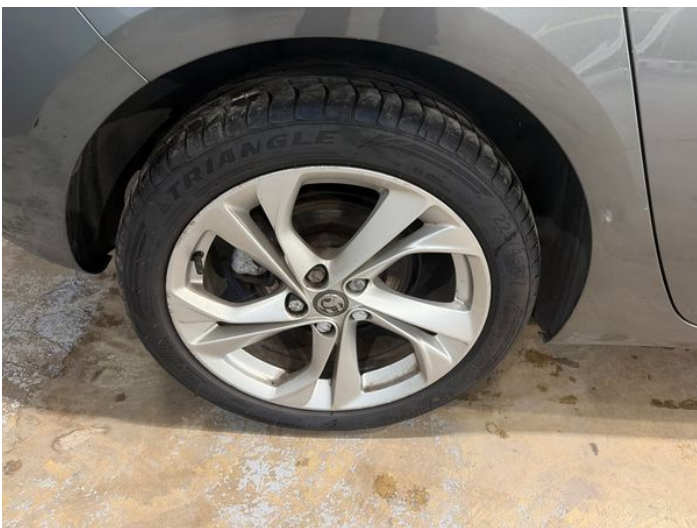
7: Wheel osr  
Scratched  
Over 50mm

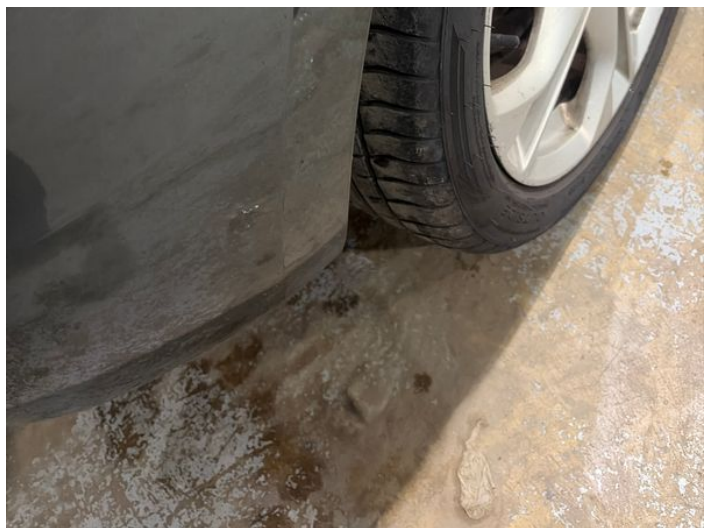
8: Bumper Rear  
Scratched  
Up To 25mm Thru Paint

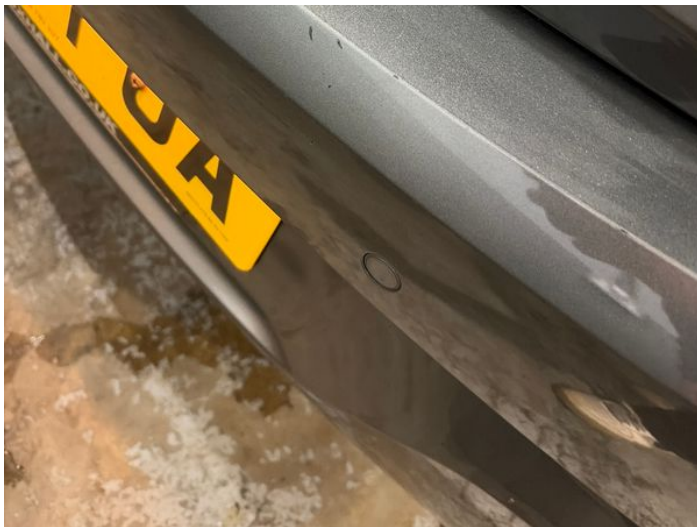
9: Bumper Rear  
Chipped  
1 To 5

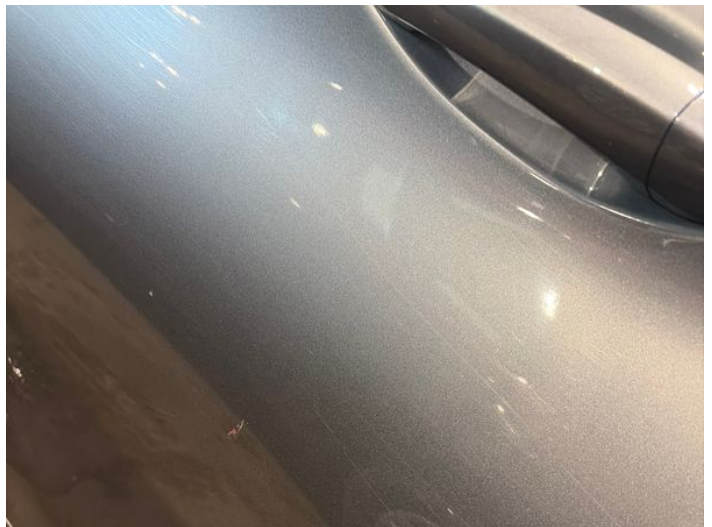
10: Door nsr  
Chipped  
Multiple Chips

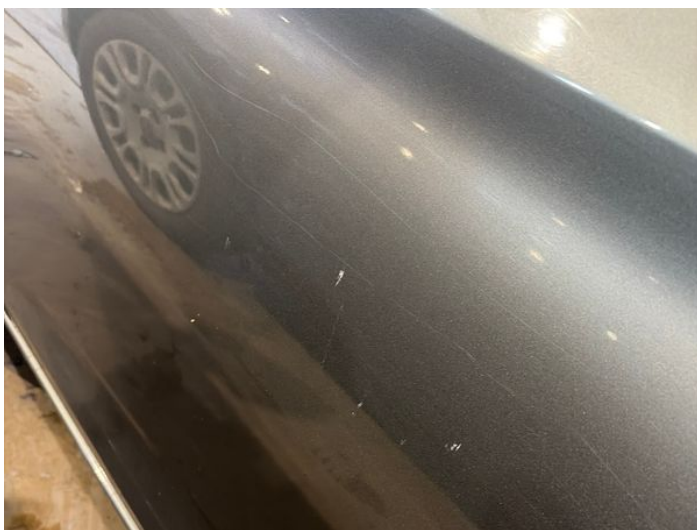
11: Door nsf  
Chipped  
Multiple Chips

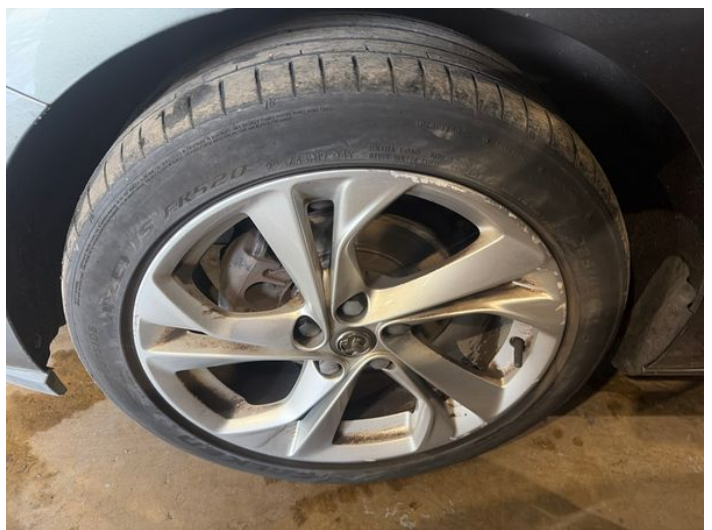
12: Wheel nsf  
Scratched  
Over 50mm

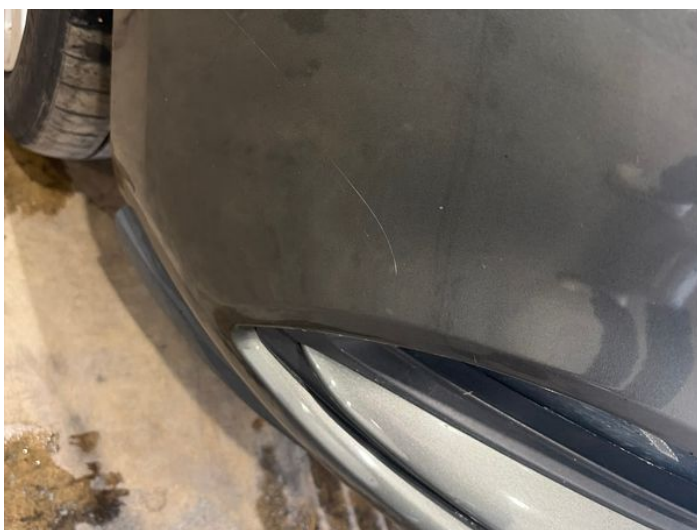
13: Bumper Front  
Scratched  
25 to 100mm Thru Paint

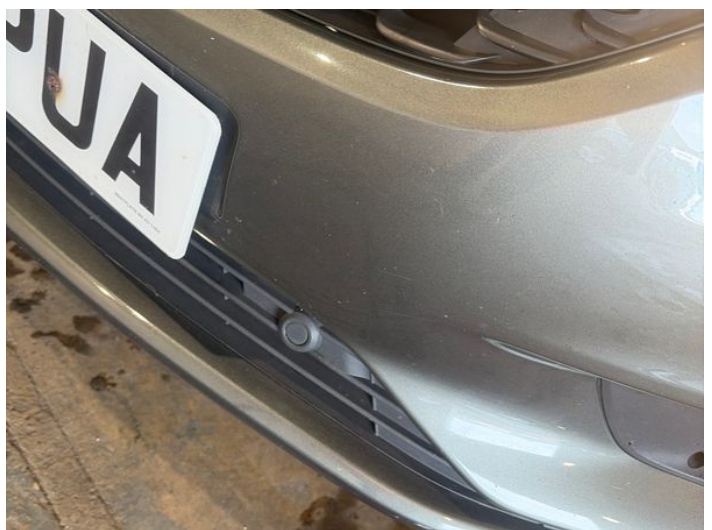
14: Bumper Front  
Chipped  
Multiple Chips

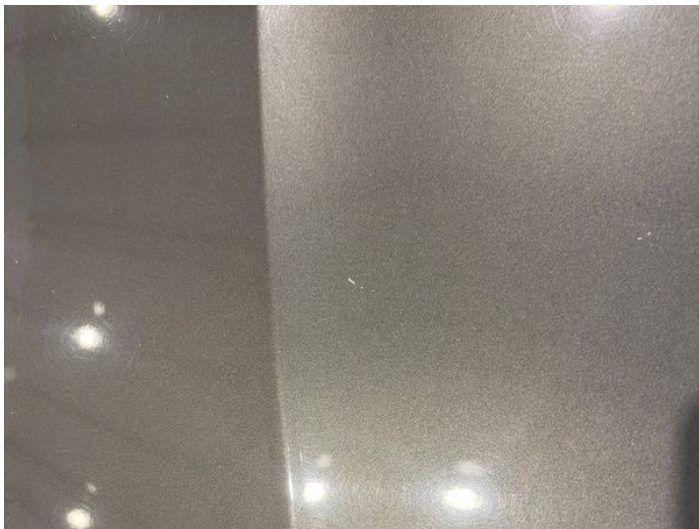
15: Bonnet  
Chipped  
1 To 5
