# VEHICLE INSPECTION REPORT

**LB17BJV**

## Vauxhall Zafira 1.4T SRi 5dr

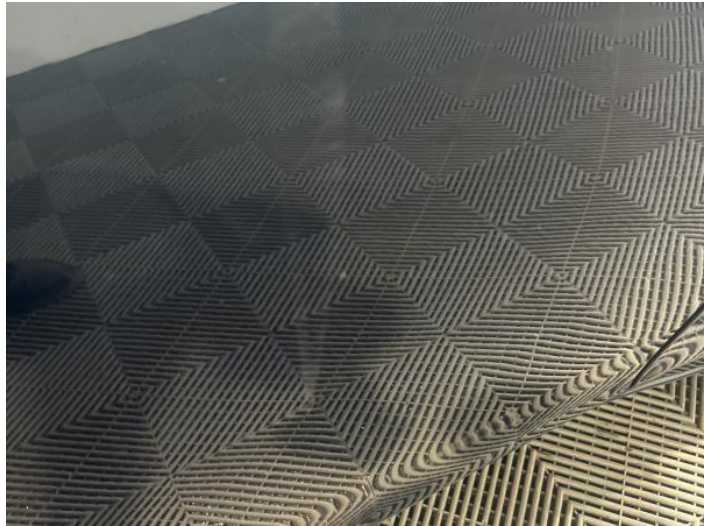
4: Door osf  
Scratched  
Over 25mm Thru Paint

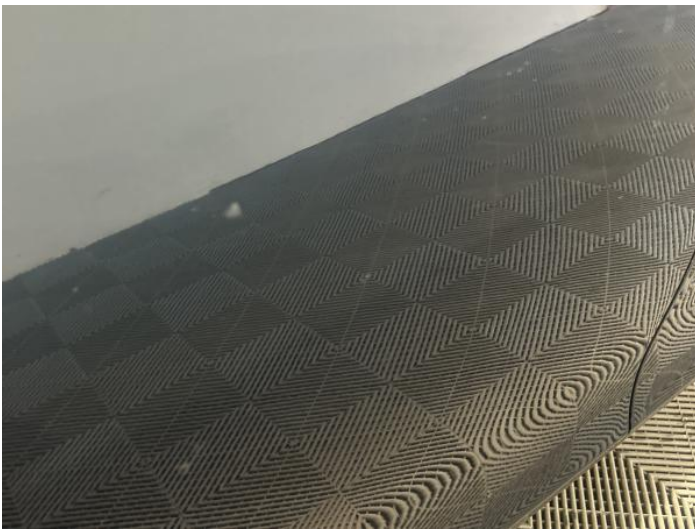
5: Door osr  
Chipped  
1 To 5

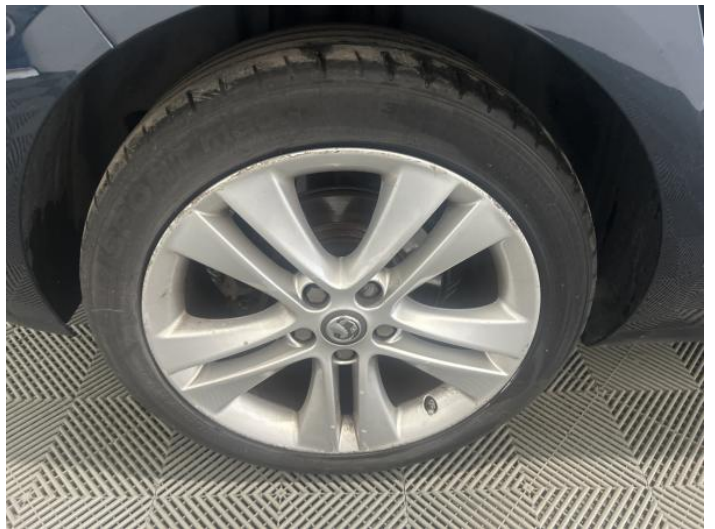
6: Wheel osr  
Scratched  
Over 50mm

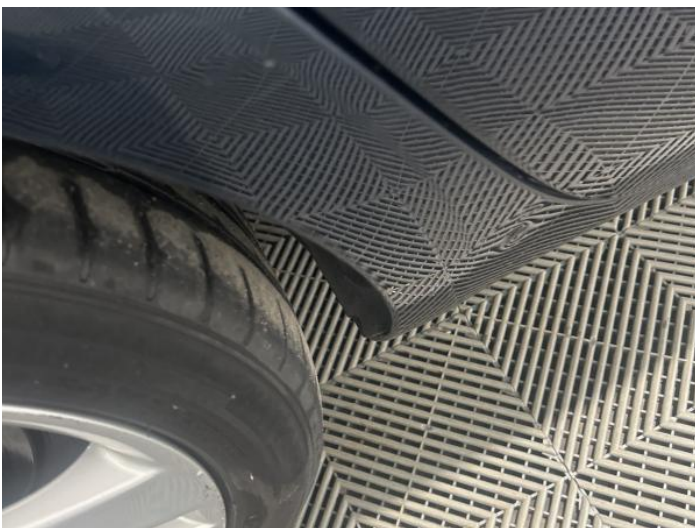
7: Qtr Panel osr  
Dented  
2 Or Less UpTo 10mm

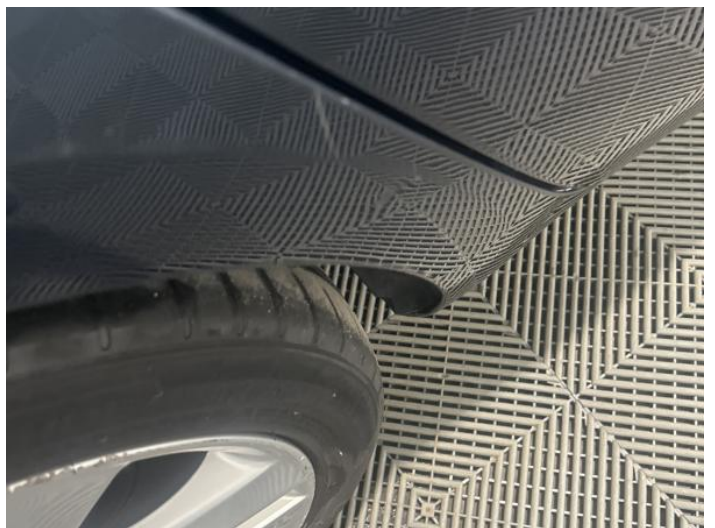
8: Qtr Panel osr  
Scratched  
UpTo 25mm Not Thru Paint

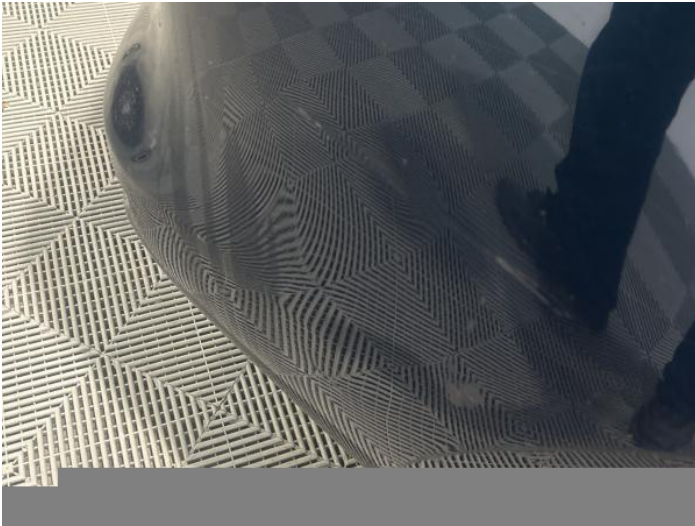
9: Bumper Rear  
Scratched  
Over 100mm Thru Paint

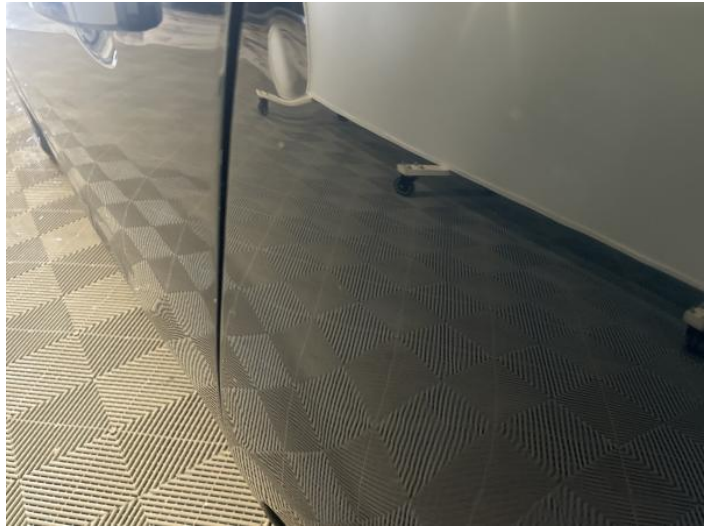
10: Qtr Panel nsr  
Dented  
Between 10mm + 30mm

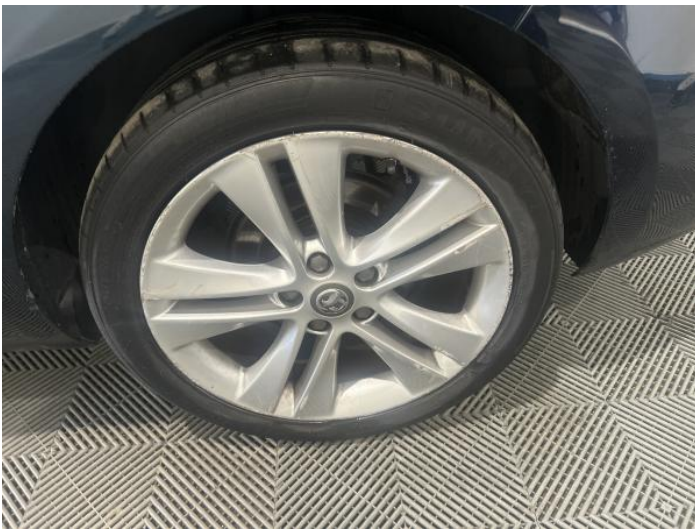
11: Wheel nsr  
Scratched  
Over 50mm

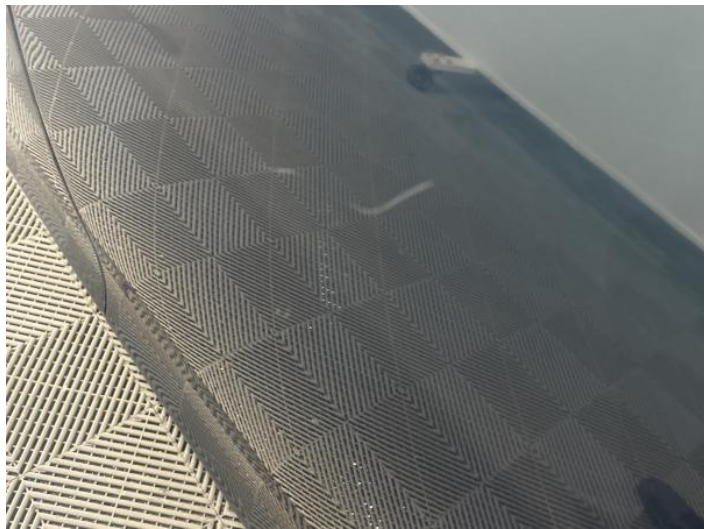
12: Door nsr  
Scratched  
Over 25mm Not Thru Paint

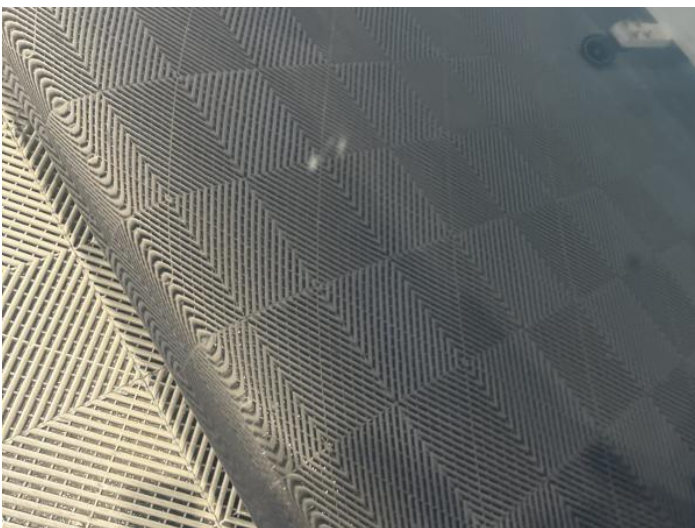
13: Door nsf  
Chipped  
1 To 5

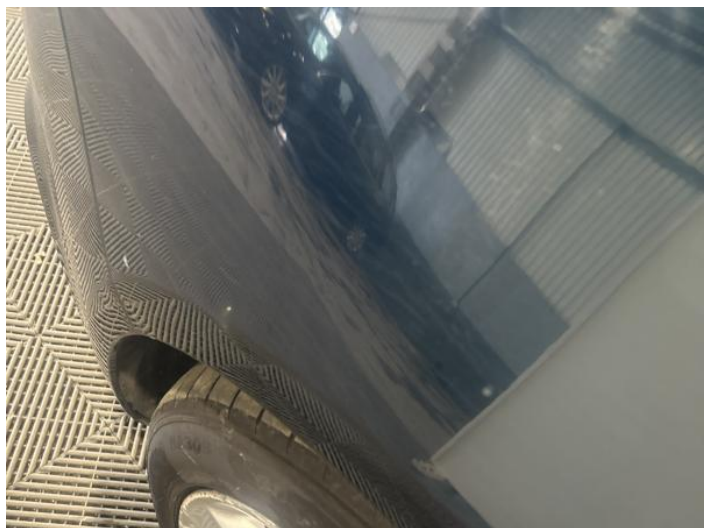
14: Wing nsf  
Scratched  
Over 25mm Not Thru Paint

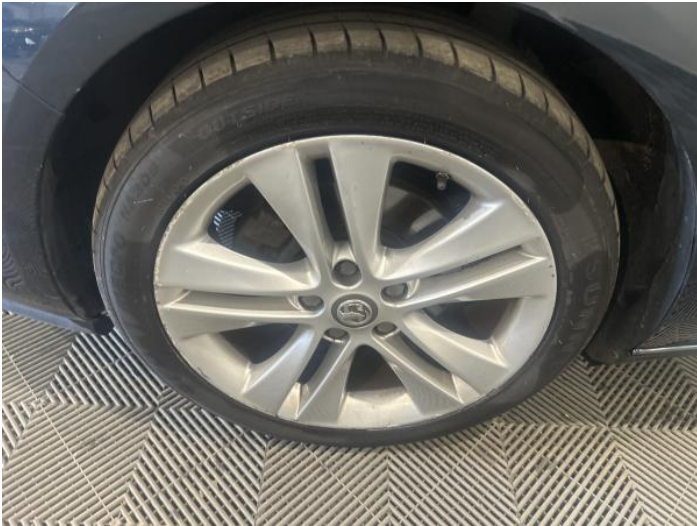
15: Wheel nsf  
Scratched  
Over 50mm

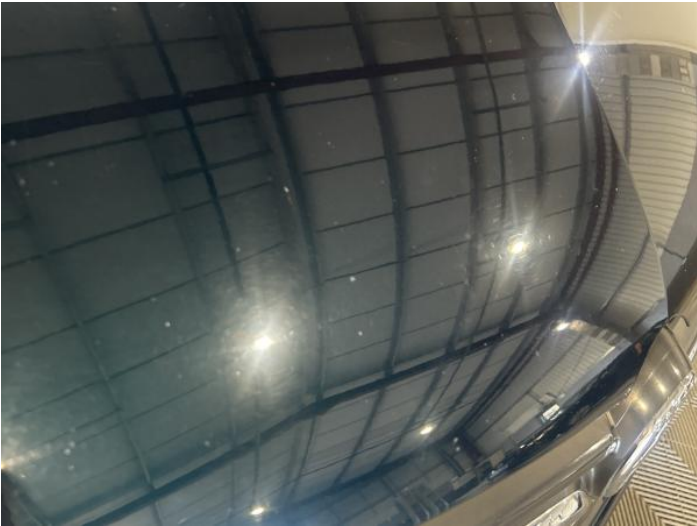
16: Bonnet  
Chipped  
Multiple Chips

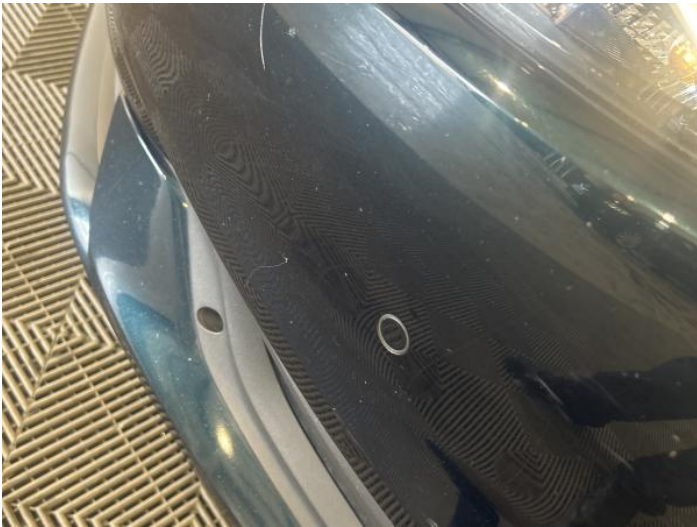
17: Bumper Front  
Scratched  
Over 100mm Thru Paint
