## VEHICLE INSPECTION REPORT

**GN69KTT**

### Mazda CX-5 2.0 GT Sport Nav+ 5dr Auto

nama  
GRADE  
**3**

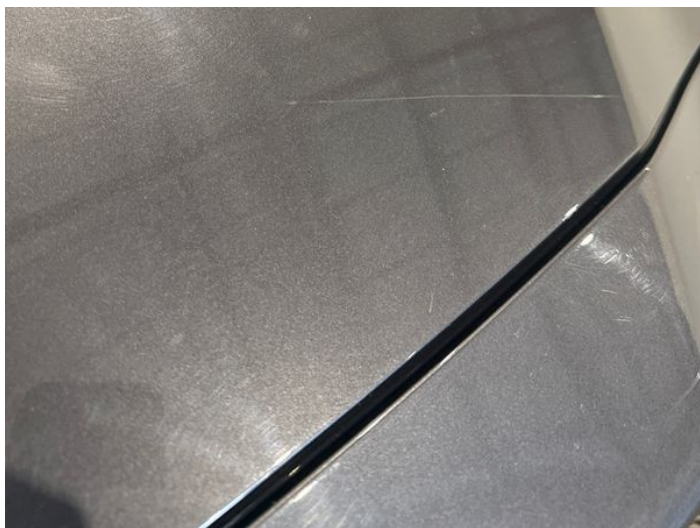
1: Bonnet  
Chipped  
1 To 5

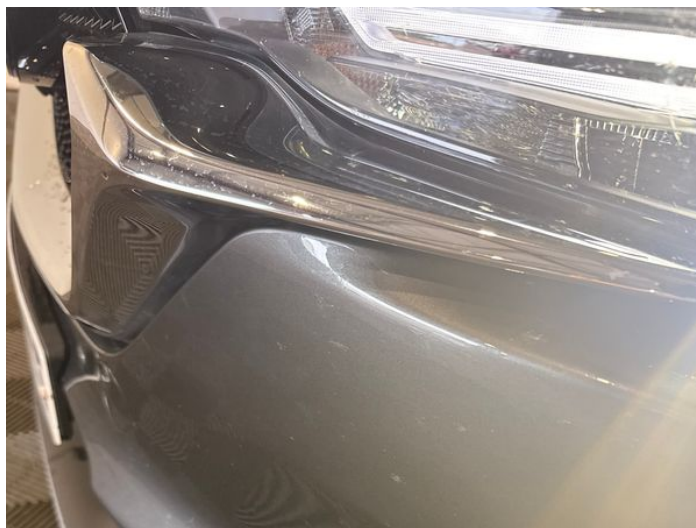
2: Bumper Front  
Chipped  
1 To 5

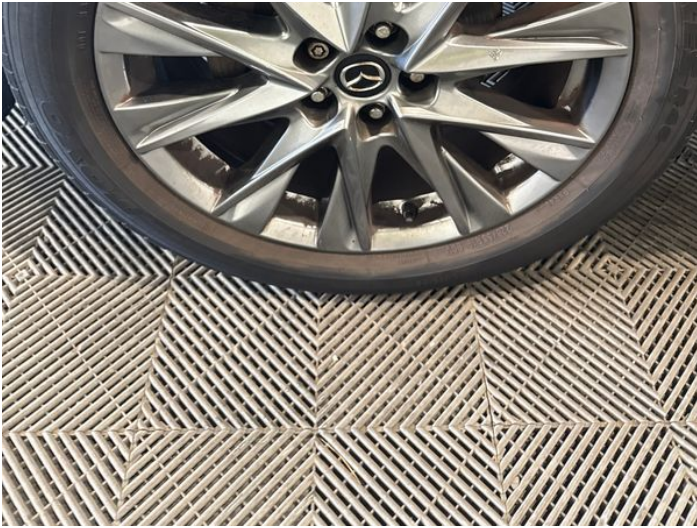
3: Wheel nsf  
Corroded  
Light

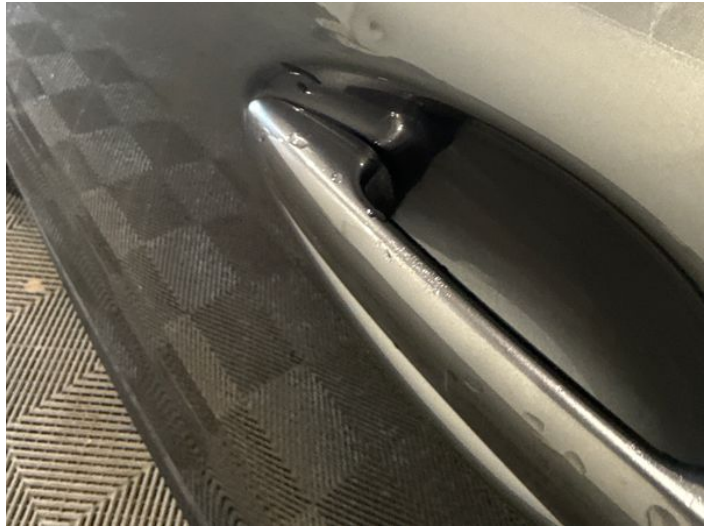
4: Door nsf  
Dented  
Between 10mm + 30mm

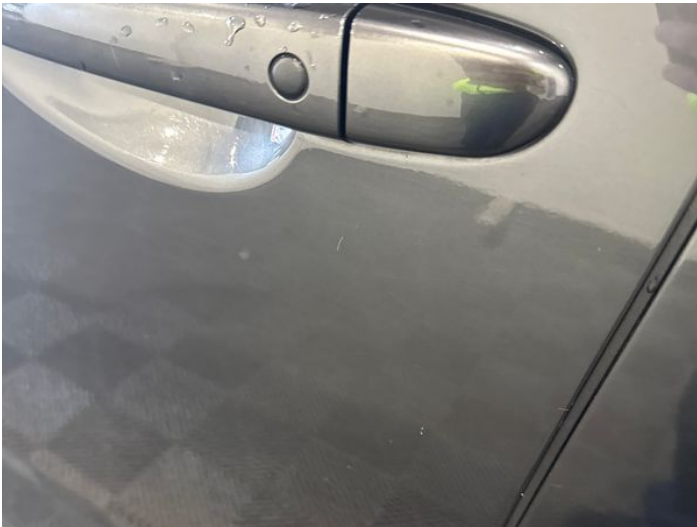
5: Door nsf  
Chipped  
1 To 5

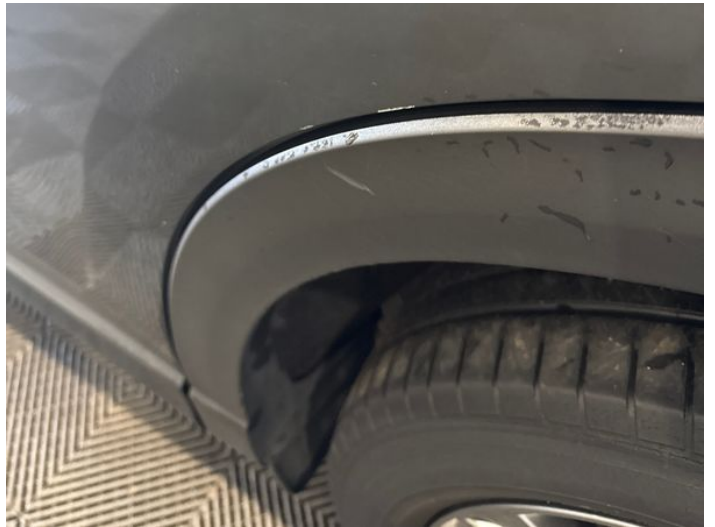
6: Door nsr  
Scratched  
Up To 25mm Thru Paint

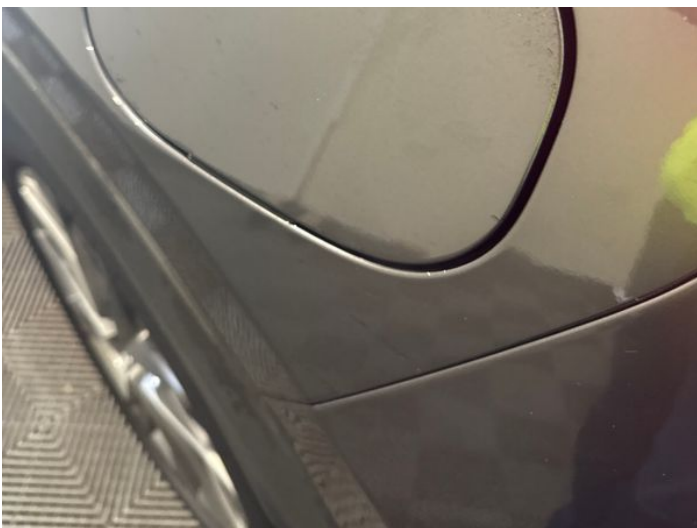
7: Qtr Panel nsr  
Chipped  
1 To 5

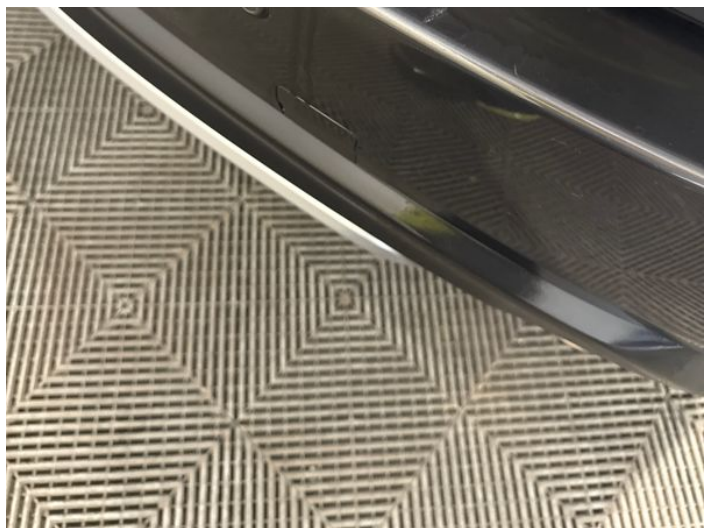
8: Bumper Rear  
Scratched  
Up To 25mm Thru Paint

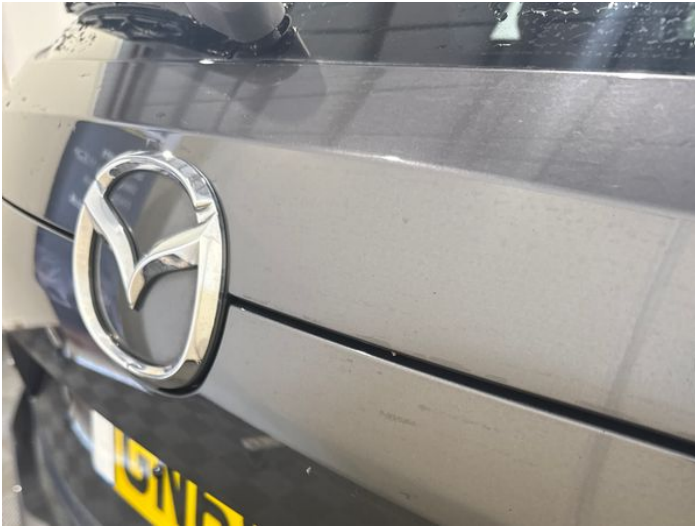
9: Tailgate  
Chipped  
1 To 5

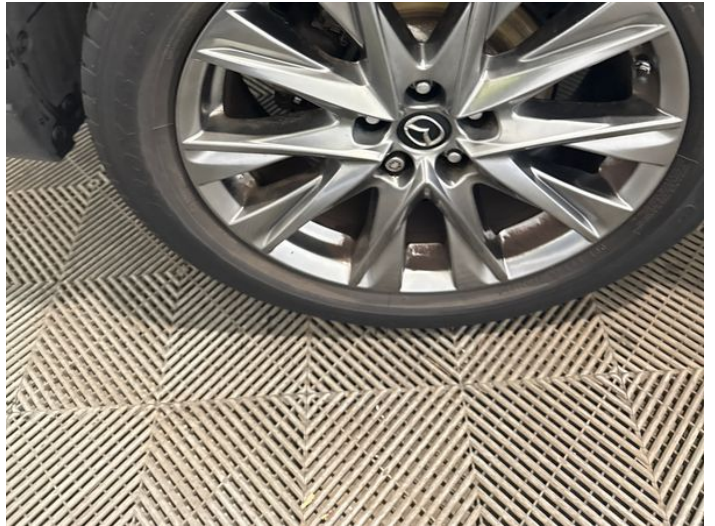
10: Wheel osr  
Corroded  
Light

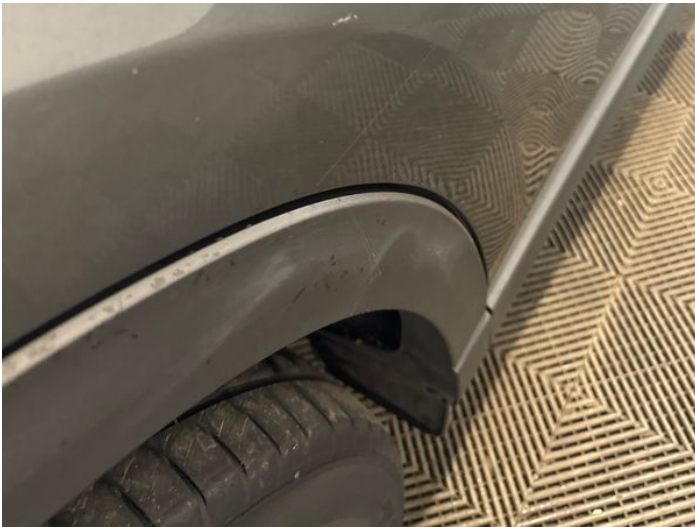
11: Door osr  
Scratched  
Over 25mm Thru Paint

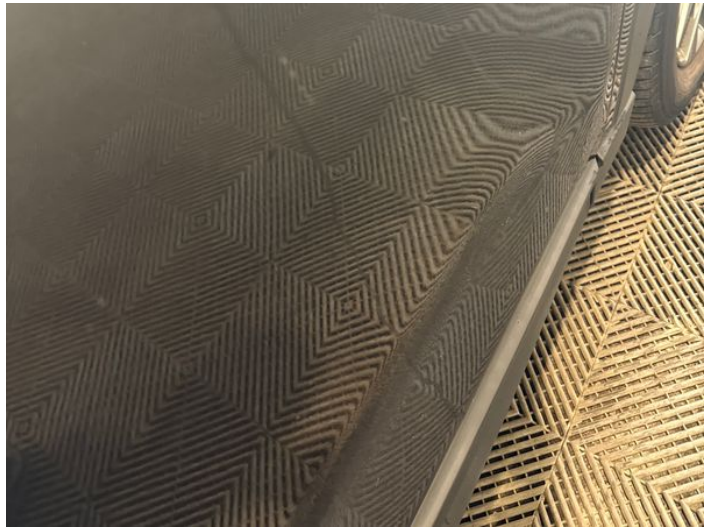
12: Door osf  
Scratched  
Over 25mm Thru Paint

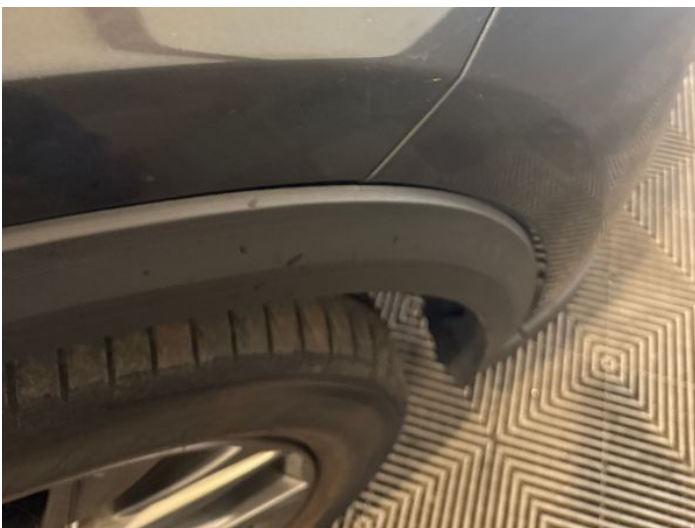
13: Wing osf  
Scratched  
UpTo 25mm Thru Paint

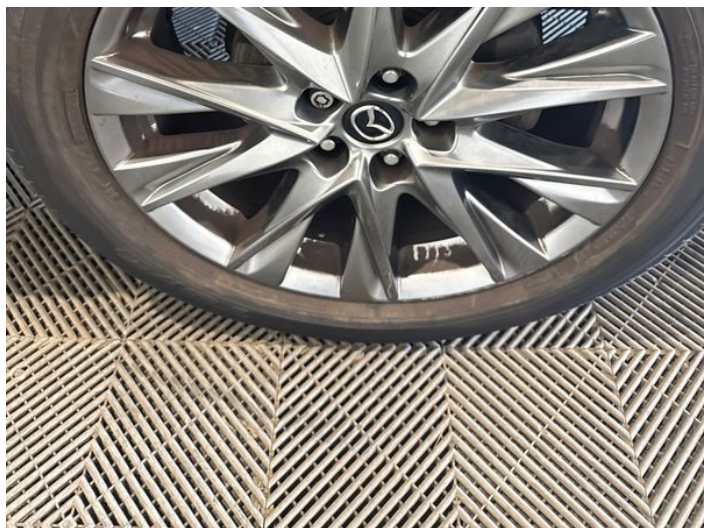
14: Wheel osf  
Scratched  
Up To 50mm

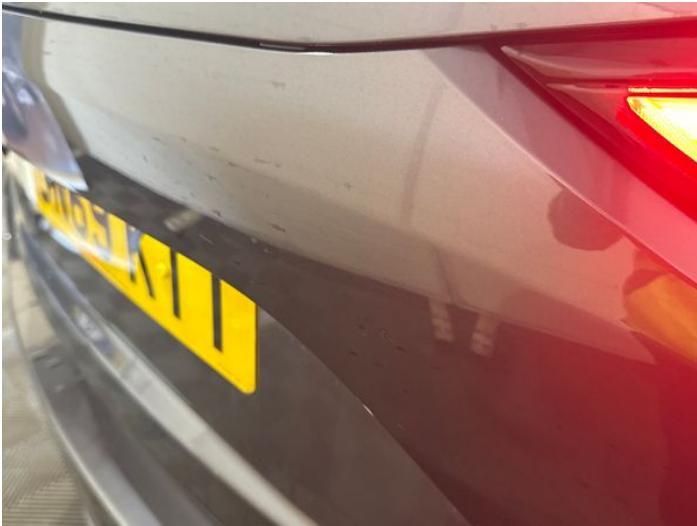
15: Tailgate Trim Panel  
Scratched (Painted)  
Over 25mm Thru Paint

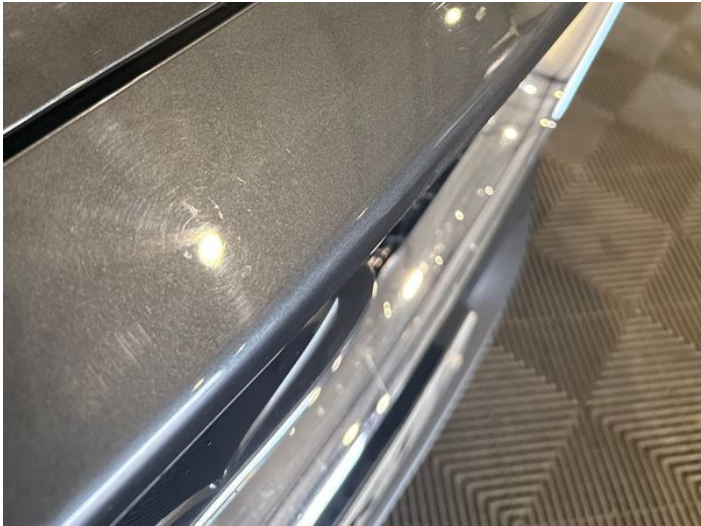
16: Bumper Front  
Dented  
With Paint Damage
