# VEHICLE INSPECTION REPORT

**EX60KPF**

## Volkswagen Golf 1.4 S 5dr

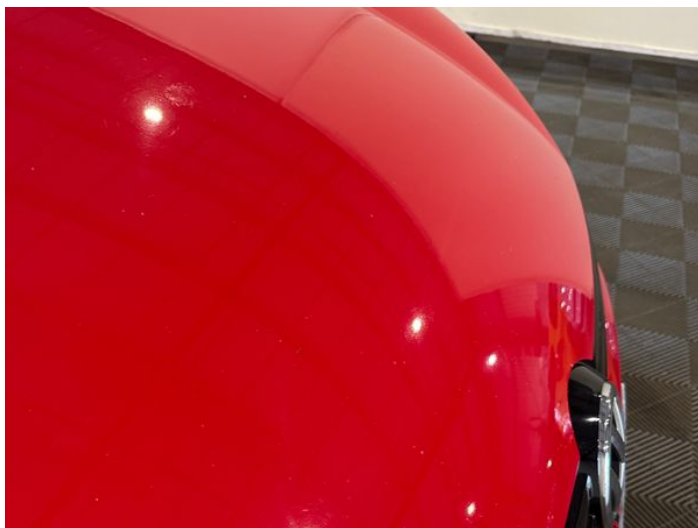
1: Bonnet  
Chipped  
Multiple Chips

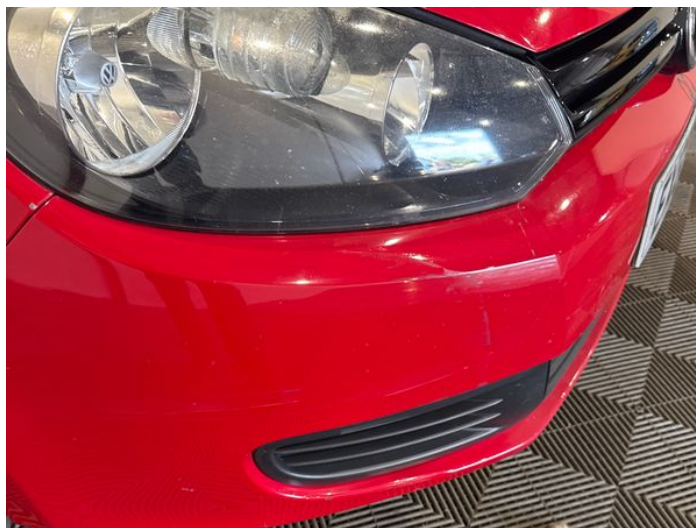
2: Bumper Front  
Dented  
With Paint Damage

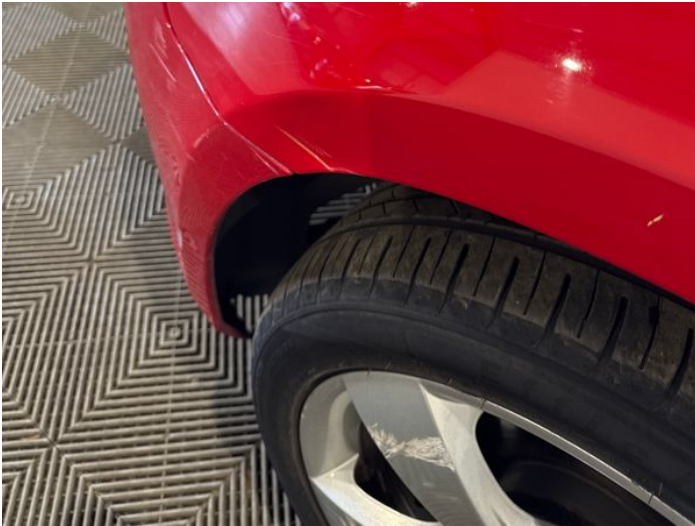
3: Wing nsf  
Dented  
With Paint Damage

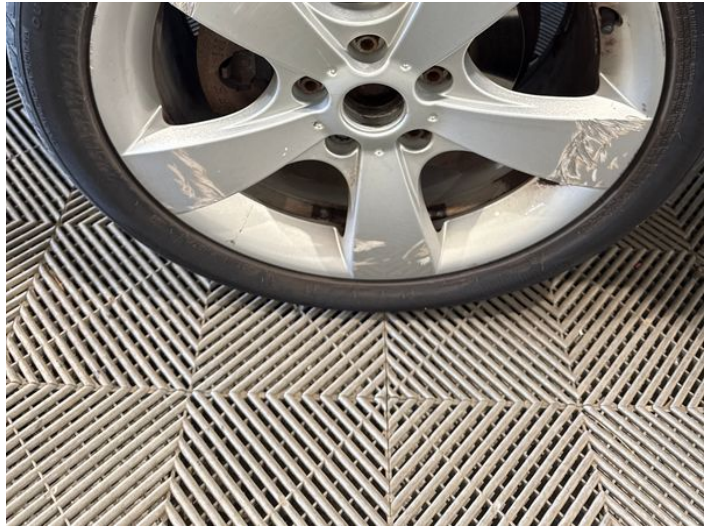
4: Wheel nsf  
Scratched  
Over 50mm

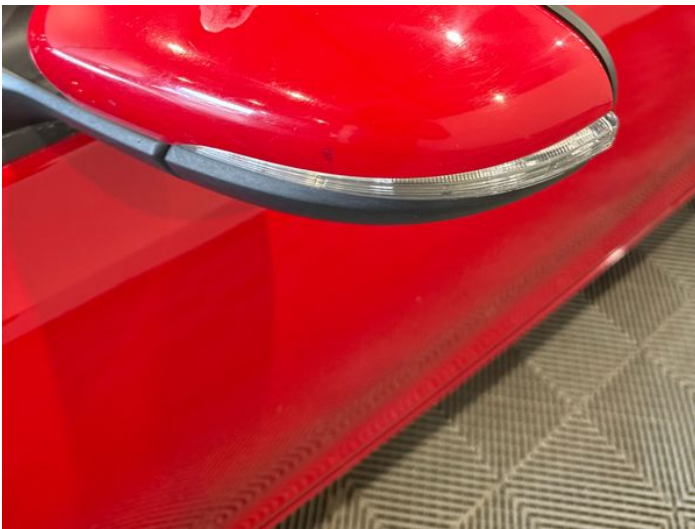
5: Door Mirror Assy nsf  
Scratched (Painted)  
Over 25mm Thru Paint

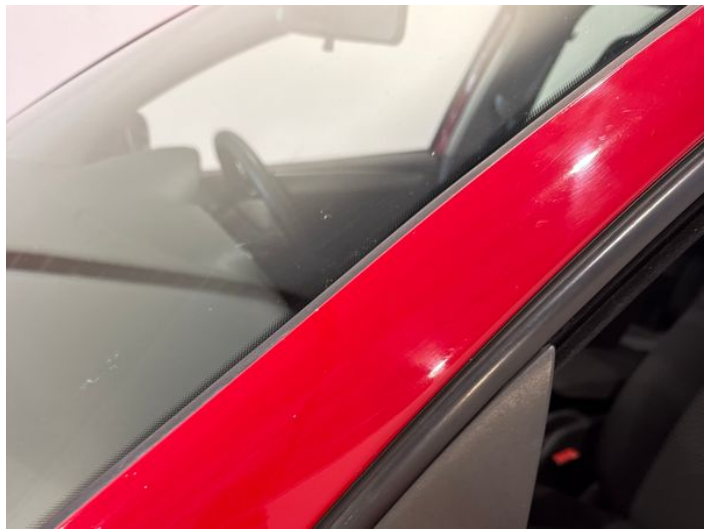
6: A Post ns  
Chipped  
1 To 5

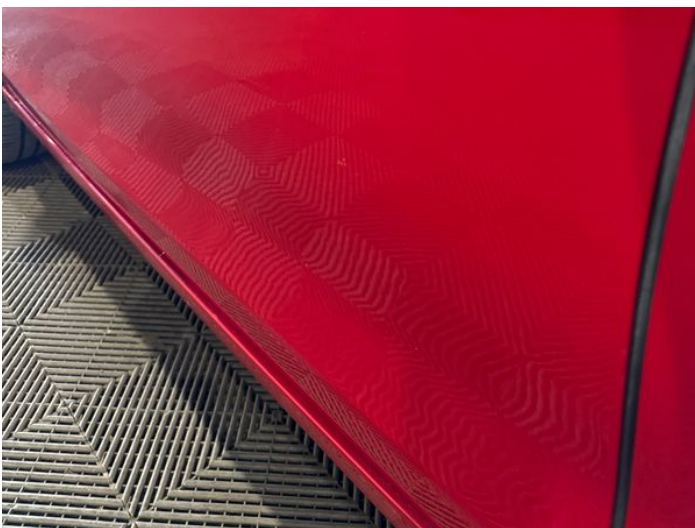
7: Door nsf  
Poor Previous Repair  
Rippled UpTo 30%

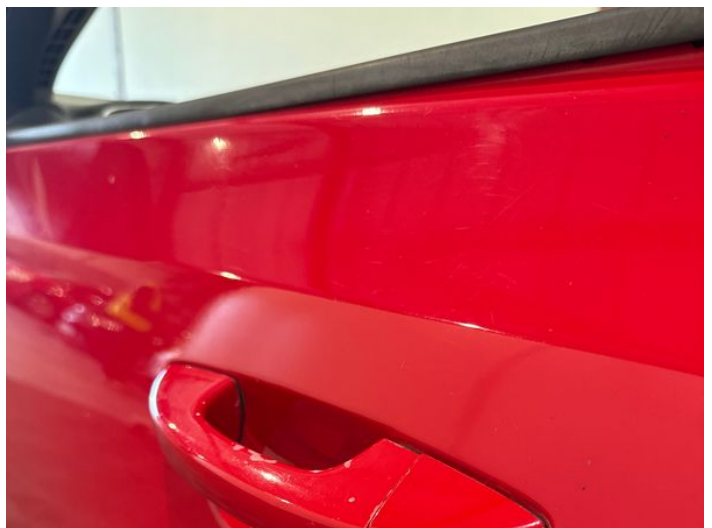
8: Handle Outer nsf  
Scratched (Painted)  
Over 25mm Thru Paint

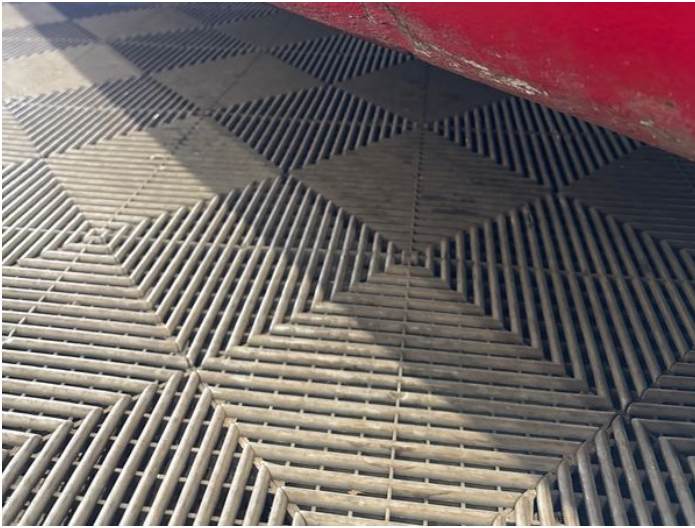
9: Sill ns  
Dented  
With Paint Damage

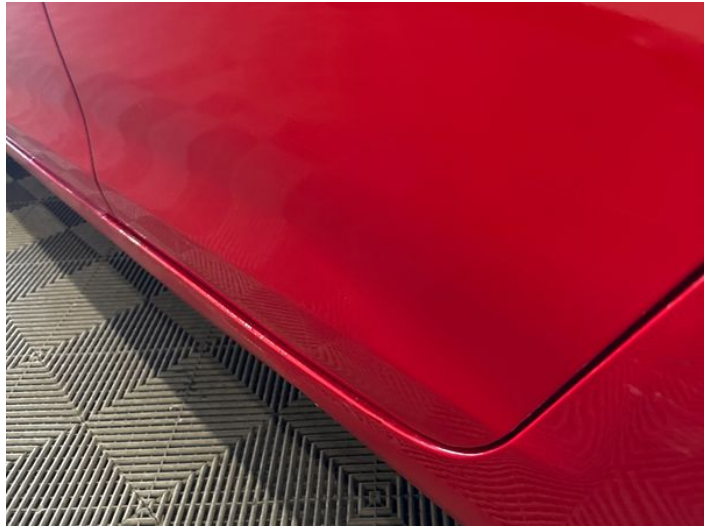
10: Door nsr  
Poor Previous Repair  
Poor Paint

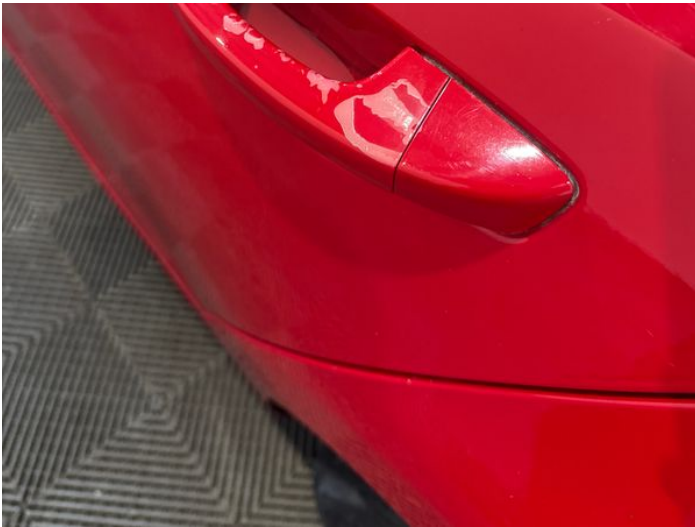
11: Door nsr  
Scratched  
Over 25mm Thru Paint

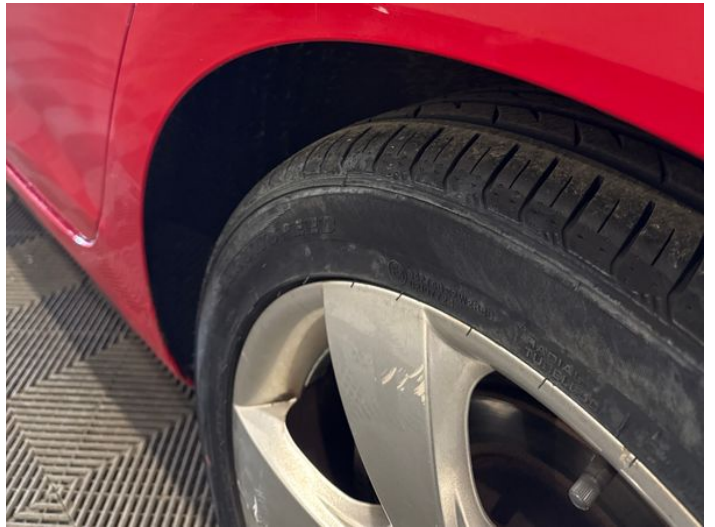
12: Qtr Panel nsr  
Scratched  
Over 25mm Thru Paint

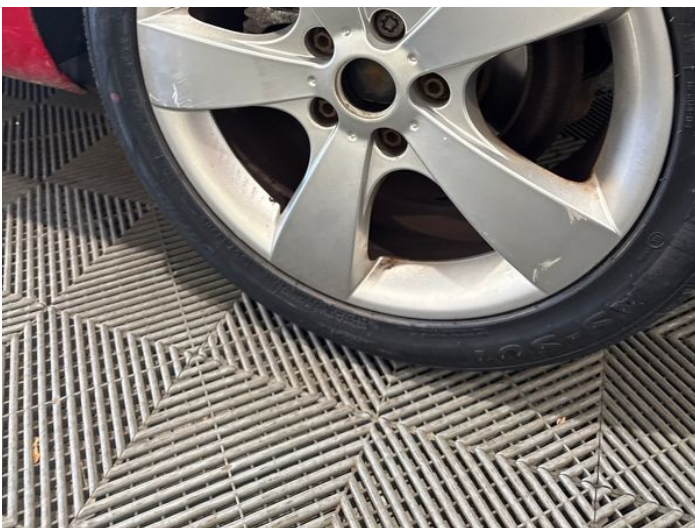
13: Wheel nsr  
Scratched  
Over 50mm

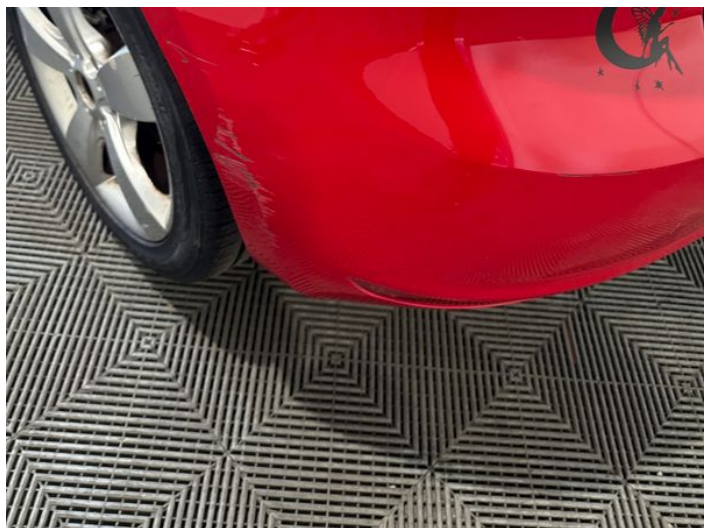
14: Bumper Rear  
Scratched  
Over 100mm Thru Paint

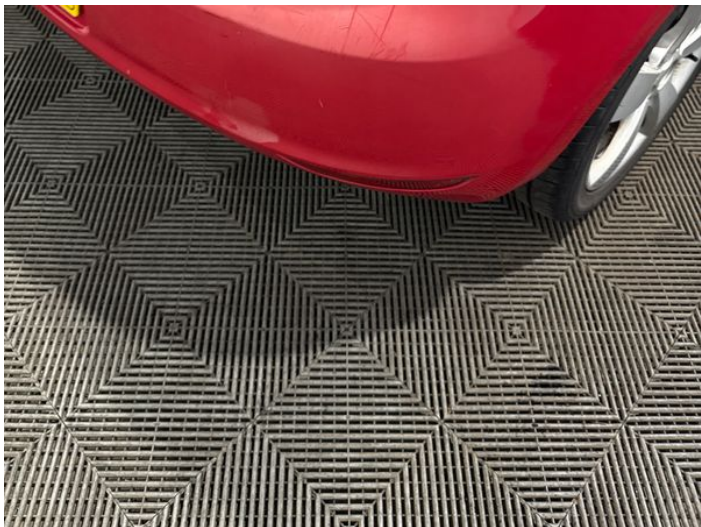
15: Bumper Rear  
Poor Previous Repair  
Poor Paint

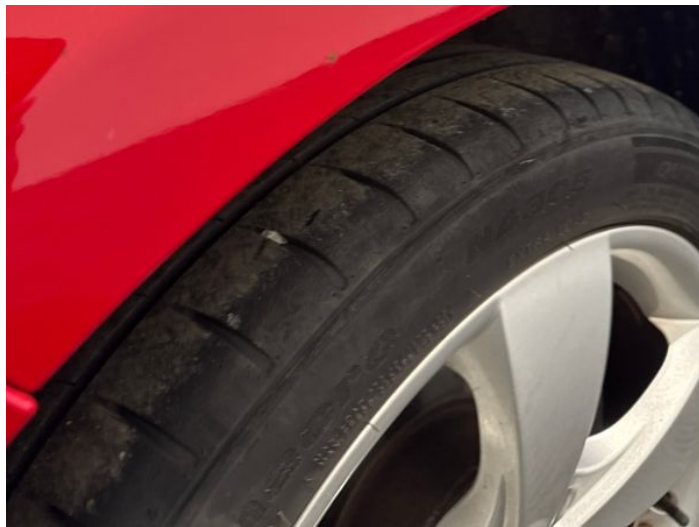
16: Qtr Panel osr  
Chipped  
1 To 5

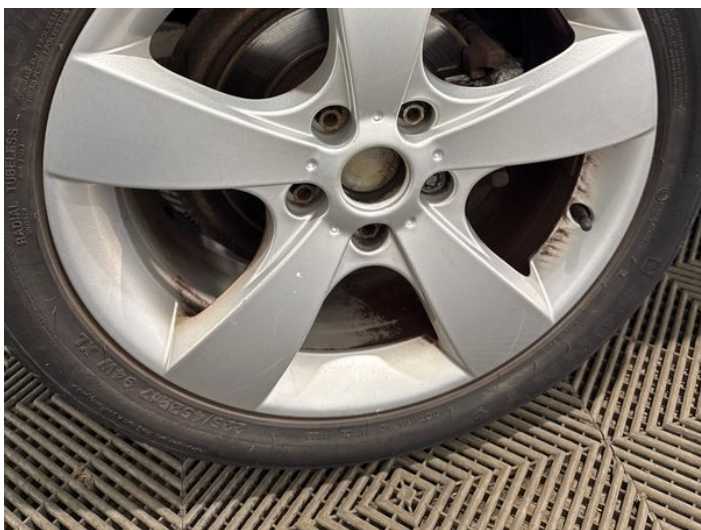
17: Wheel osr  
Scratched  
Up To 50mm

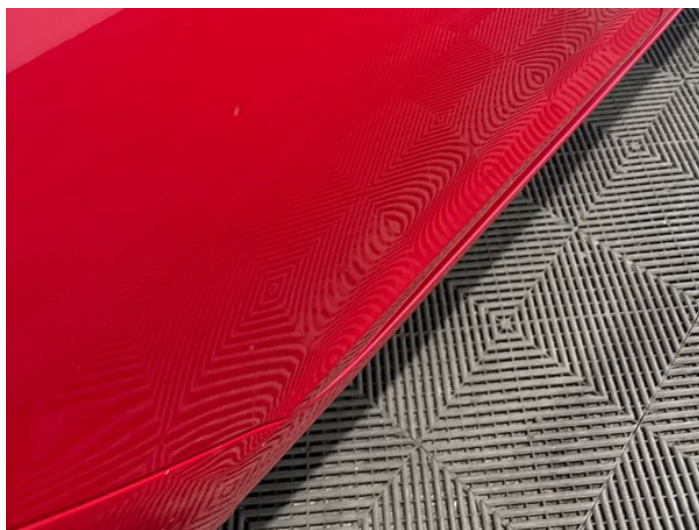
18: Door osr  
Chipped  
1 To 5

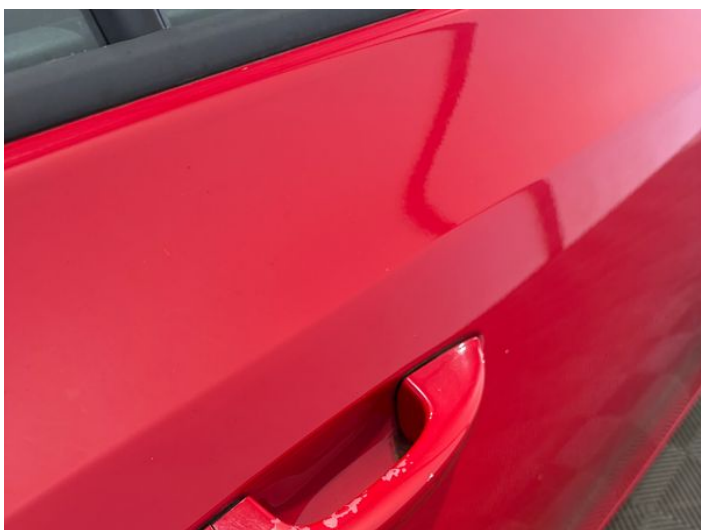
19: Door osr  
Scratched  
Over 25mm Thru Paint

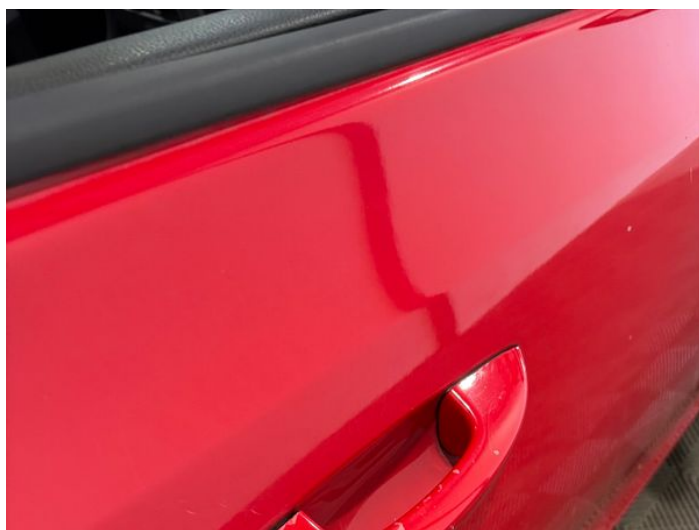
20: Handle Outer osf  
Scratched (Painted)  
Over 25mm Thru Paint

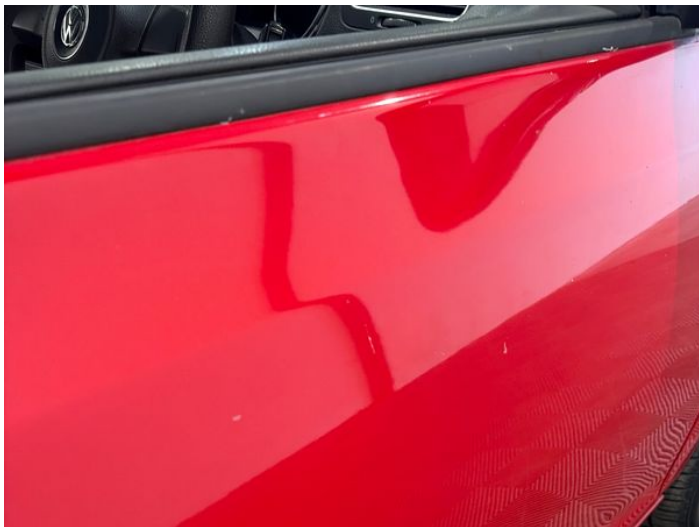
21: Door osf  
Chipped  
Multiple Chips

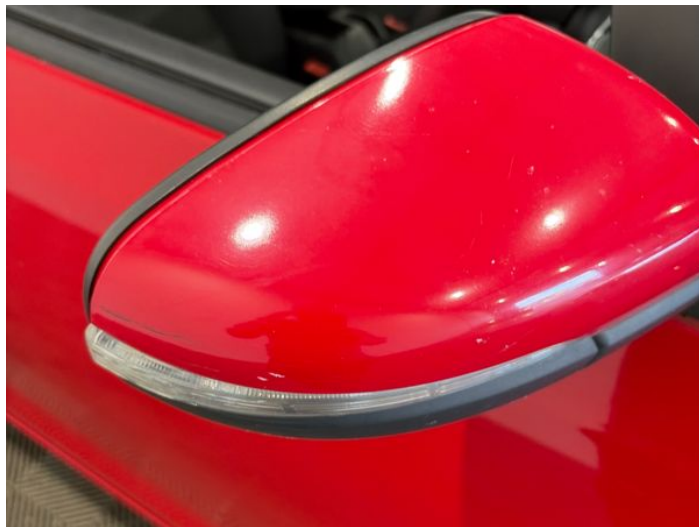
22: Door Mirror Assy osf  
Scratched (Painted)  
UpTo 25mm Thru Paint

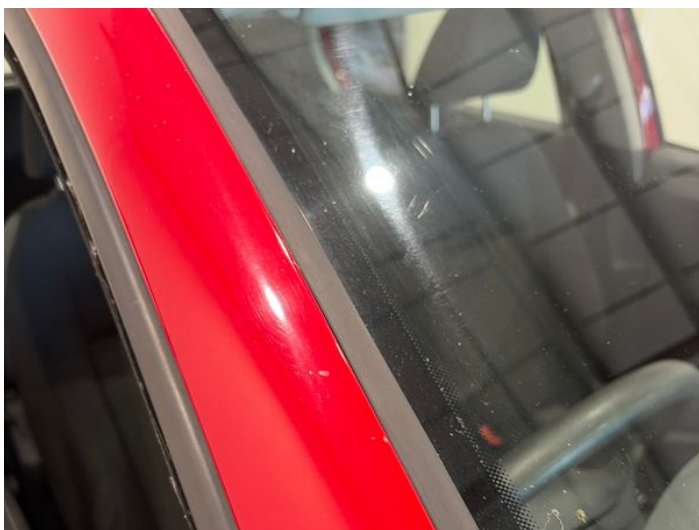
23: A Post os  
Chipped  
1 To 5

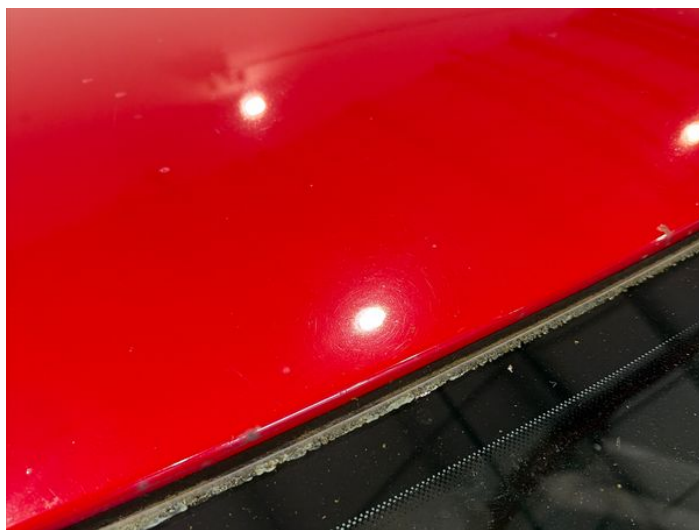
24: Roof  
Chipped  
Edge Chip

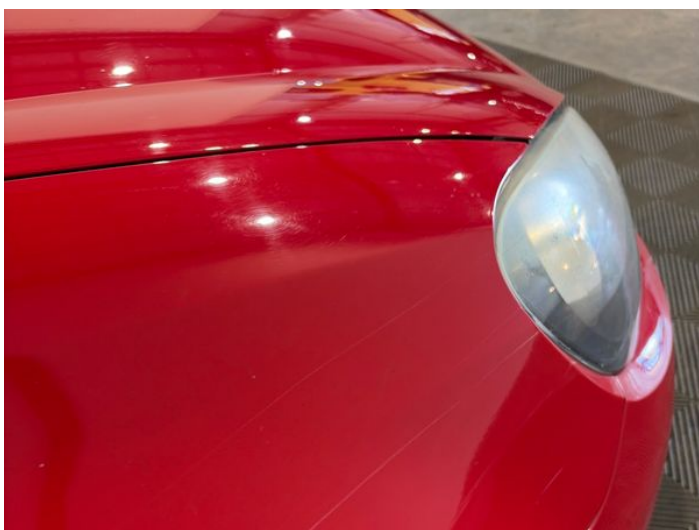
25: Wing osf  
Scratched  
Over 25mm Thru Paint

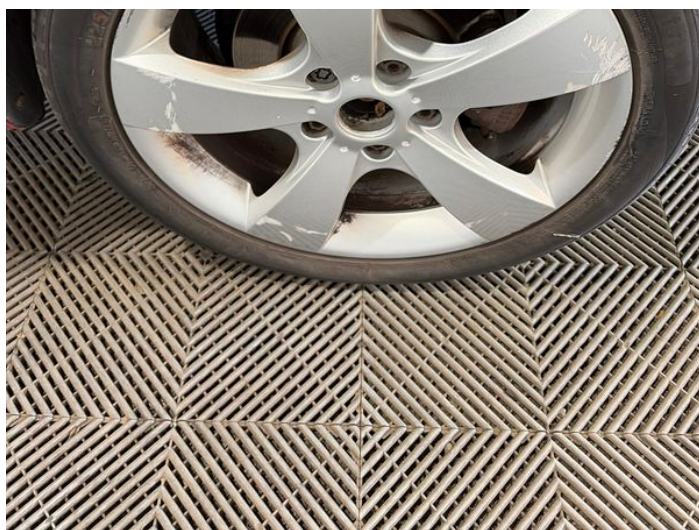
26: Wheel osf  
Scratched  
Over 50mm

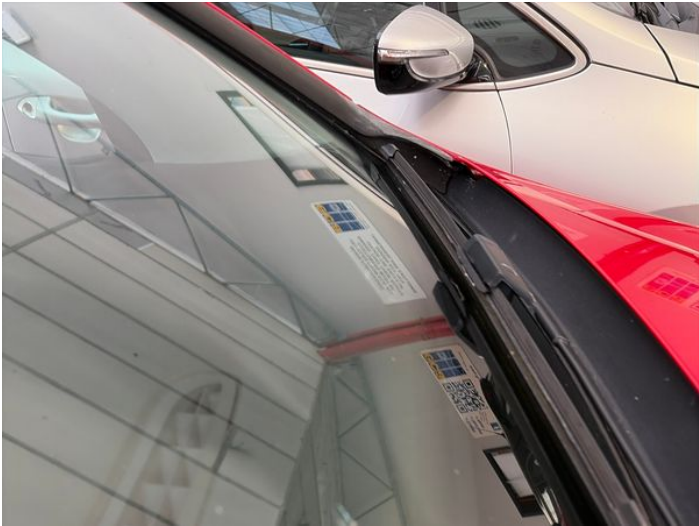
27: Screen Front  
Cracked  
Replace
