VEHICLE INSPECTION REPORT

FP74KSX

Dacia Jogger 1.0 TCe Extreme 5dr

Cat: S Incident History

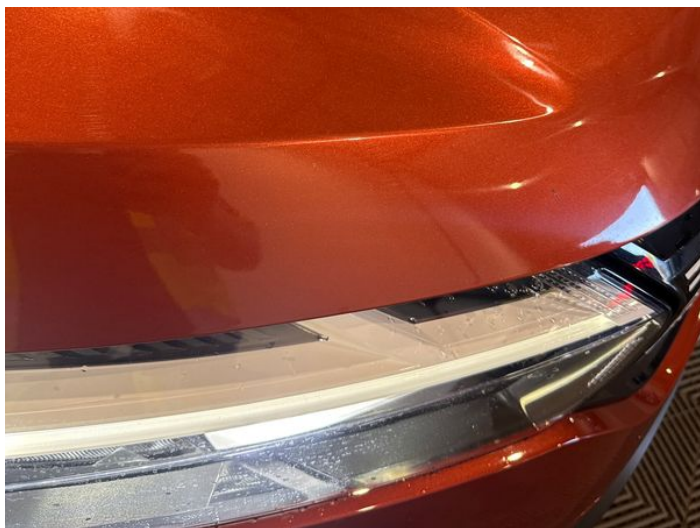
1: Bonnet  
Chipped  
1 To 5

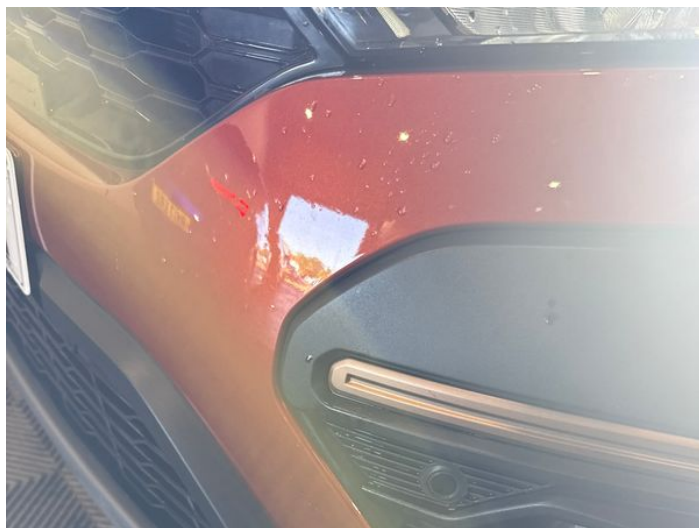
2: Bumper Front  
Chipped  
1 To 5

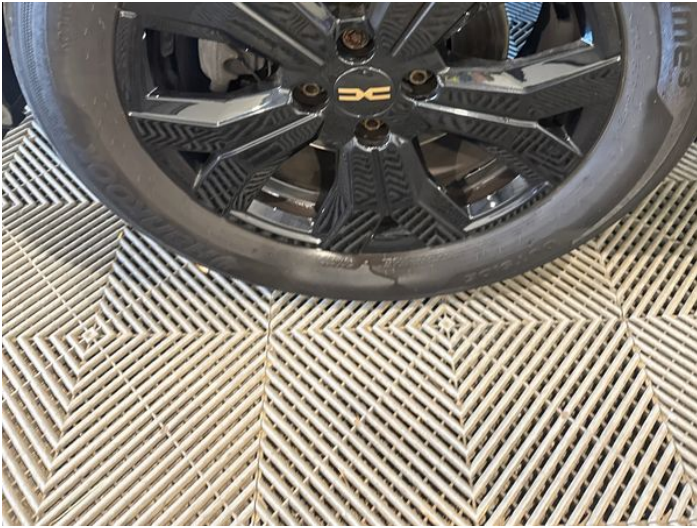
3: Wheel nsf  
Scratched  
Over 50mm

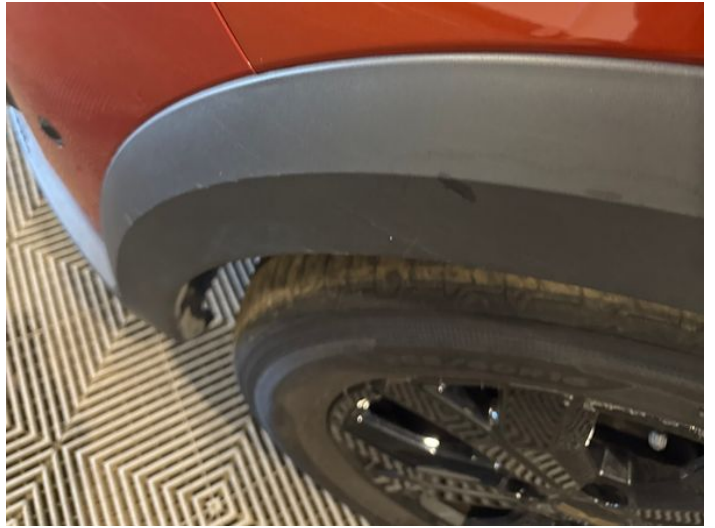
4: Wing nsf  
Scratched  
Over 25mm Thru Paint

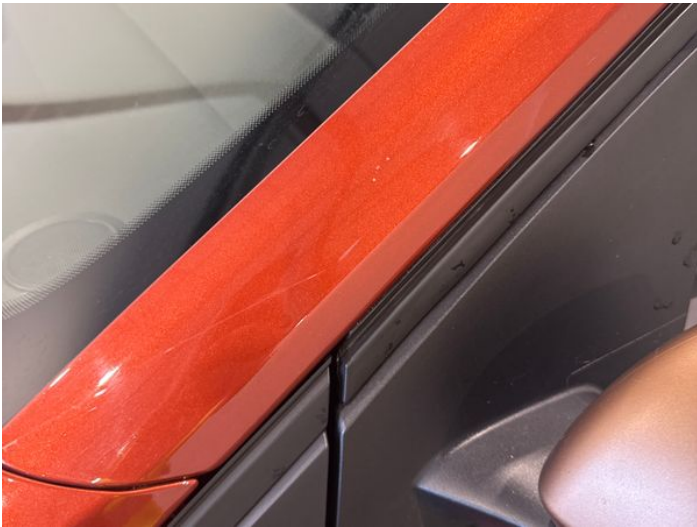
5: A Post ns  
Chipped  
1 To 5

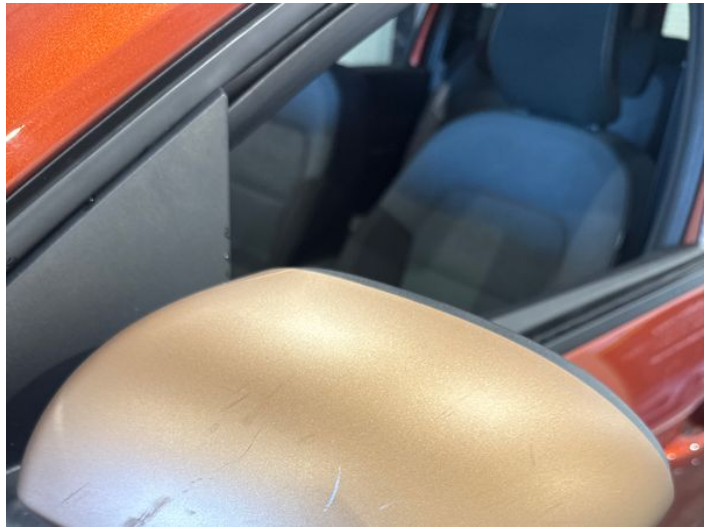
6: Door Mirror Assy nsf  
Scratched (Painted)  
UpTo 25mm Thru Paint

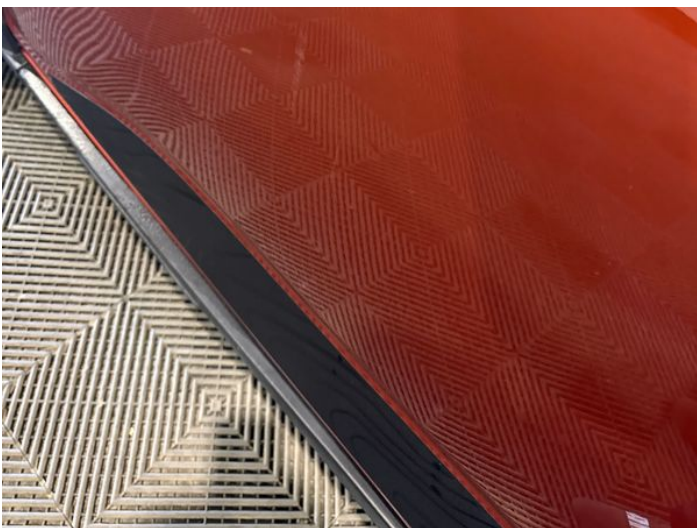
7: Door nsf  
Scratched  
Over 25mm Thru Paint

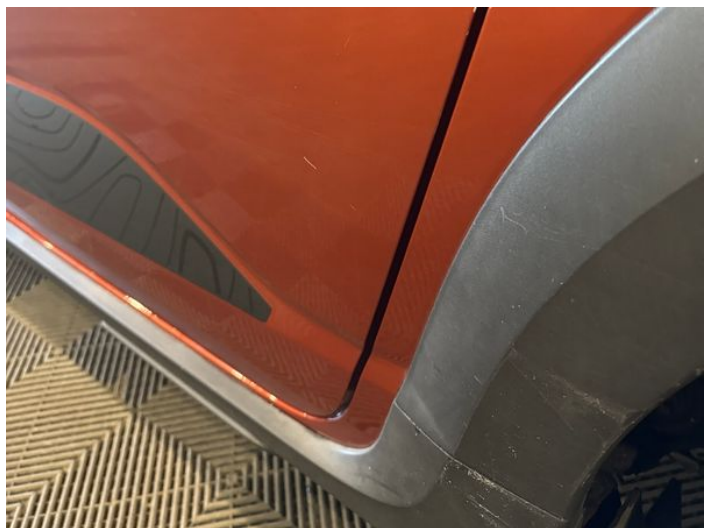
8: Door nsr  
Scratched  
UpTo 25mm Thru Paint

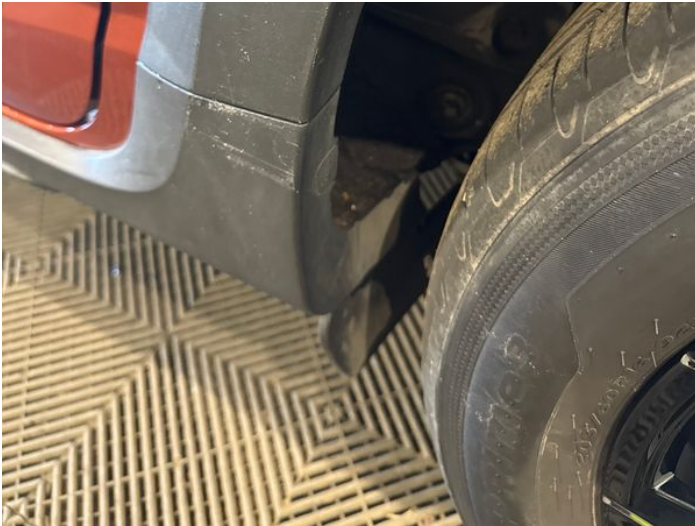
9: Qtr Panel Arch Extension ns  
Scuffed (Unpainted)  
UpTo 100mm

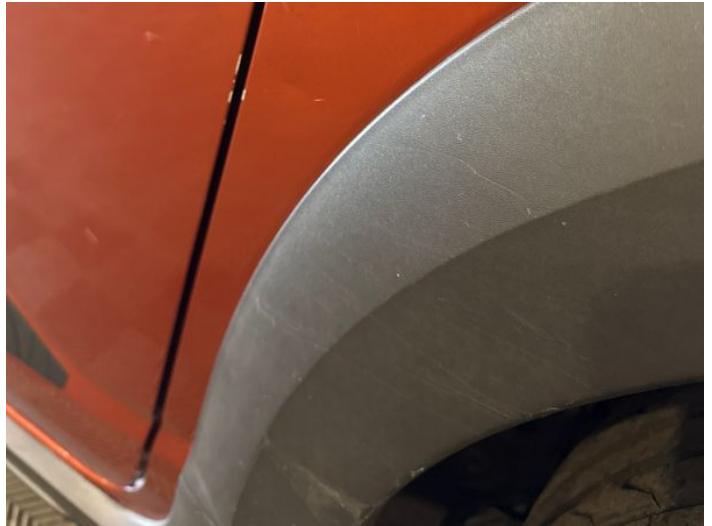
10: Qtr Panel nsr  
Dented  
Between 10mm + 30mm

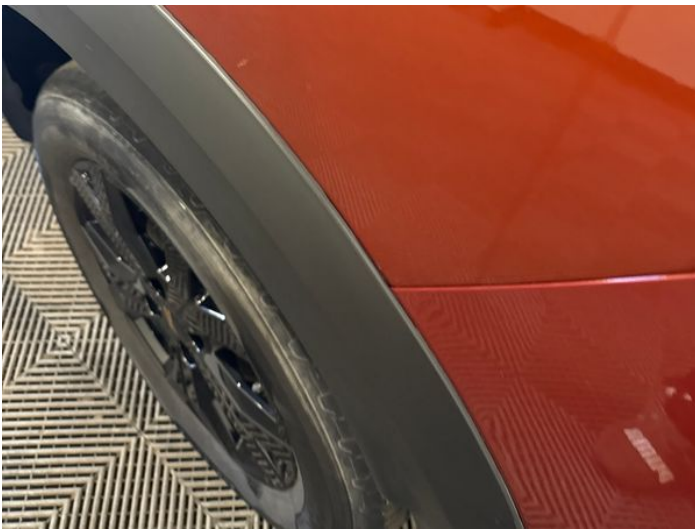
11: Qtr Panel nsr  
Scratched  
UpTo 25mm Thru Paint

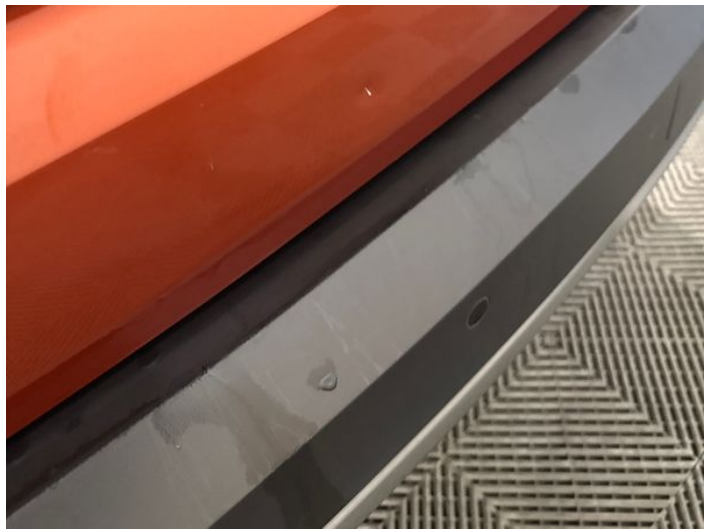
12: Tailgate  
Dented  
2 Or Less UpTo 10mm

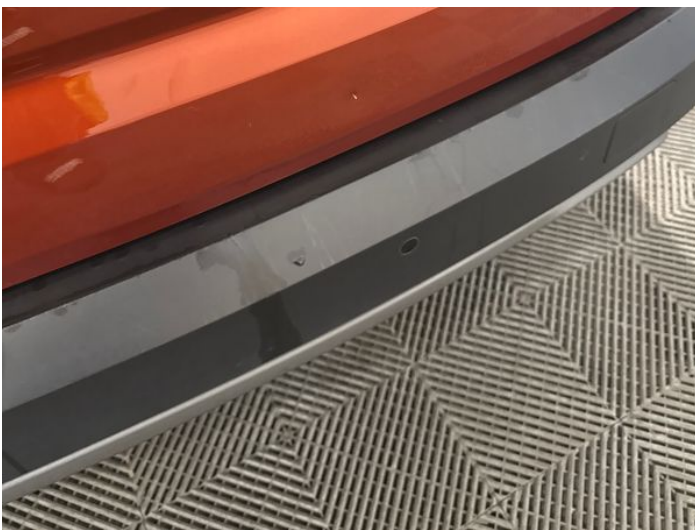
13: Tailgate  
Chipped  
1 To 5

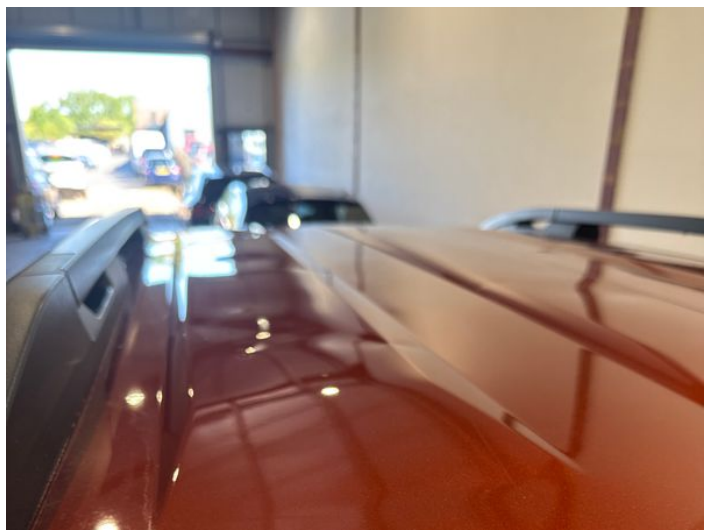
14: Roof  
Dented  
Over 30mm

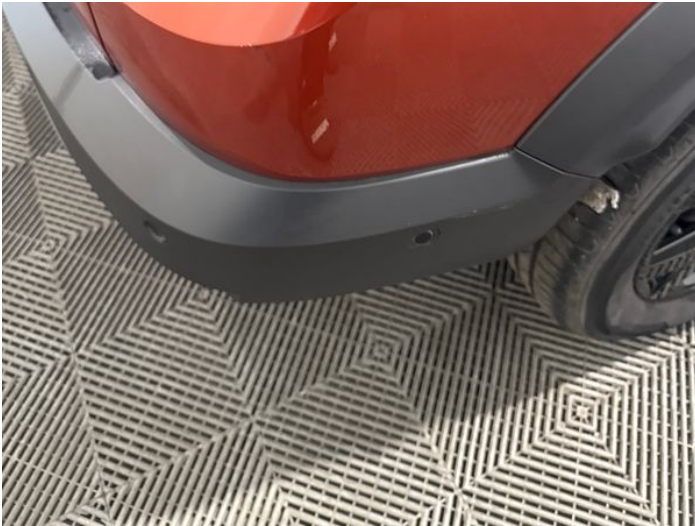
15: Bumper Rear  
Scratched  
25 to 100mm Thru Paint

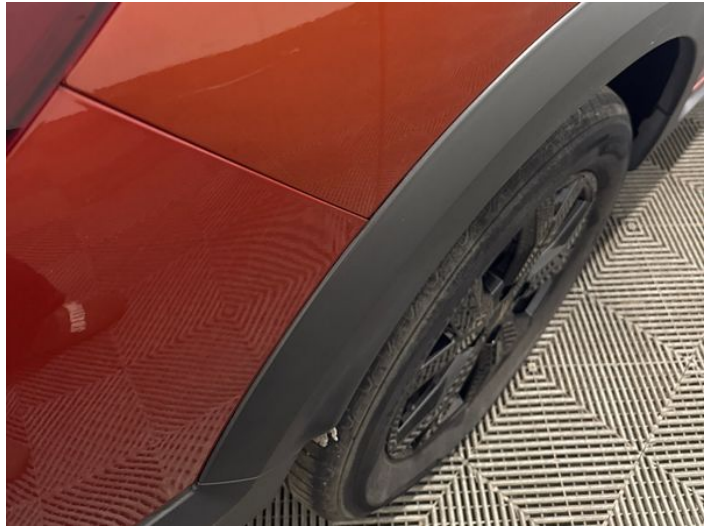
16: Qtr Panel osr  
Scratched  
Over 25mm Thru Paint

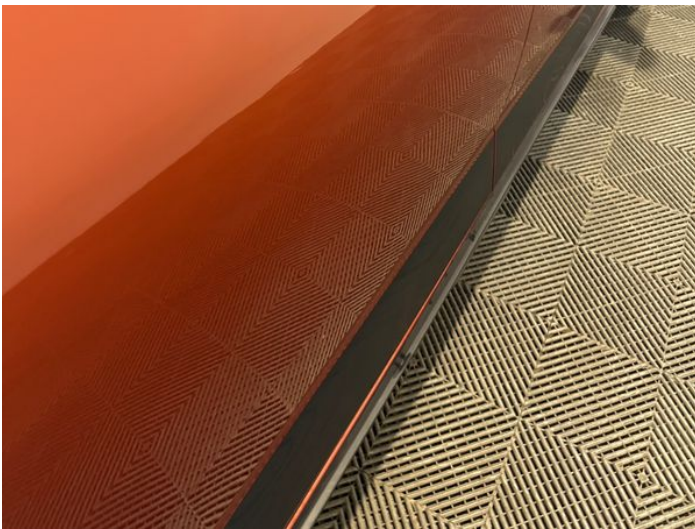
17: Door osr  
Dented  
Over 30mm

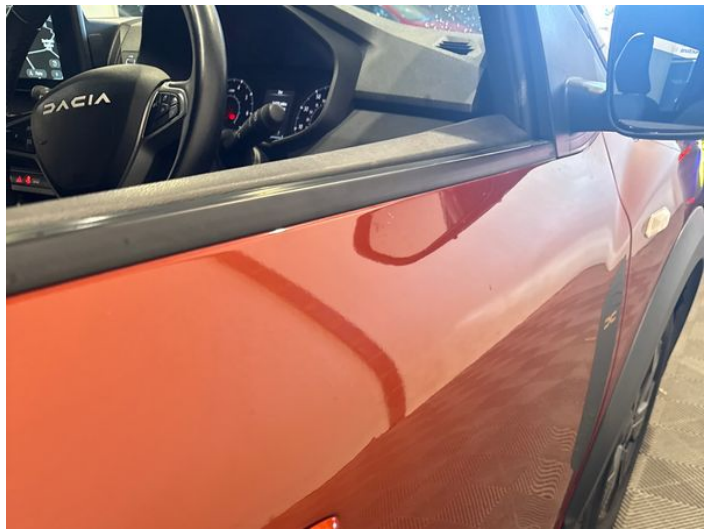
18: Door osf  
Dented  
Between 10mm + 30mm
