## VEHICLE INSPECTION REPORT

**SD63PPU**

### Lexus CT 200h 1.8 Advance 5dr CVT Auto

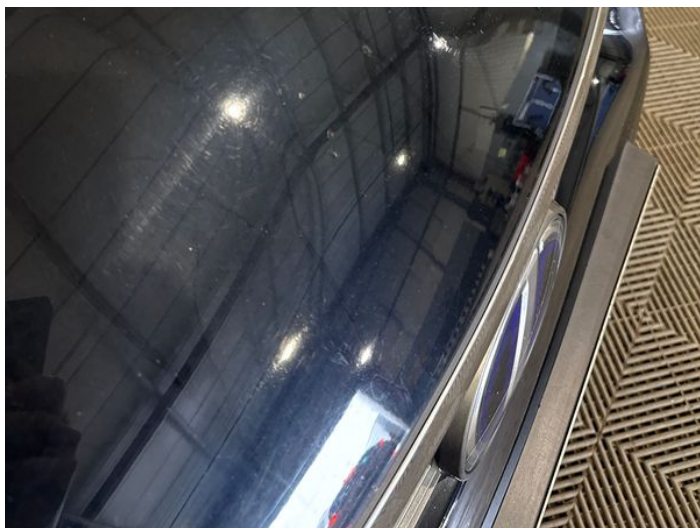
1: Bonnet  
Chipped  
Multiple Chips

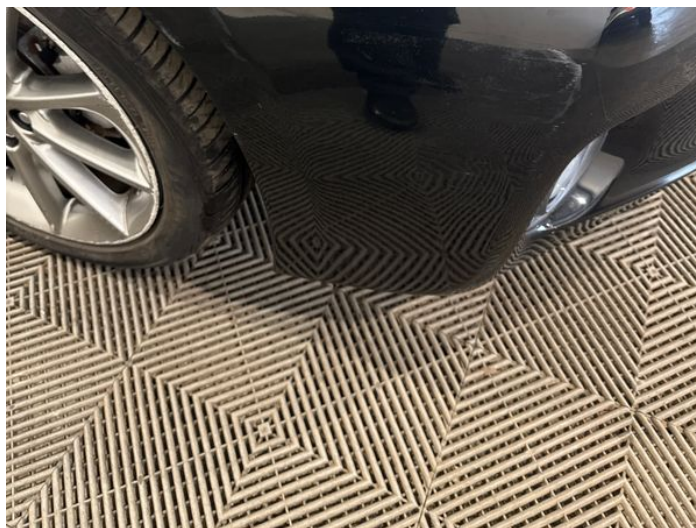
2: Bumper Front  
Dented  
With Paint Damage

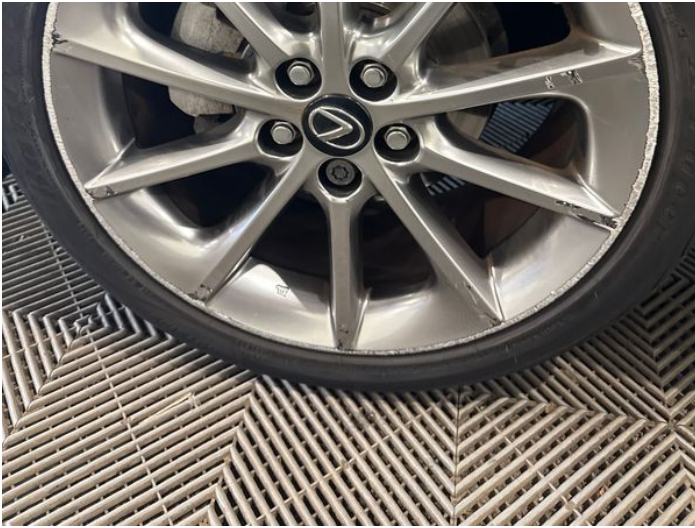
3: Wheel nsf  
Scratched  
Over 50mm

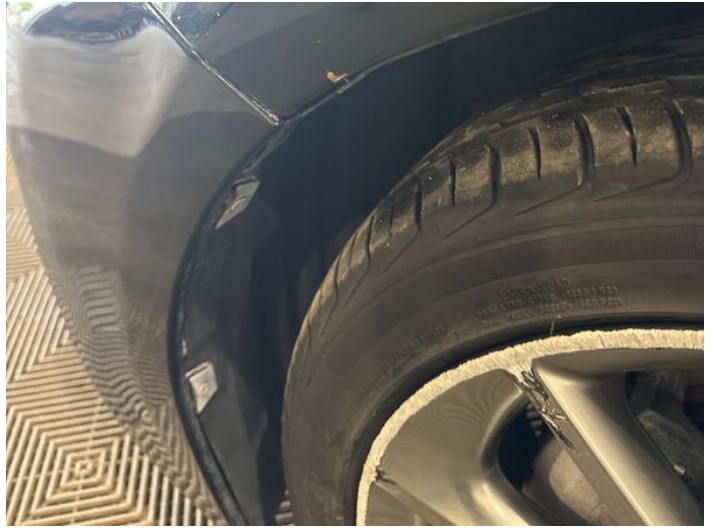
4: Wing nsf  
Scratched  
Rusted

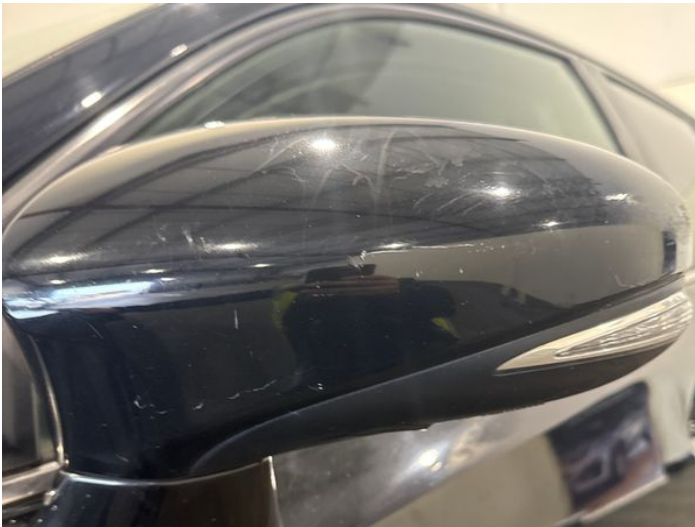
5: Door Mirror Assy nsf  
Scratched (Painted)  
Over 25mm Thru Paint

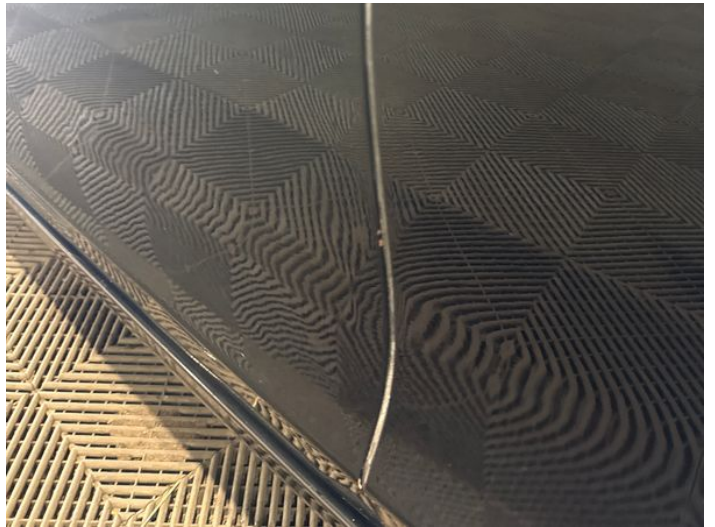
6: Door nsf  
Chipped  
Edge Chip

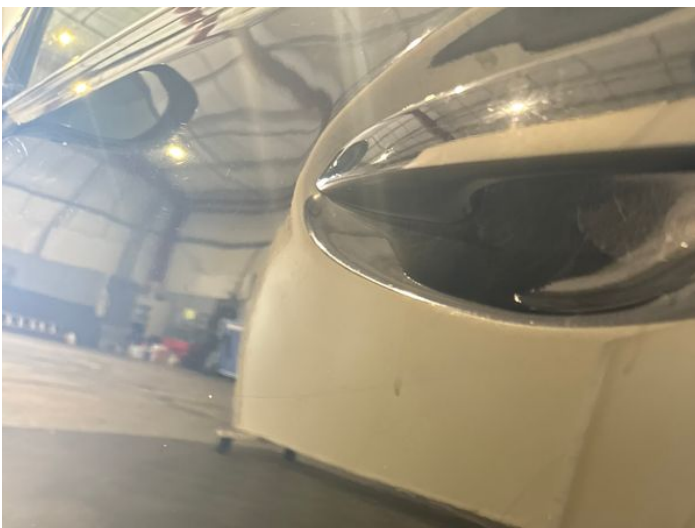
7: Door nsf  
Chipped  
1 To 5

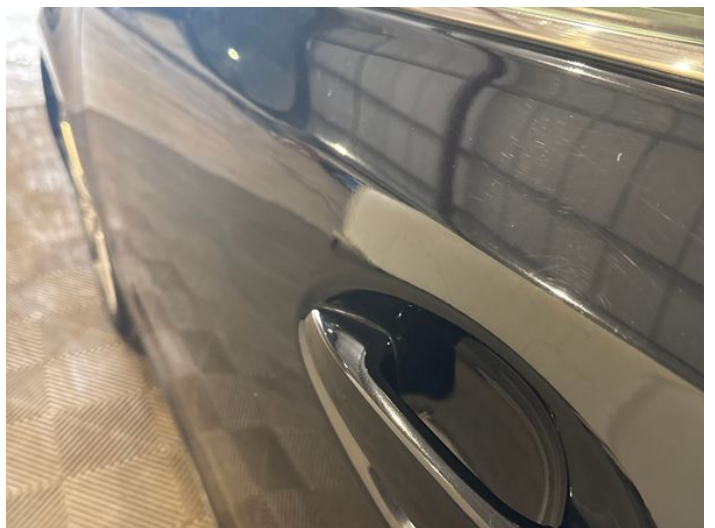
8: Door nsf  
Dented  
Over 30mm

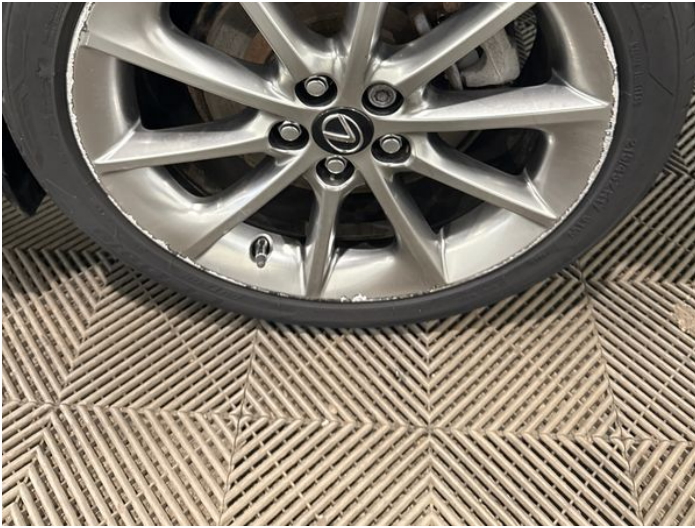
9: Wheel nsr  
Scratched  
Over 50mm

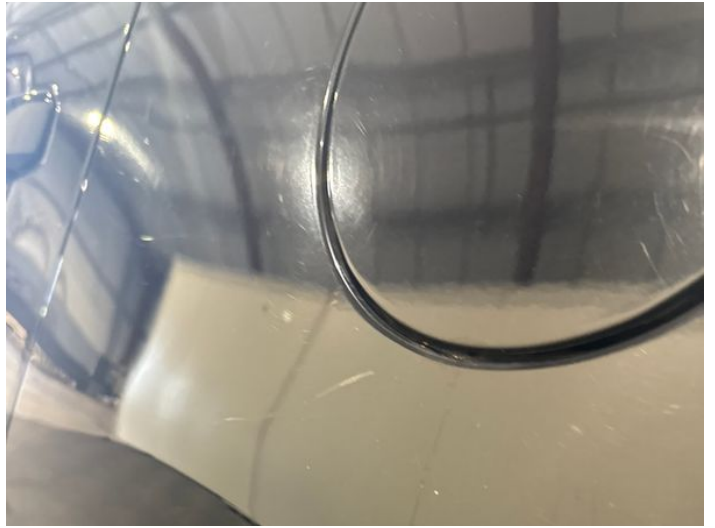
10: Qtr Panel nsr  
Scratched  
Over 25mm Thru Paint

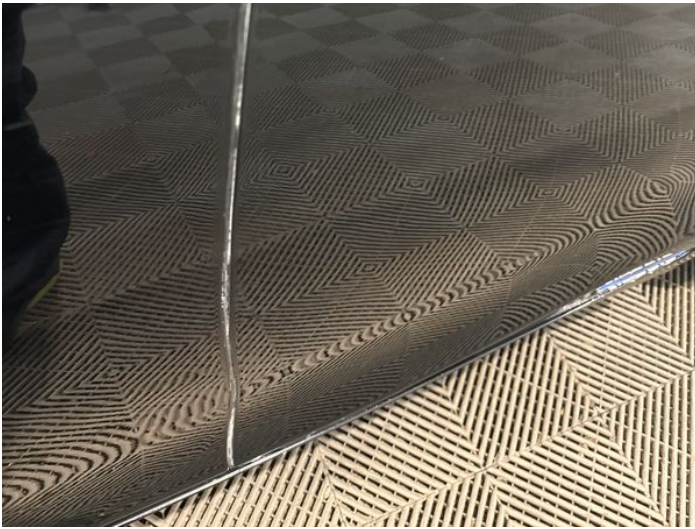
11: Door nsr  
Chipped  
Edge Chip

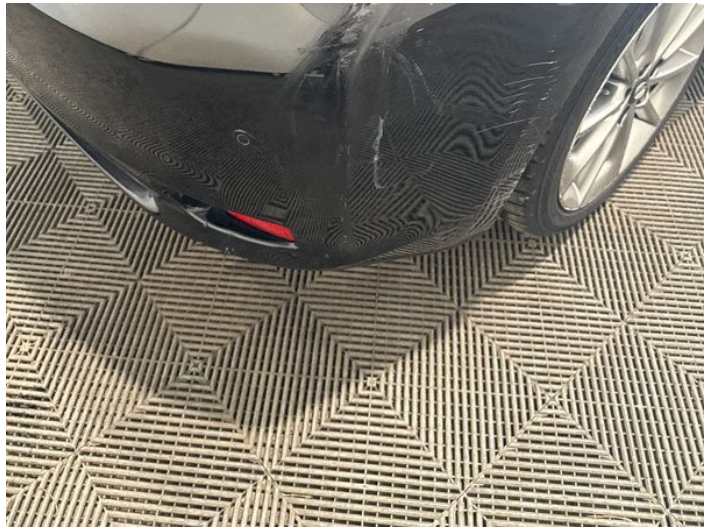
12: Bumper Rear  
Scratched  
Over 100mm Thru Paint

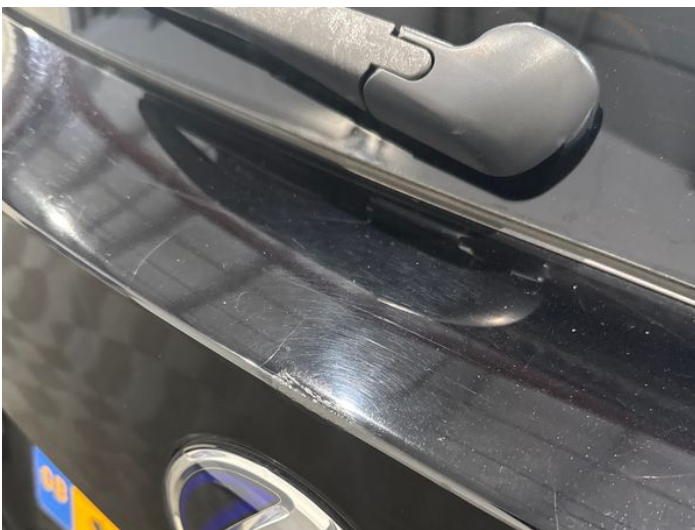
13: Tailgate  
Scratched  
Over 25mm Thru Paint

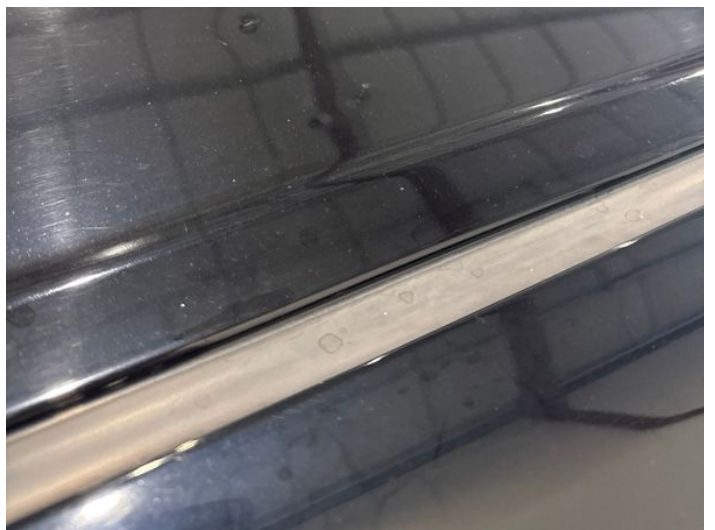
14: Roof  
Dented  
Over 30mm

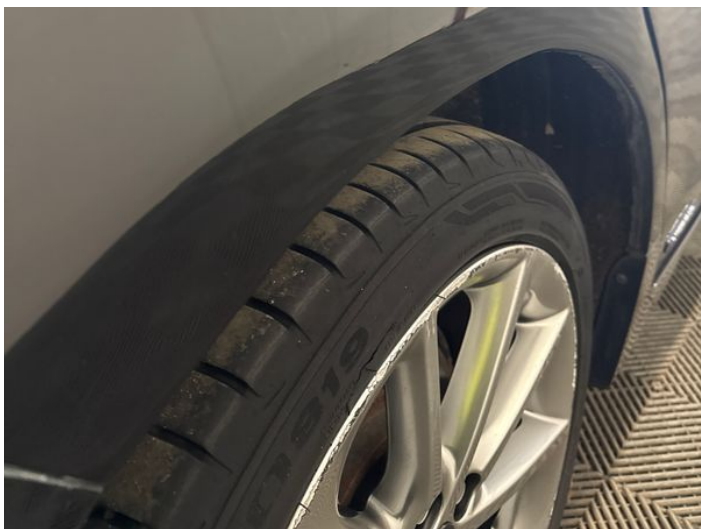
15: Qtr Panel osr  
Poor Previous Repair  
Poor Paint

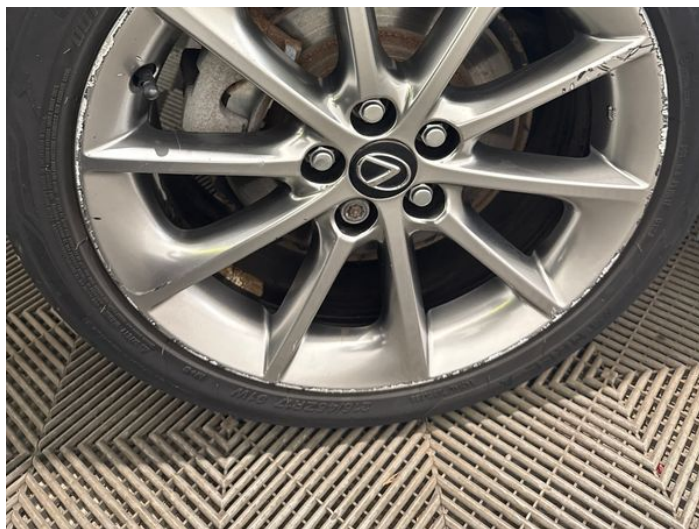
16: Wheel osr  
Scratched  
Over 50mm

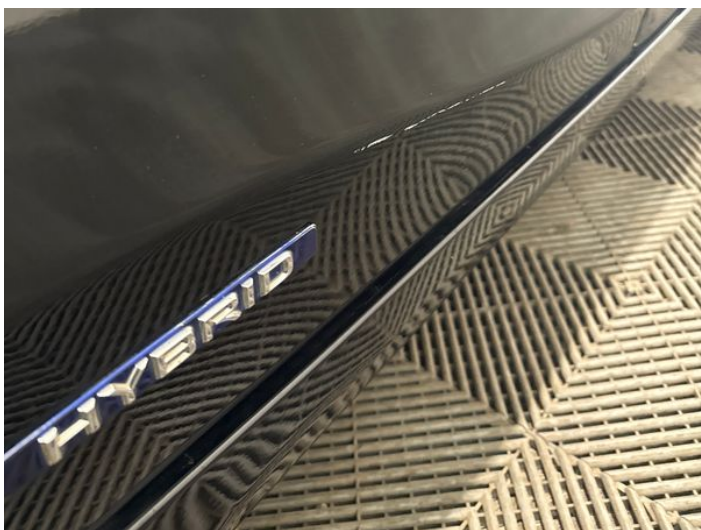
17: Door osr  
Scratched  
Over 25mm Thru Paint

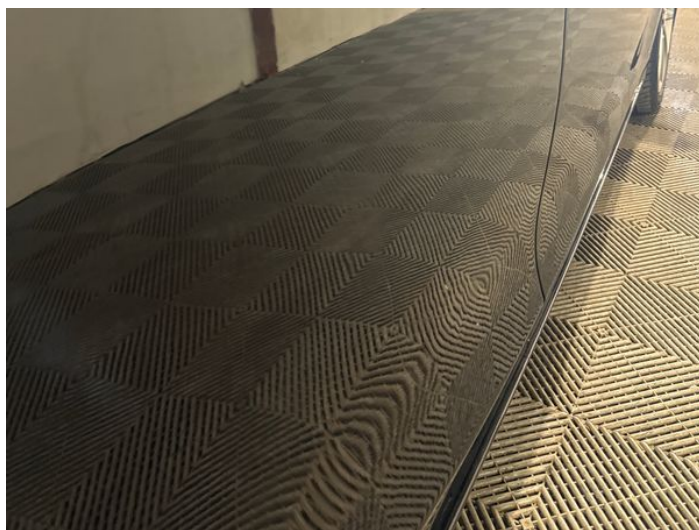
18: Door osr  
Dented  
Between 10mm + 30mm

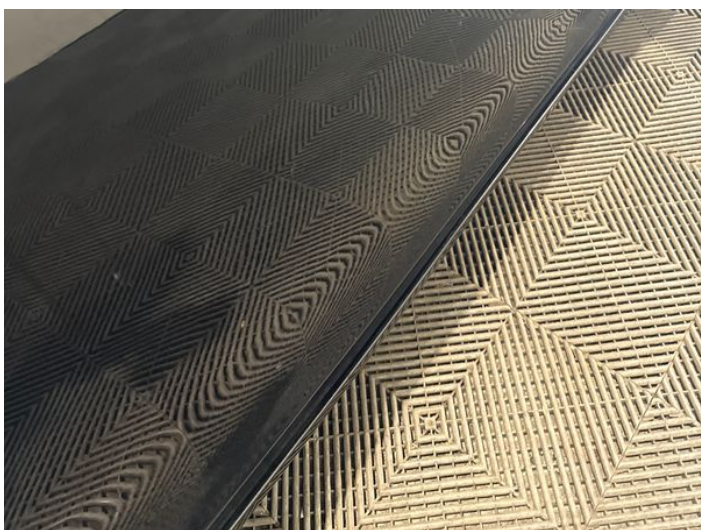
19: Door osf  
Scratched  
Over 25mm Thru Paint

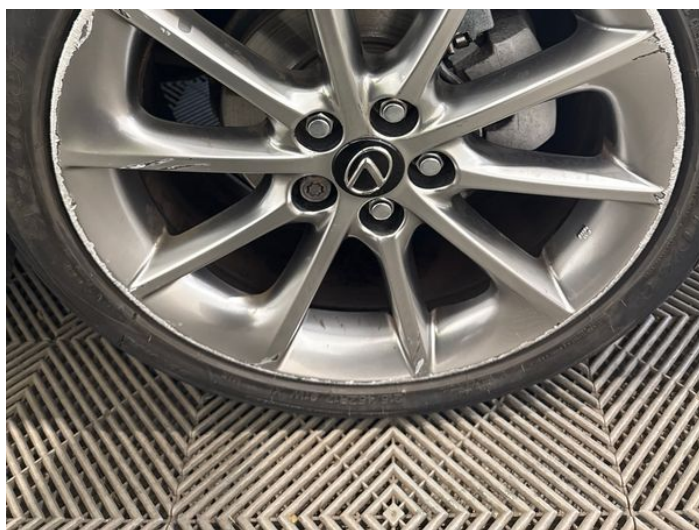
20: Wheel osf  
Scratched  
Over 50mm

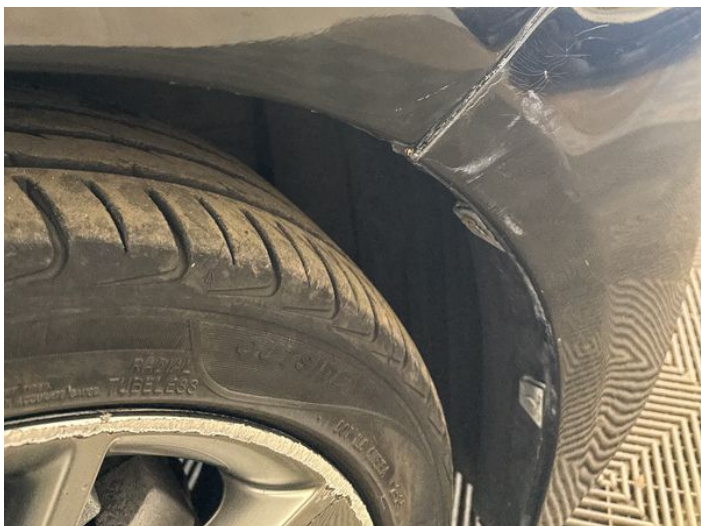
21: Wing osf  
Scratched  
UpTo 25mm Thru Paint

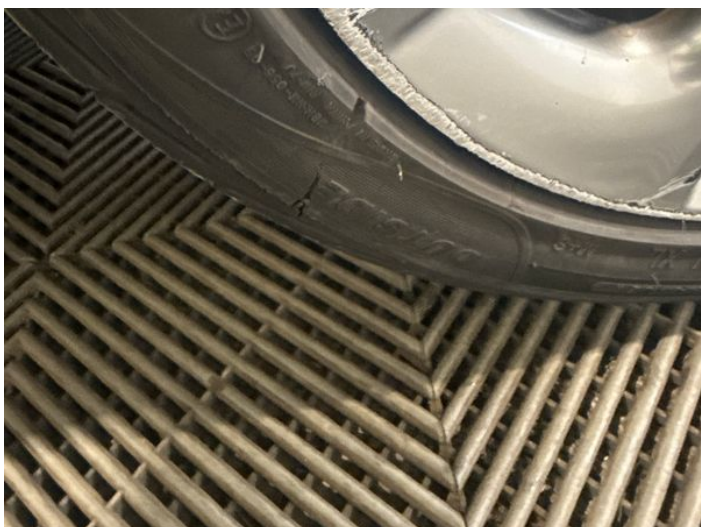
| OSF | BUDGET | Damaged |

23: Tyre osf  
Damaged  
Replace

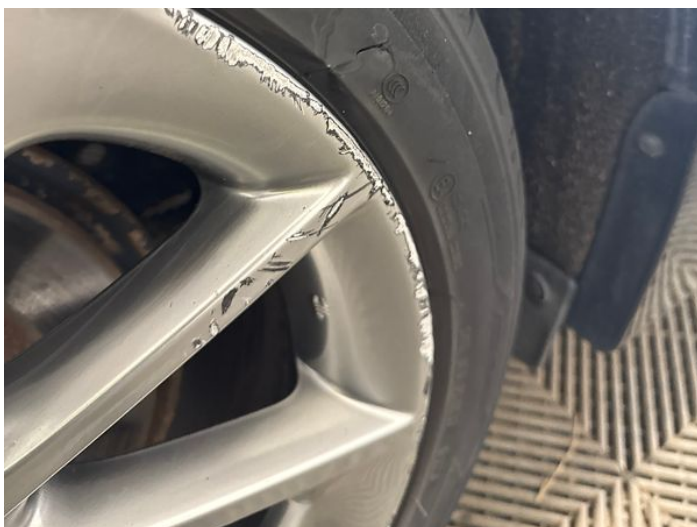
| OSR | BUDGET | Damaged |

24: Tyre osr  
Damaged  
Replace

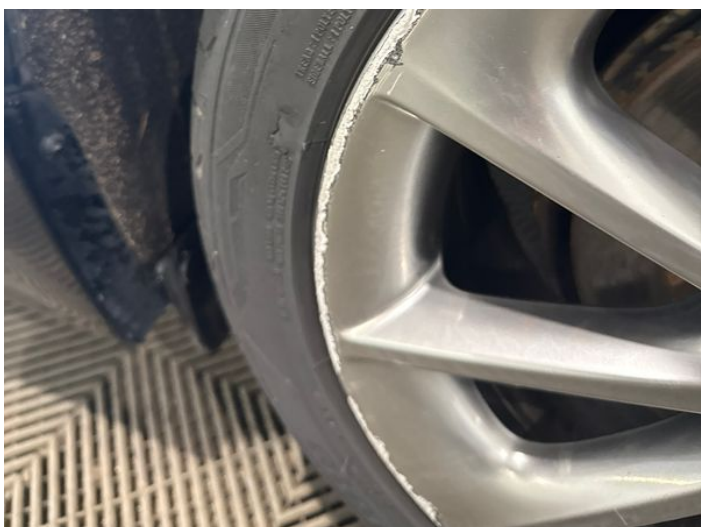
| NSR | BUDGET | Damaged |

25: Tyre nsr  
Damaged  
Replace

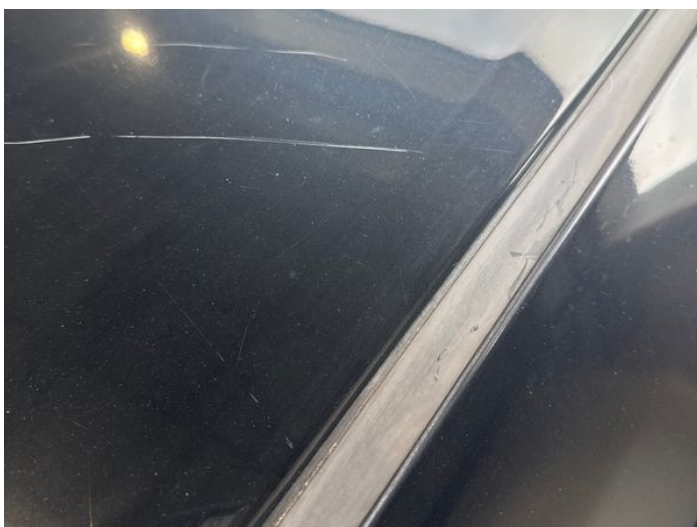
26: Roof  
Scratched  
Over 25mm Thru Paint
