## VEHICLE INSPECTION REPORT

**WM20HFA**

### Seat Ateca 1.5 TSI EVO FR Sport [EZ] 5dr

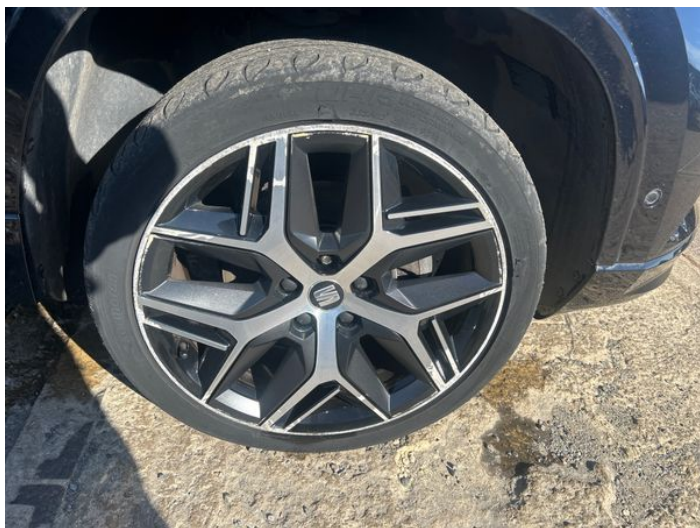
1: Wheel osf  
Scratched  
Over 50mm

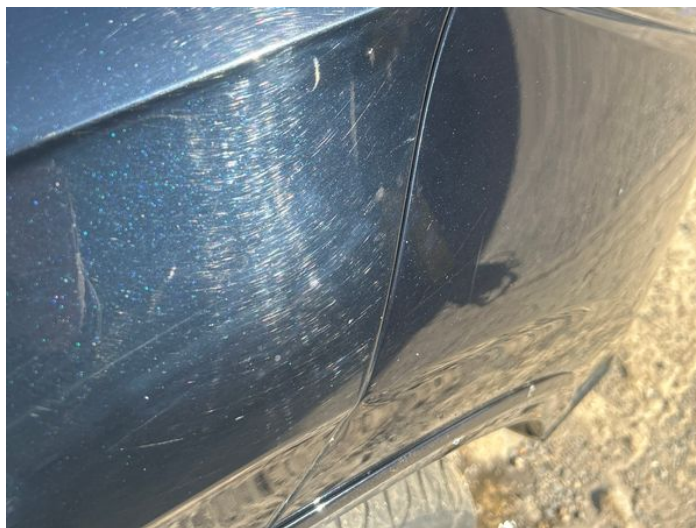
2: Wing osf  
Chipped  
1 To 5

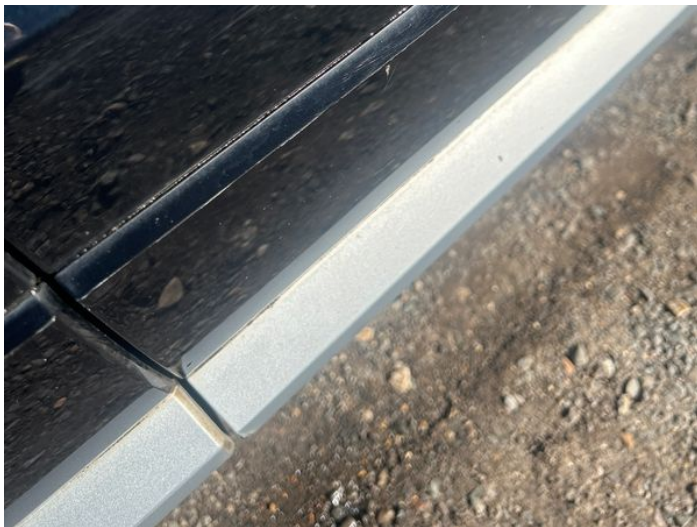
3: Door osf  
Scratched  
Over 25mm Thru Paint

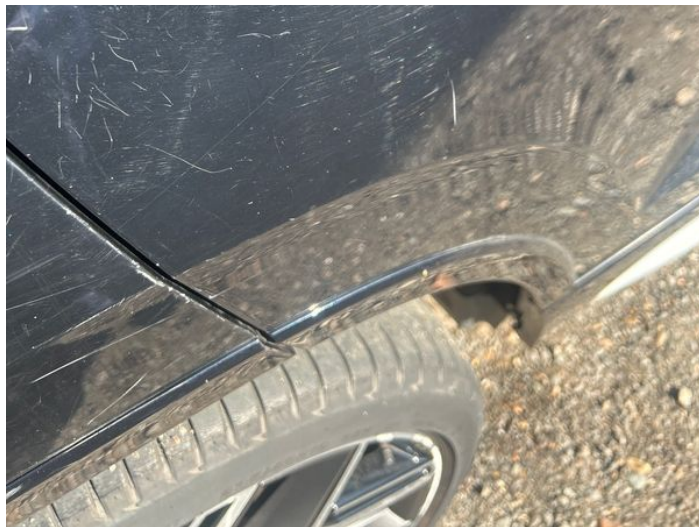
4: Door osr  
Scratched  
Over 25mm Thru Paint

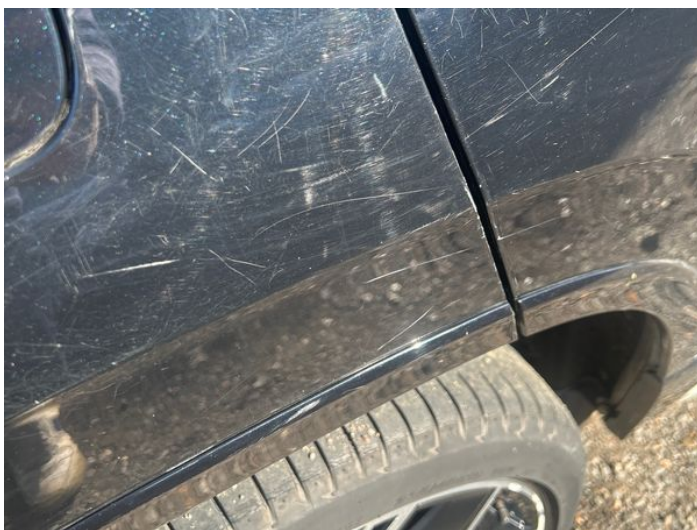
5: Qtr Panel osr  
Scratched  
Over 25mm Thru Paint

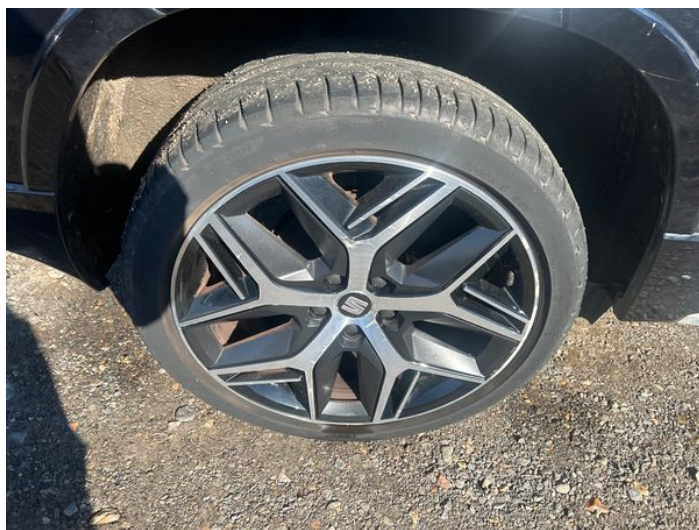
6: Wheel osr  
Corroded  
Light

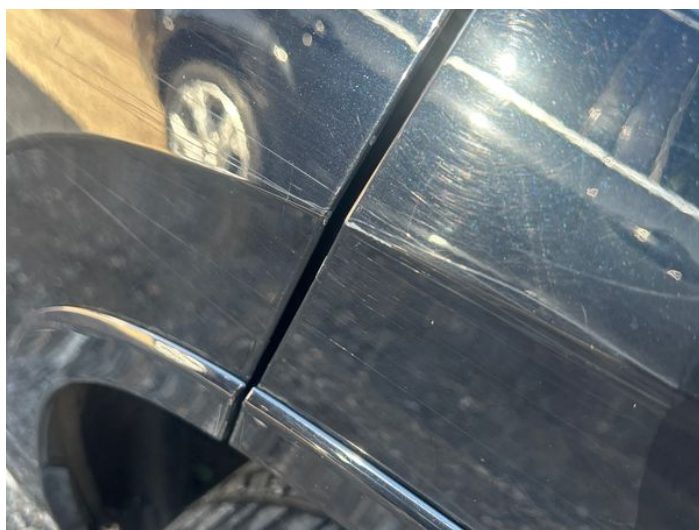
8: Qtr Panel nsr  
Scratched  
UpTo 25mm Thru Paint

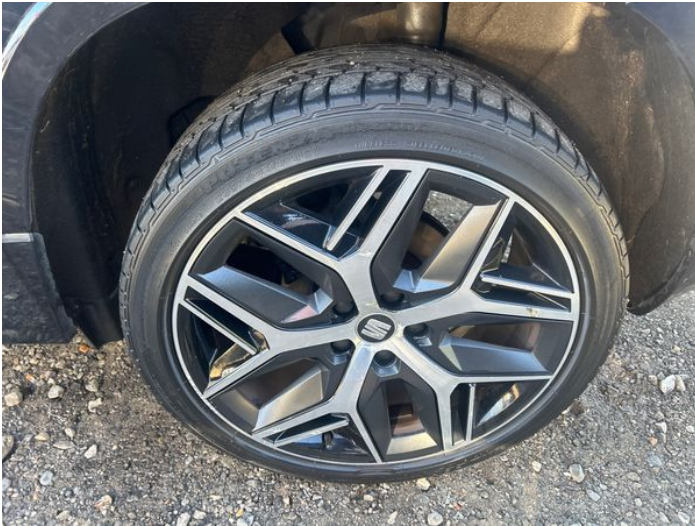
9: Wheel nsr  
Corroded  
Light

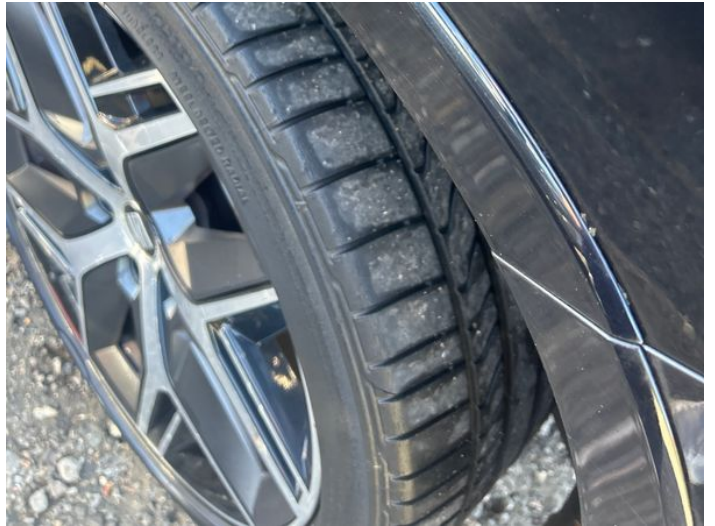
10: Qtr Panel Moulding ns  
Scratched (Painted)  
UpTo 25mm Thru Paint

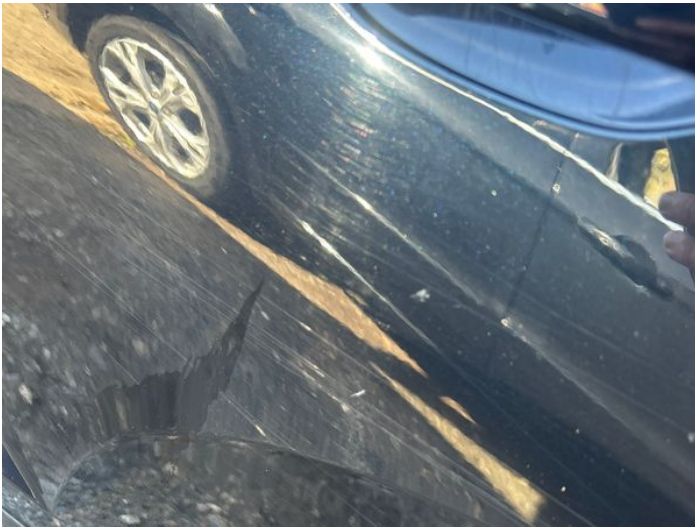
11: Door nsr  
Chipped  
1 To 5

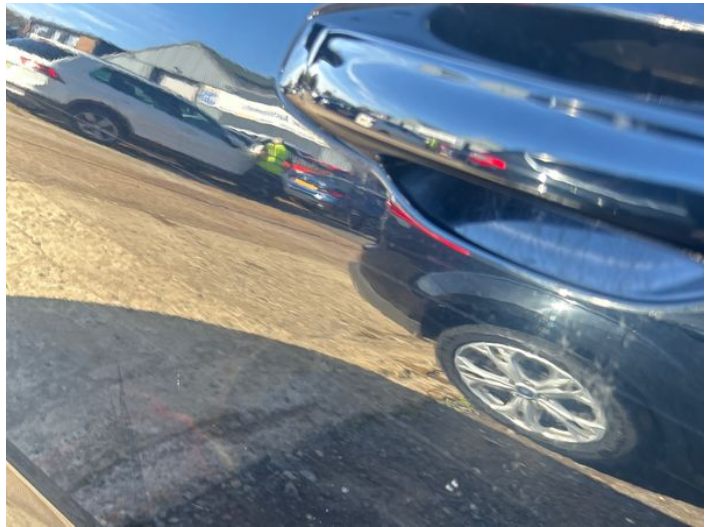
12: Door nsf  
Chipped  
1 To 5

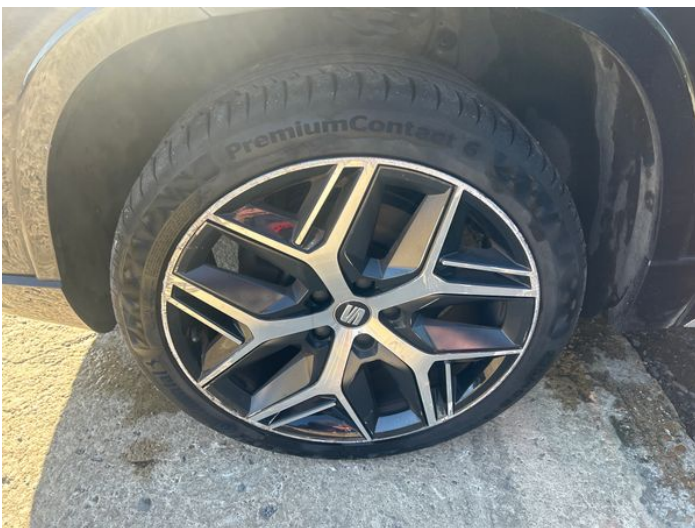
13: Wheel nsf  
Scratched  
Over 50mm

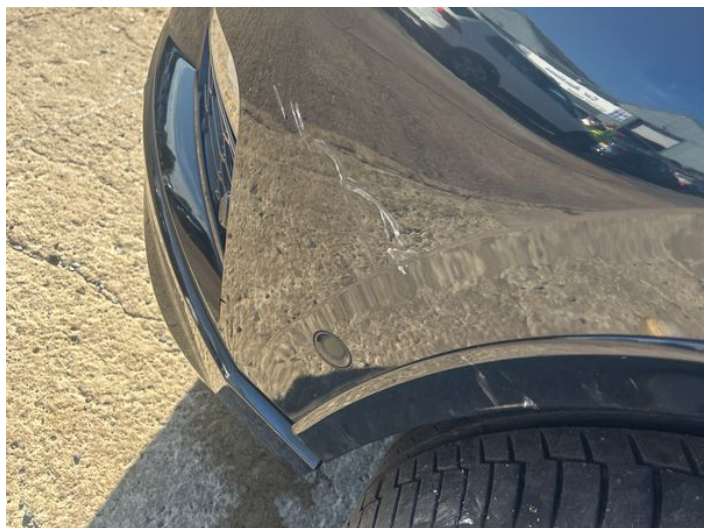
14: Bumper Front  
Scratched  
Over 100mm Thru Paint

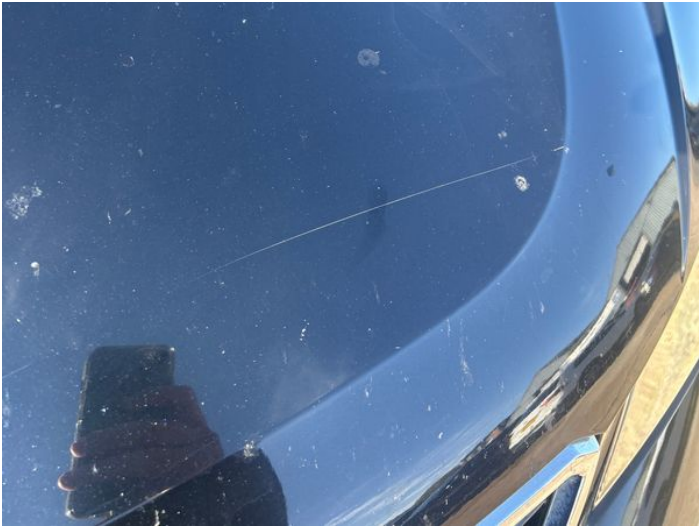
15: Bonnet  
 Scratched  
 Over 25mm Thru Paint

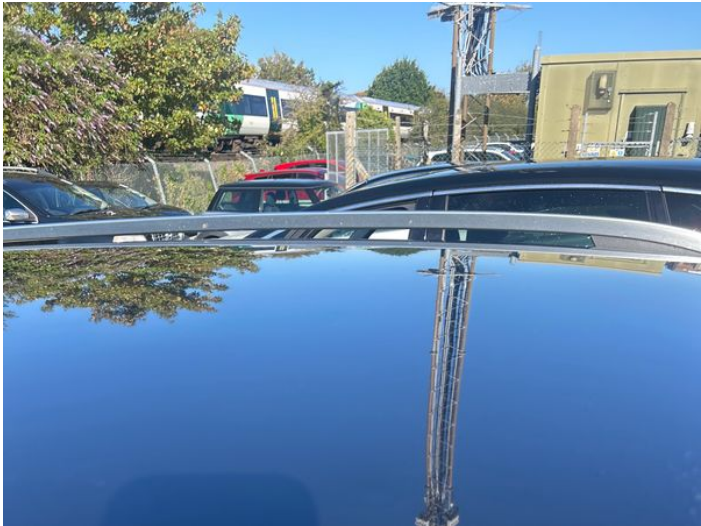
16: Roof  
 Dented  
 2 Or Less UpTo 10mm

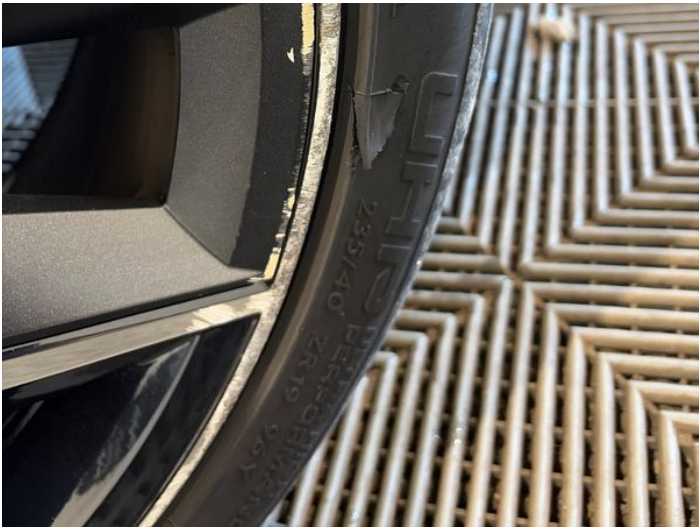
| OSF | KORMORAN | Damaged |

17: Tyre osf  
 Damaged  
 Replace

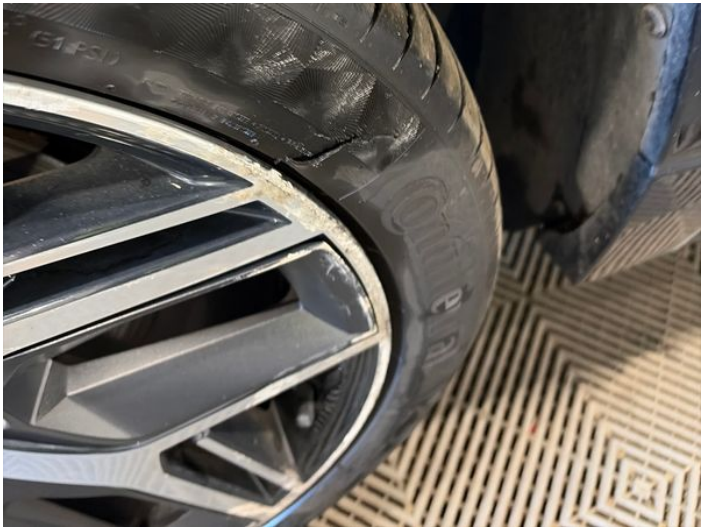
| NSF | CONTINENTAL | Damaged |

18: Tyre nsf  
 Damaged  
 Replace
