# VEHICLE INSPECTION REPORT

**BT69FZA**

## Mercedes-Benz A Class A180d AMG Line 5dr

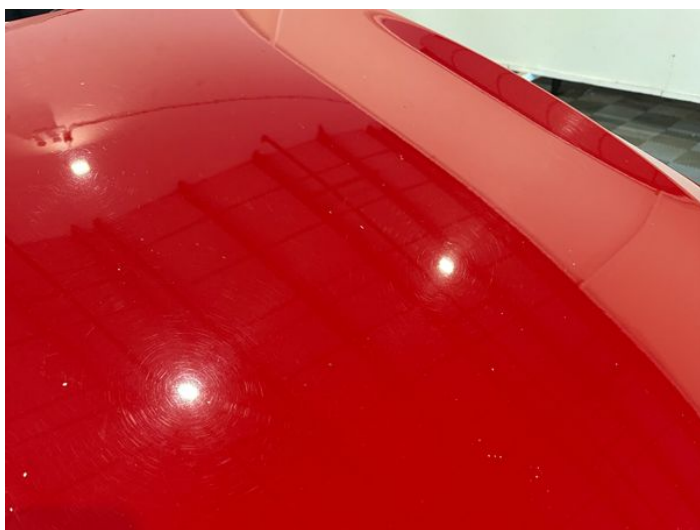
1: Bonnet  
Chipped  
Multiple Chips

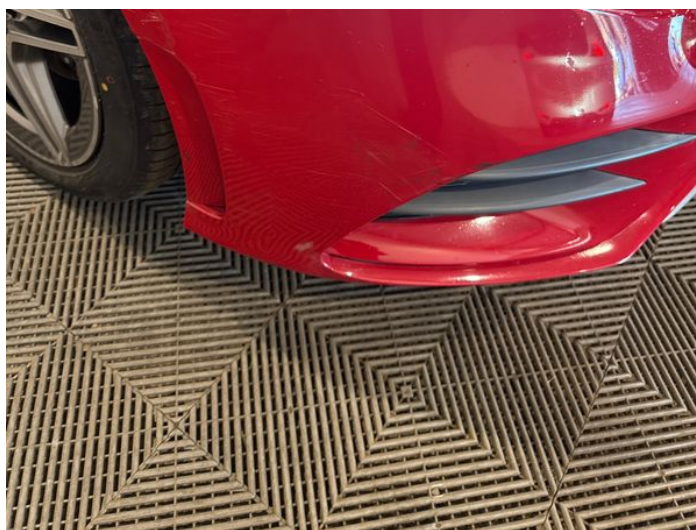
2: Bumper Front  
Scratched  
Over 100mm Thru Paint

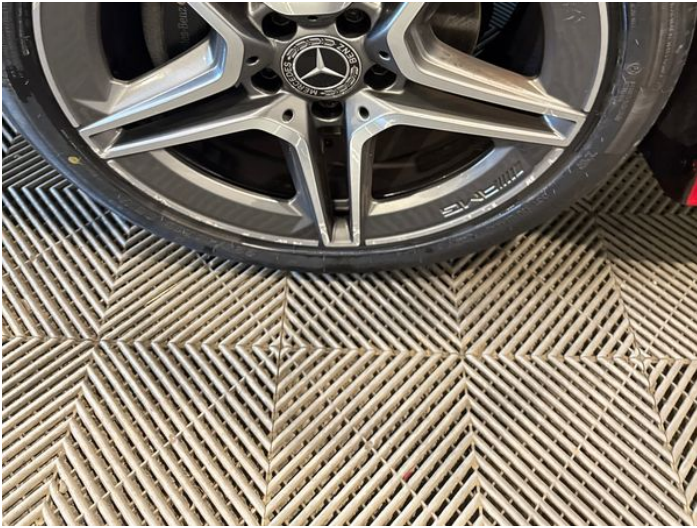
3: Wheel nsf  
Scratched  
Over 50mm

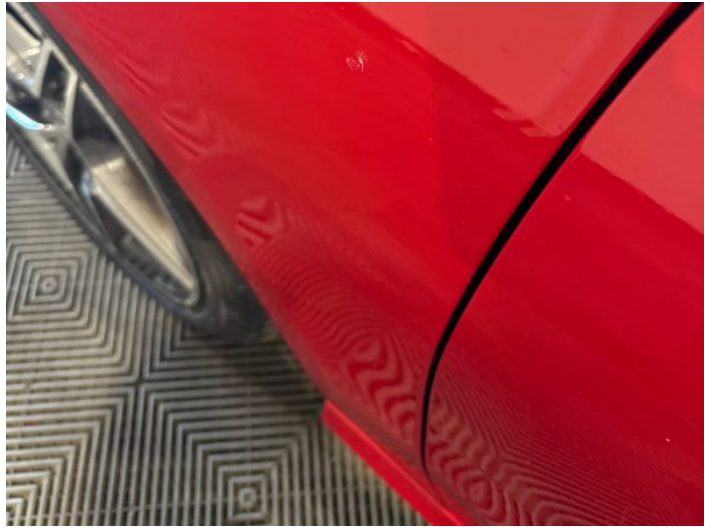
4: Wing nsf  
Scratched  
UpTo 25mm Thru Paint

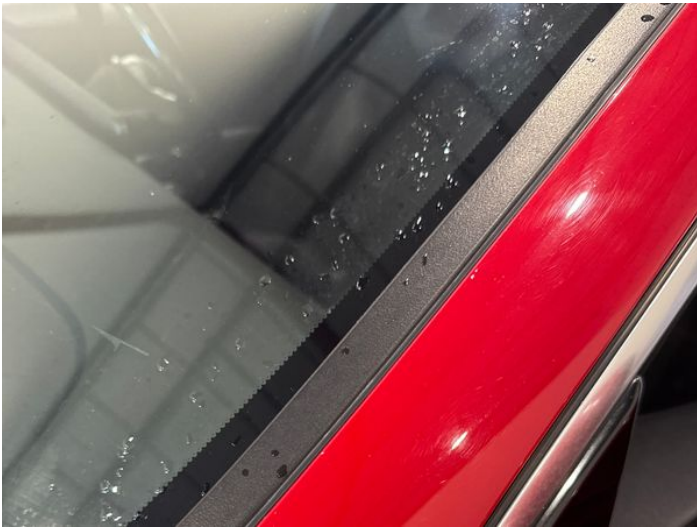
5: A Post ns  
Chipped  
1 To 5

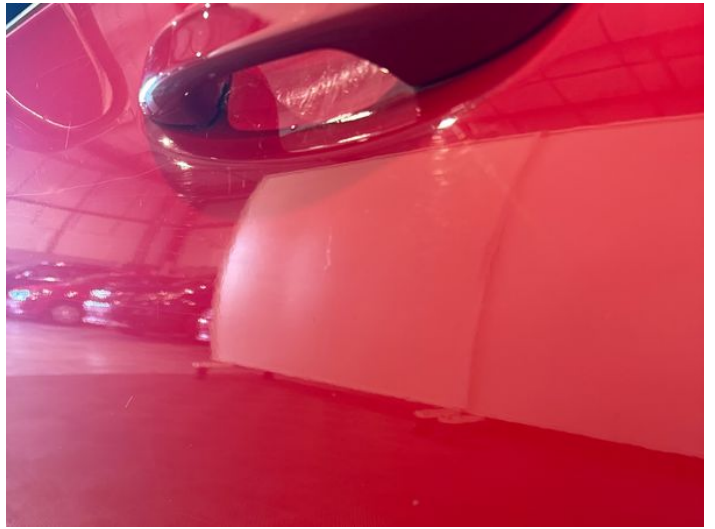
6: Door nsf  
Scratched  
UpTo 25mm Thru Paint

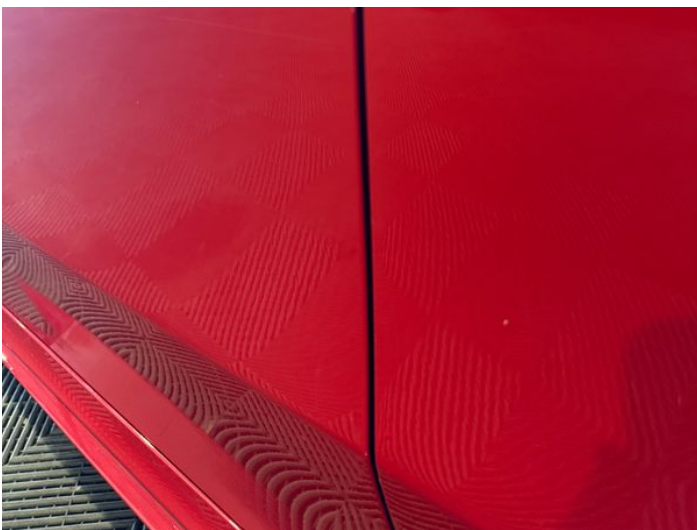
7: Door nsf  
Chipped  
Edge Chip

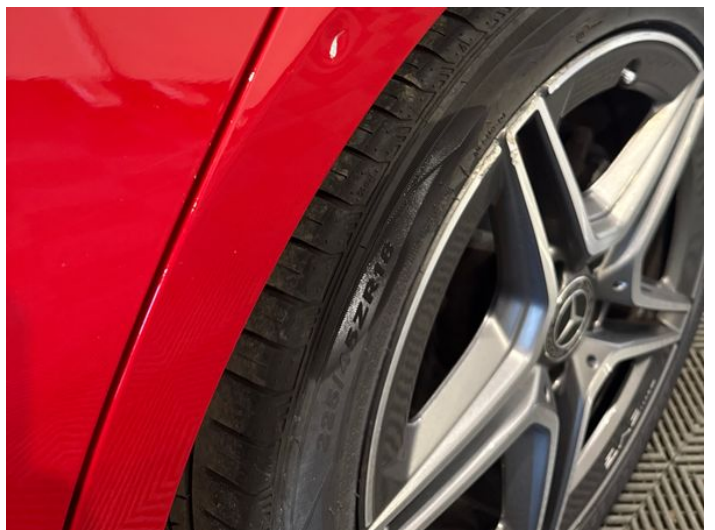
8: Qtr Panel nsr  
Dented  
With Paint Damage

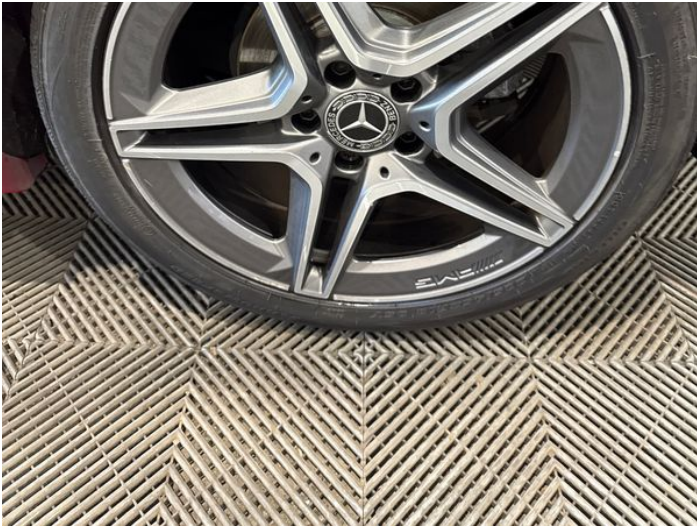
9: Wheel nsr  
Scratched  
Over 50mm

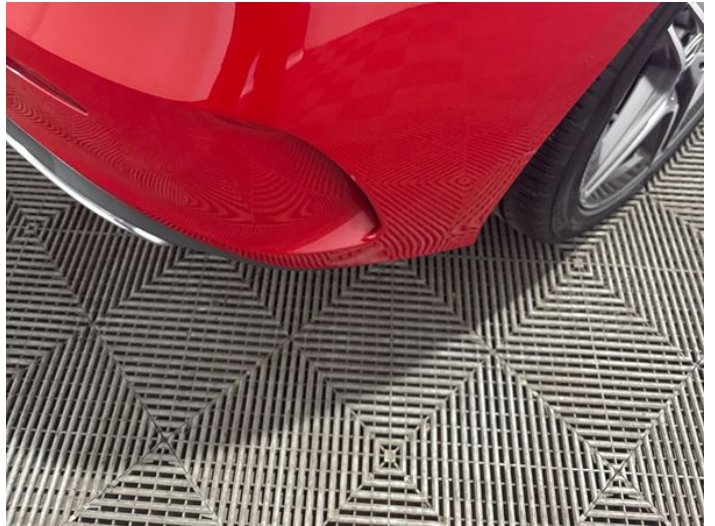
10: Bumper Rear  
Scratched  
25 to 100mm Thru Paint

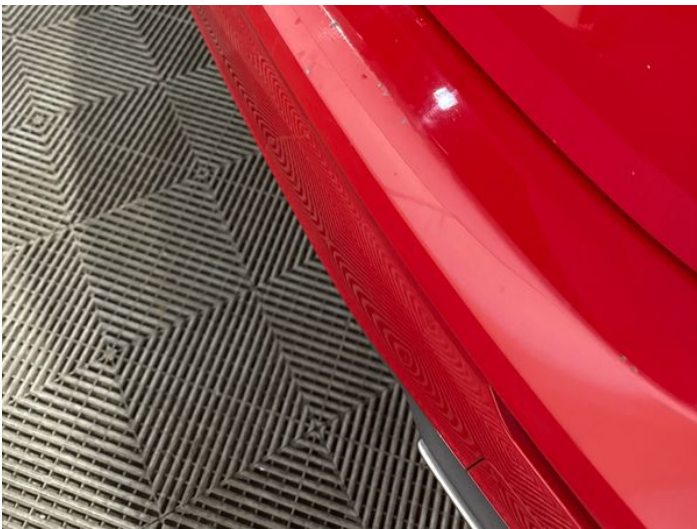
11: Bumper Rear  
Scratched  
25 to 100mm Thru Paint

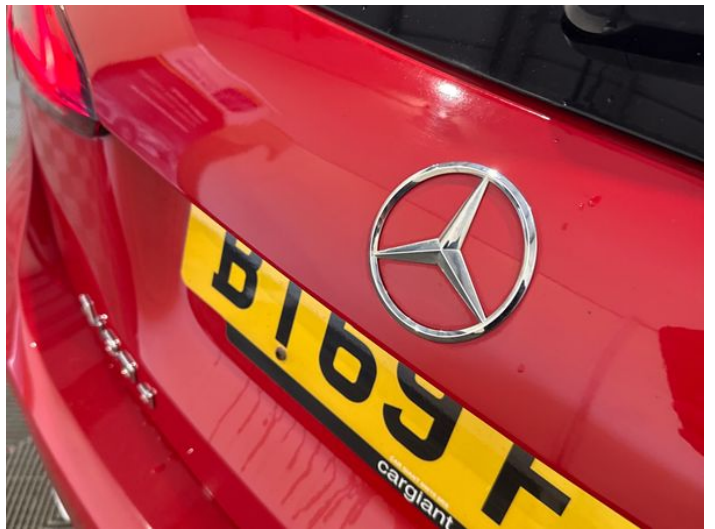
12: Tailgate  
Dented  
Over 30mm

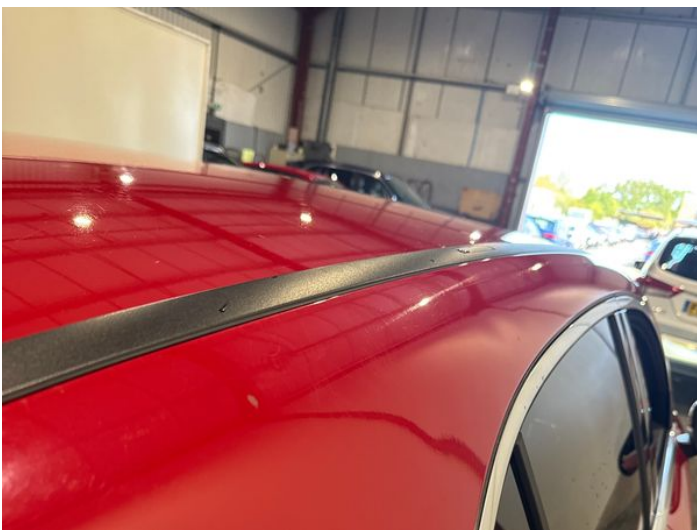
13: A Post os  
Dented  
Over 30mm

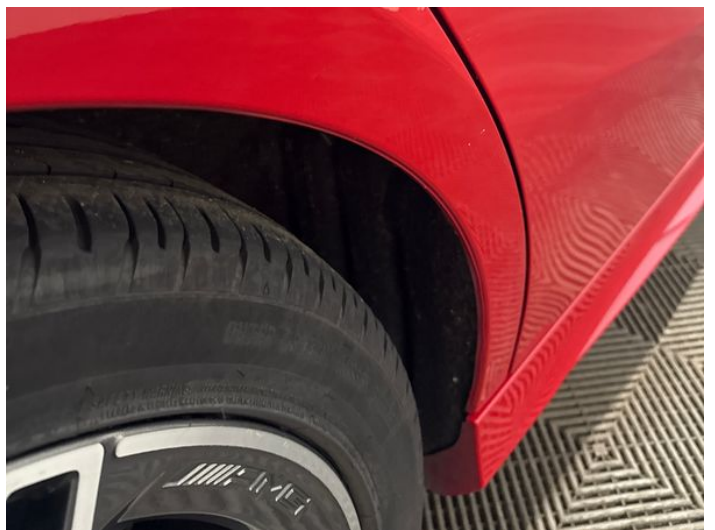
14: Qtr Panel osr  
Dented  
Between 10mm + 30mm

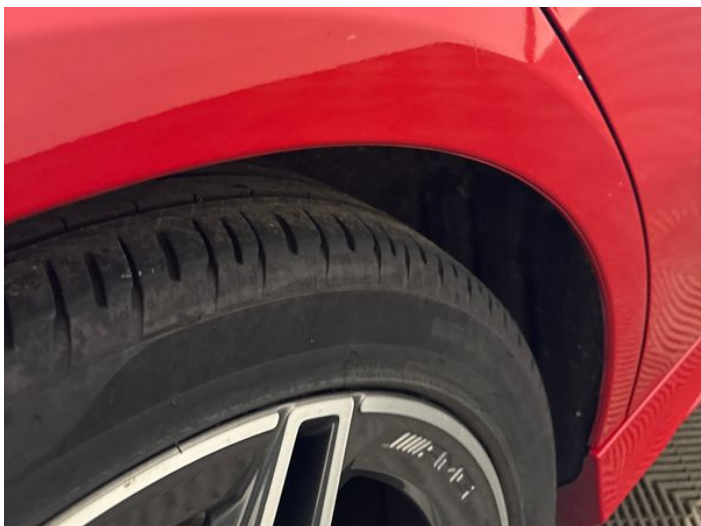
15: Qtr Panel osr  
Chipped  
1 To 5

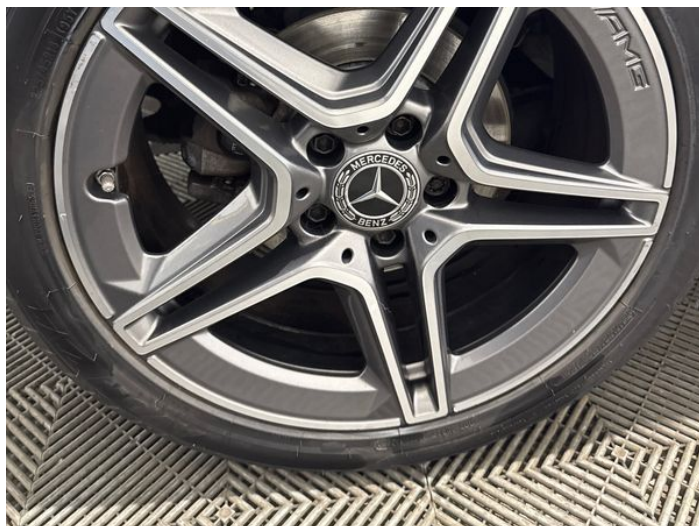
16: Wheel osr  
Scratched  
Up To 50mm

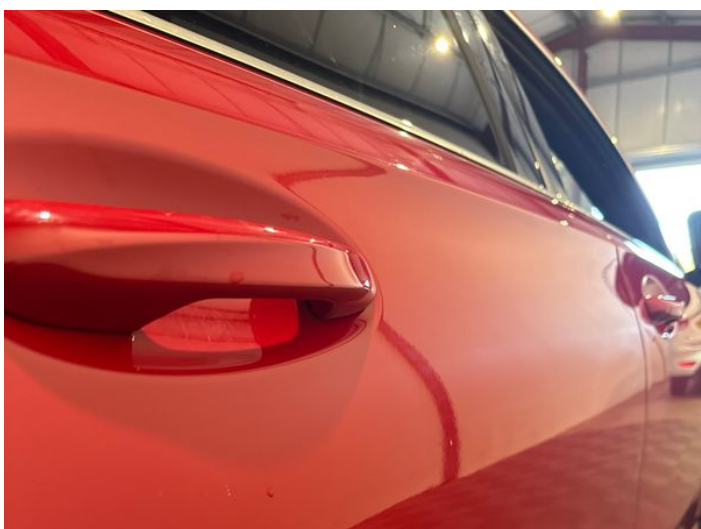
17: Door osr  
Poor Previous Repair  
Rippled Up To 30%

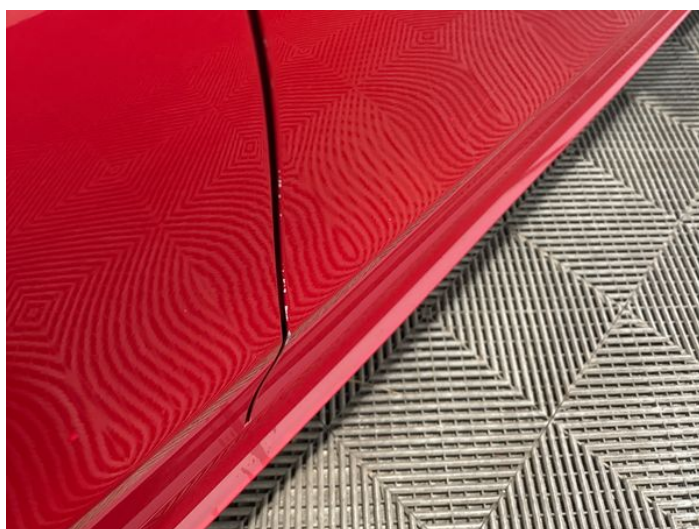
18: Door osf  
Chipped  
Edge Chip

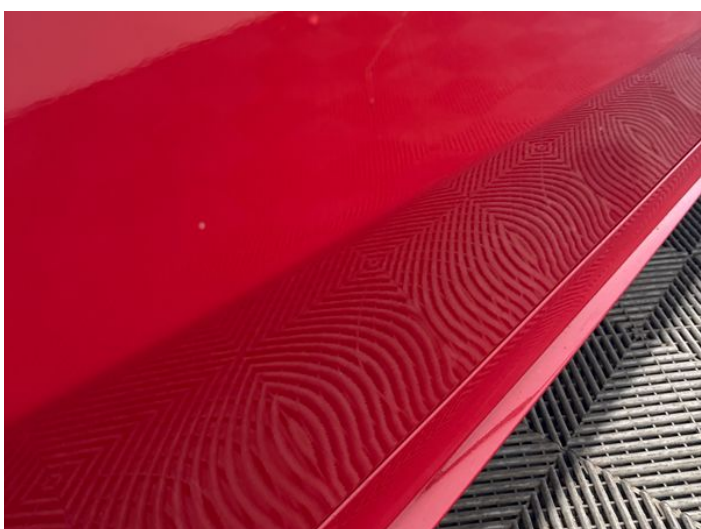
19: Door osf  
Poor Previous Repair  
Poor Paint

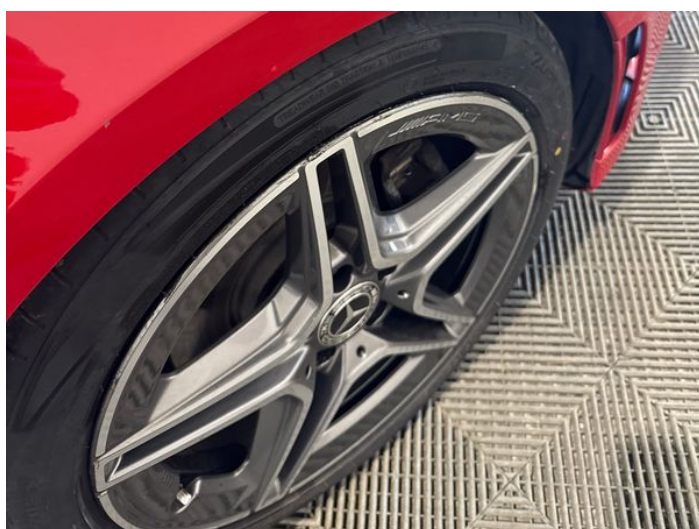
20: Wing osf  
Chipped  
1 To 5

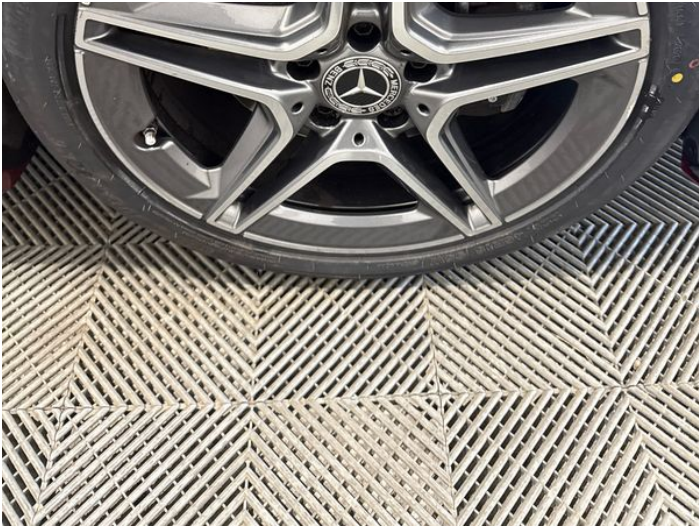
21: Wheel osf  
Scratched  
Over 50mm

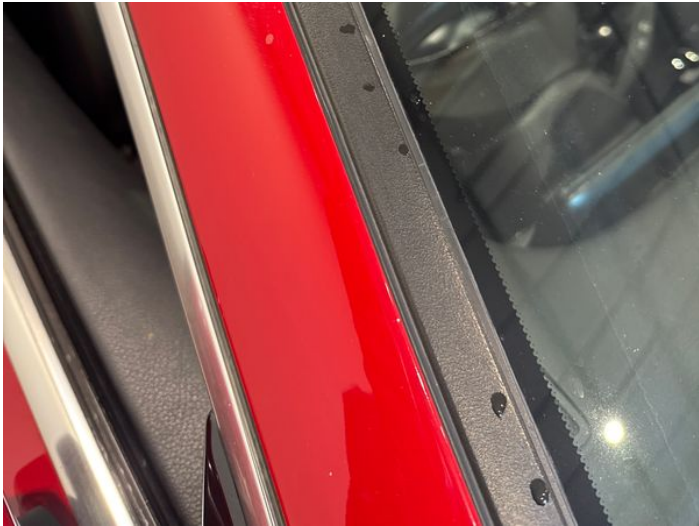
22: A Post os  
Chipped  
1 To 5

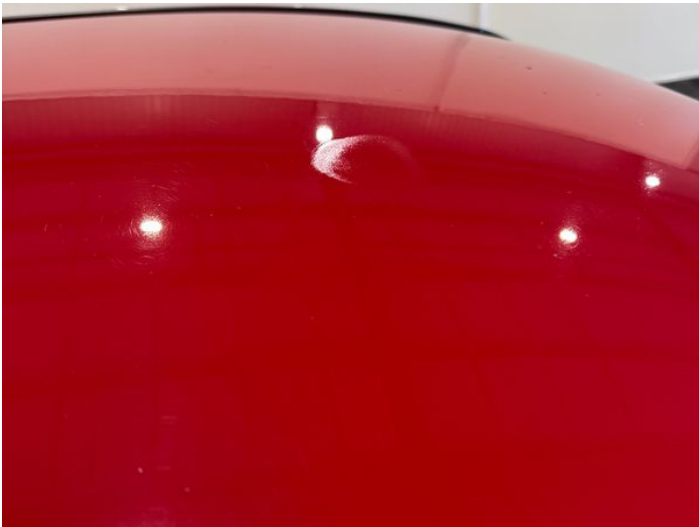
23: Roof  
Scratched  
Over 25mm Thru Paint
