## VEHICLE INSPECTION REPORT

**PX15OEJ**

### Citroen DS3 1.2 PureTech Dsign Plus 3dr

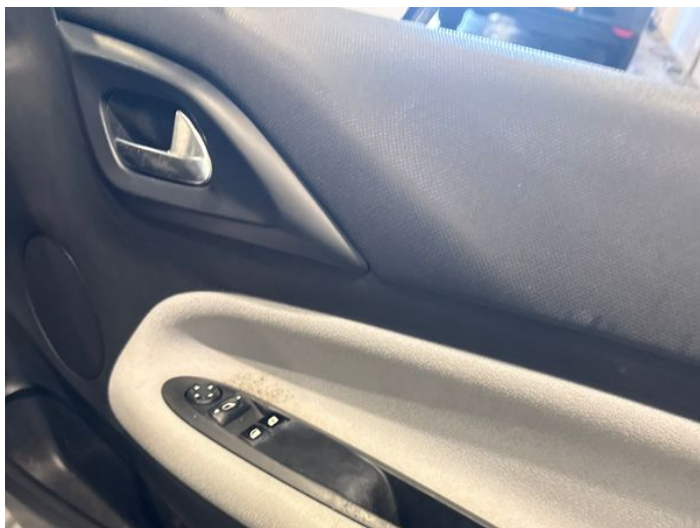
1: Door Pad osf  
Scuffed  
Over 25mm

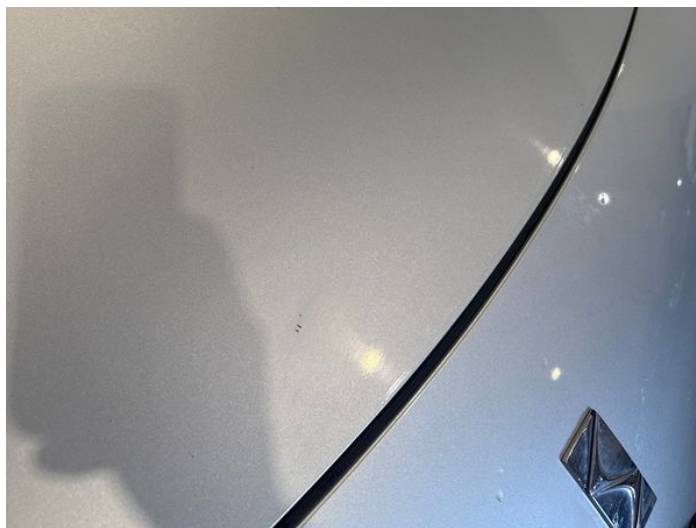
2: Bonnet  
Scratched  
Over 25mm Thru Paint

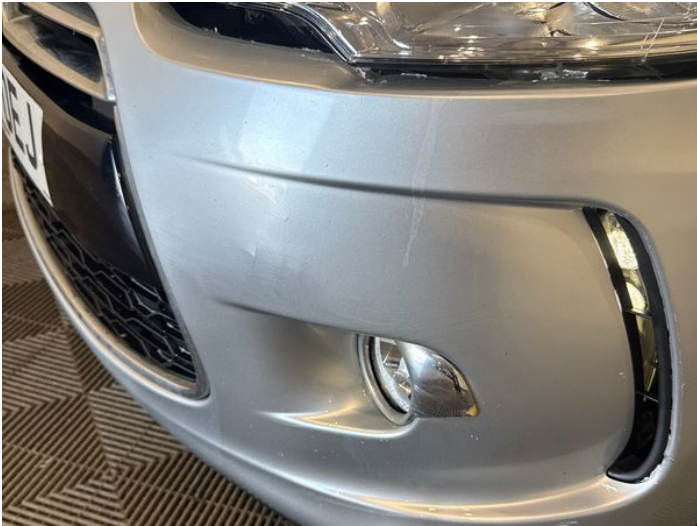
3: Bumper Front  
Dented  
With Paint Damage

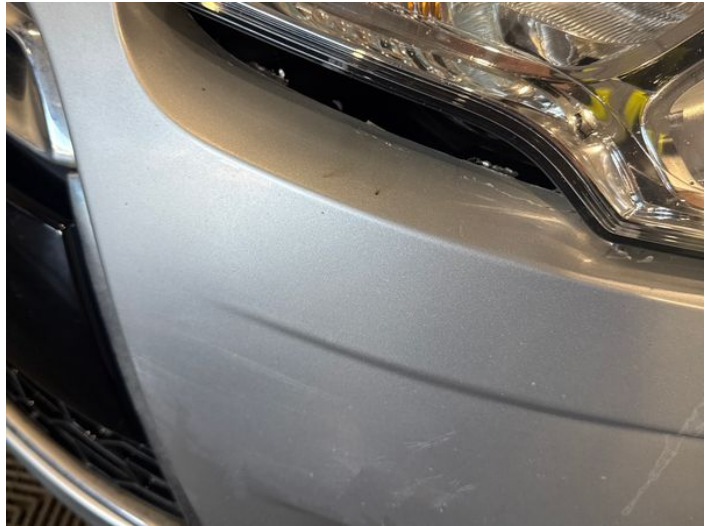
4: Bumper Front Moulding  
Missing  
Replace

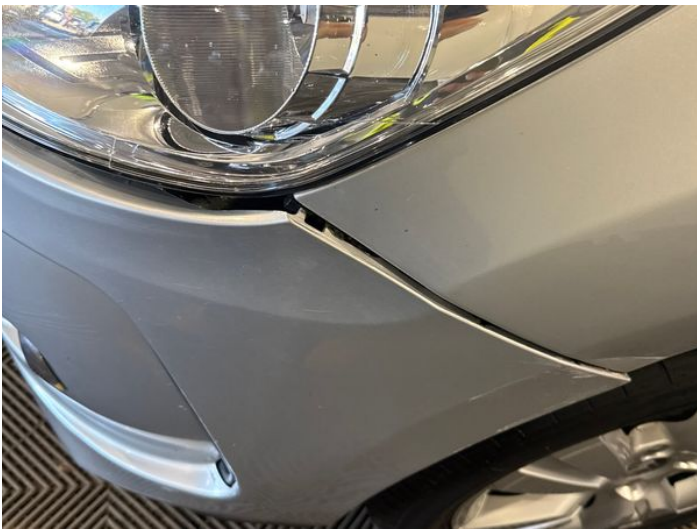
5: Bumper Front  
Insecure  
Action Required

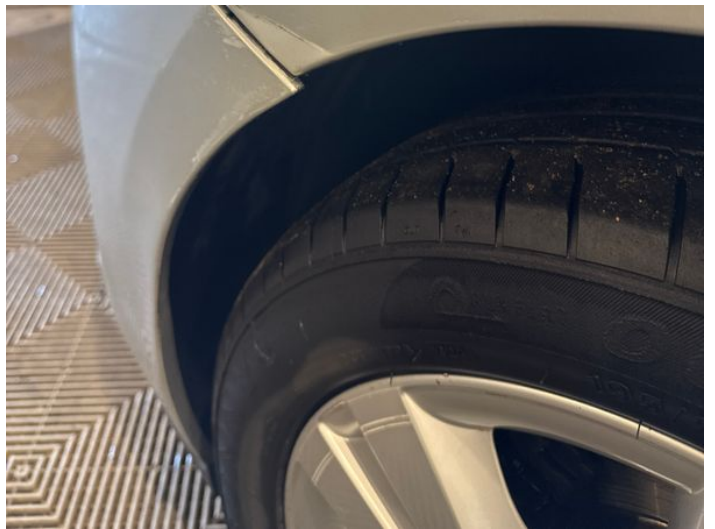
6: Wing nsf  
Dented  
With Paint Damage

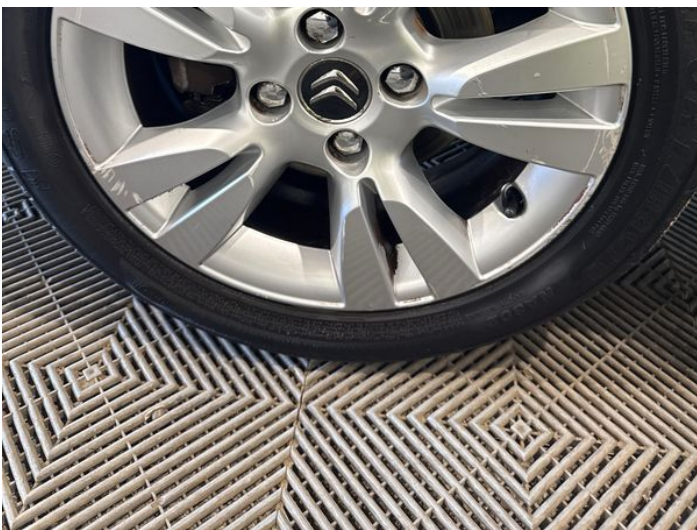
7: Wheel nsf  
Scratched  
Over 50mm

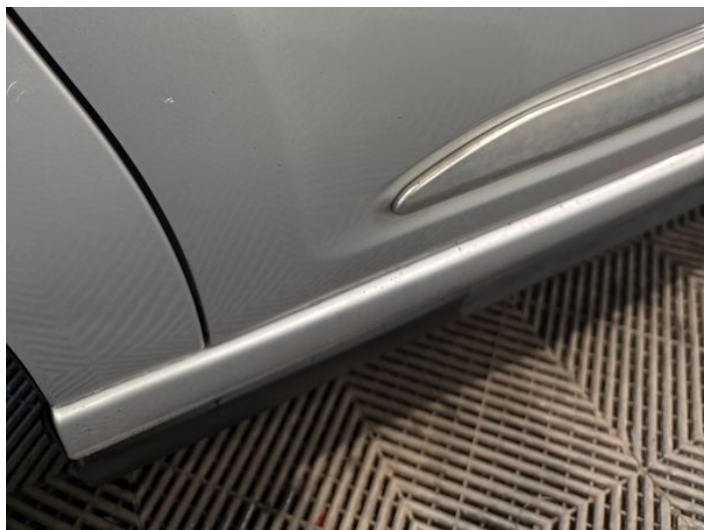
8: Door nsf  
Chipped  
1 To 5

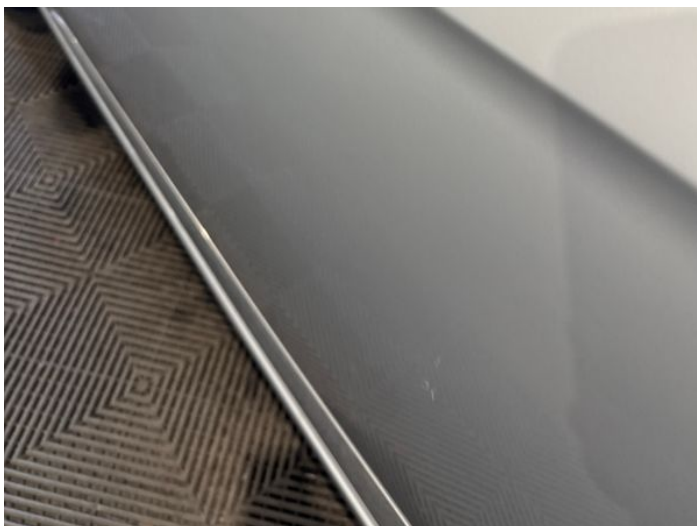
9: Door nsf  
Dented  
Between 10mm + 30mm

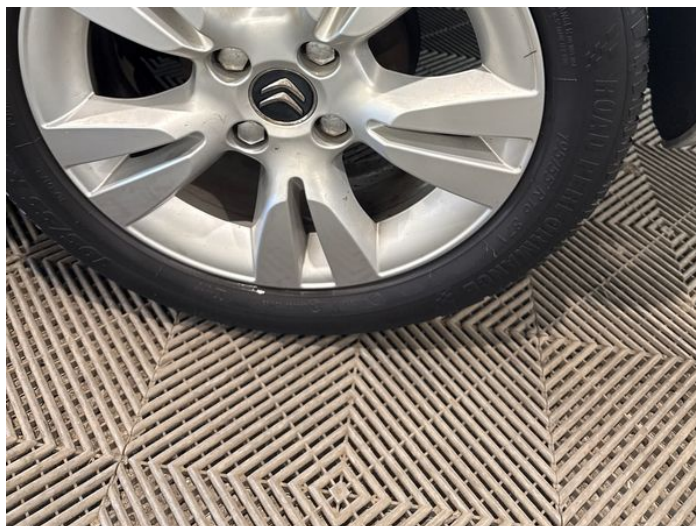
10: Wheel nsr  
Scratched  
Up To 50mm

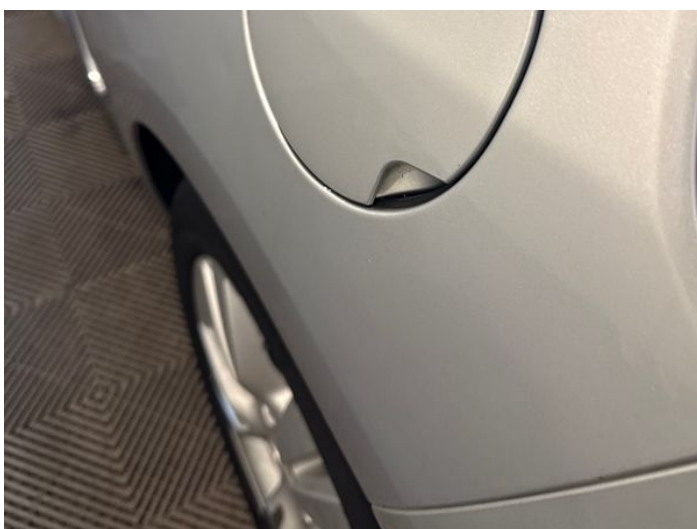
11: Qtr Panel nsr  
Dented  
2 Or Less UpTo 10mm

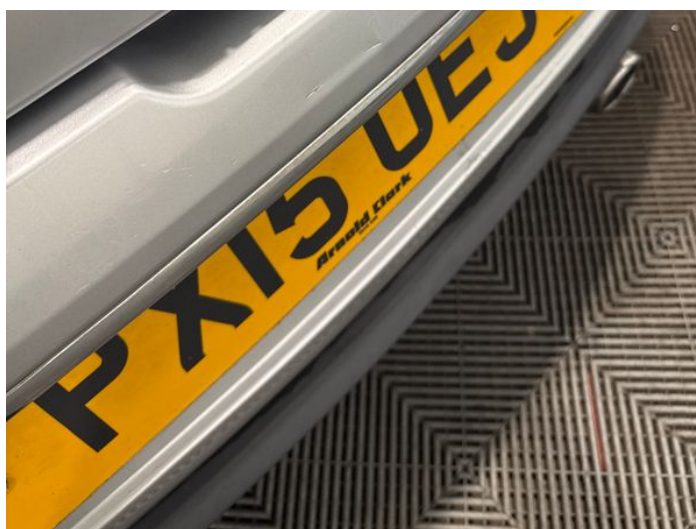
12: Bumper Rear  
Dented  
With Paint Damage

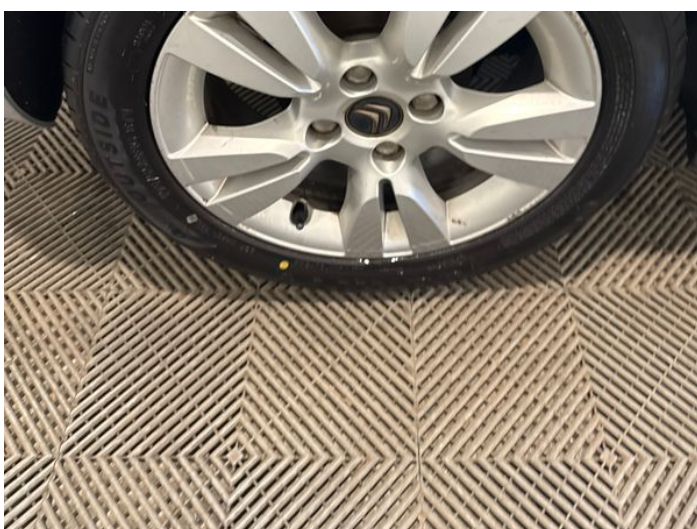
13: Wheel osr  
Scratched  
Over 50mm

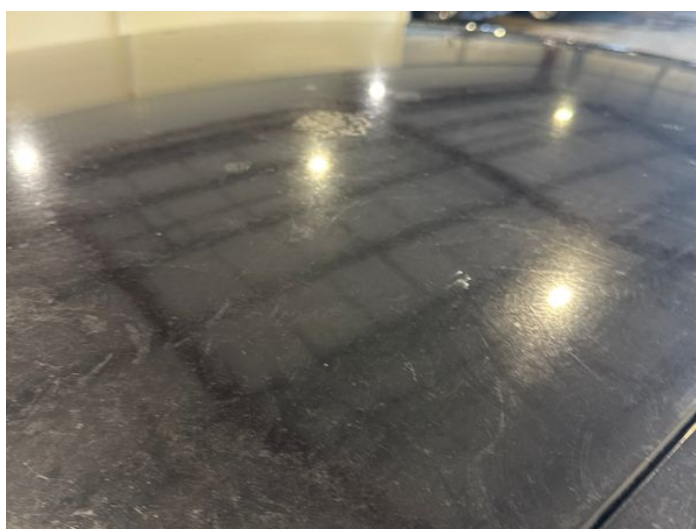
14: Roof  
Scratched  
Over 25mm Thru Paint

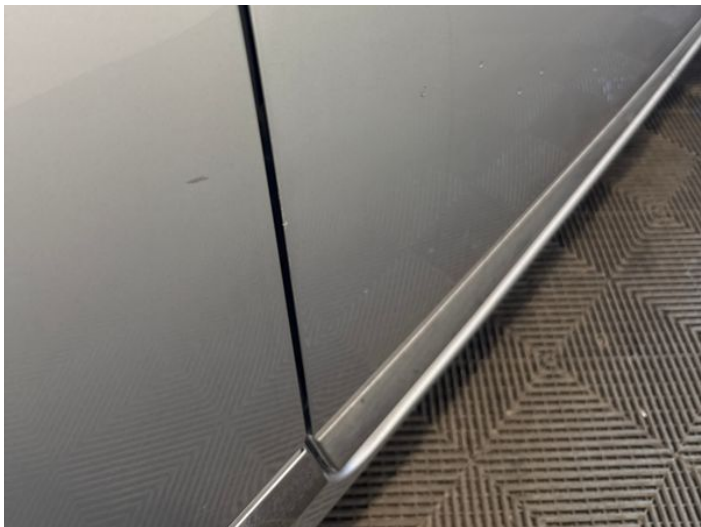
15: Door osf  
Chipped  
Edge Chip

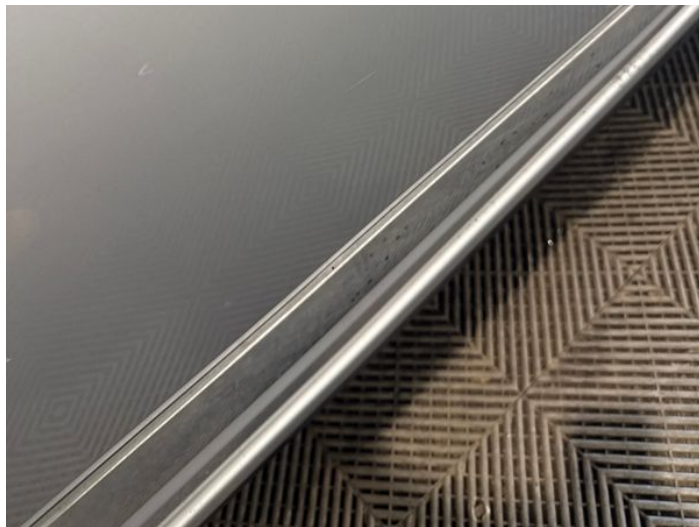
16: Door osf  
Scratched  
UpTo 25mm Thru Paint

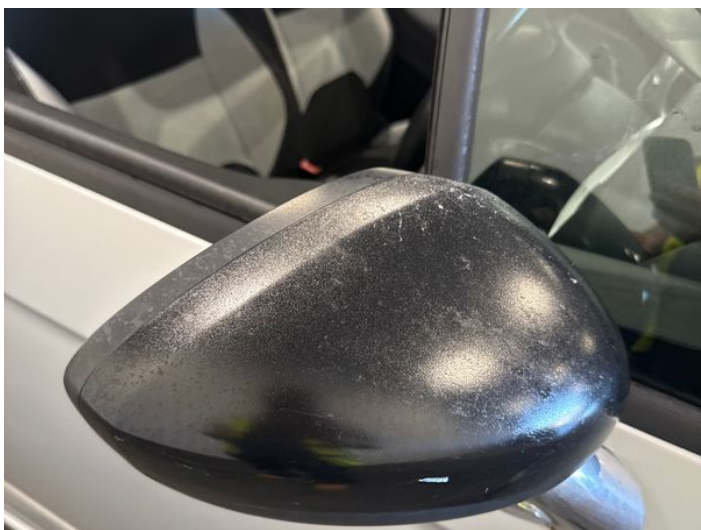
17: Door Mirror Assy osf  
Scratched (Painted)  
Over 25mm Thru Paint

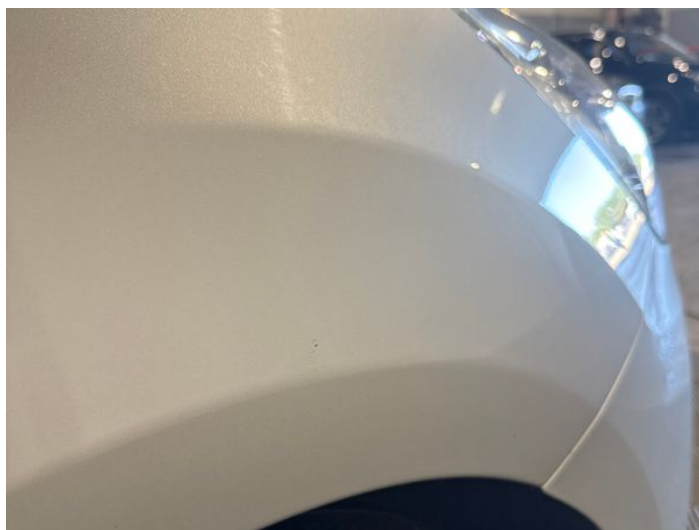
18: Wing osf  
Chipped  
1 To 5

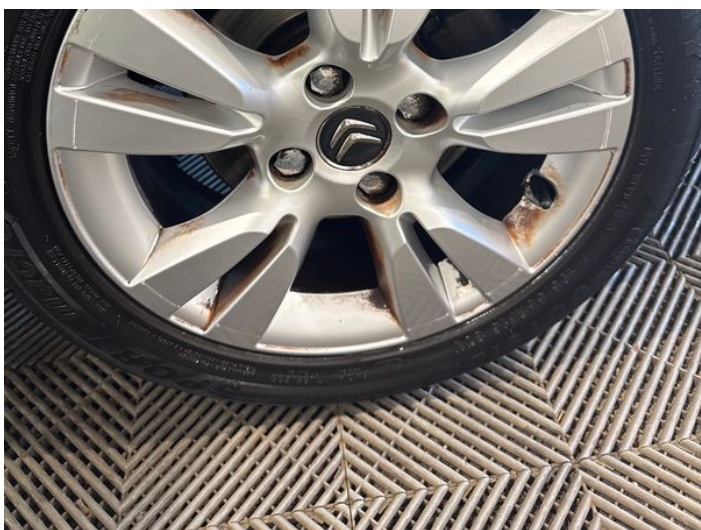
19: Wheel osf  
Scratched  
Over 50mm
