# VEHICLE INSPECTION REPORT

**EN13TWU**

## Hyundai IX35 2.0 CRDi Premium 5dr

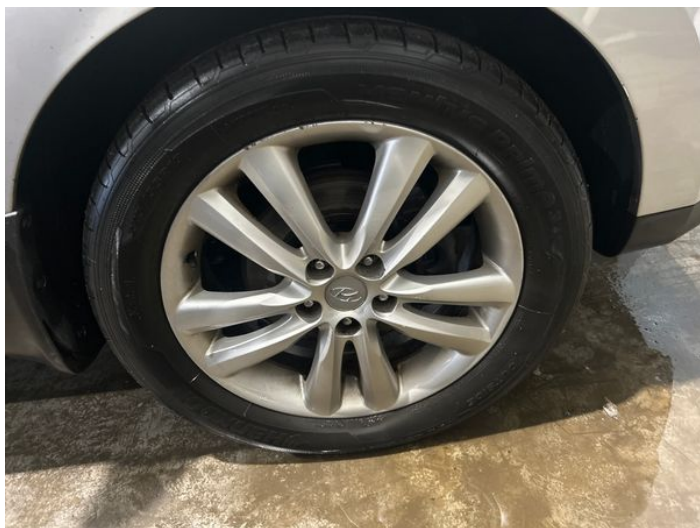
1: Wheel osf  
Scratched  
Over 50mm

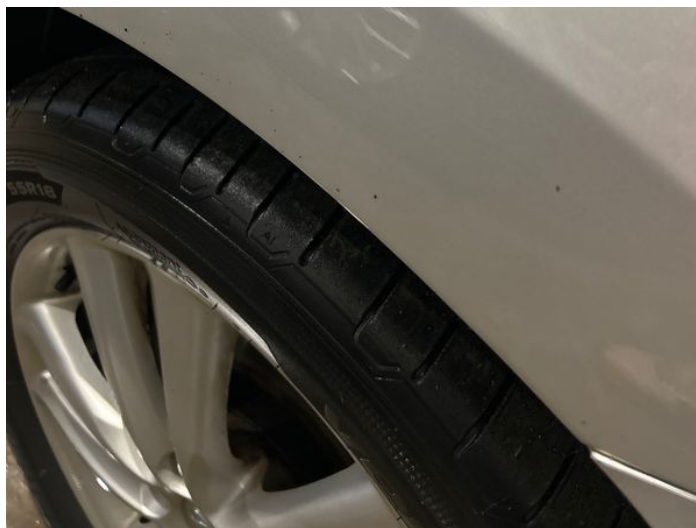
2: Wing osf  
Chipped  
1 To 5

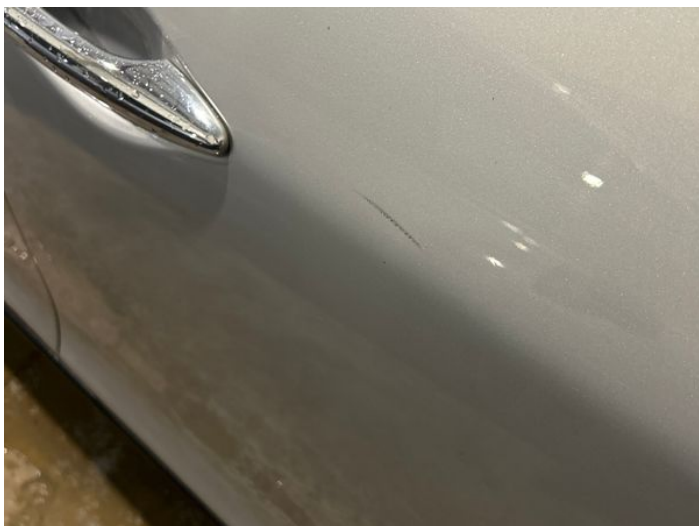
3: Door osf  
Scratched  
UpTo 25mm Thru Paint

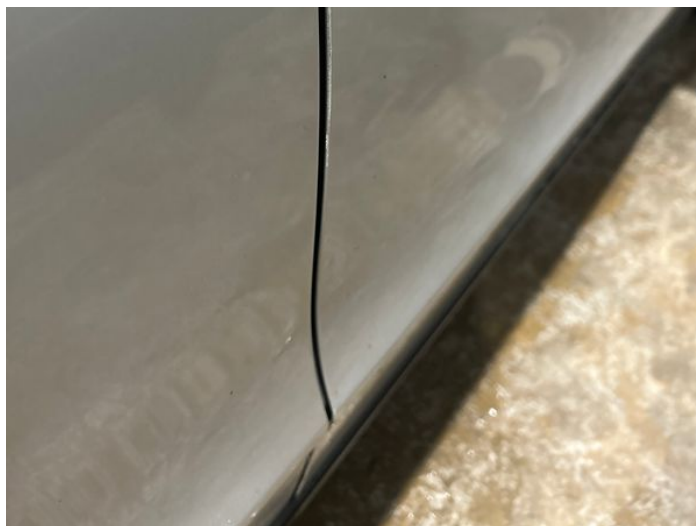
4: Door osf  
Chipped  
Edge Chip

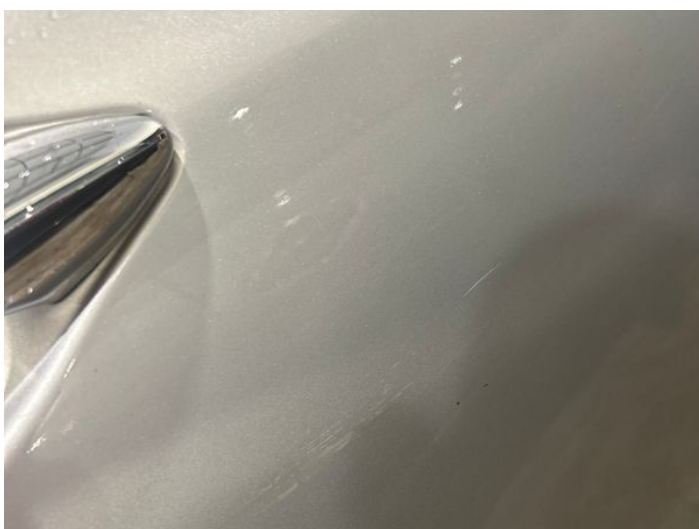
5: Door osr  
Scratched  
Over 25mm Thru Paint

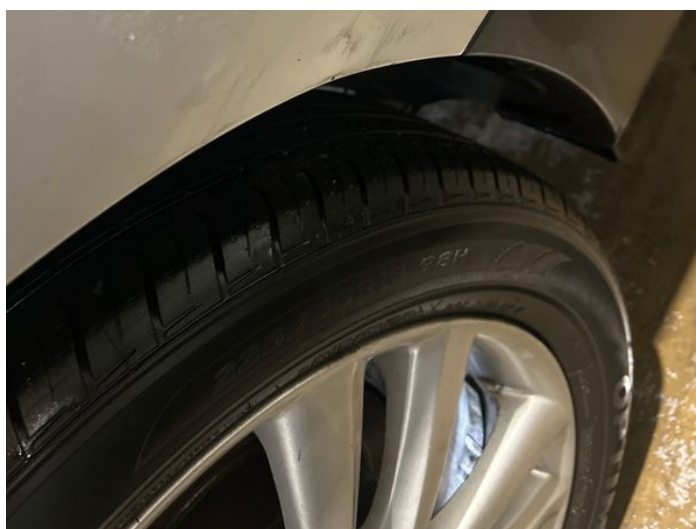
6: Qtr Panel osr  
Dented  
With Paint Damage

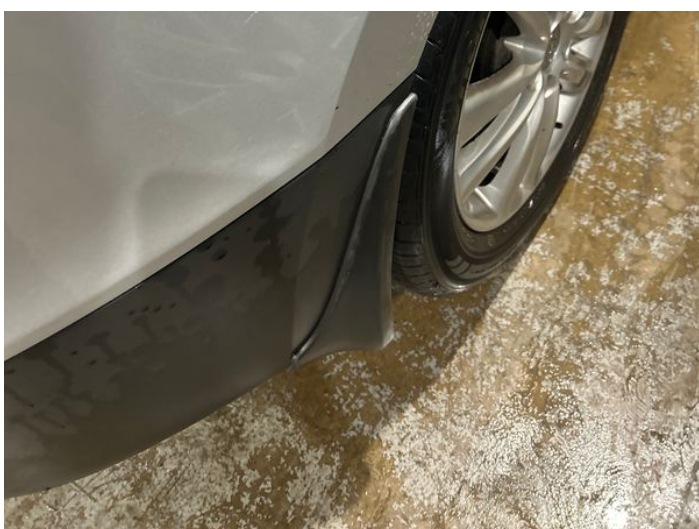
7: Bumper Rear  
Scratched  
25 to 100mm Thru Paint

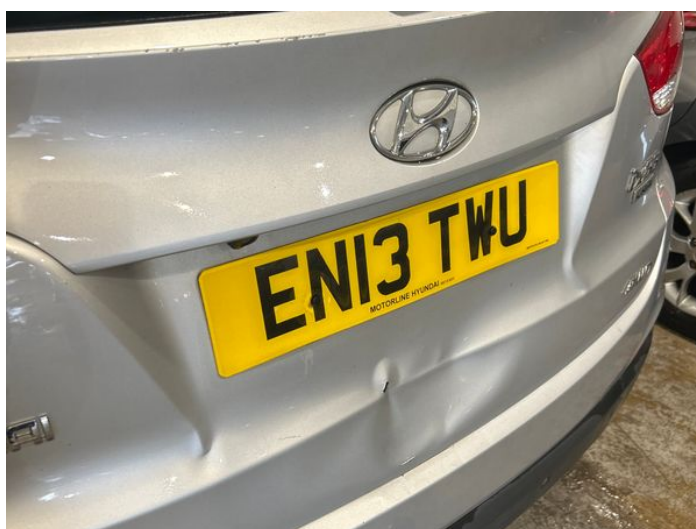
8: Tailgate  
Dented  
With Paint Damage

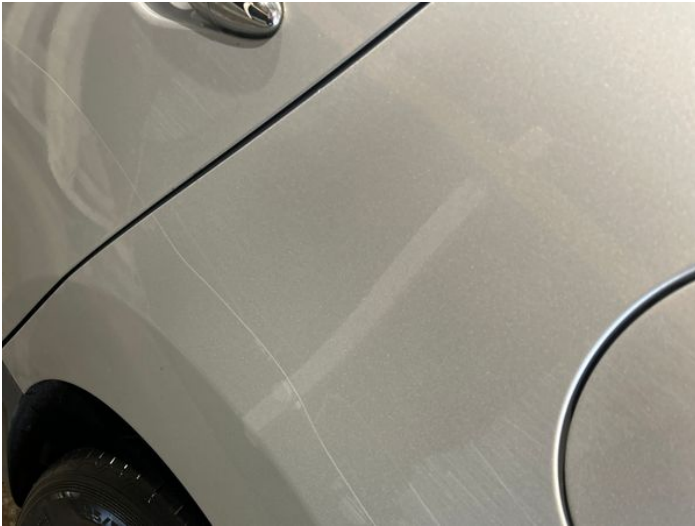
9: Qtr Panel nsr  
Scratched  
Over 25mm Thru Paint

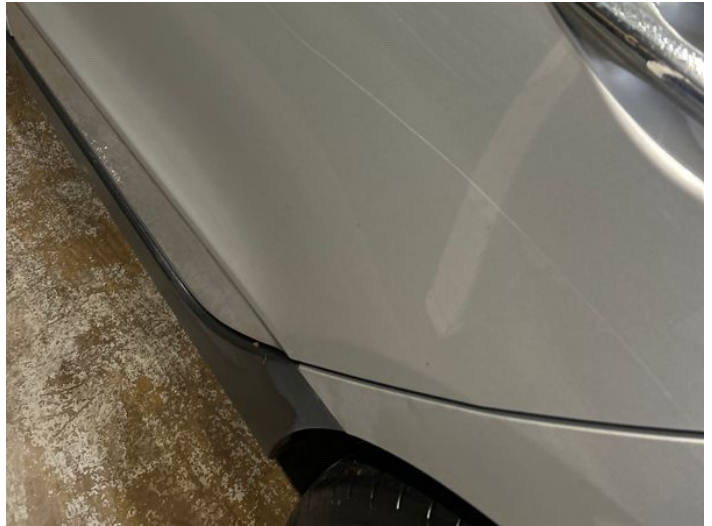
10: Door nsr  
Scratched  
Over 25mm Thru Paint

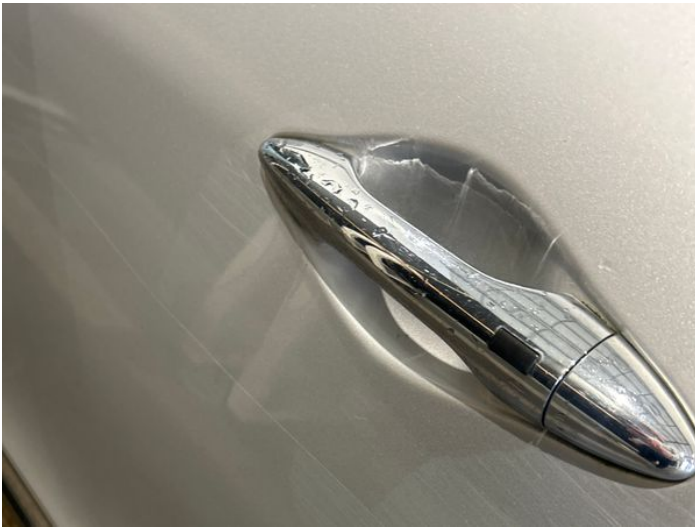
11: Door nsf  
Scratched  
Over 25mm Thru Paint

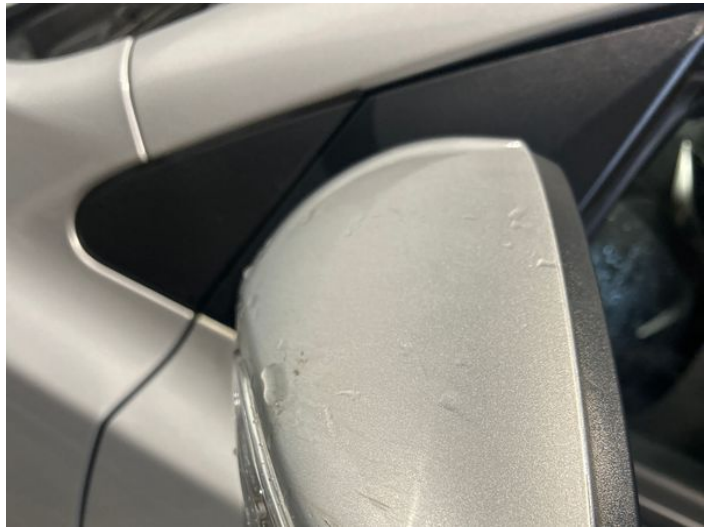
12: Door Mirror Assy nsf  
Scratched (Painted)  
UpTo 25mm Thru Paint

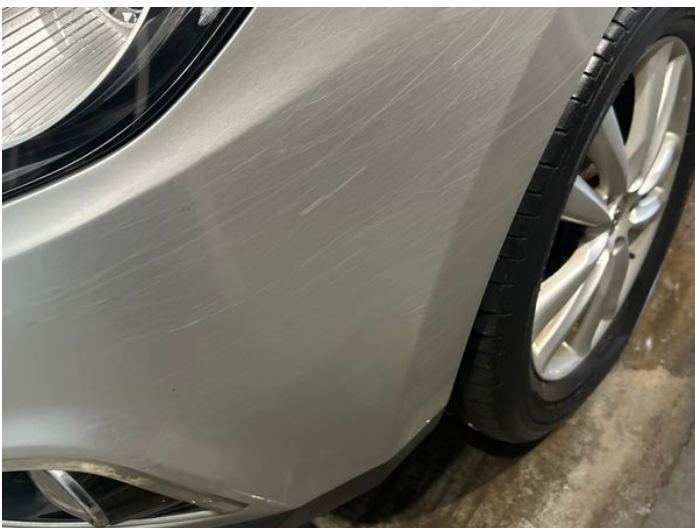
13: Bumper Front  
Scratched  
Over 100mm Thru Paint

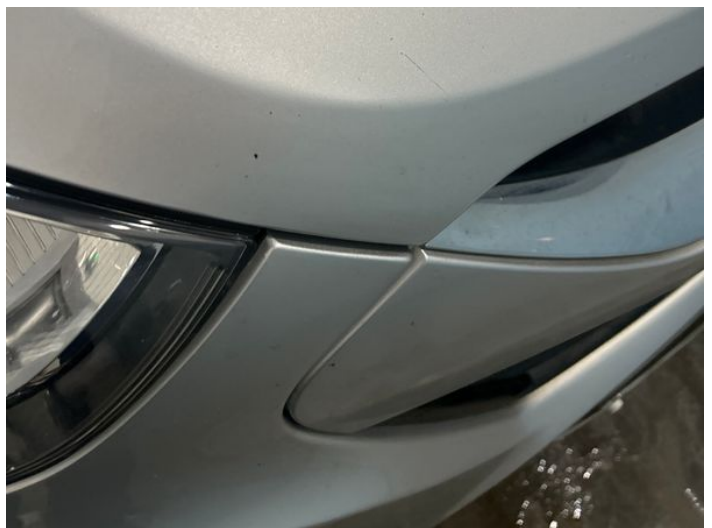
14: Bonnet  
Chipped  
1 To 5

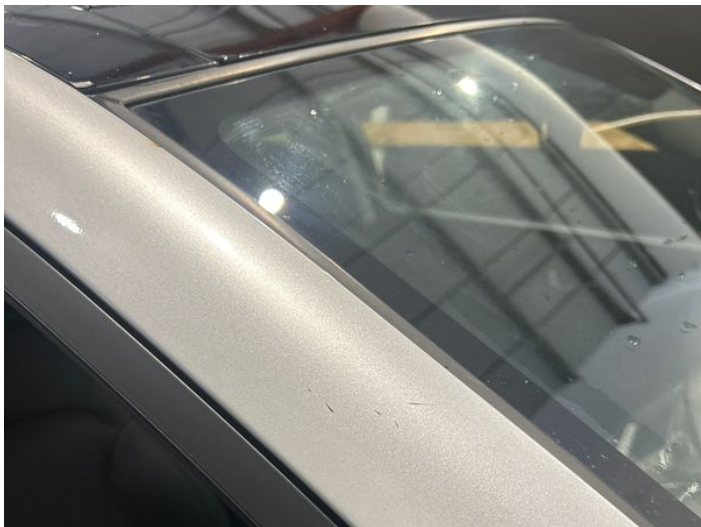
15: A Post os  
Chipped  
1 To 5
