## VEHICLE INSPECTION REPORT

**GV18JYX**

### Mercedes-Benz GLA GLA 200d AMG Line 5dr Auto

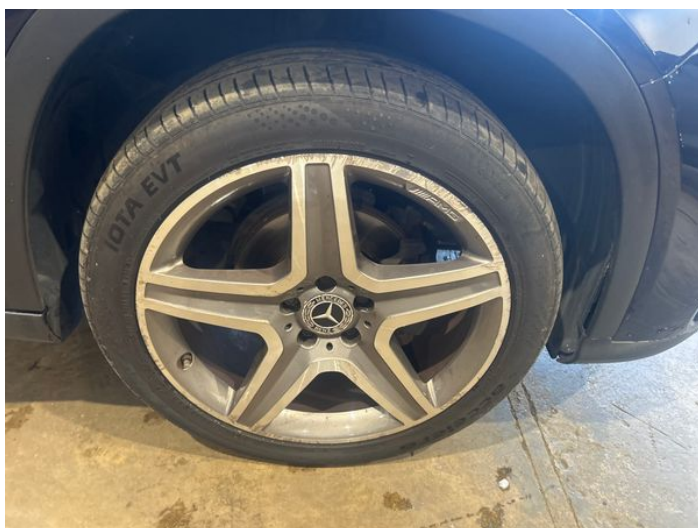
1: Wheel osf  
Scratched  
Over 50mm

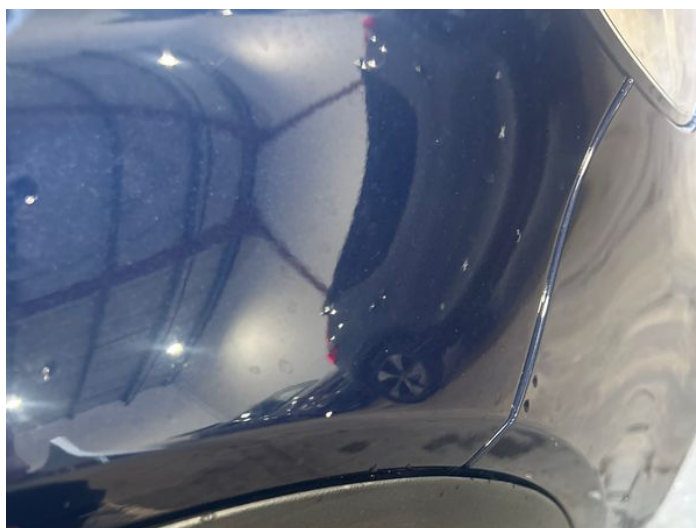
2: Wing osf  
Chipped  
1 To 5

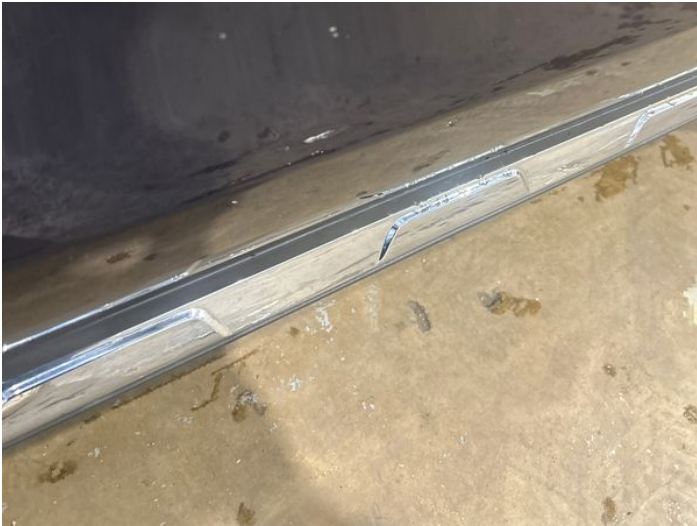
3: Door osf  
Chipped  
1 To 5

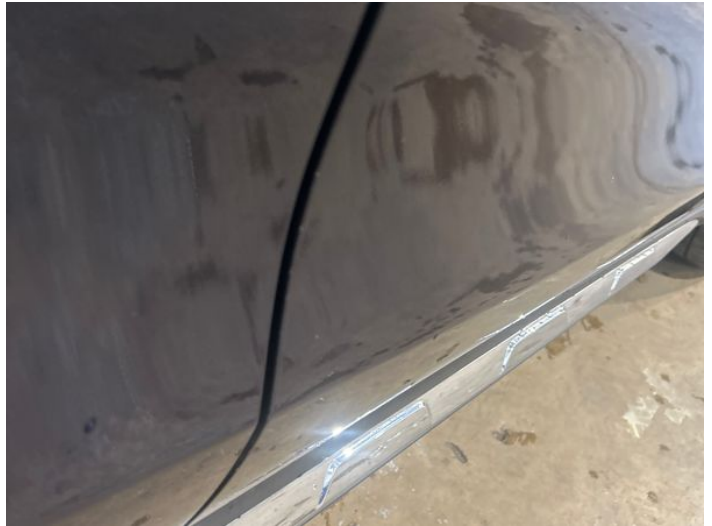
4: Door osf  
Chipped  
Edge Chip

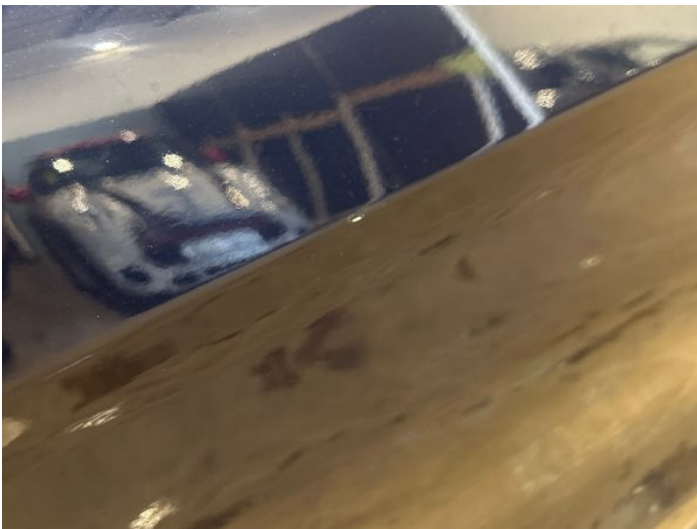
5: Door osr  
Chipped  
1 To 5

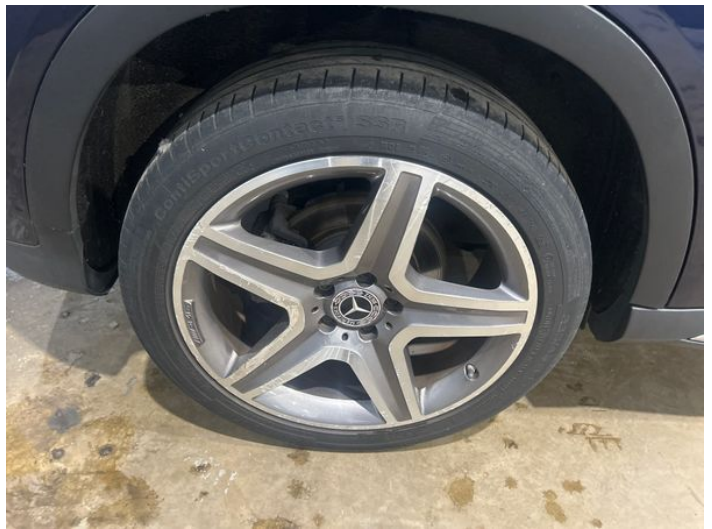
6: Wheel osr  
Corroded  
Light

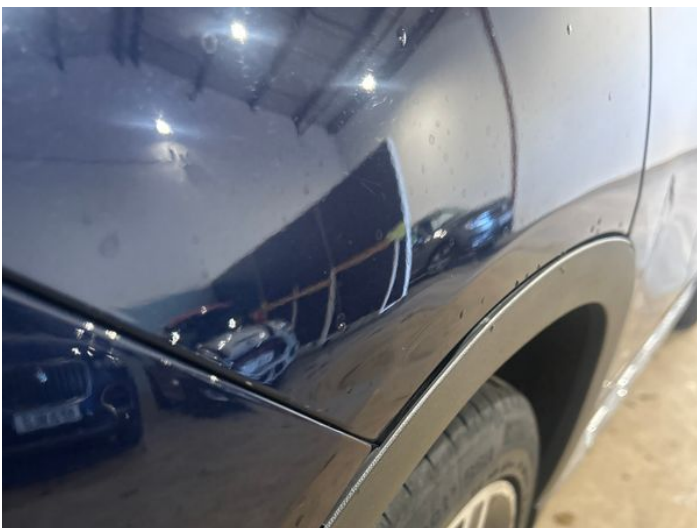
7: Qtr Panel osr  
Dented  
Between 10mm + 30mm

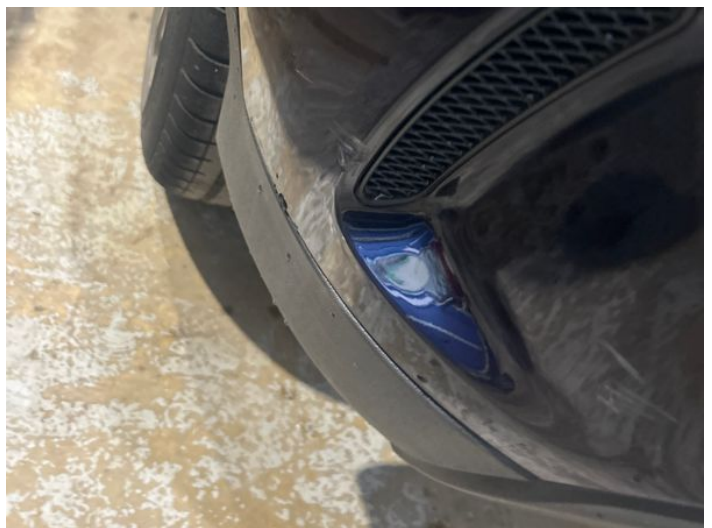
8: Bumper Rear  
Dented  
With Paint Damage

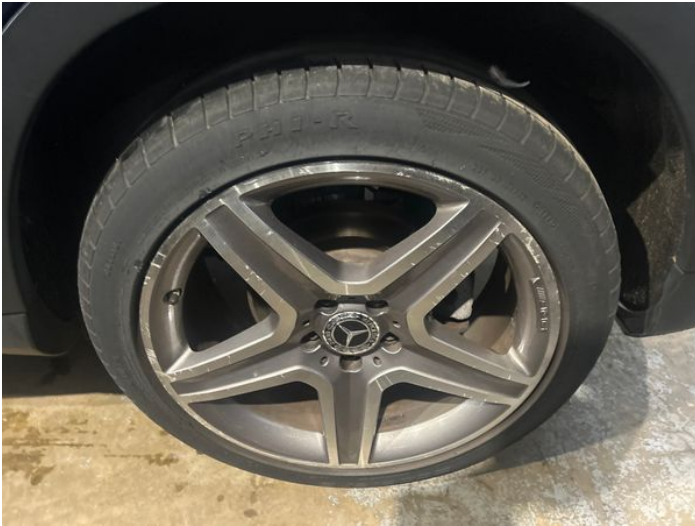
9: Wheel nsr  
Corroded  
Light

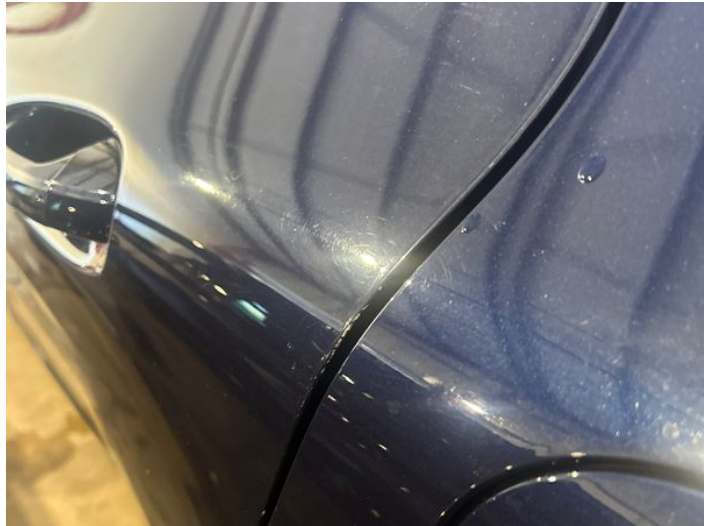
10: Door nsr  
Chipped  
Edge Chip

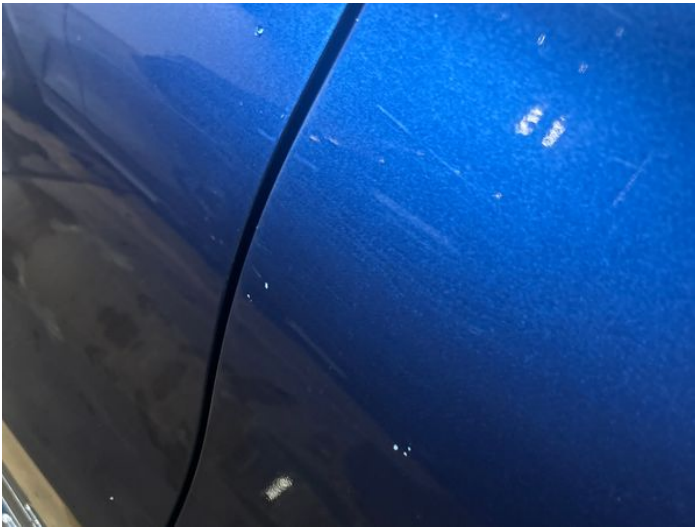
11: Door nsr  
Chipped  
1 To 5

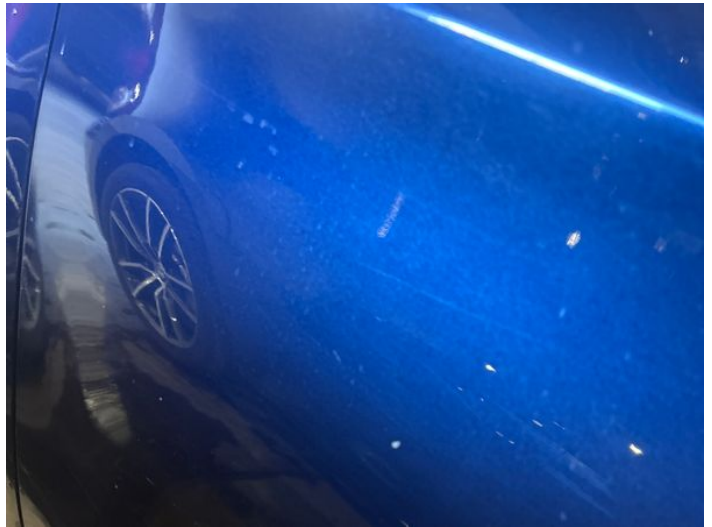
12: Door nsf  
Chipped  
1 To 5

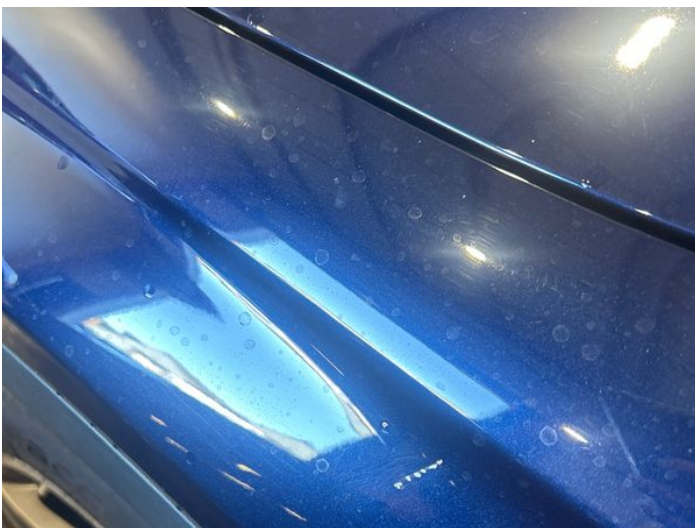
13: Wing nsf  
Chipped  
Multiple Chips

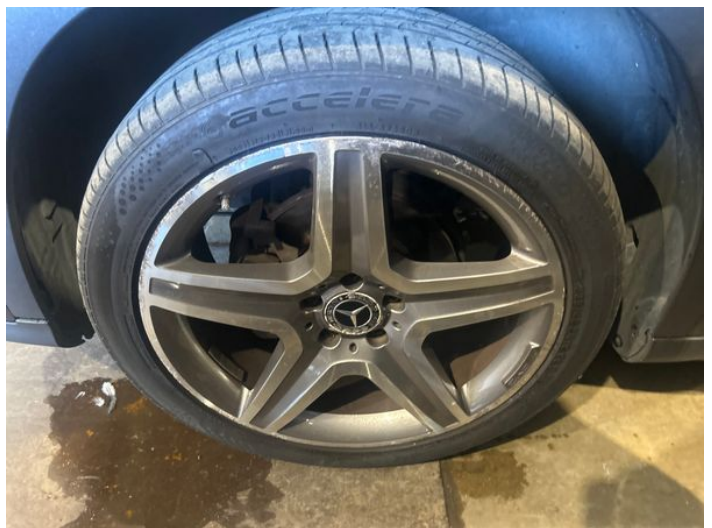
14: Wheel nsf  
Scratched  
Over 50mm

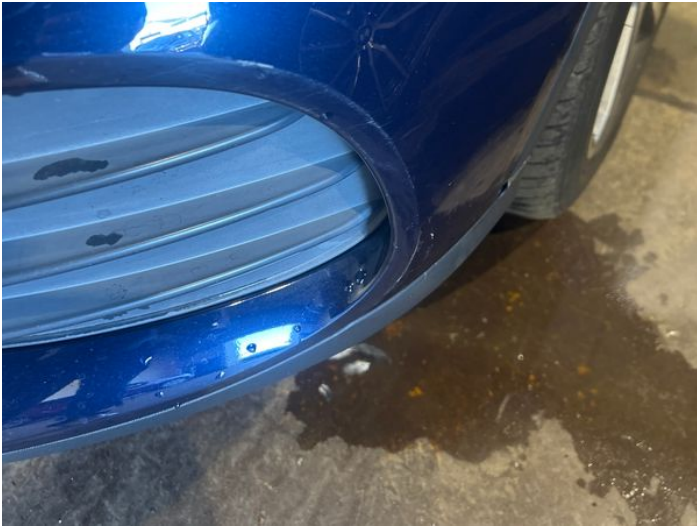
15: Bumper Front  
Scratched  
25 to 100mm Thru Paint

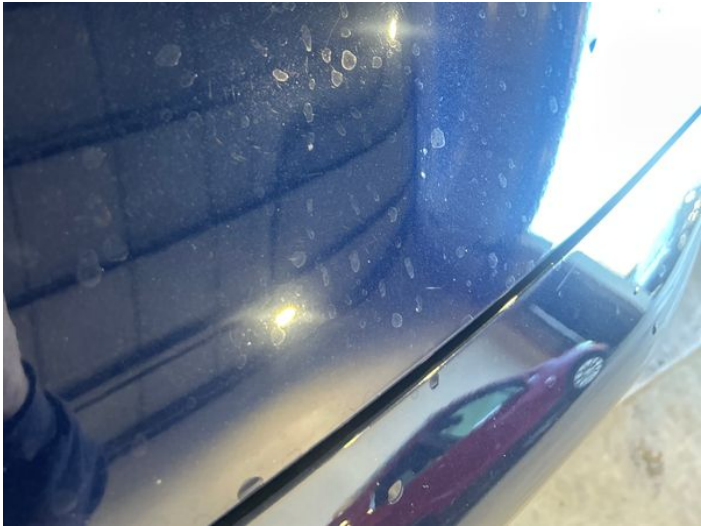
16: Bonnet  
Chipped  
1 To 5

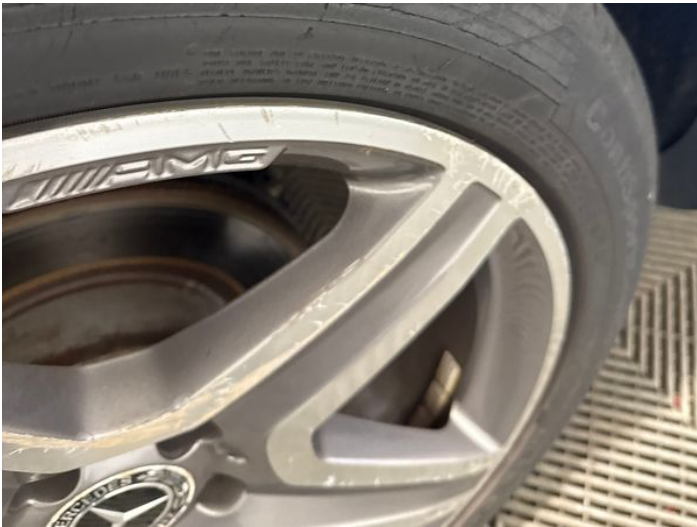
| OSR | CONTINENTAL | Damaged |

17: Tyre osr  
Damaged  
Replace
